# Arboricultural Report

## - Tree Safety Audit

Site Address:  
St Edwards Church, Grange Road,  
Netley Abbey, SO31 5FF

Date: 07<sup>th</sup> October 2023

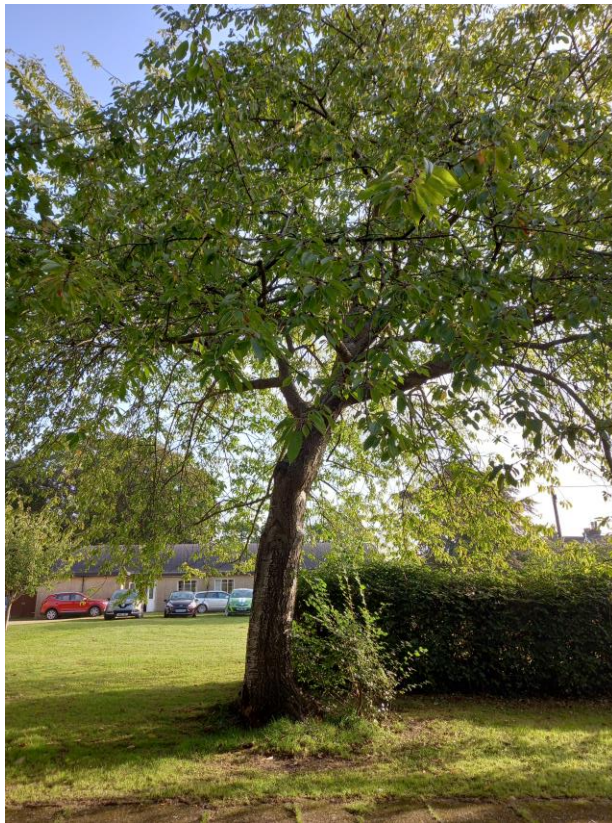
| Tree no. | Species | Location | Ht (m) | 1st Stem Diameter (mm) | 2nd Stem | Age Class | Physiological condition | Structural condition | Preliminary Recommendations | Priority rating |
|---|---|---|---|---|---|---|---|---|---|---|
| T2 | Cherry | East side of footpath. | 8 | 510 | | | Fair.Good leaf volume and colour. Evidence of fungal colonisation in heartwood. | Poor. Significant wound on west side of stem base, large area of central decay present, no buttress to west. Whole canopy biased north-northeast so there is no tension root anchoring the tree. Developed compression roots. | Plan to remove and replant | 2- within 1 year |

*T2 – cherry. Whole tree*

| Tree no. | Species | Location | Ht (m) | 1st Stem diameter (mm) | Preliminary Recommendations | Priority rating | Notes |
|---|---|---|---|---|---|---|---|
| T2 | Cherry | East side of footpath. | 8 | 510 | Plan to remove and replant | 2- within 1 year | |

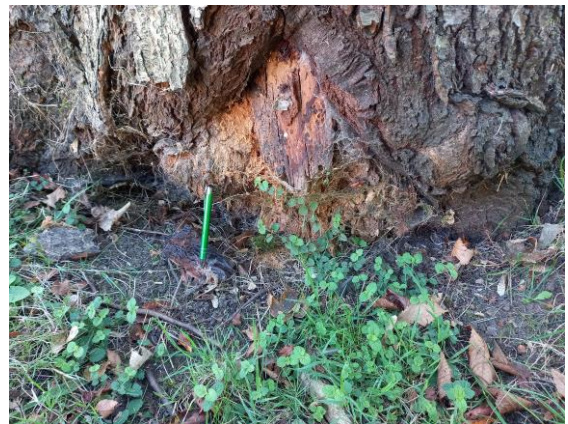
*T2 – cherry. Decay at base*

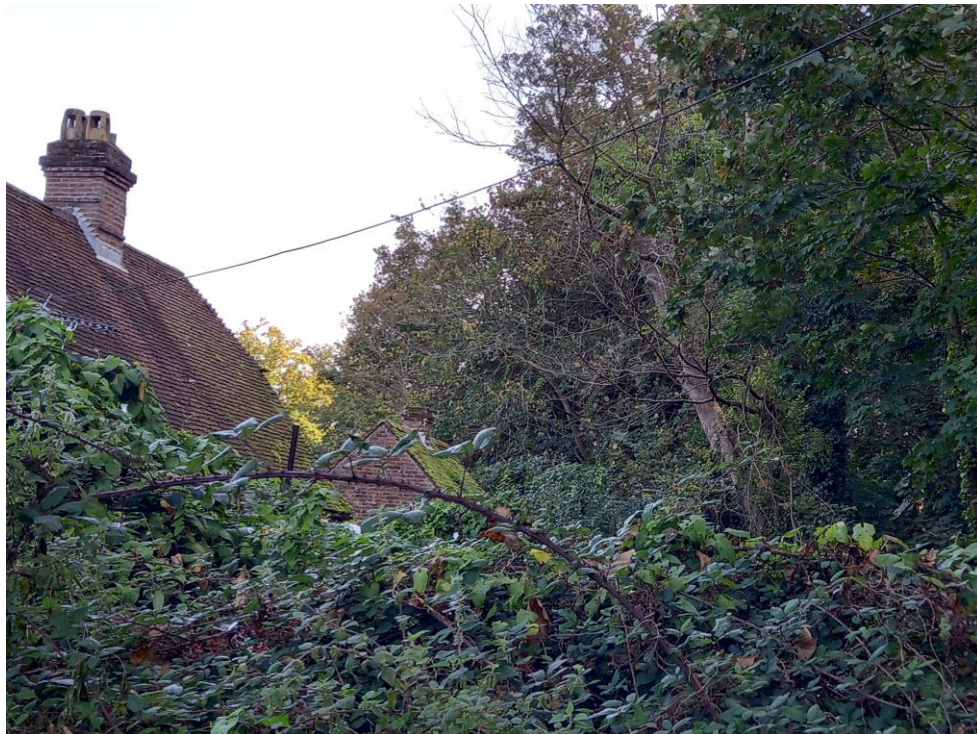
| Tree no. | Species | Location | Ht (m) | 1st Stem Diameter (mm) | 2nd Stem | Age Class | Physiological condition | Structural condition | Preliminary Recommendations | Priority rating |
|---|---|---|---|---|---|---|---|---|---|---|
| T5 | Ash | Behind cottage in Abbey grounds | 5 | 290 | | Pole | Dead | Dead and biased toward house | Fell, just within striking distance of cottage or railings | 1- within 3 months |

*T5 – cherry. Dead ash behind cottage*

| Tree no. | Species | Location | Ht (m) | 1st Stem diameter (mm) | Preliminary Recommendations | Priority rating | Notes |
|---|---|---|---|---|---|---|---|
| T5 | Ash | Behind cottage in Abbey grounds | 5 | 290 | Fell, just within striking distance of cottage or railings | 1- within 3 months | |

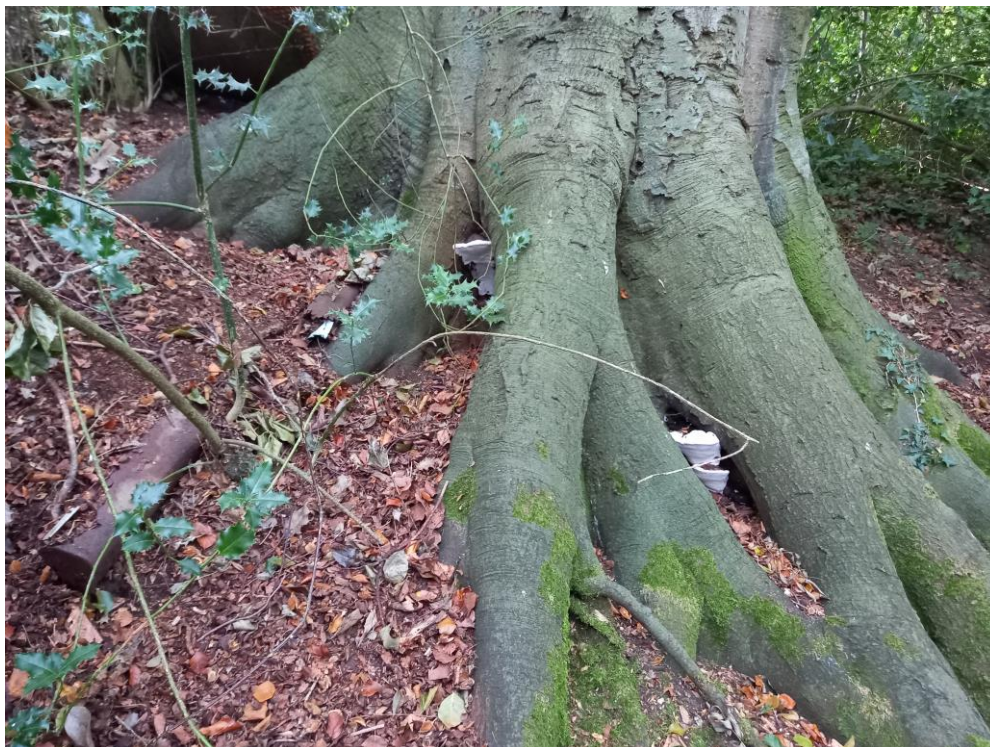
| Tree no. | Species | Location | Ht (m) | 1st Stem Diameter (mm) | 2nd Stem | Age Class | Physiological condition | Structural condition | Preliminary Recommendations | Priority rating |
|---|---|---|---|---|---|---|---|---|---|---|
| T8 | Beech | In woodland on bank to east | 26* | 1320 | | OMa | Good | Good to fair. <i>Ganoderma Spp. fungal fruiting bodies</i> present at 6 points around base of stem. See arboricultural info. Good buttressing especially on downhill (north) side. Large lever arm to north with an open union. Area of damage on main stem opposite scaffold, north side, c.800x300mm, occluding. Multiple nails on west side, possible tree house in the past. | None, noted. | None, noted. |

#### 8.2 *Ganoderma species* fungi. Ganoderma is a fungal pathogen of trees that produces a white rot in trees. This can, over time, cause hollowing of the stem as the fungus preferentially degrades the lignin component of wood, leaving a stringy white mass of cellulose. In advanced stages, the compressive strength of the wood is significantly reduced. Prior to this, the partially decayed wood retains tensile strength for considerable time, so trees colonised with *Ganoderma* can become hollowed, but the sapwood is relatively unaffected meaning trees can thrive for many generations after colonisation. Trees will often respond to localised decay laying down additional wood to strengthen potential weak points. Over time, a tree may develop a 'life belt' of buckled wood as the tree sinks under its own compressive weight. There are several species of *Ganoderma* with varying rates of degradation but should rarely trigger an immediate response to fell unless the tree is in poor condition and the colonisation is extensive.

*T8 beech with Ganoderma at base.*

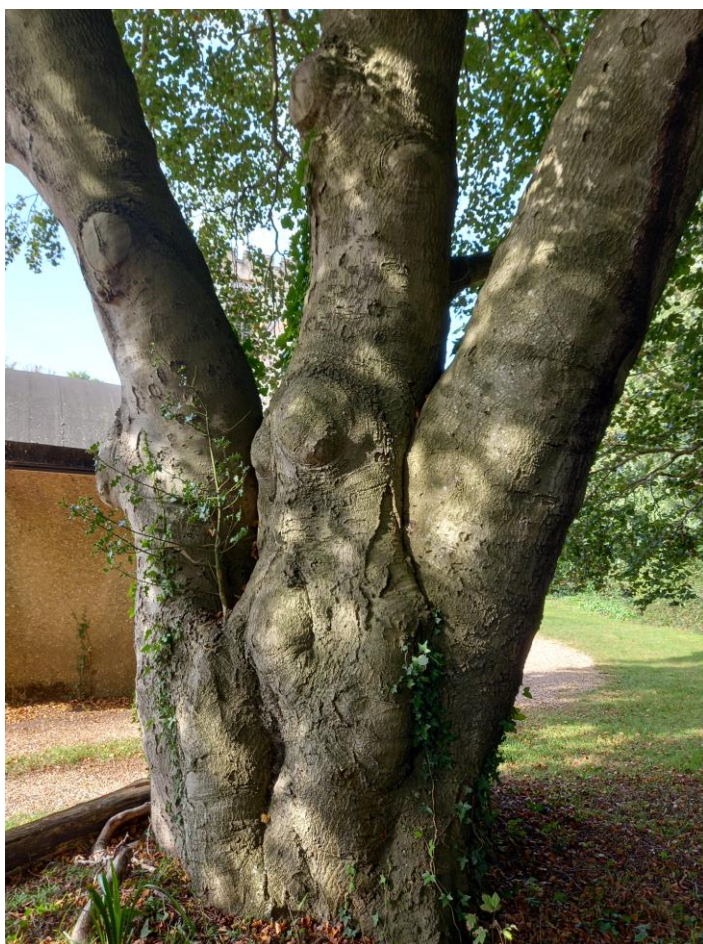
| Tree no. | Species | Location | Ht (m) | 1st Stem Diameter (mm) | 2nd Stem | Age Class | Physiological condition | Structural condition | Preliminary Recommendations | Priority rating |
|---|---|---|---|---|---|---|---|---|---|---|
| T11 | Beech | East of site | 22 | 1310 | | Veteran | Good | Good. Three stems from 1-1.5m above ground level. Slight reaction ribs at unions but not significant for age. Water filled cavity north-northwest side of stem at 0.6m above ground level. Holly, epiphytic, on south side 1m, well rooted into union. Multiple historic pruning wounds, mostly occluded on lower main and southern stem but 2 larger unoccluded wounds/stub ends on northern branch. Low target. Evidence of decay behind several pruning wounds on upper southern stem. Visible bat features present, high likelihood of roost sites present. | None, noted. | None, noted. |

*T11 Beech in car park.*
