# Tree Survey Report

Highwood

Site:  
POS 14

Ref:  
June 2023  
JFA10259 POS 14

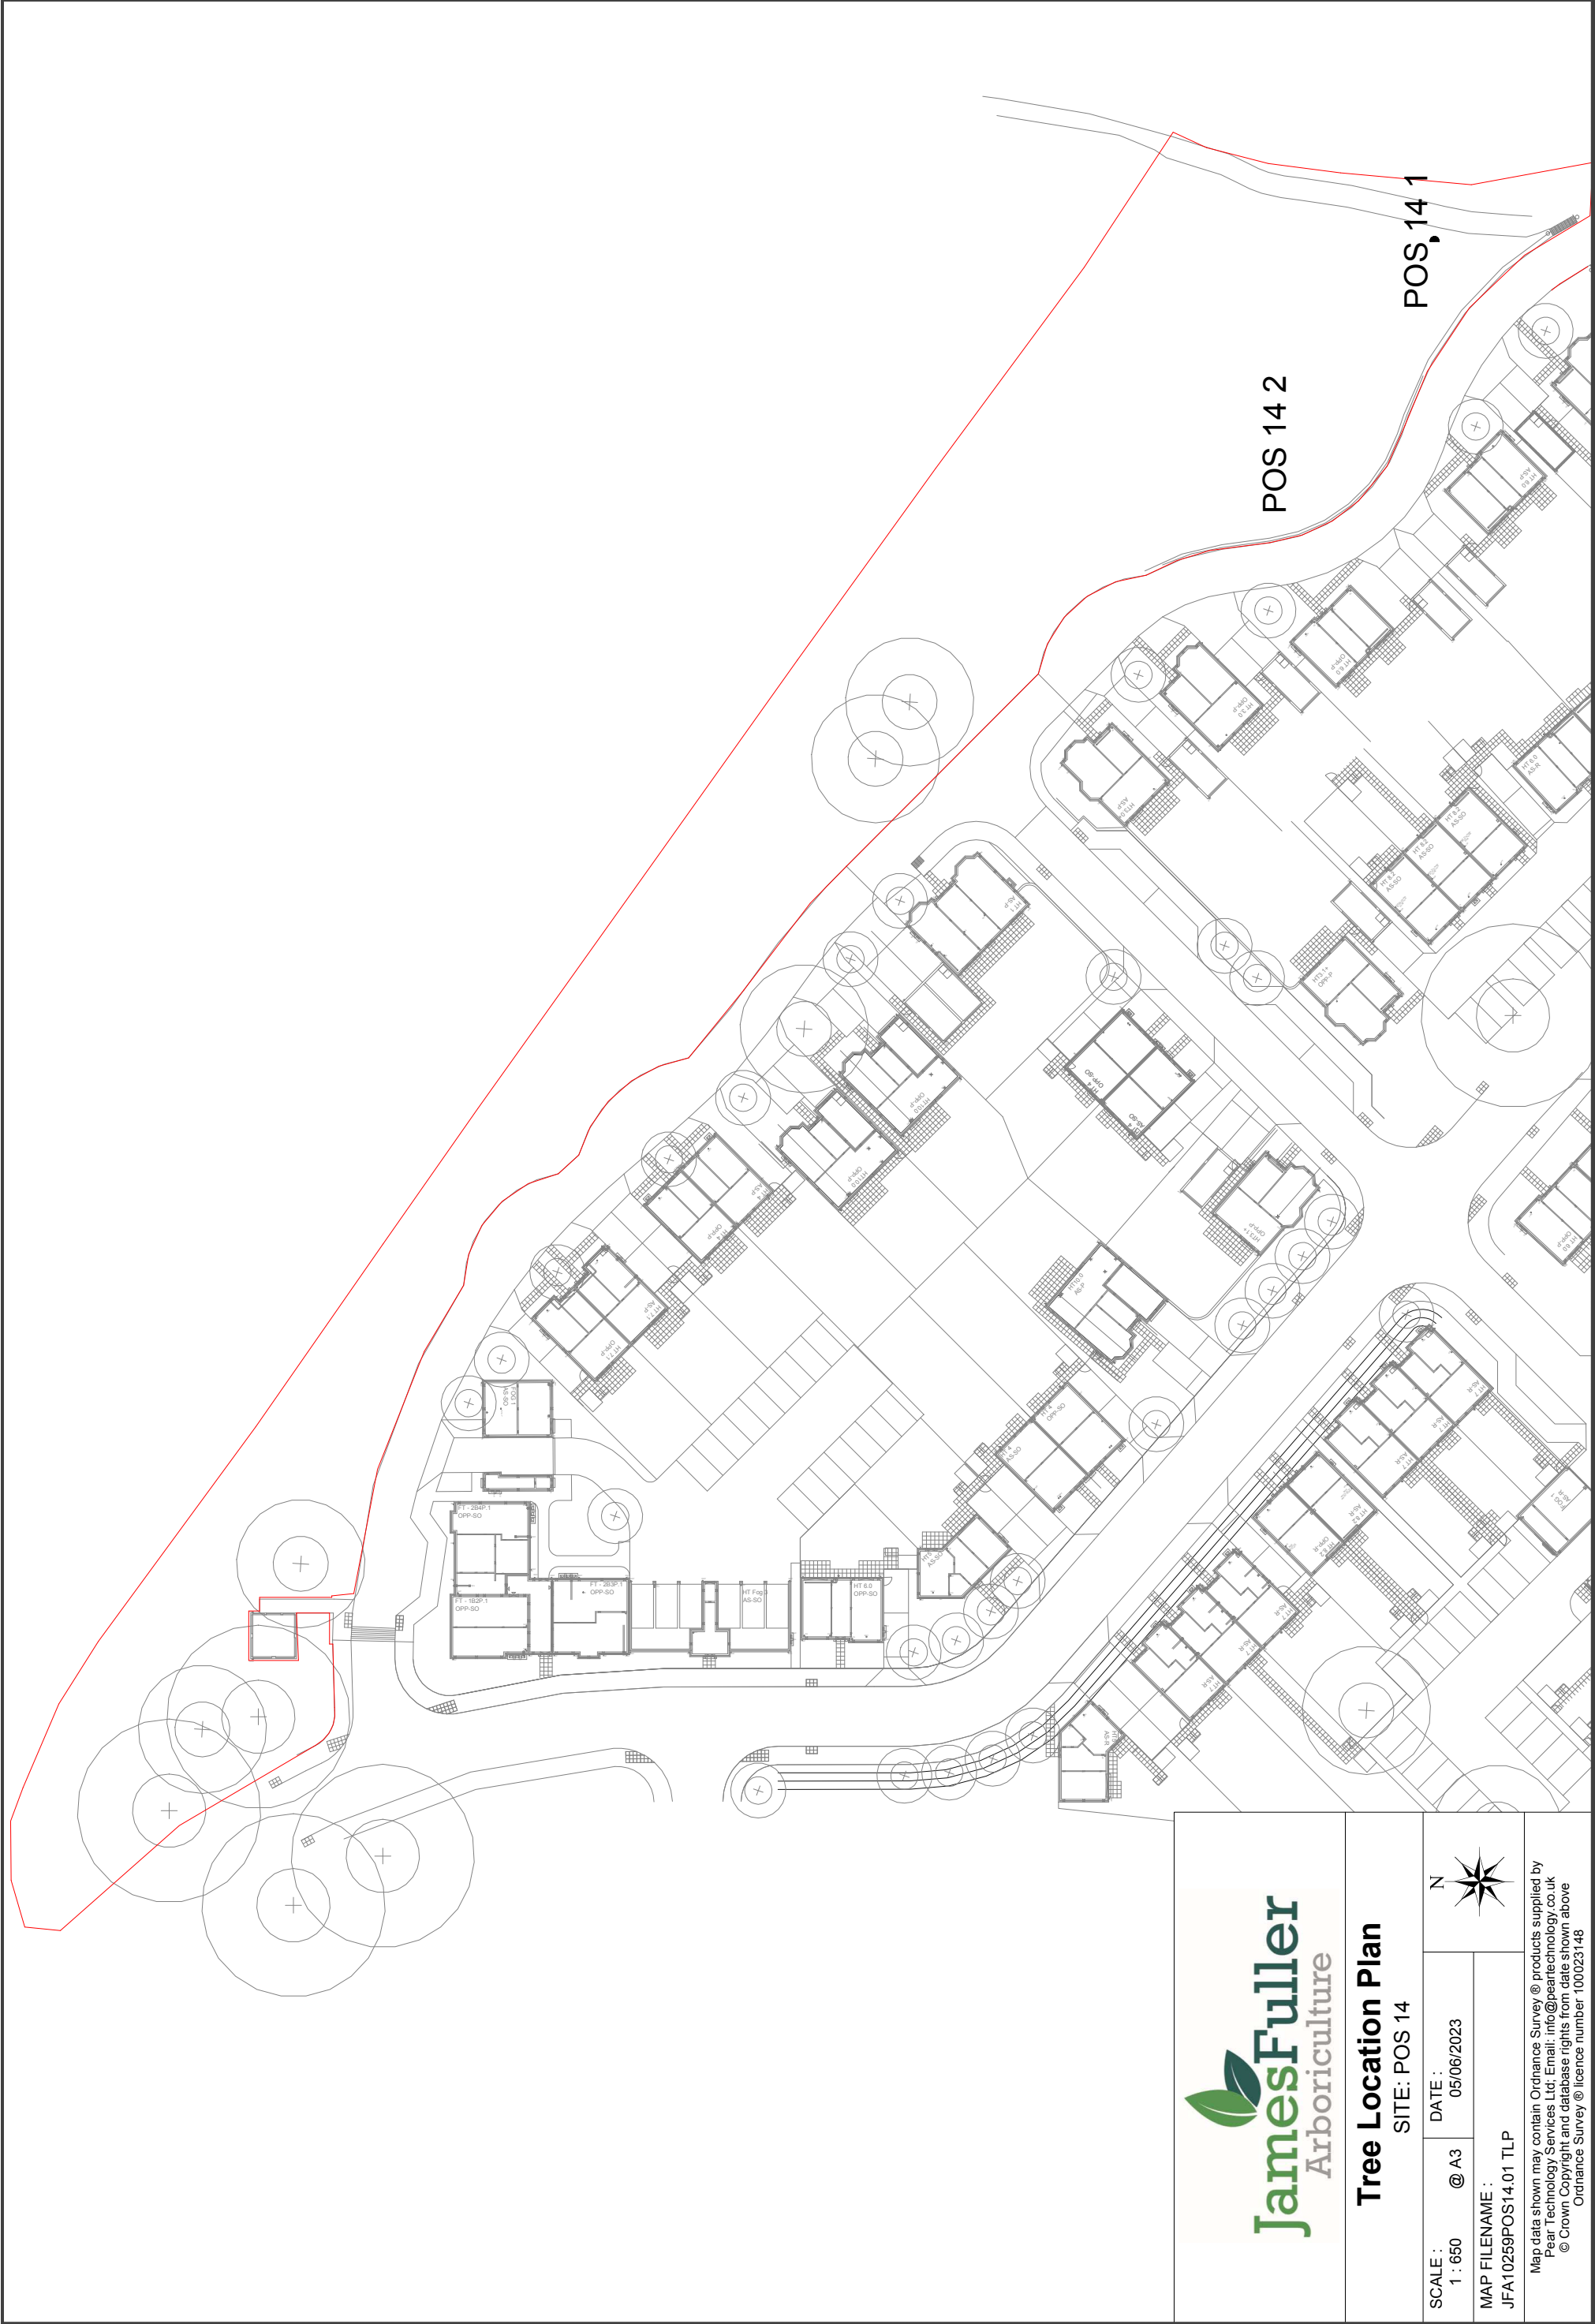
Tree Location Plan

| Tree No | Species | H't (m) | Stem Diameter | Branch Spread | Life Stage | Physiological Condition | Structural Condition | Major Defect | Preliminary Management | Works Method | Traffic Management | Action |
|---|---|---|---|---|---|---|---|---|---|---|---|---|
| POS 14 1 | Common Lime<br><i>Tilia europaea</i> | 10-15 | 150-300 | 10-15 | Semi-Mature | Good | Good | Low hanging branches over footpath | Crown lift to 3.5m over footpath | Working from height | Yes | 3 Months |
| POS 14 2 | Pedunculate Oak<br><i>Quercus robur</i> | 15-20 | >600 | 15-20 | Veteran | Good | Poor | Major decay and cavities in main stems, Dense vegetation at base | Clear around base and resurvey within 1 month<br>Reduce central upright stems by 3m, consider use of MEWP for access | Working from height | No | 3 Months |
