# Arboricultural Report

## - Tree Safety Audit

Site Address:  
St Leonards Church, Church Lane,  
Old Bursledon, SO31 8AA

Date: 28<sup>th</sup> October 2023

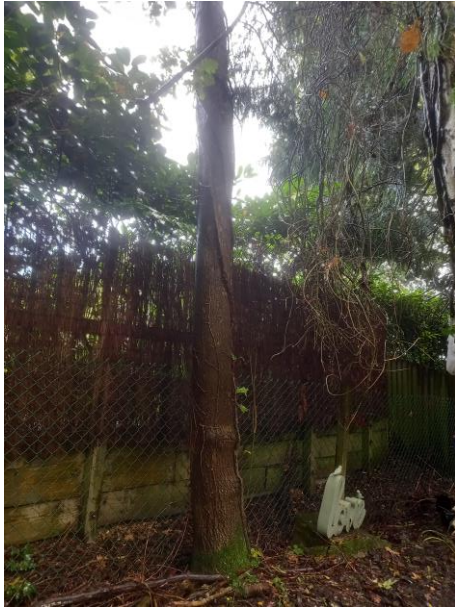
*T1 ash*

| Tree no. | Species | Location | Ht (m) | Stem diameter (mm) | 2nd/mi n stem | Age Class | Physiological condition | Structural condition | Preliminary Recommendations | Priority rating | Notes |
|---|---|---|---|---|---|---|---|---|---|---|---|
| T1 | Ash | Nw boundary | 12 | 270 | | EMa | Poor. Chalara. Some dead sections, little live canopy remains | Poor. Will be compromised | Fell | 1- within 6 months. | Target of neighbours' property. |

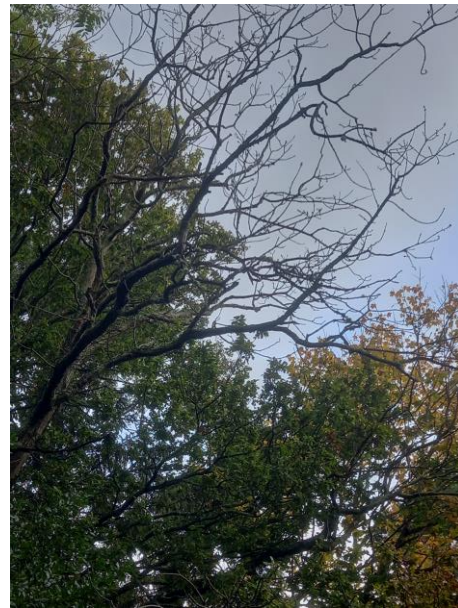
*T4 ash*

| Tree no. | Species | Location | Ht (m) | Stem diameter (mm) | 2nd/mi n stem | Age Class | Physiological condition | Structural condition | Preliminary Recommendations | Priority rating | Notes |
|---|---|---|---|---|---|---|---|---|---|---|---|
| G4 | Ash + dead ivy clad one to west. | Northwest boundary | 11 | 310 | | EMa | Dead | Poor. Will be compromised | Fell | 1- within 6 months. | Target of neighbour property. |

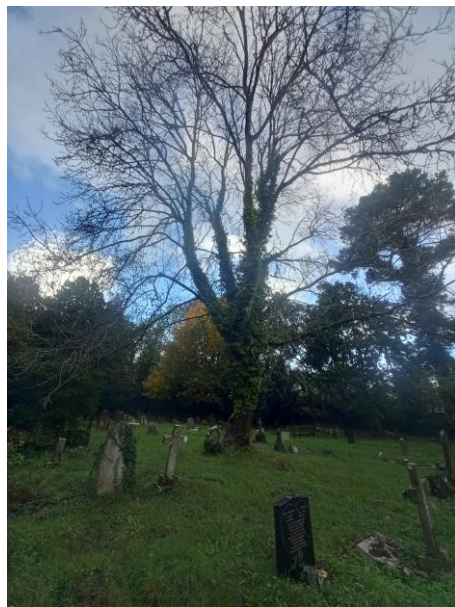
*T6 ash*

| Tree no. | Species | Location | Ht (m) | Stem diameter (mm) | 2nd/mi n stem | Age Class | Physiological condition | Structural condition | Preliminary Recommendations | Priority rating | Notes |
|---|---|---|---|---|---|---|---|---|---|---|---|
| T6 | Ash | Open grown central churchyard | 13 | 560 | | Ma | Dead | Poor. Will be compromised by chalara. Ivy clad. | Fell | 1- within 6 months. | Target of graves, lane and other trees. |

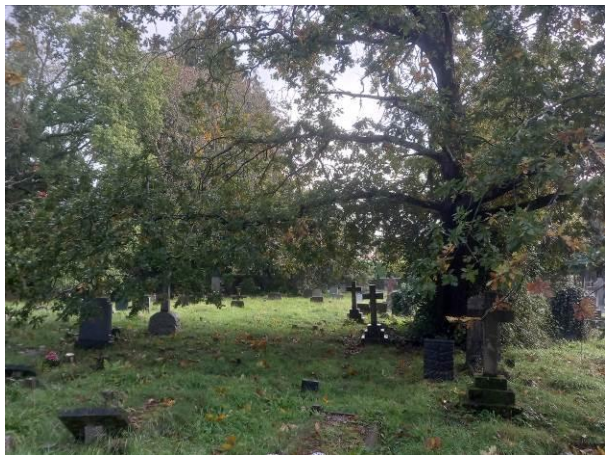
*T7 oak*

| Tree no. | Species | Location | Ht (m) | Stem diameter (mm) | 2nd/mi n stem | Age Class | Physiological condition | Structural condition | Preliminary Recommendations | Priority rating | Notes |
|---|---|---|---|---|---|---|---|---|---|---|---|
| T7 | Oak | Open grown central churchyard | 11 | 350 | | EMa | Good | Good. Low over churchard | Lift to 2.5m above ground level over churchyard including removal of one lower lateral on north side c. 120mm diameter. | 2- within 1 year | |

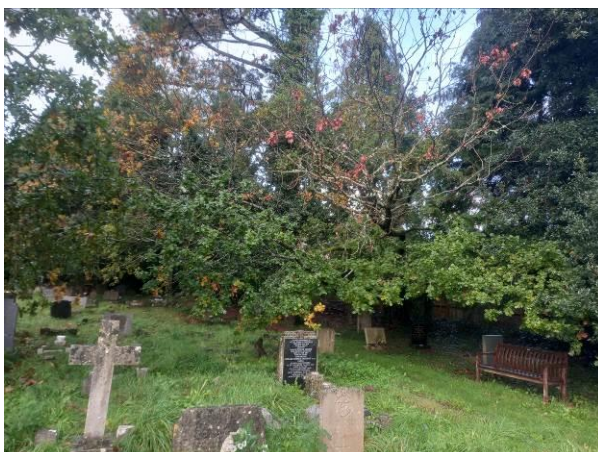
*T9 oak*

| Tree no. | Species | Location | Ht (m) | Stem diameter (mm) | 2nd/mi n stem | Age Class | Physiological condition | Structural condition | Preliminary Recommendations | Priority rating | Notes |
|---|---|---|---|---|---|---|---|---|---|---|---|
| T9 | Oak | Central northern boundary | 5 x | 5 x multistem form, max 280 | 160 | Ema | Fair. Relatively low foliar mass due to form. Fungal (tbc) colonisation of bark fissures on east side of stem | Poor. Multiple stems originating from ground level, mostly prostrate and subsiding over churchyard. Southeast stem has decayed stub at 1.5m. | Fell. Replant with native oak on top of bank | 2- within 1 year | |

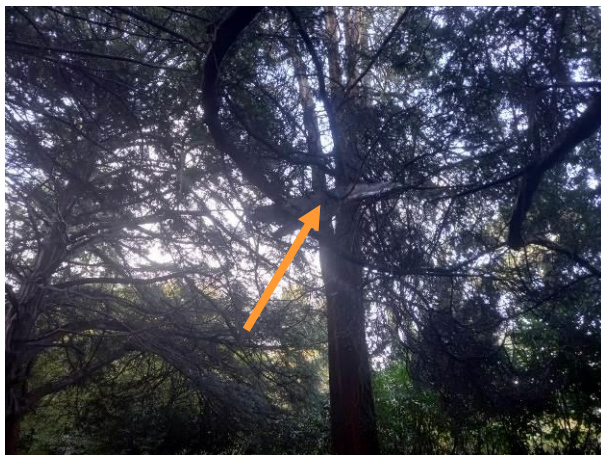
| Tree no. | Species | Location | Ht (m) | Stem diameter (mm) | 2nd/mi n stem | Age Class | Physiological condition | Structural condition | Preliminary Recommendations | Priority rating | Notes |
|---|---|---|---|---|---|---|---|---|---|---|---|
| T10 | Yew | Old churchyard, yew to west of church. | 13 | 930 | | Ma | Good | Good. Hanger from adjacent Western red cedar lodged in west side of canopy. | Remove hanger | 1- within 6 months. | |

*T10 hanger (arrowed)*

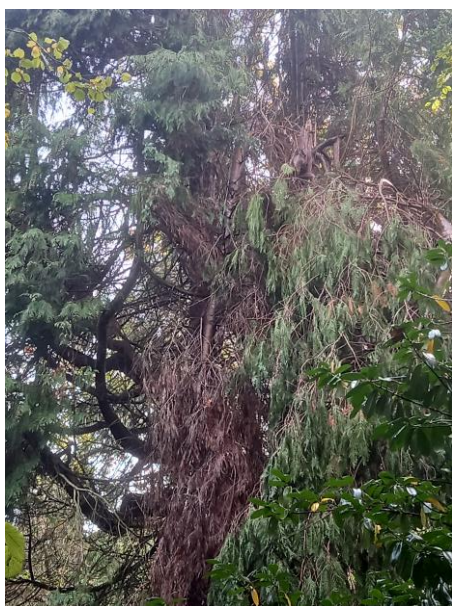
*T11 western red cedar*

| Tree no. | Species | Location | Ht (m) | Stem diameter (mm) | 2nd/mi n stem | Age Class | Physiological condition | Structural condition | Preliminary Recommendations | Priority rating | Notes |
|---|---|---|---|---|---|---|---|---|---|---|---|
| T11 | Western red cedar | West end of old churchyard | 16 | 1070 | | LaMa | Fair to good | Fair to poor. Failed from historic reduction on west side of canopy at c 10m. | Re-reduce to historic reduction points at c 10m | 2- within 1 year | This tree had dropped several branches from this reduction point in the last 5 years. |

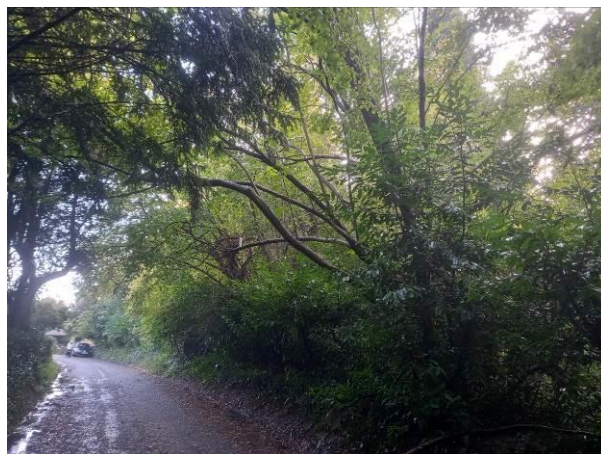
*T12 hazel coppice*

| Tree no. | Species | Location | Ht (m) | Stem diameter (mm) | 2nd/mi n stem | Age Class | Physiological condition | Structural condition | Preliminary Recommendations | Priority rating | Notes |
|---|---|---|---|---|---|---|---|---|---|---|---|
| T12 | Hazel | By stone bag | 9 | 100 | 60 | EMa | Good | Fair to poor. Outgrown coppice starting to break out | Recoppice to near ground level | 3- within next inspection interval | |

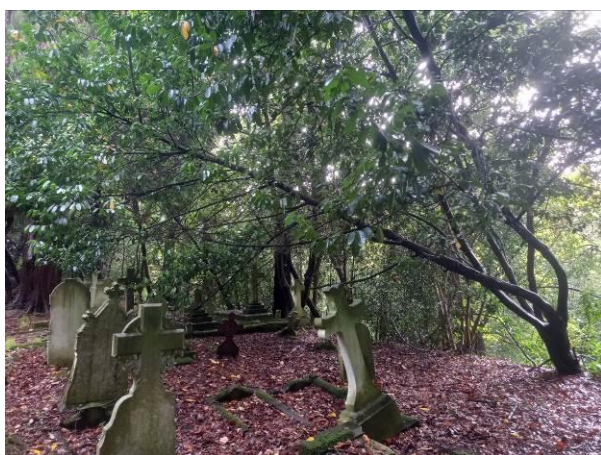
*T13 laurel*

| Tree no. | Species | Location | Ht (m) | Stem diameter (mm) | 2nd/mi n stem | Age Class | Physiological condition | Structural condition | Preliminary Recommendations | Priority rating | Notes |
|---|---|---|---|---|---|---|---|---|---|---|---|
| T13 | Laurel | Southern boundary, extending nearly to path | 4 | 230 | | EMa | Good | Poor. Growing at acute angle, will subside as tips grow heavier. | Fell to near ground level | 3- within next inspection interval | |

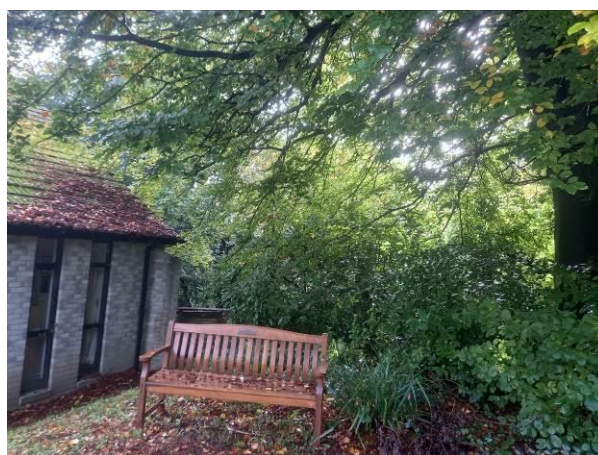
*T14 beech*

| Tree no. | Species | Location | Ht (m) | Stem diameter (mm) | 2nd/mi n stem | Age Class | Physiological condition | Structural condition | Preliminary Recommendations | Priority rating | Notes |
|---|---|---|---|---|---|---|---|---|---|---|---|
| T14 | Beech | Southwest of reading room | 20 | 940 | | Ma | Good | Good good to fair, tight fork at 7m, appears stable. Low over reading room roof | Lift to clear by 2-2.5m | 2- within 1 year | |
