# Arboricultural Record

## - Tree Safety Audit

Site Address:  
Sherborne School, Lakewood Road,  
Chandler's Ford, SO53 1EU

Reference: KTML39323

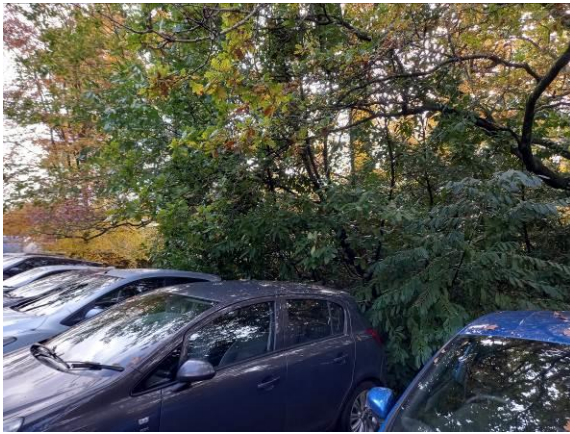
*Group 3*

| Tree no. | Species | Location | Ht (m) | 1st or largest stem | 2nd or small-est stem | Age Class | Physiological condition | Structural condition | Preliminary Recommendations | Priority rating | Notes |
|---|---|---|---|---|---|---|---|---|---|---|---|
| G3 | Laurel | Southern corner, encroaching parking | 5 | 40 | 20 | Y | Good | Good. Low over cars | Cut back hard to clear encroachment | 2 - within 1 year | |

| Tree no. | Species | Location | Preliminary Recommendations | Priority rating | Notes |
|---|---|---|---|---|---|
| G3 | Laurel | Southern corner, encroaching parking | Cut back hard to clear encroachment | 2- within 1 year | |

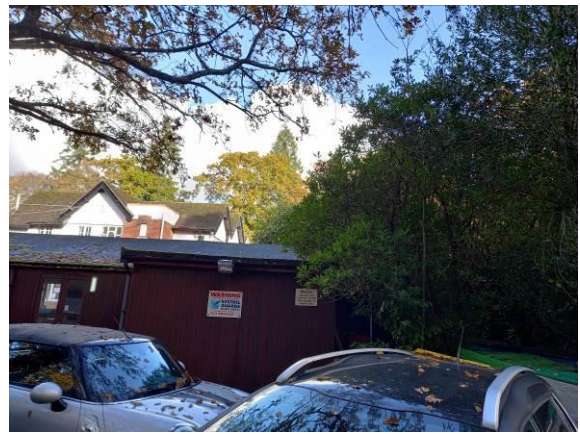
*Group 6 - laurel*

| Tree no. | Species | Location | Ht (m) | 1st or largest stem | 2nd or small-est stem | Age Class | Physiological condition | Structural condition | Preliminary Recommendations | Priority rating | Notes |
|---|---|---|---|---|---|---|---|---|---|---|---|
| G6 | Laurel | South of shed | 3 | 30 | | Y | Good | Good. In contact with shed roof. | Cut back hard to clear roof by 2m | 2 - within 1 year | |

| Tree no. | Species | Location | Preliminary Recommendations | Priority rating | Notes |
|---|---|---|---|---|---|
| G6 | Laurel | South of shed | Cut back hard to clear roof by 2m | 2- within 1 year | |

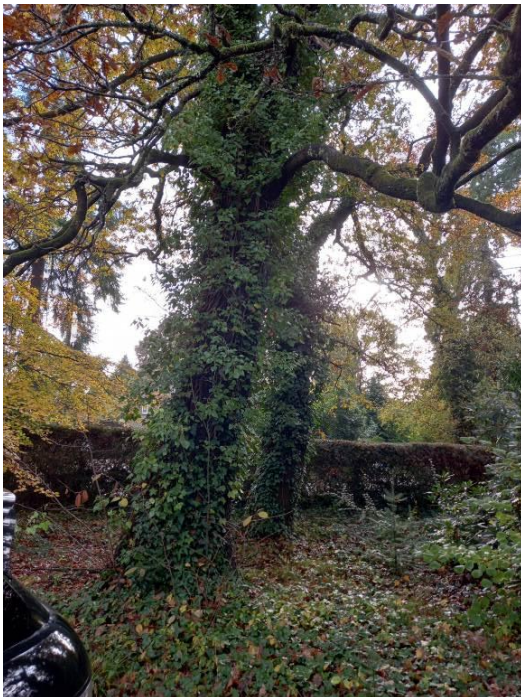
| Tree no. | Species | Location | Ht (m) | 1st or largest stem | 2nd or small-est stem | Age Class | Physiological condition | Structural condition | Preliminary Recommendations | Priority rating | Notes |
|---|---|---|---|---|---|---|---|---|---|---|---|
| T1 | Oak | Southern corner | 22 | 890 oi | | Ma | Good. Minor deadwood. | Fair. Cavity to east side of stem c. 0.4 to 1.1m. Degraded heartwood within, good reaction wood and good buttressing. Ivy to 70% ht. | Sever ivy. | 2 - within 1 year | |
| T2 | Oak | Southern corner | 20 | 640 oi | | Ma | Fair to good | God to fair. Biased south over road | Sever ivy. | 2 - within 1 year | |

*T1 and T2 behind Group 3*

| Tree no. | Species | Location | Preliminary Recommendations | Priority rating | Notes |
|---|---|---|---|---|---|
| T1 | Oak | Southern corner | Sever ivy. | 2- within 1 year | |
| T2 | Oak | Southern corner | Sever ivy. | 2- within 1 year | |

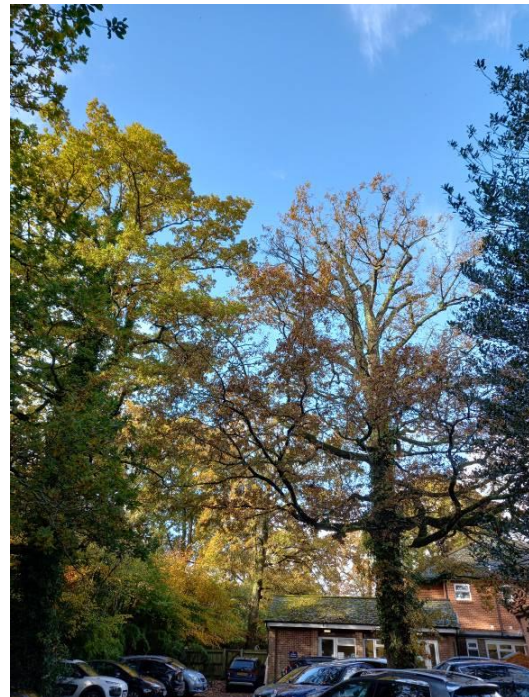
*T5*

| Tree no. | Species | Location | Ht (m) | 1st or largest stem | 2nd or small-est stem | Age Class | Physiological condition | Structural condition | Preliminary Recommendations | Priority rating | Notes |
|---|---|---|---|---|---|---|---|---|---|---|---|
| T5 | Oak | In car park | 22 | 810 oi | | Ma | Sparse compared with other oaks nearby. 1m regrowth from recent reduction | Fair. No signs of instability. | Sever ivy. | 2 - within 1 year | Compaction from vehicles is a likely cause of damage. |

| Tree no. | Species | Location | Preliminary Recommendations | Priority rating | Notes |
|---|---|---|---|---|---|
| T5 | Oak | In car park | Sever ivy. | 2- within 1 year | Compaction from vehicles is a likely cause of damage. |

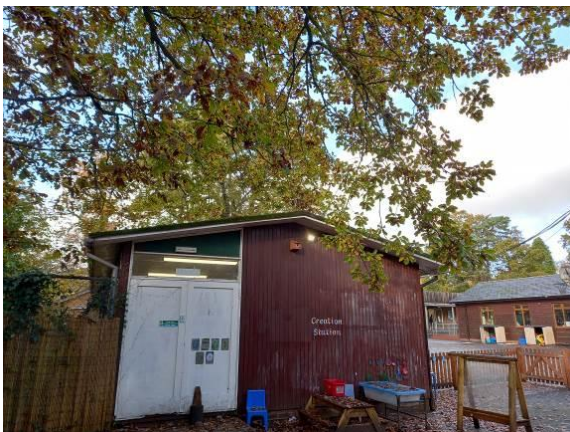
*T7*

| Tree no. | Species | Location | Ht (m) | 1st or largest stem | 2nd or small-est stem | Age Class | Physiological condition | Structural condition | Preliminary Recommendations | Priority rating | Notes |
|---|---|---|---|---|---|---|---|---|---|---|---|
| T7 | Oak | South of classroom, nursery | 20 | 790 | | Ma | Good. Wound on base of stem on west side. | Good to fair. Shear crack in branch to north-northeast of upper canopy - stabilised. Two other wounds on inner side of highest branches, good reaction growth visible. Low over roofs | Crown lift to clear classroom & shed by 2-2.5m to good pruning points. | 2 - within 1 year | |

| Tree no. | Species | Location | Preliminary Recommendations | Priority rating | Notes |
|---|---|---|---|---|---|
| T7 | Oak | South of classroom, nursery | Crown lift to clear classroom & shed by 2-2.5m to good pruning points. | 2- within 1 year | |

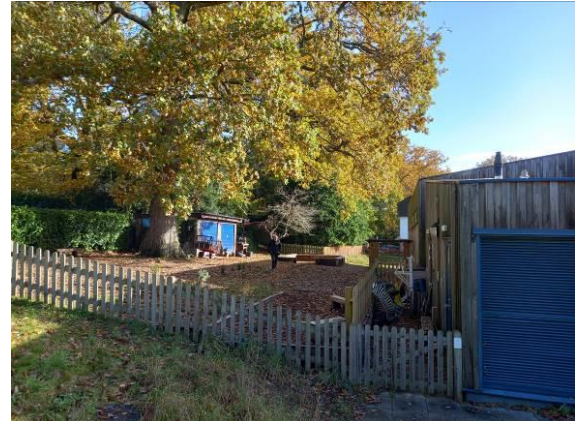
*T14*

| Tree no. | Species | Location | Ht (m) | 1st or largest stem | 2nd or small-est stem | Age Class | Physiological condition | Structural condition | Preliminary Recommendations | Priority rating | Notes |
|---|---|---|---|---|---|---|---|---|---|---|---|
| T14 | Oak | North boundary | 21 | 1110 | | LaMa | Good. Bark loss to north buttresses probably due to small feet. Minor twiggy dieback at tips. | Fair to good. Canopy biased south. Growing close to classroom roof. | Proximity pruning to clear roof by 2-2.5m. Max cut size 40mm Ø. Clear stem epicormic to 4.5m | 2- within 1 year | |

| Tree no. | Species | Location | Preliminary Recommendations | Priority rating | Notes |
|---|---|---|---|---|---|
| T14 | Oak | North boundary | Proximity pruning to clear roof by 2-2.5m. Max cut size 40mm Ø. Clear stem epicormic to 4.5m | 2- within 1 year | |

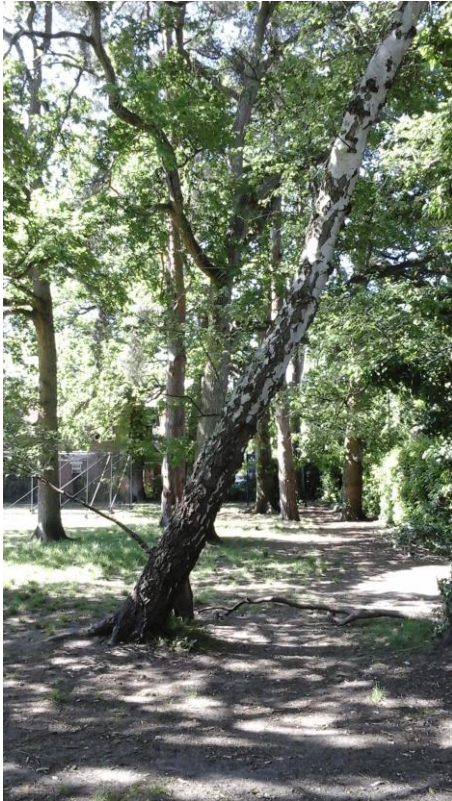
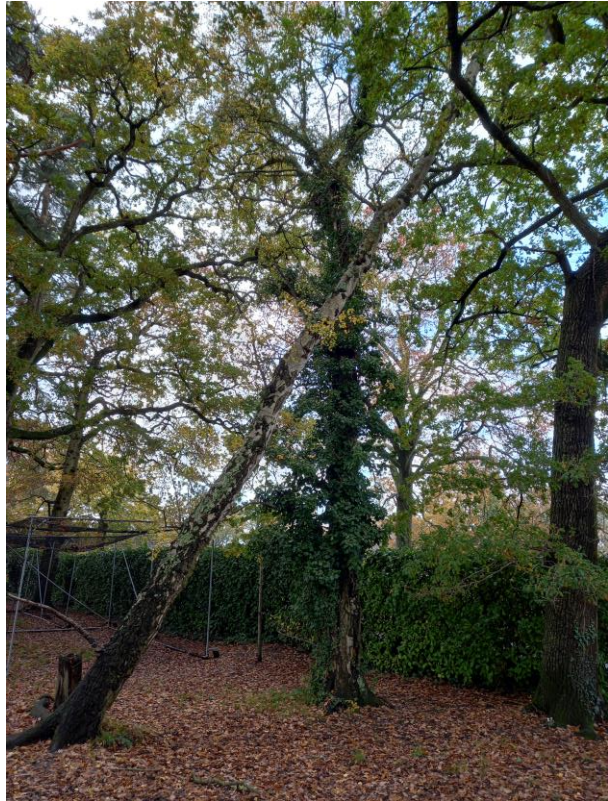
| Tree no. | Species | Location | Ht (m) | 1st or largest stem | 2nd or small-est stem | Age Class | Physiological condition | Structural condition | Preliminary Recommendations | Priority rating | Notes |
|---|---|---|---|---|---|---|---|---|---|---|---|
| T10 | Birch | Northwest boundary | 21 | 430 | | Ma | Fair to poor. Relatively small crown for stem girth. | Fair to poor. C35° off vertical lean to west towards road. Adjacent oak would catch it if it failed. | Noted. | N/A | |

*Photo of T14 leaning (now T10) to compare angle:*

*June 2021*

*November 2023 – angle has increased, oak will halt progress*

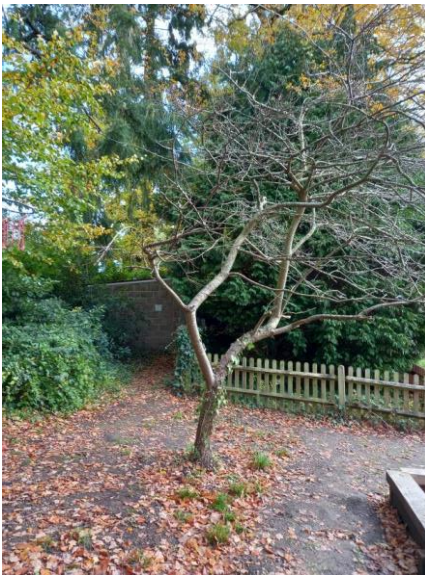
| Tree no. | Species | Location | Ht (m) | 1st or largest stem | 2nd or small-est stem | Age Class | Physiological condition | Structural condition | Preliminary Recommendations | Priority rating | Notes |
|---|---|---|---|---|---|---|---|---|---|---|---|
| T15 | Cherry | Near shed | 3.5 | 170 | | Y | Dead | Dead but stable | Fell and replace. | 3- within next inspection interval | |

*T15 – dead cherry*

| Tree no. | Species | Location | Preliminary Recommendations | Priority rating | Notes |
|---|---|---|---|---|---|
| T15 | Cherry (dead) | Near shed | Fell and replace. Dead. Exempt works | 3- within next inspection interval | |

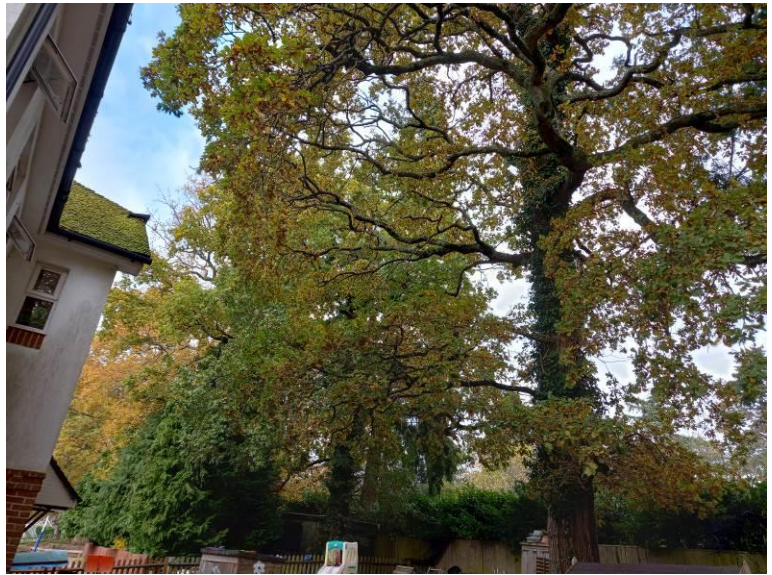
*T17*

- 4.4 T17 is a notable tree already, its position in the nursery area of the school means it will need to be carefully managed for safety given the high target, but this is easily achieved with routine inspections necessary for your Duty of Care and occasional interventions. Other large girth trees of some age are present.

| Tree no. | Species | Location | Ht (m) | 1st or largest stem | 2nd or small-est stem | Age Class | Physiological condition | Structural condition | Preliminary Recommendations | Priority rating | Notes |
|---|---|---|---|---|---|---|---|---|---|---|---|
| T17 | Oak | North of nursery | 23 | 980 oi | | LaMa | Good. Minor deadwood in lower crown and a few moderate sections. Ivy colonisation to 60% | Good. | Deadwood thoroughly on south side over play area. Sever ivy. | 1- within 3 months | |

| Tree no. | Species | Location | Preliminary Recommendations | Priority rating | Notes |
|---|---|---|---|---|---|
| T17 | Oak | North of nursery | Deadwood thoroughly on south side over play area. Sever ivy. | 1- within 3 months | |

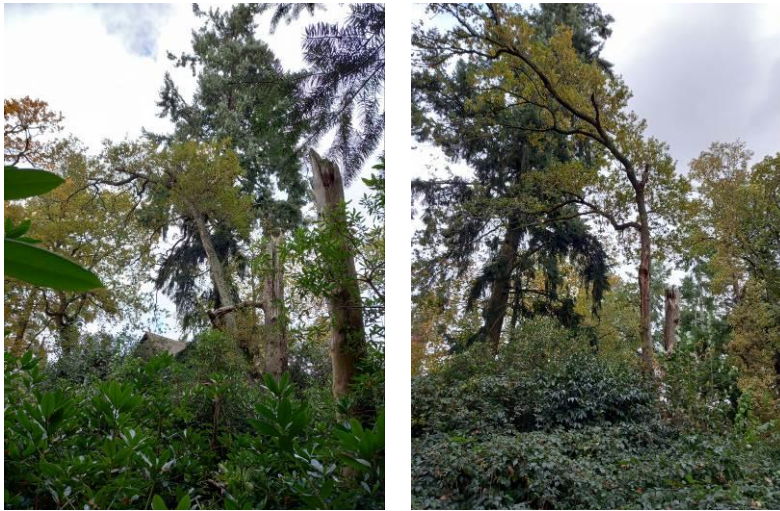
| Tree no. | Species | Location | Ht (m) | 1st or largest stem | 2nd or small-est stem | Age Class | Physiological condition | Structural condition | Preliminary Recommendations | Priority rating | Notes |
|---|---|---|---|---|---|---|---|---|---|---|---|
| T18 | Oak. | Northeast boundary, possibly offsite | 13 | 400 | | Ma | Fair to poor | Poor. Remains of a failed tree.section swept to west with a rear - out wound on underside. | Low target but fell if school's, advise neighbour if not. | 3- within next inspection interval | Determine ownership before carrying out works. |

*T18 from different angles to show offset canopy remains.*

| Tree no. | Species | Location | Preliminary Recommendations | Priority rating | Notes |
|---|---|---|---|---|---|
| T18 | Oak. | Northeast boundary, possibly offsite | Low target but fell if school's, advise neighbour if not. | 3- within next inspection interval | Determine ownership before carrying out works. |
