# Arboricultural Consultancy for Esure

| Insured | Mrs Dawn Linington | Address | 19 Beechwood Rise, Southampton, Hampshire, SO18 3PW | | |
| Client | Subsidence Management Services | Contact | Richard Bryant | Claim No. | IFS-ESU-SUB-22-0103393 |
| Report Date | 03/05/2023 | | | | |

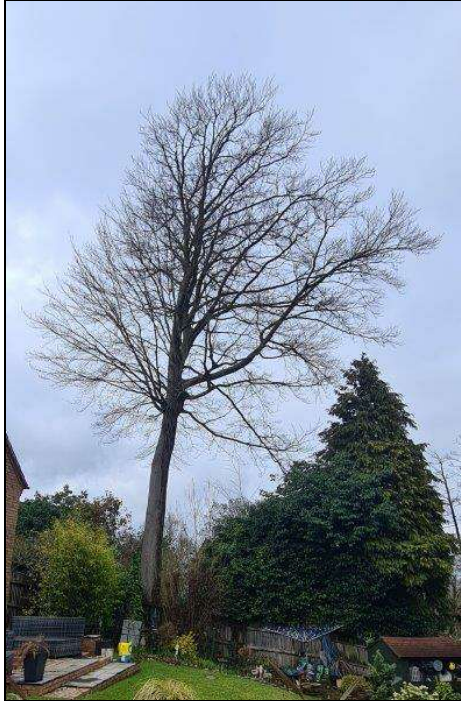
T1 - Beech (Common)

With due regards to species profile, size and proximity, T1 (Beech) and T3 (Cypress) are considered the dominant features proximate to the focal area(s) of movement and accordingly, where vegetation is confirmed as being causal, we have identified them as the primary cause of the current subsidence damage.

| Tree No. | Species | Age Cat | Approx. Height (m) | Distance to Building (m) * | Ownership | Action | Requirement |
|---|---|---|---|---|---|---|---|
| T1 | Beech (Common) | 3 | 23 | 9.4 | A - Third Party | Remove | Remove close to ground level and treat stump to inhibit regrowth |

Consequently, we have advocated the complete removal of T1, S1, T3 & T5 as it will offer the most certain arboricultural solution likely to restore long-term stability.

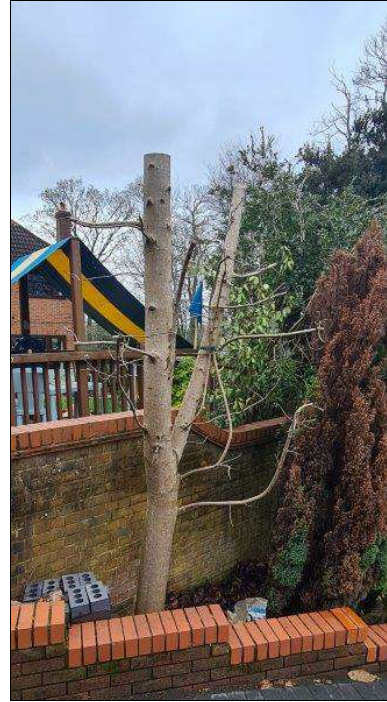
T5 - Maple (Norway)

S1 (Laurel (Portuguese)) and T5 Maple (Norway) are also considered to retain a contributory influence, albeit in a secondary capacity when compared to the above.

| Tree No. | Species | Age Cat | Approx. Height (m) | Distance to Building (m) * | Ownership | Action | Requirement |
|---|---|---|---|---|---|---|---|
| T5 | Maple (Norway) | 1 | 2.5 | 2.3 | C - Insured | Remove | Remove close to ground level; do not treat stump due to translocation risk. Where such a risk exists, we advise that any emergent regrowth is removed annually. |

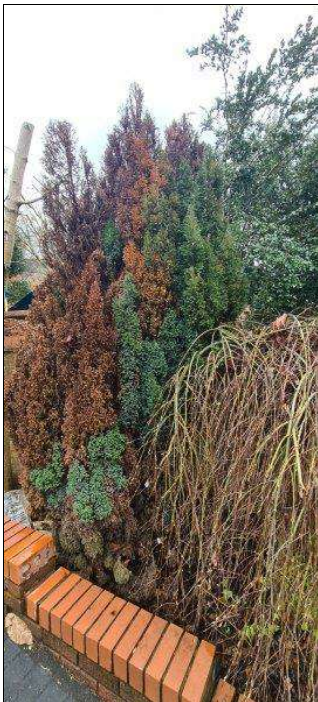
T6 - Cypress

| Tree No. | Species | Age Cat | Approx. Height (m) | Distance to Building (m) * | Ownership | Action | Requirement |
|---|---|---|---|---|---|---|---|
| T6 | Cypress | 1 | 2.5 | 4 | C - Insured | Action to avoid future risk | Maintain at broadly current dimensions by way of regular pruning. |

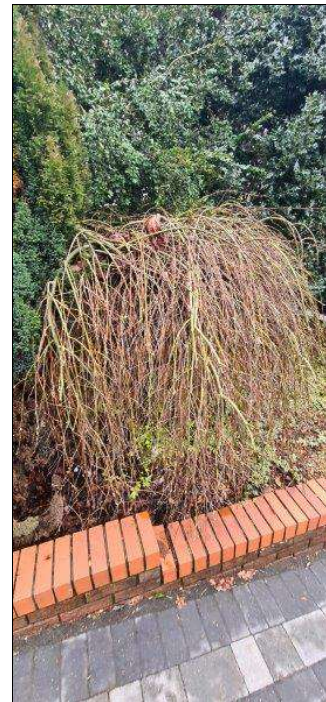
T7 - Willow

| Tree No. | Species | Age Cat | Approx. Height (m) | Distance to Building (m) * | Ownership | Action | Requirement |
|---|---|---|---|---|---|---|---|
| T7 | Willow | 1 | 2.2 | 4.8 | C - Insured | Action to avoid future risk | Maintain at broadly current dimensions by way of regular pruning. |

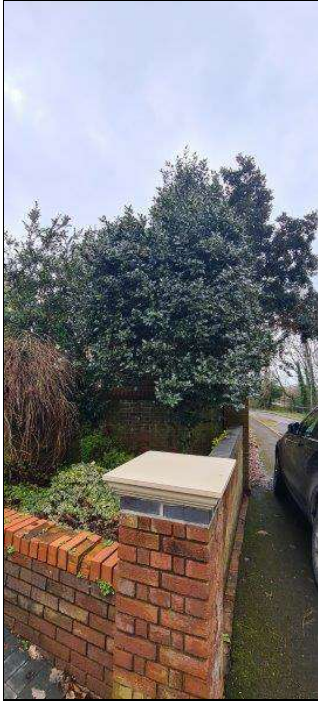
T8 - Holly

| Tree No. | Species | Age Cat | Approx. Height (m) | Distance to Building (m) * | Ownership | Action | Requirement |
|---|---|---|---|---|---|---|---|
| T8 | Holly | 1 | 4.6 | 7.7 | C - Insured | Action to avoid future risk | Maintain at broadly current dimensions by way of regular pruning. |

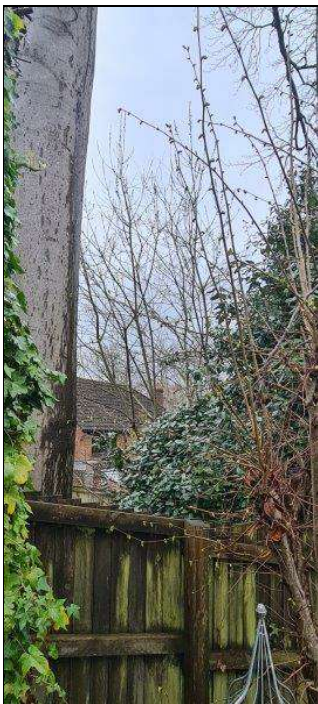
T2 - Willow

| Tree No. | Species | Age Cat | Approx. Height (m) | Distance to Building (m) * | Ownership | Action | Requirement |
|---|---|---|---|---|---|---|---|
| T2 | Willow | 1 | 6 | 9 | A - Third Party | Action to avoid future risk | Maintain at broadly current dimensions by way of regular pruning. |

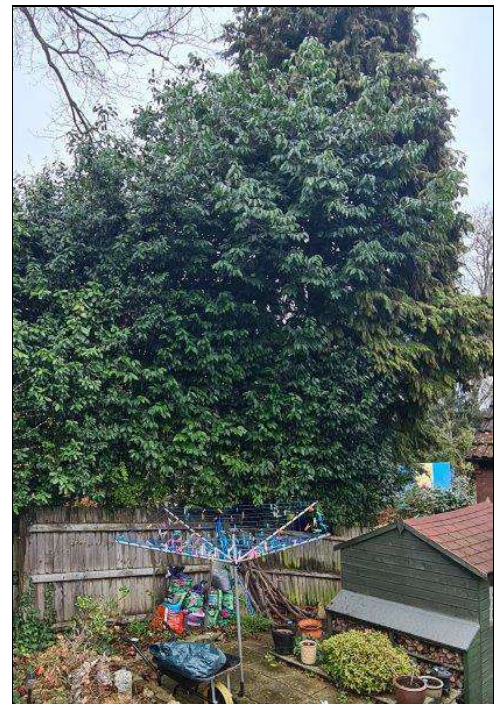
S1 - Laurel (Portugeuse)

| Tree No. | Species | Age Cat | Approx. Height (m) | Distance to Building (m) * | Ownership | Action | Requirement |
|---|---|---|---|---|---|---|---|
| S1 | Laurel (Portuguese) | 1 | 8.5 | 3.5 | A - Third Party | Remove | Remove close to ground level and treat stump to inhibit regrowth. |

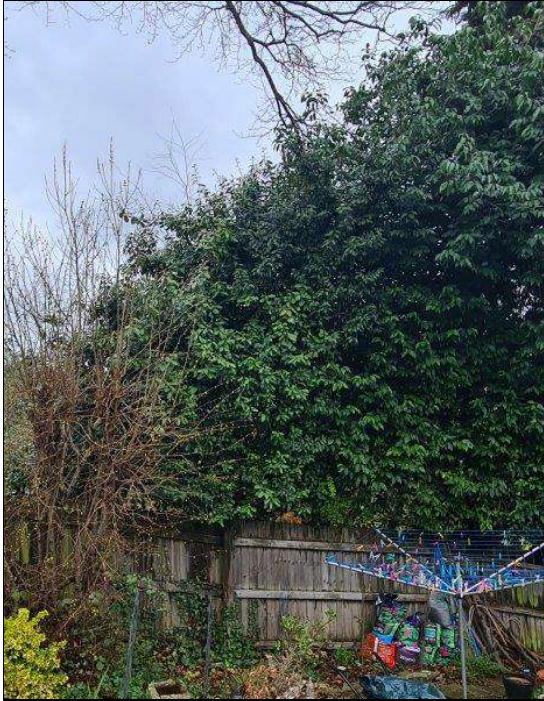
S2 - Choisya

| Tree No. | Species | Age Cat | Approx. Height (m) | Distance to Building (m) * | Ownership | Action | Requirement |
|---|---|---|---|---|---|---|---|
| S2 | Choisya | 1 | 6 | 6.3 | A - Third Party | Action to avoid future risk | Maintain at broadly current dimensions by way of regular pruning. |

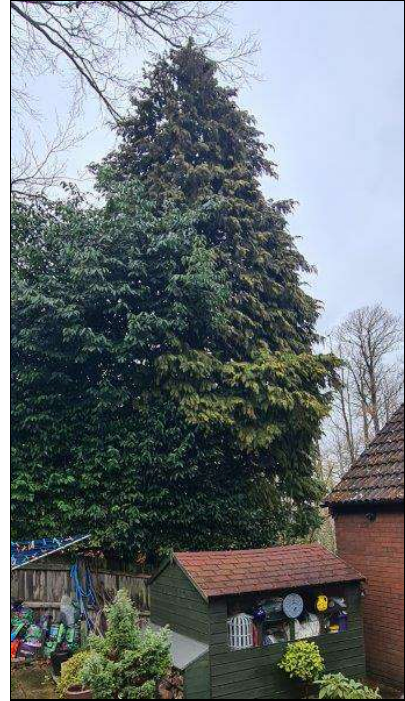
T3 - Cypress

| Tree No. | Species | Age Cat | Approx. Height (m) | Distance to Building (m) * | Ownership | Action | Requirement |
|---|---|---|---|---|---|---|---|
| T3 | Cypress | 1 | 12.4 | 2.4 | A - Third Party | Remove | Remove close to ground level. |

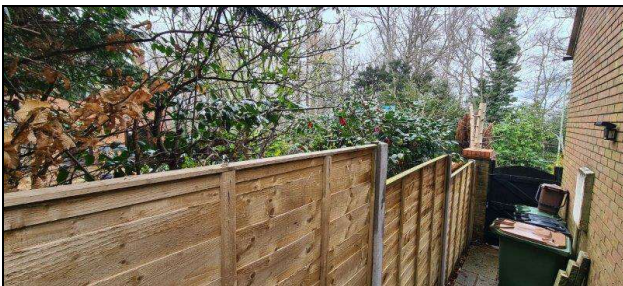
SG1 - Mixed species shrubs

| Tree No. | Species | Age Cat | Approx. Height (m) | Distance to Building (m) * | Ownership | Action | Requirement |
|---|---|---|---|---|---|---|---|
| SG1 | Mixed species group | 1 | 2.6 | 1.4 | A - Third Party | Action to avoid future risk | Maintain at broadly current dimensions by way of regular pruning. |

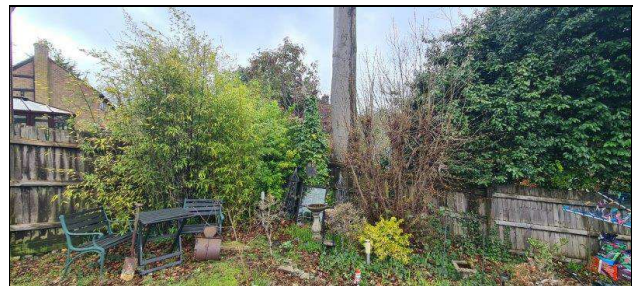
SG2 - Mixed species shrubs

| Tree No. | Species | Age Cat | Approx. Height (m) | Distance to Building (m) * | Ownership | Action | Requirement |
|---|---|---|---|---|---|---|---|
| SG2 | Mixed species group | 1 | 3.8 | 8.4 | C - Insured | Action to avoid future risk | Maintain at broadly current dimensions by way of regular pruning. |

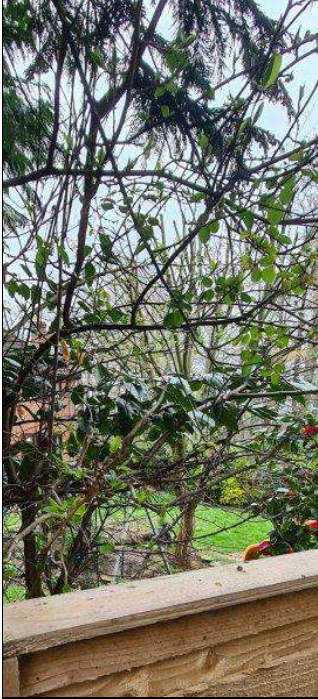
T4 - Maple

| Tree No. | Species | Age Cat | Approx. Height (m) | Distance to Building (m) * | Ownership | Action | Requirement |
|---|---|---|---|---|---|---|---|
| T4 | Maple | 1 | 5 | 7 | A - Third Party | Action to avoid future risk | Maintain at broadly current dimensions by way of regular pruning. |

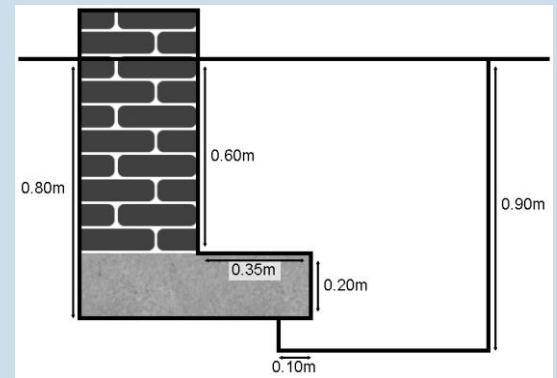
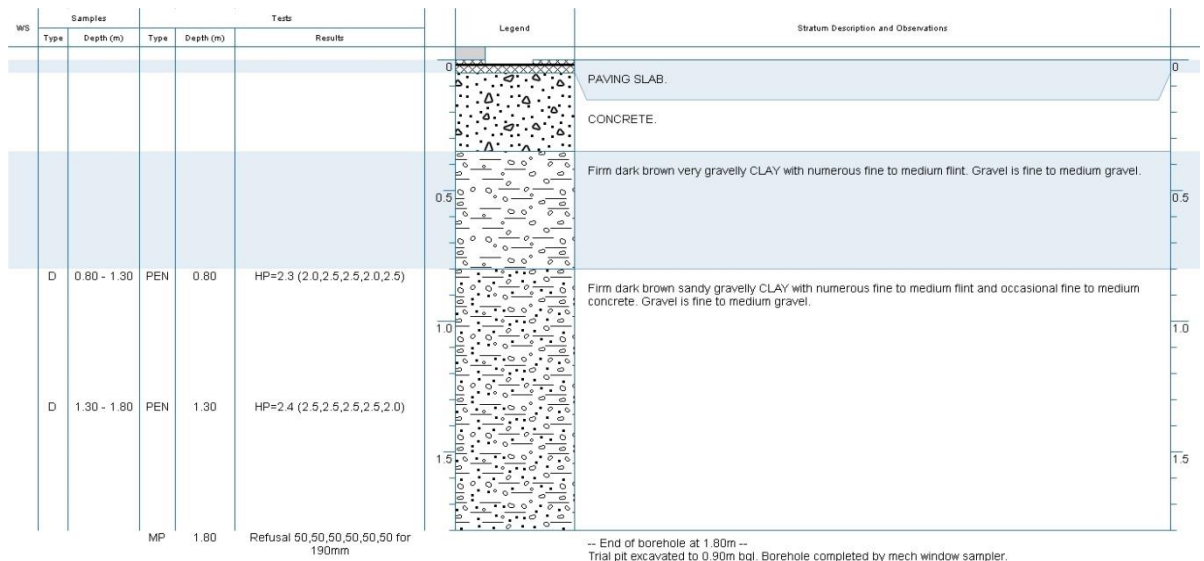
## TP/BH1 Foundation Detail and Borehole Log

Garage foundation comprised of brick wall to 600mm bgl, bearing on concrete to 800mm bgl, with a total projection of 350mm from the elevation. Underside of foundation (USF) was exposed to 100mm back from the face of the foundation and probed 450mm back from the face of the foundation.

Garage foundation was exposed and the underside of foundation (USF) recorded to be 0.8m bgl (TP/BH 1).

Mackintosh Probe (MP) refusal at 1.8m bgl due to gravels and flint within the clay (TP/BH 1).

Roots not encountered from 0.8m bgl to 1.8m bgl (TP/BH 1). Extensive inspection of soil samples encountered no roots.

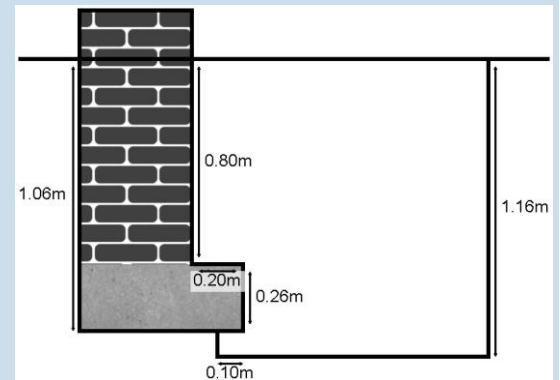
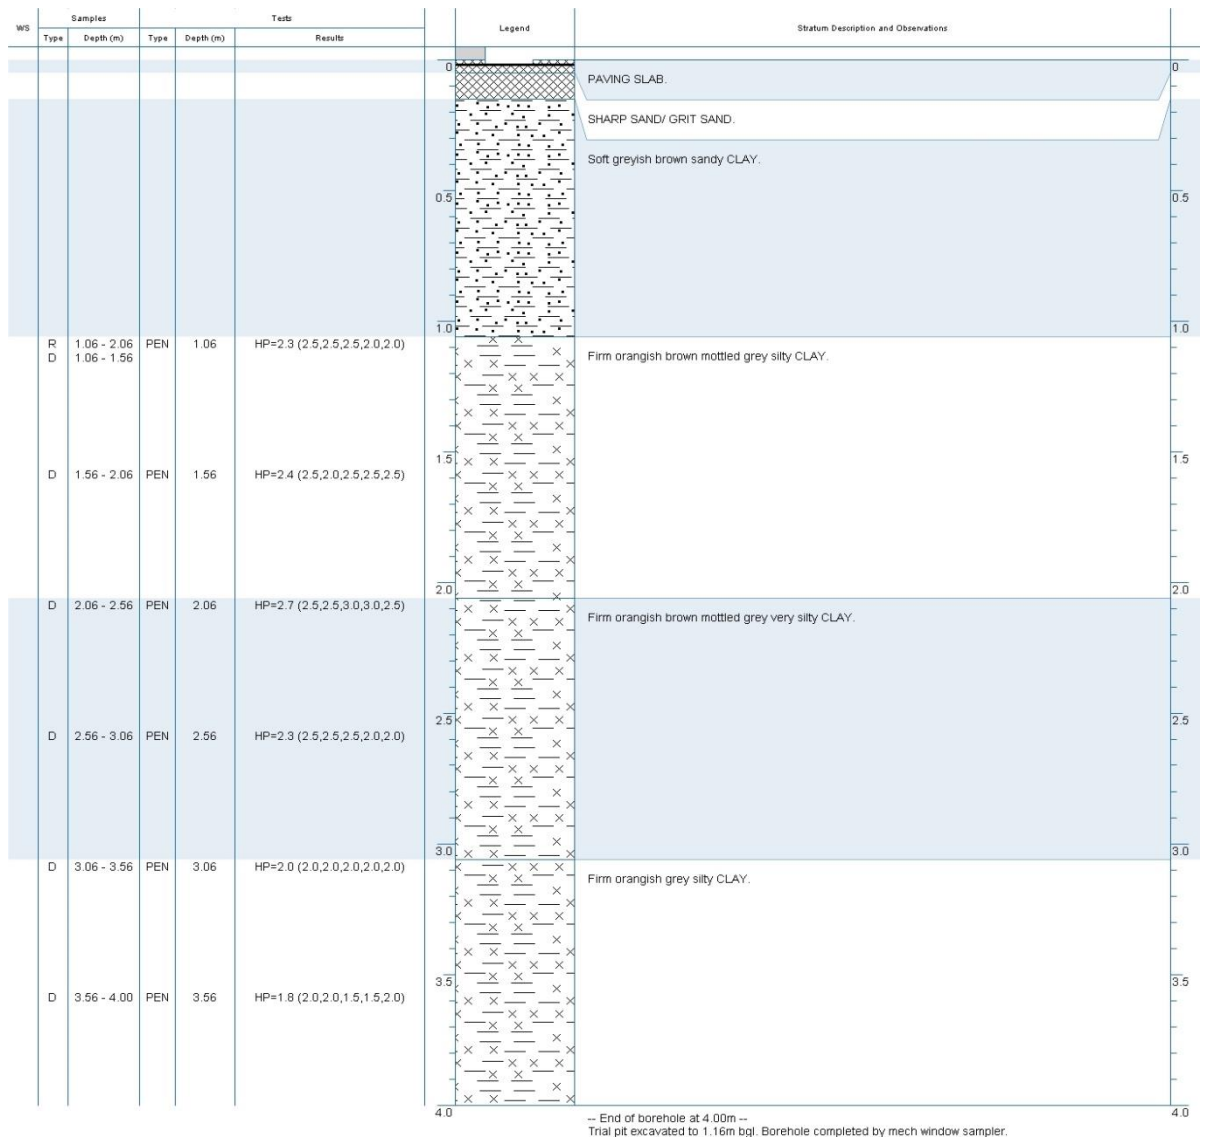
## TP/BH2 Foundation Detail and Borehole Log

Extension foundation comprised of brick wall to 800mm bgl, bearing on concrete to 1060mm bgl, with a total projection of 200mm from the elevation. Underside of foundation (USF) was exposed to 100mm back from the face of the foundation and probed 350mm back from the face of the foundation.

Extension foundation was exposed and the underside of foundation (USF) recorded to be 1.06m bgl (TP/BH 2).

Roots encountered to 1.06m bgl (TP/BH 2).
