Our Ref: 231571 - Let 1

1 December 2023

**Re: Tree issues at 5 Coultas Road, Chandlers Ford, Eastleigh, SO53 5BA**

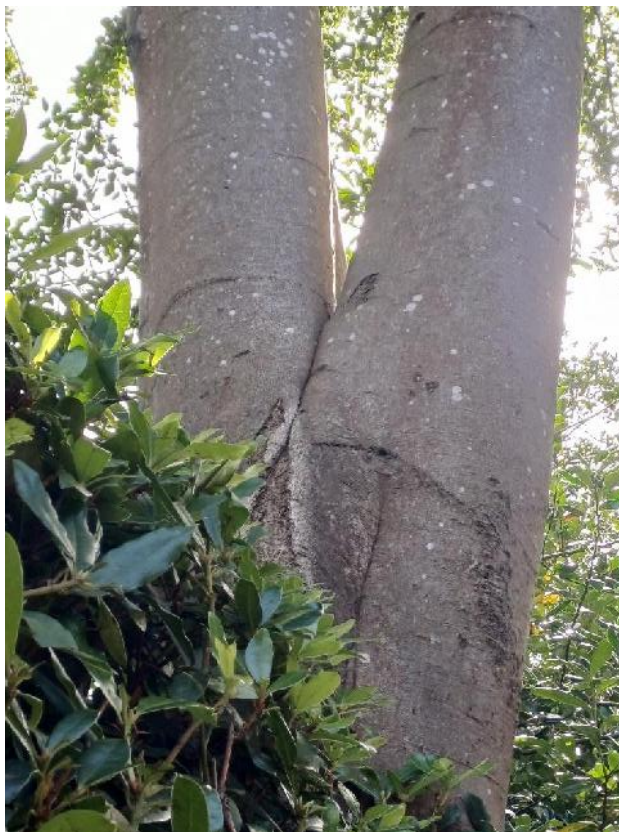
It has been documented that twin stemmed trees with tight forks and bark-to-bark contact have a higher failure propensity than single stem trees, or indeed twin stemmed trees with no bark-to-bark contact. Principally, this is related to incremental changes in stem diameters forcing the union apart. This can be particularly concerning during adverse weather events (which are becoming increasingly common), such as high winds, when the loading on tree stems can be quite high. It has also been documented that lower stem branching has a mechanical dampening effect on trunk movement. Consequently, the lack of lower branching and reduction in dampening is particularly concerning, particularly when further increases in tree height are factored in.

**Photograph 1:** Tree T1 with tight fork and bark to bark contact

On consideration of the condition of the tree, along with the structural engineer's comments, my opinion is that the tree should be felled. I understand that it is the subject of a confirmed Tree Preservation Order (TPO) and so you will need to apply to the council for its permission to remove it. I feel that the loss of the tree should be acceptable to the council to maintain acceptable levels of risk and I would be happy to make the tree work application on your behalf. However, please be advised that the council do have the option of refusing consent, in which case you do have the right to appeal their decision.

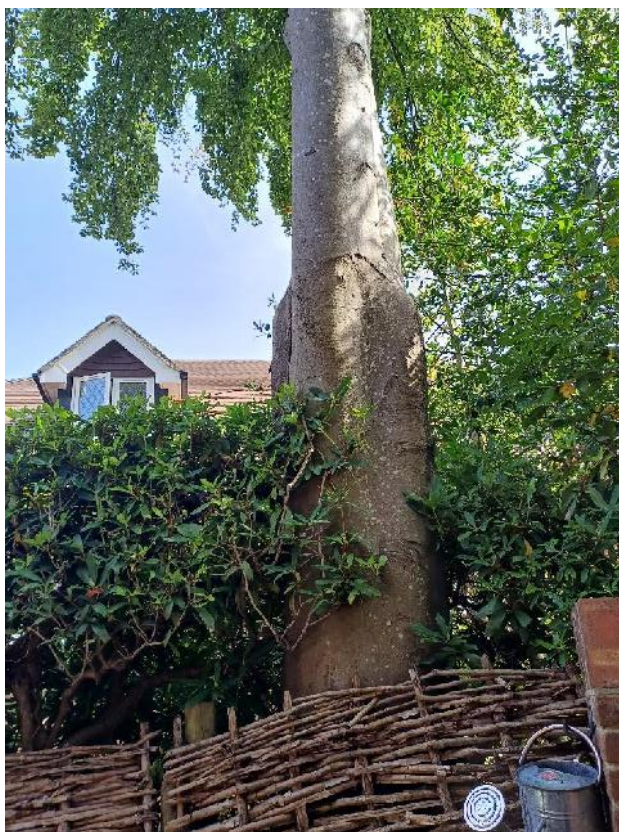
**Photograph 2:** Tree T1 with lateral stem broadening below union

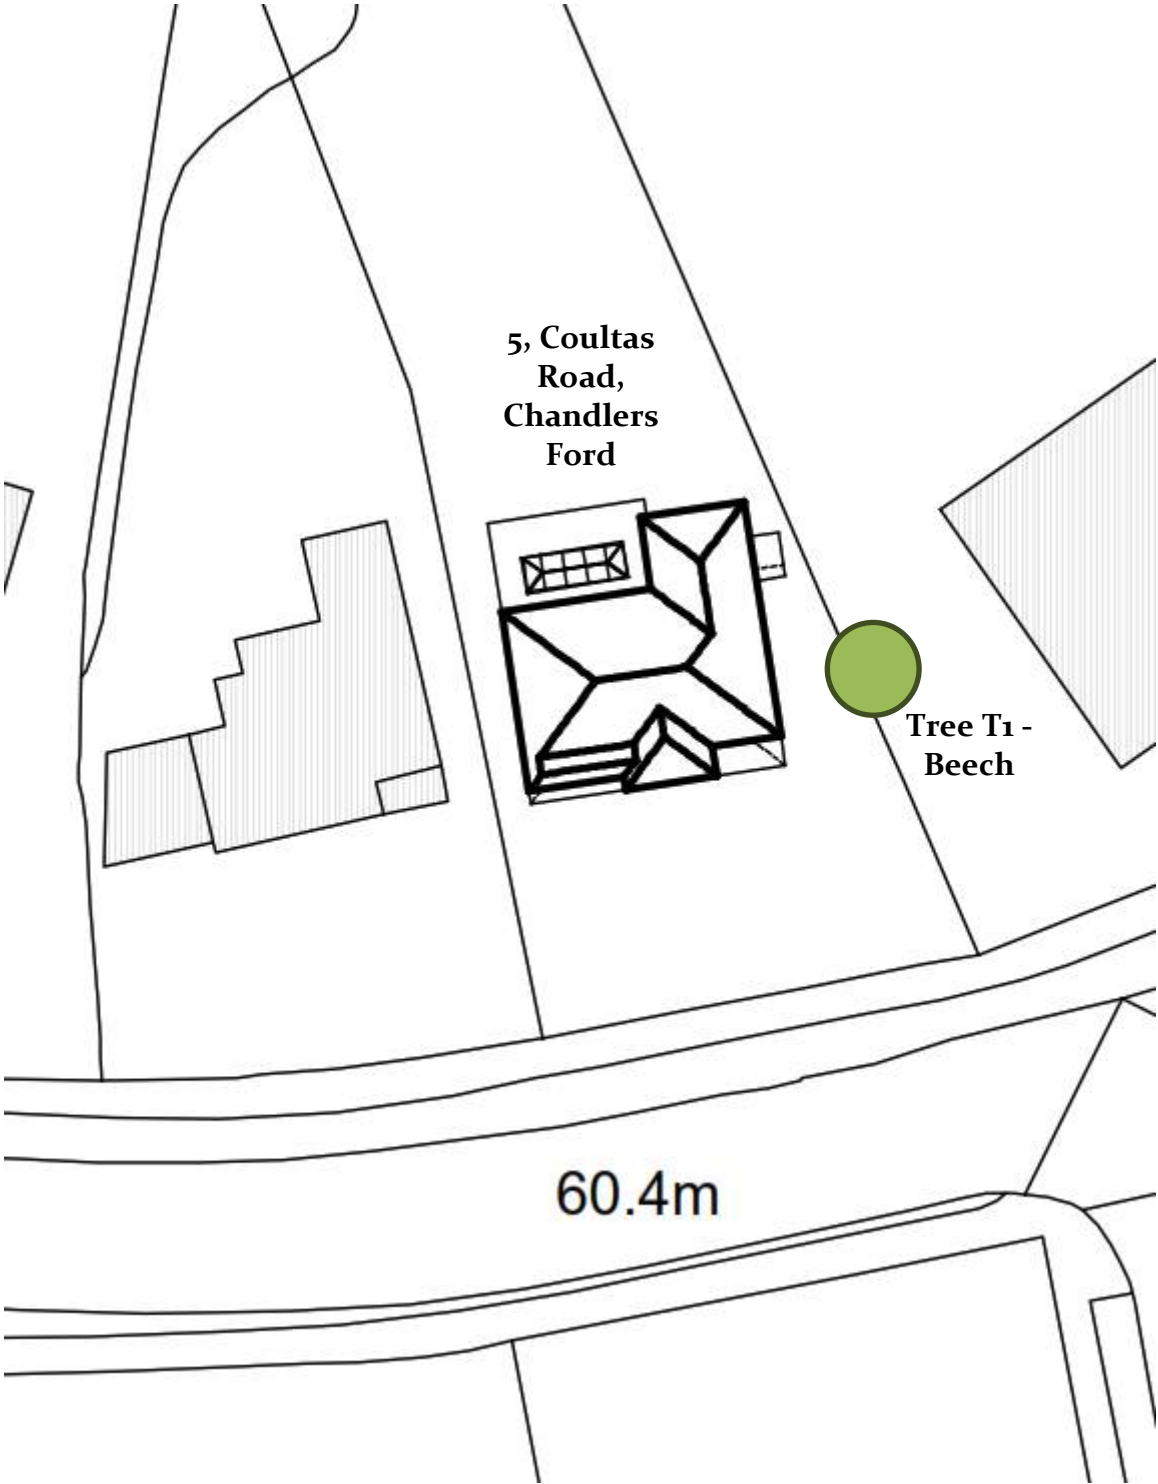
Tree Plan

I noted that the tree is located to the east of your house, close to the common boundary, but positioned on land owned by your neighbour. Its location is identified on the appended tree plan as tree T1 and I can confirm it is a beech tree (*Fagus sylvatica*), with a stem diameter of around 57cm measured at 1.5m above ground level and a height of approximately 23m. The tree is twin (co-dominant) stemmed at around 2.5m above ground level and I noted areas of bark-to-bark contact between the stem union (photograph 1) and a noticeable lateral broadening of the main tree stem below the union (photograph 2). I also noted that the tree appears to have been pruned in the past, with multiple old and occluding wounds on its main stem with a corresponding lack of lower branching.
