16<sup>th</sup> October 2023  
TDB/456318/tdb

### **Structural Inspection of garden walls at 5 Coultas Road, Chandlers Ford.**

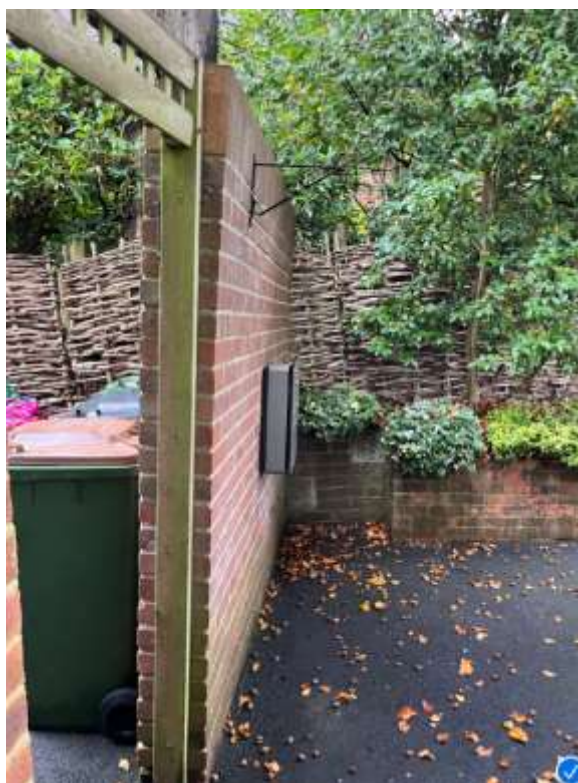
Figure 1

- 5.1.1** The wall is very clearly out of plumb, placing a 600mm long level against the wall showed it to be out of plumb by 40mm (1:15 gradient). **Figure 1** shows the wall is out of plumb, but it can be seen that the wall also bends outwards at the top.
- 5.1.2** A spirit level placed along a bed joint of the wall shows that the wall is out of level, sloping from west to east, in the direction of where the tree is located.
- 5.1.3** I was informed on site that the wall has very recently been repointed due to significant loss of mortar within the joints. No new cracking has appeared since.
- 5.1.4** **Figure 2** shows the freestanding wall abutting the retaining wall. It can be seen that that the walls are not bonded together.

**6.1** It is apparent that both walls have been subject to quite severe degradation. This is probably in relation to various causes; the age of the walls, their suspected insufficient foundation depth bearing within shrinkable soil, and the close proximity to a mature tree.

**6.2** A beech tree has a moderate water demand and the soils of the London Clay Formation are likely to be of High volume change potential. Referencing the NHBC 'building near trees' tables, a Beech tree is suspected to have an effect on High shrinkable soils up to a depth of > 2m, at a distance of 1m away. This is likely the cause of why the walls are out of plumb; the foundations have failed due to the effect of tree roots.

**6.3** A quick assessment shows that the centreline of the freestanding wall at the top is outside the face of the wall width at the base, and therefore risk associated with failure is very high. It is advised that the freestanding wall is taken down to safeguard people and property against the risk of sudden collapse.
