**Subsidence  
Monitoring  
Services**

Monitoring visit 3 of 5

## Monitoring Plus Report

| Address | 27 The Foxgloves<br>Hedge End<br>Southampton<br><br>SO30 0UG | Principal area of damage | to be advised | Installed | 09/06/2023 |

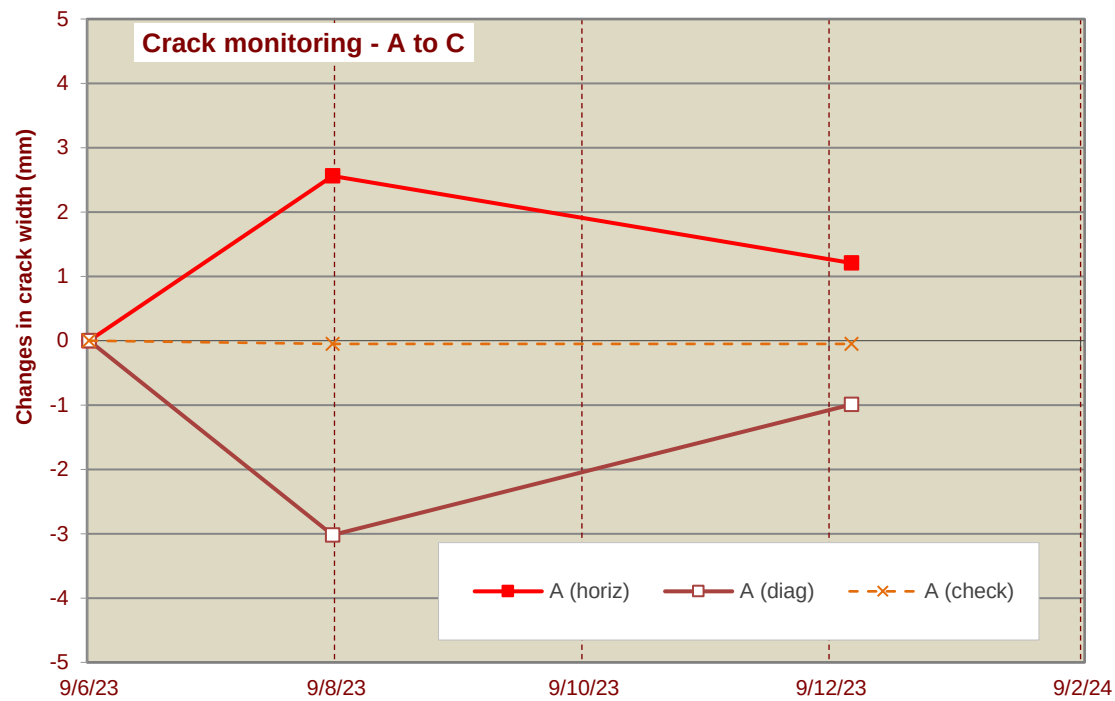
A (horiz) Demec triplet, internal, conservatory.

Crack monitoring
