BS5837: 2012

Arboricultural Survey & Impact Assessment

Ocean House, site of the former Hilton House, Weston Parade, Southampton, SO31 5FB

**11/15/2025**

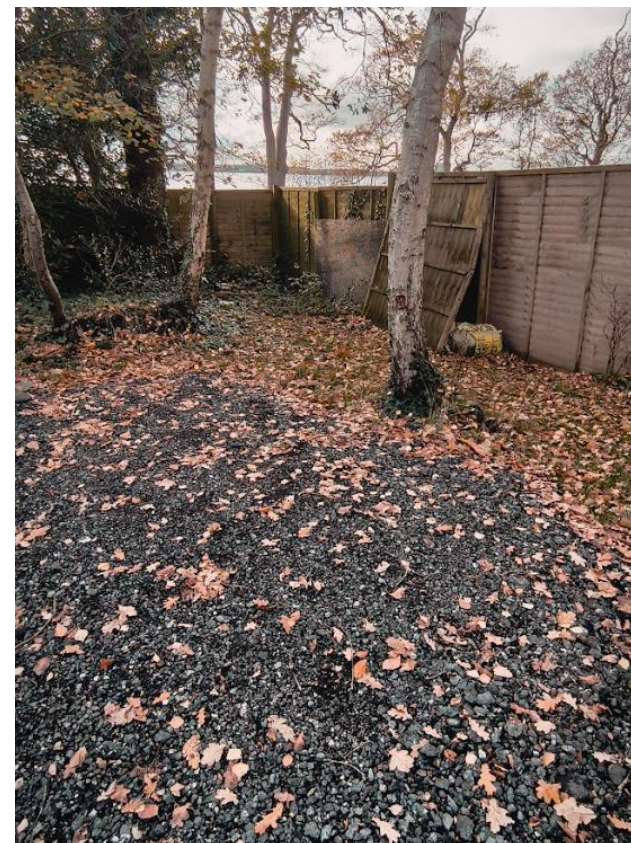
Figure 7: Gravel in the RPA of G4

Geogrid, Cellweb, or similar no-dig gravel based cellular reinforcement mesh back filled with gravel, to form protection to root areas from compaction and arrest the lateral displacement of aggregate (Indraratna, Hussaini and Vinod, 2013), whilst allowing gaseous exchange and water infiltration, may be a recommended addition on the proposed pitch locations on the gravel driveway area to ensure full compliance with BS5837:2012 – Subject to planning officers approval.

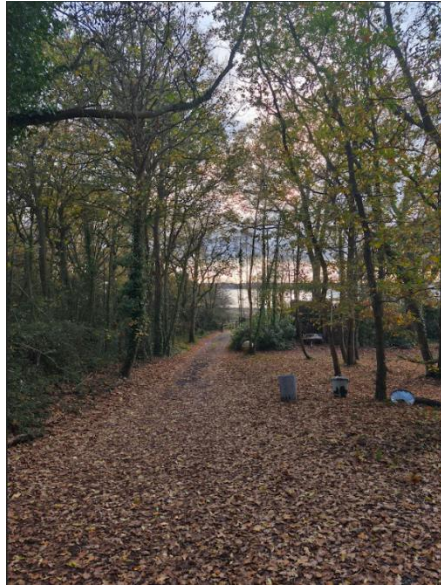
*Figure 12: Eastern gravel driveway  
viewed North - South*

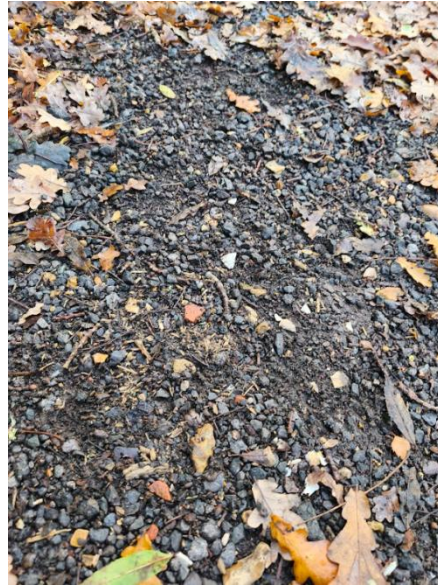
*Figure 11: Gravel surface detail*

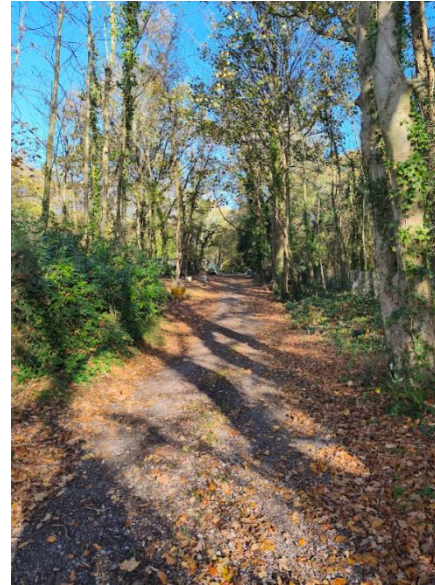
*Figure 10: Eastern gravel driveway  
viewed South - North*

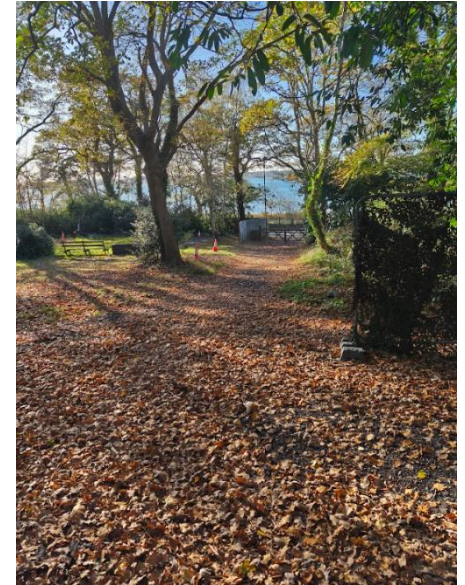
*Figure 9: Western gravel driveway  
viewed North - South*

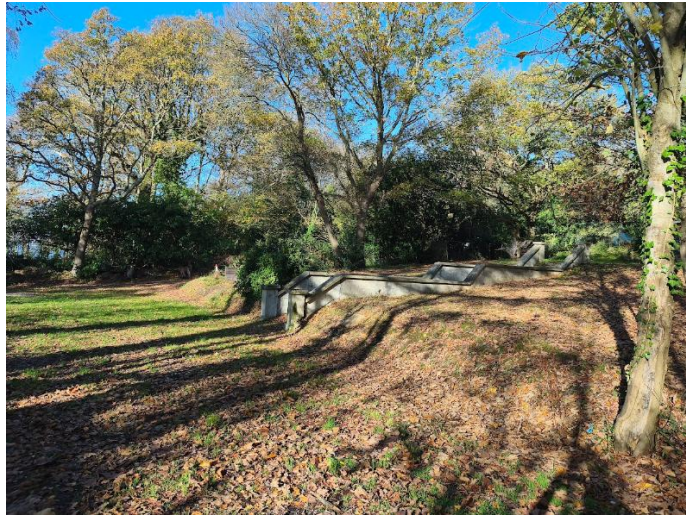
*Figure 13: Grassed trackway viewed East - West*

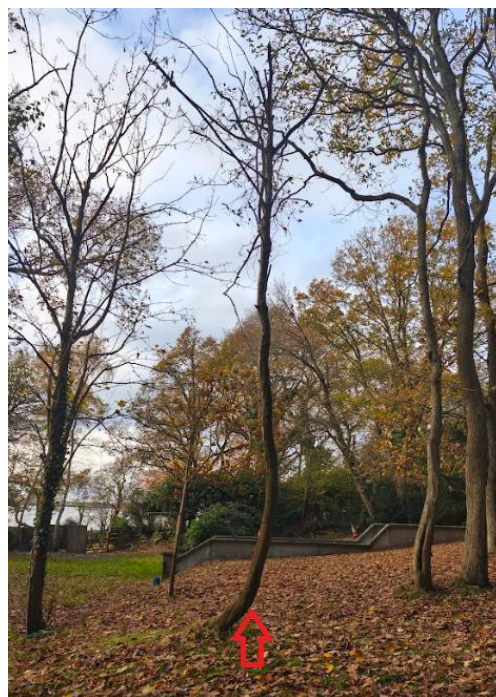
Figure 14: T62, a dead oak.

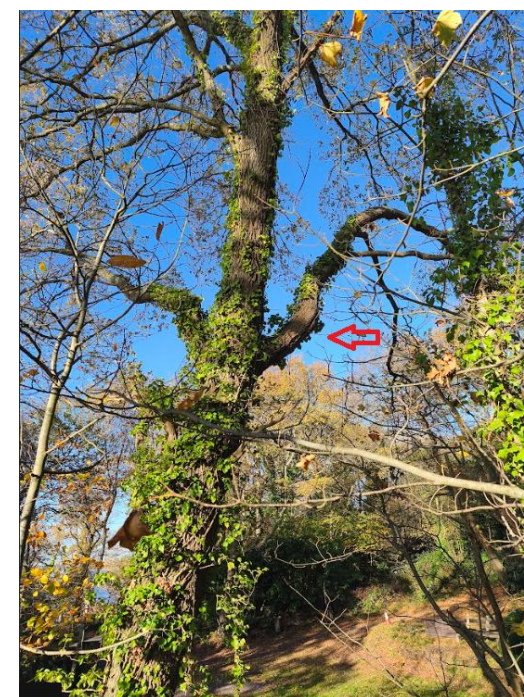
Figure 15: T55, Hazard beam crack location

| Label Seq | Common name | Species | Life stage | Condition | Notes | Recommendations | Est remaining contribution (<10, 10+, 20+, 40+) | BS Cat | Sub Cat | Priority Timescale |
|---|---|---|---|---|---|---|---|---|---|---|
| T55 | Oak | <i>Quercus robur</i> | Mature | Good | Deadwood - Minor (<50mm dia) rope swing in tree (x 1 Unit) - third primary lateral branch at 8m north branch sagging with visible canopy gap and 1.5m long Hazard beam - | Local reduction - third primary lateral branch at approx 8m north. Hazard beam crack. Above union. Reduce end weight by pruning secondary and tertiary branches approx 4-5m to an appropriate pruning point. Pruning wound not to exceed approx 15cm dia. Remove rope swing. | 40+ | A | 2 | Medium 1-3 months |

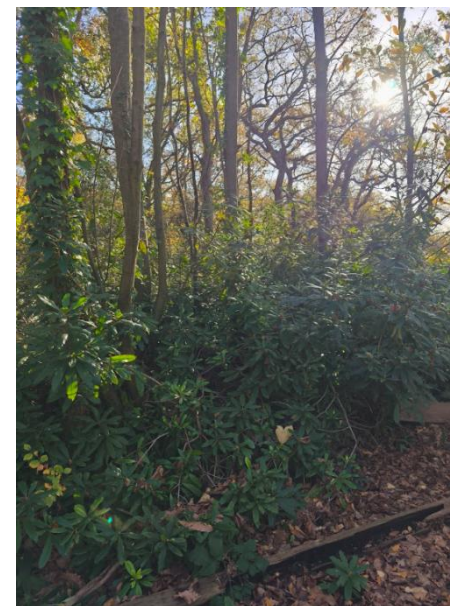
The implementation of this development requires the removal of no trees, shrubs or groups of trees. Rhododendron/laurel underscore removal has been carried out, particularly at the Northern half of the site. However in the course of this survey 2 health and safety items are proposed. T62, a dead Sycamore adjacent the driveway to be felled, and T55, a mature oak to have a localised reduction to one defect branch to prevent a larger wound from a catastrophic branch failure. These items are noted in the *Tree Survey Schedule* (Appendix C) and locations are noted on the *Tree Location Plan (01)* (Appendix A).

Figure 16: *Rhododendron underscore*
