**79 Ashdown Road, Chandlers' Ford,  
Eastleigh SO53 5QX**

## **Arboricultural report**

**Carried out on 27<sup>th</sup> December 2026  
by David White,  
LANTRA-approved Professional Tree Inspector  
on behalf of Oakfall Tree Surgery**

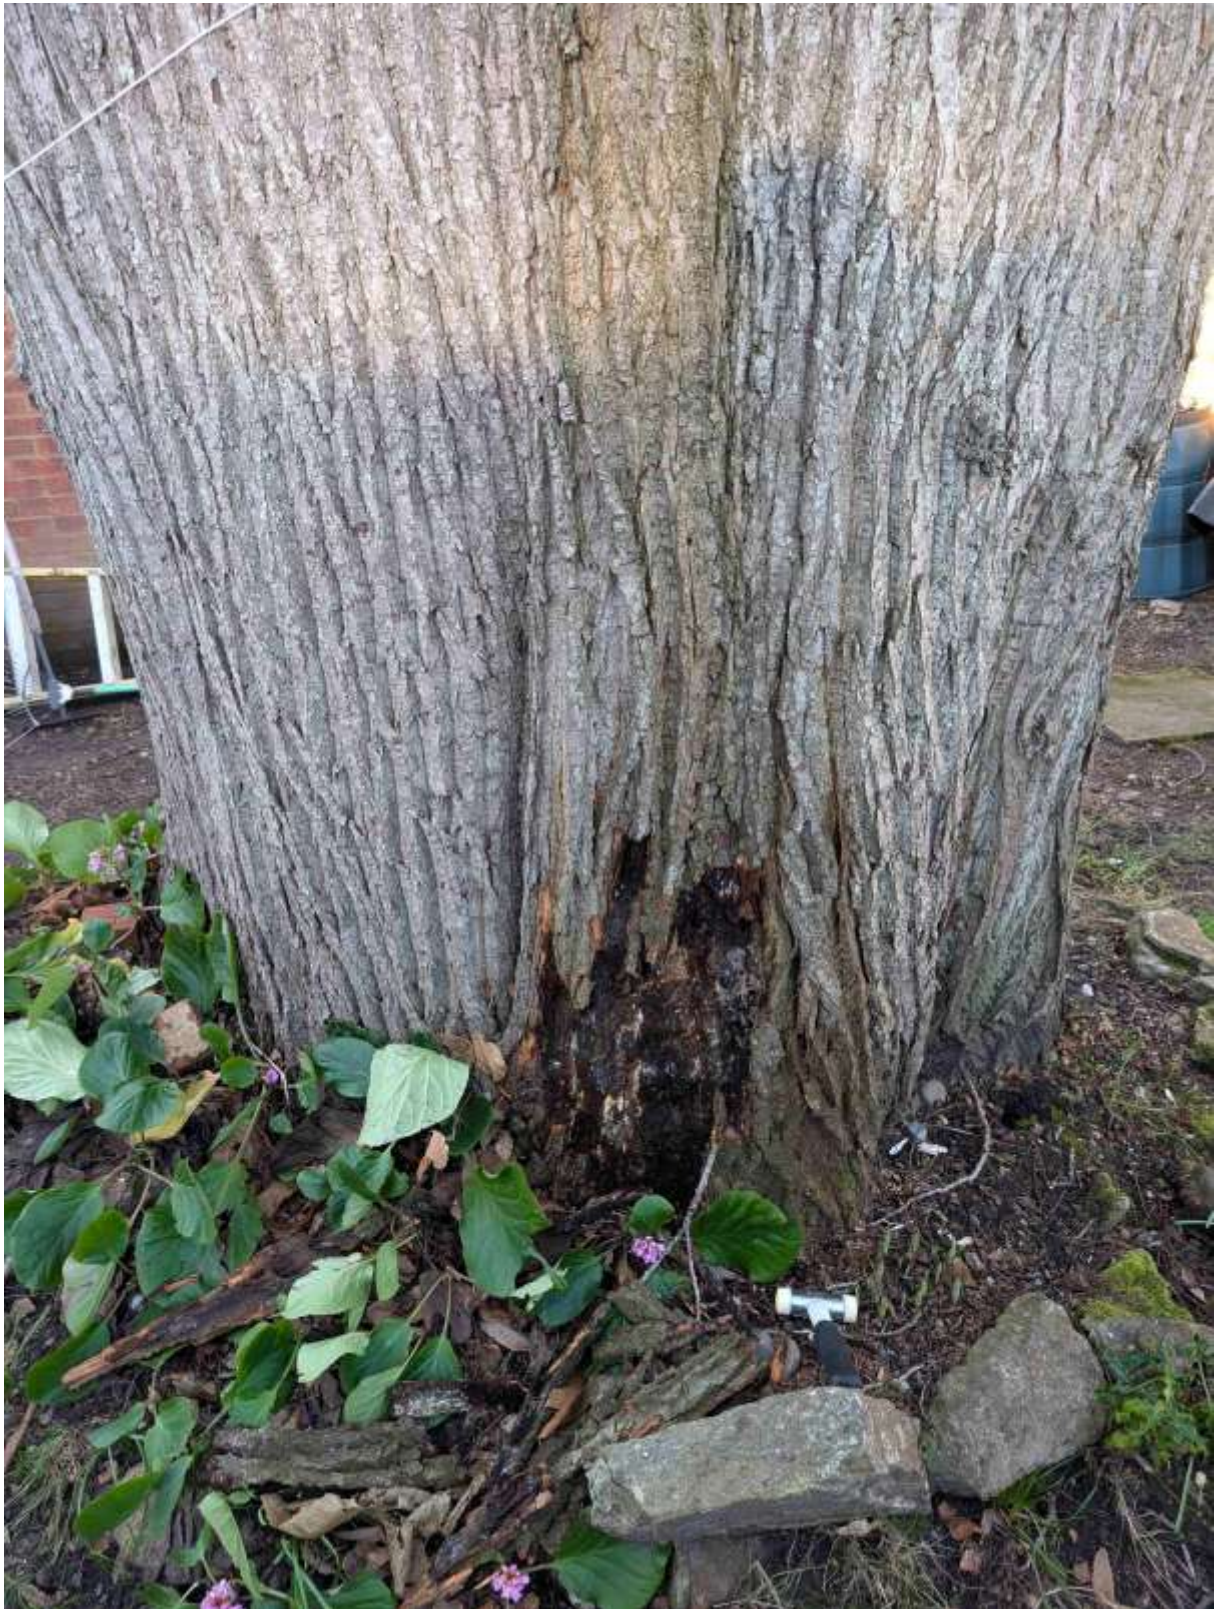
- East side of base, area of necrotic bark approximately 30cm wide by 60cm tall exposing slightly weathered/softened wood, no significant penetration with probe. (see figure 1)
- Further hollow sound at base just to left of bark delamination for 30cm.
- South side of base, vague audible defects around base, no penetration but dull sound when struck. (see figure 4)
- Buttress on North side sounds normal, the rest of the base sounds slightly off/dull. (see figure 2)
- Potential audible defects up main stem but not in usual vertical strips, more like multiple small isolated pockets.
- Main union is a compression fork. (see figures 5 & 6)
- Gap in canopies between 2 main stems. (see figure 7)

This tree has multiple features of concern, the visible decay on the east side of the base along with inconsistent sounding with a mallet around the majority of rest of

base suggest the beginnings of dysfunction/decay, although there was not yet significant penetration when tested.

*Figure 1: East side of base, area of decay*

Due to these concerns and in relation the target rich environment, I am sadly **recommending the tree be removed within 6 months.**

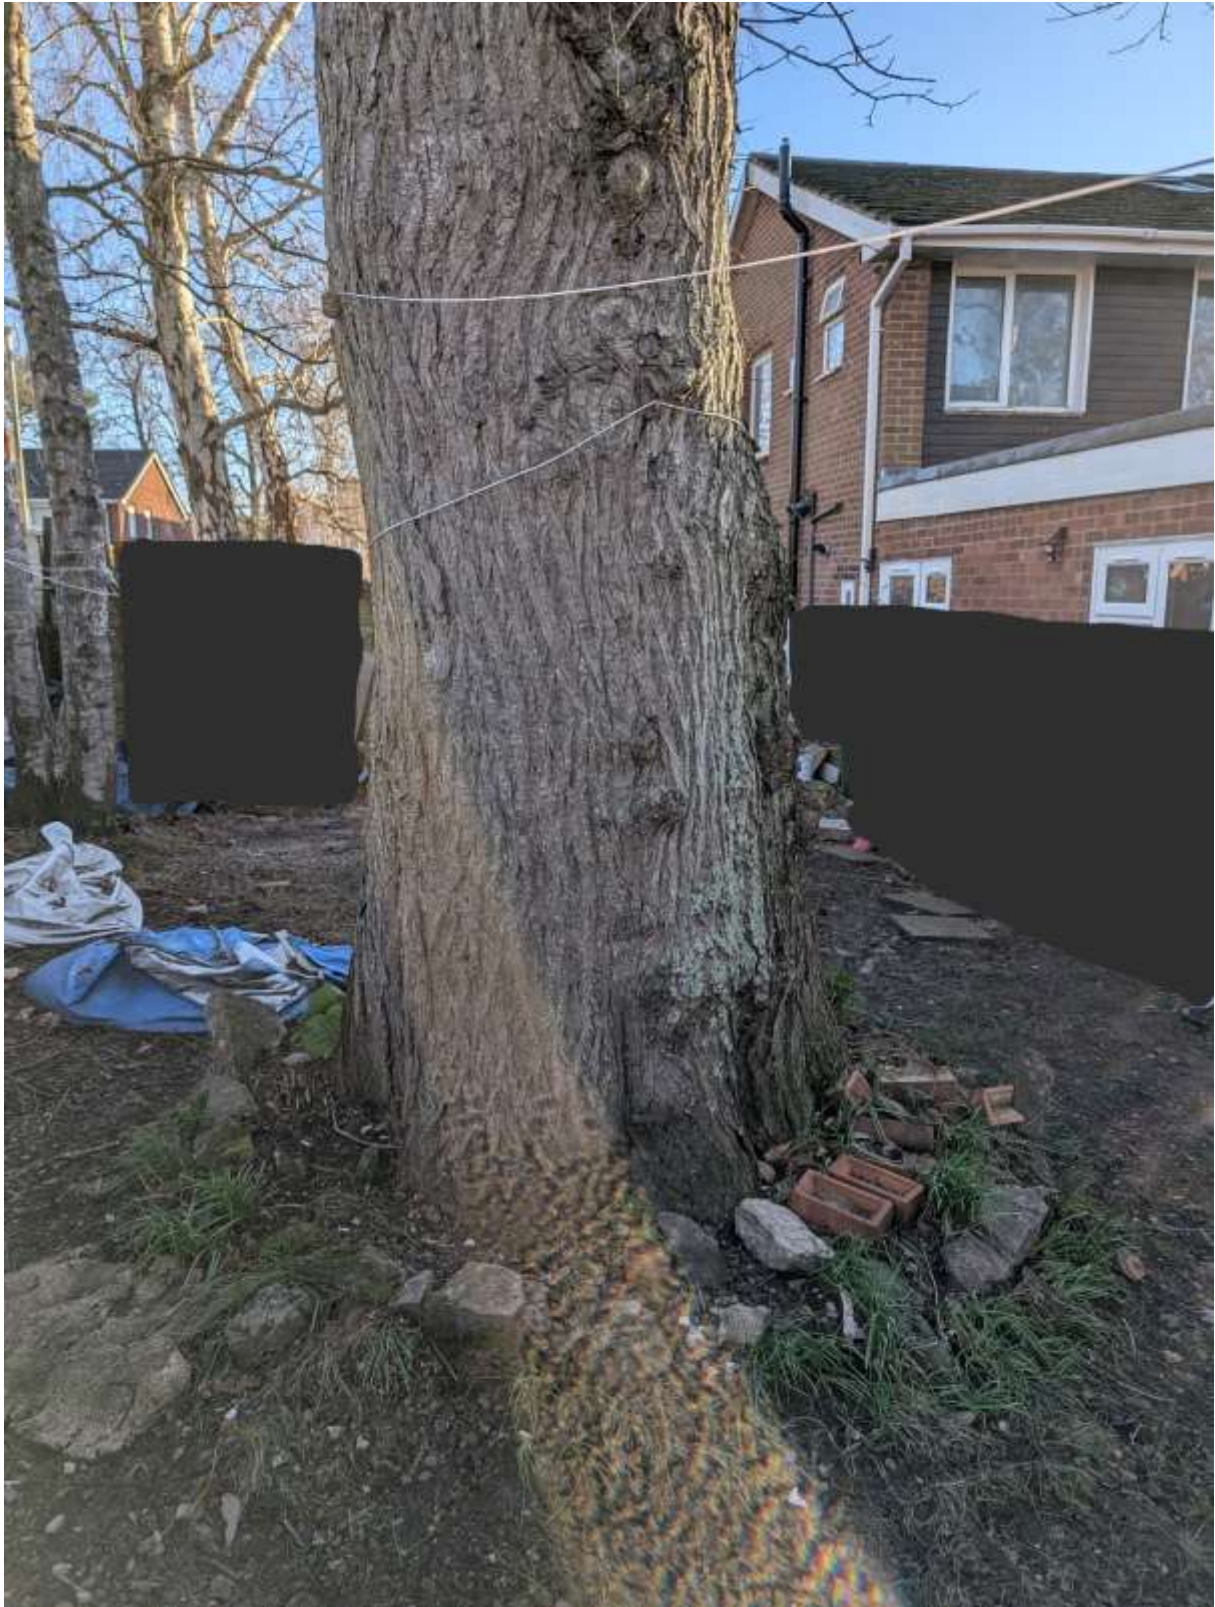
*Figure 2: North side of base*

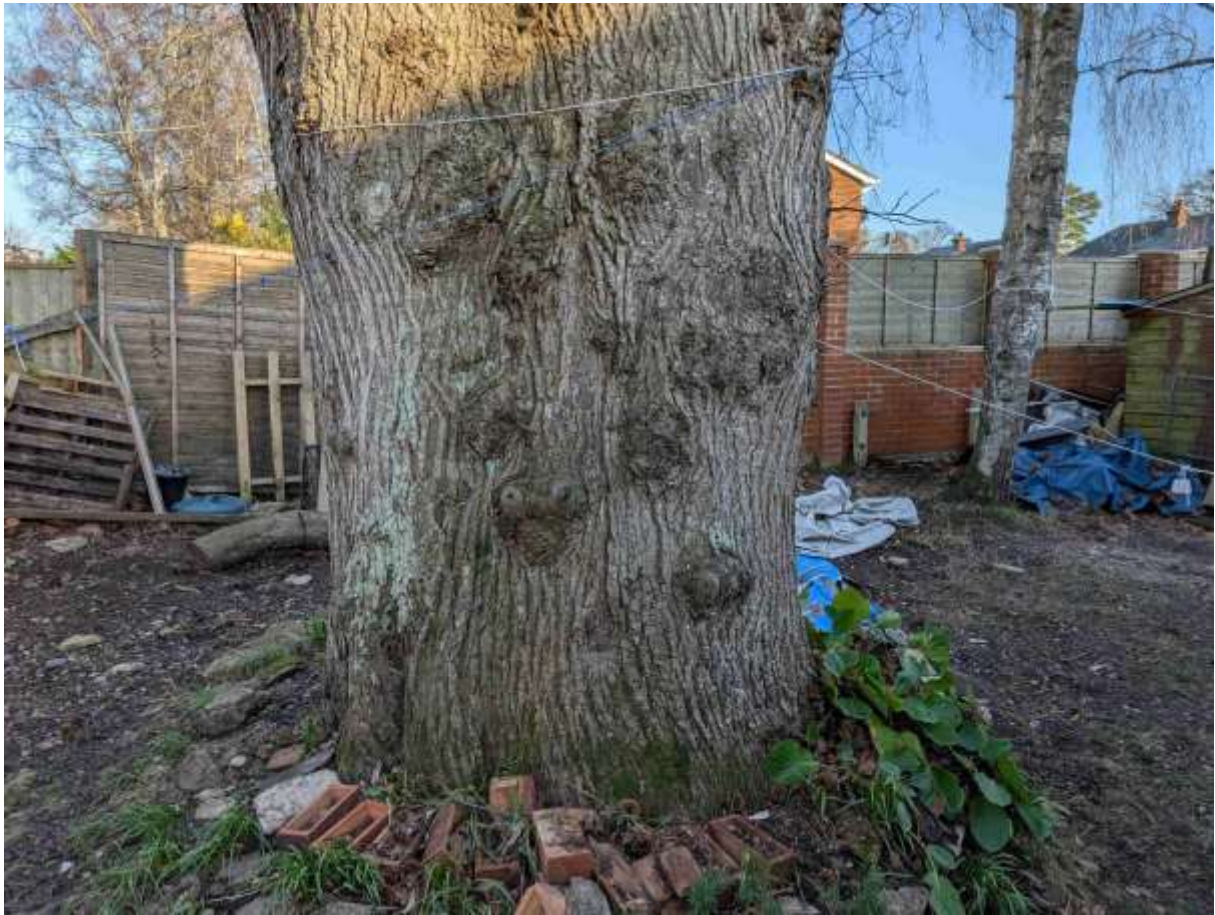
*Figure 3: West side of base*

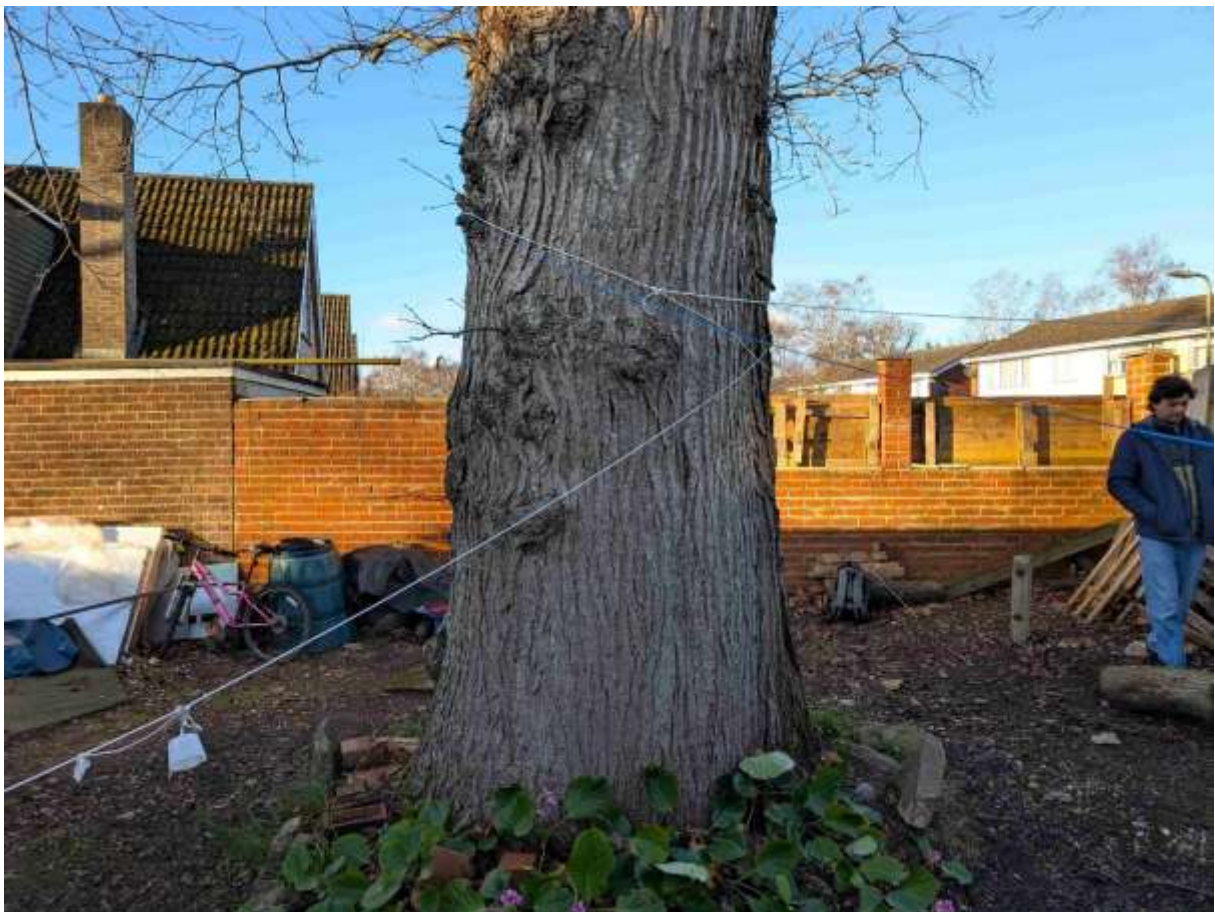
*Figure 4: South side of base*

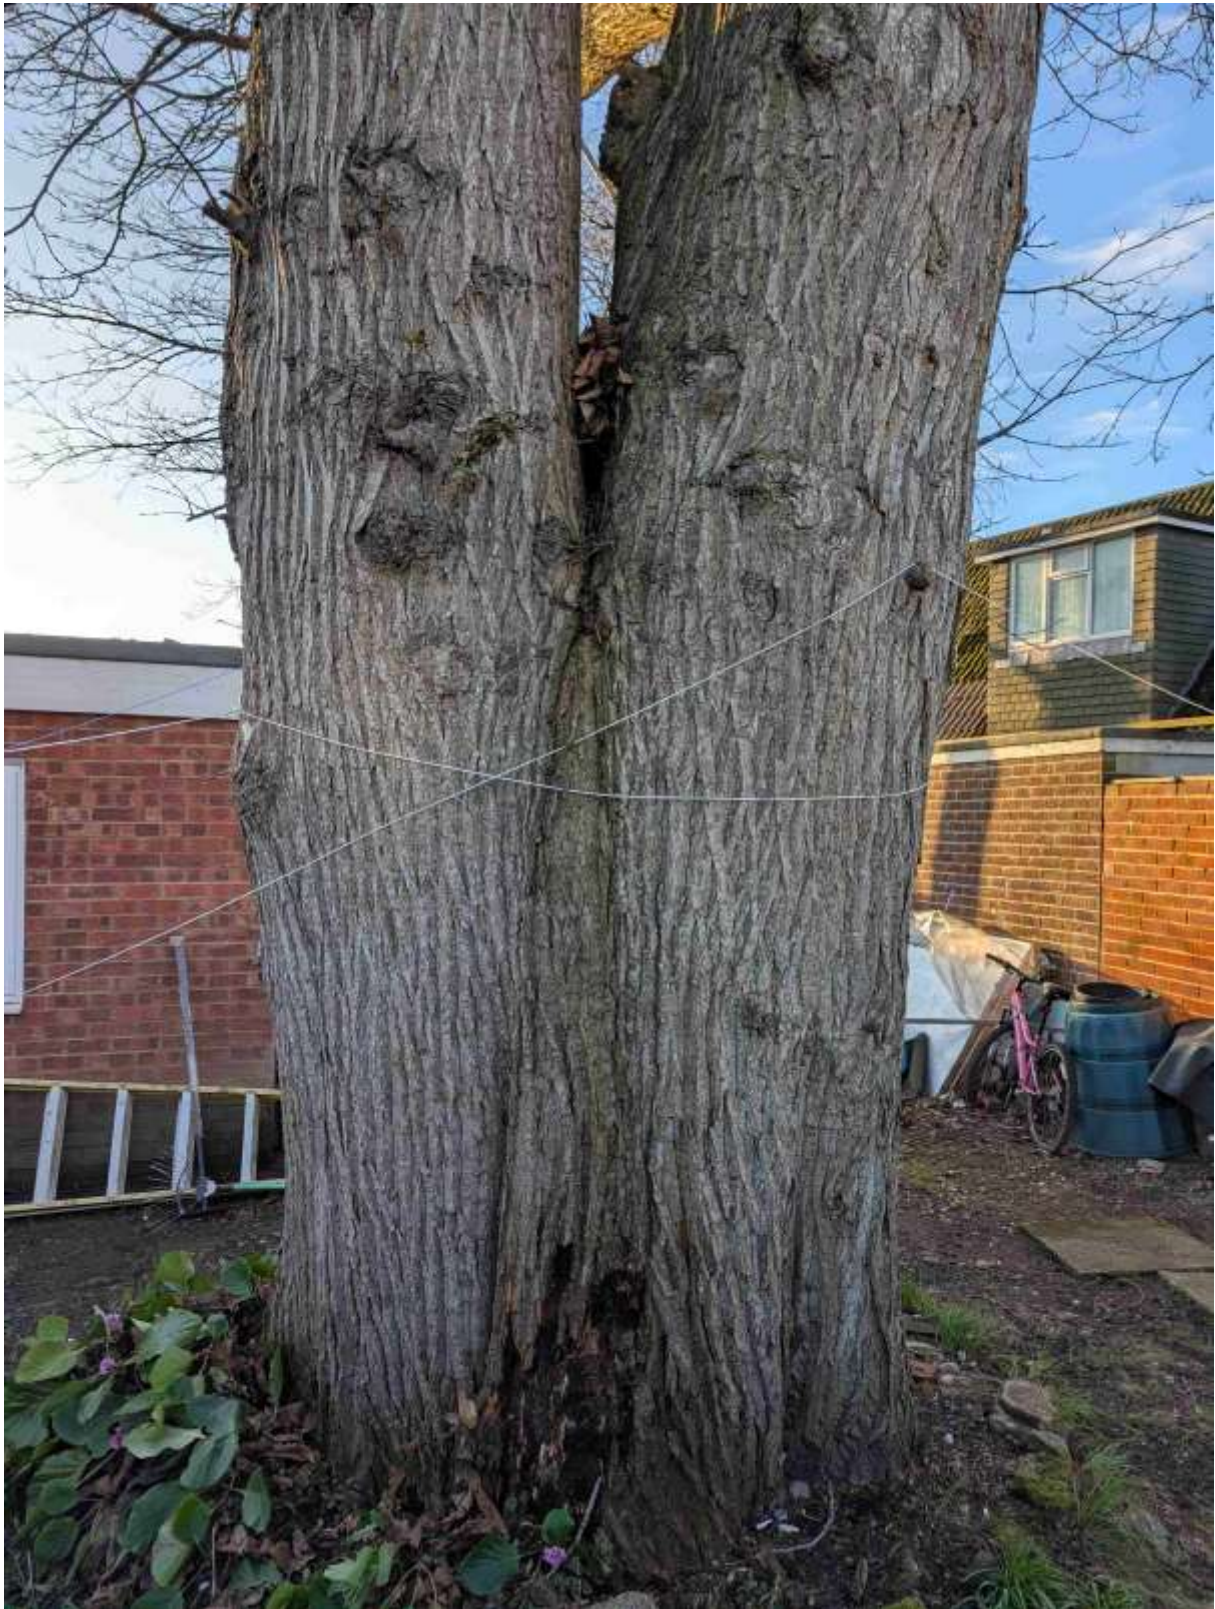
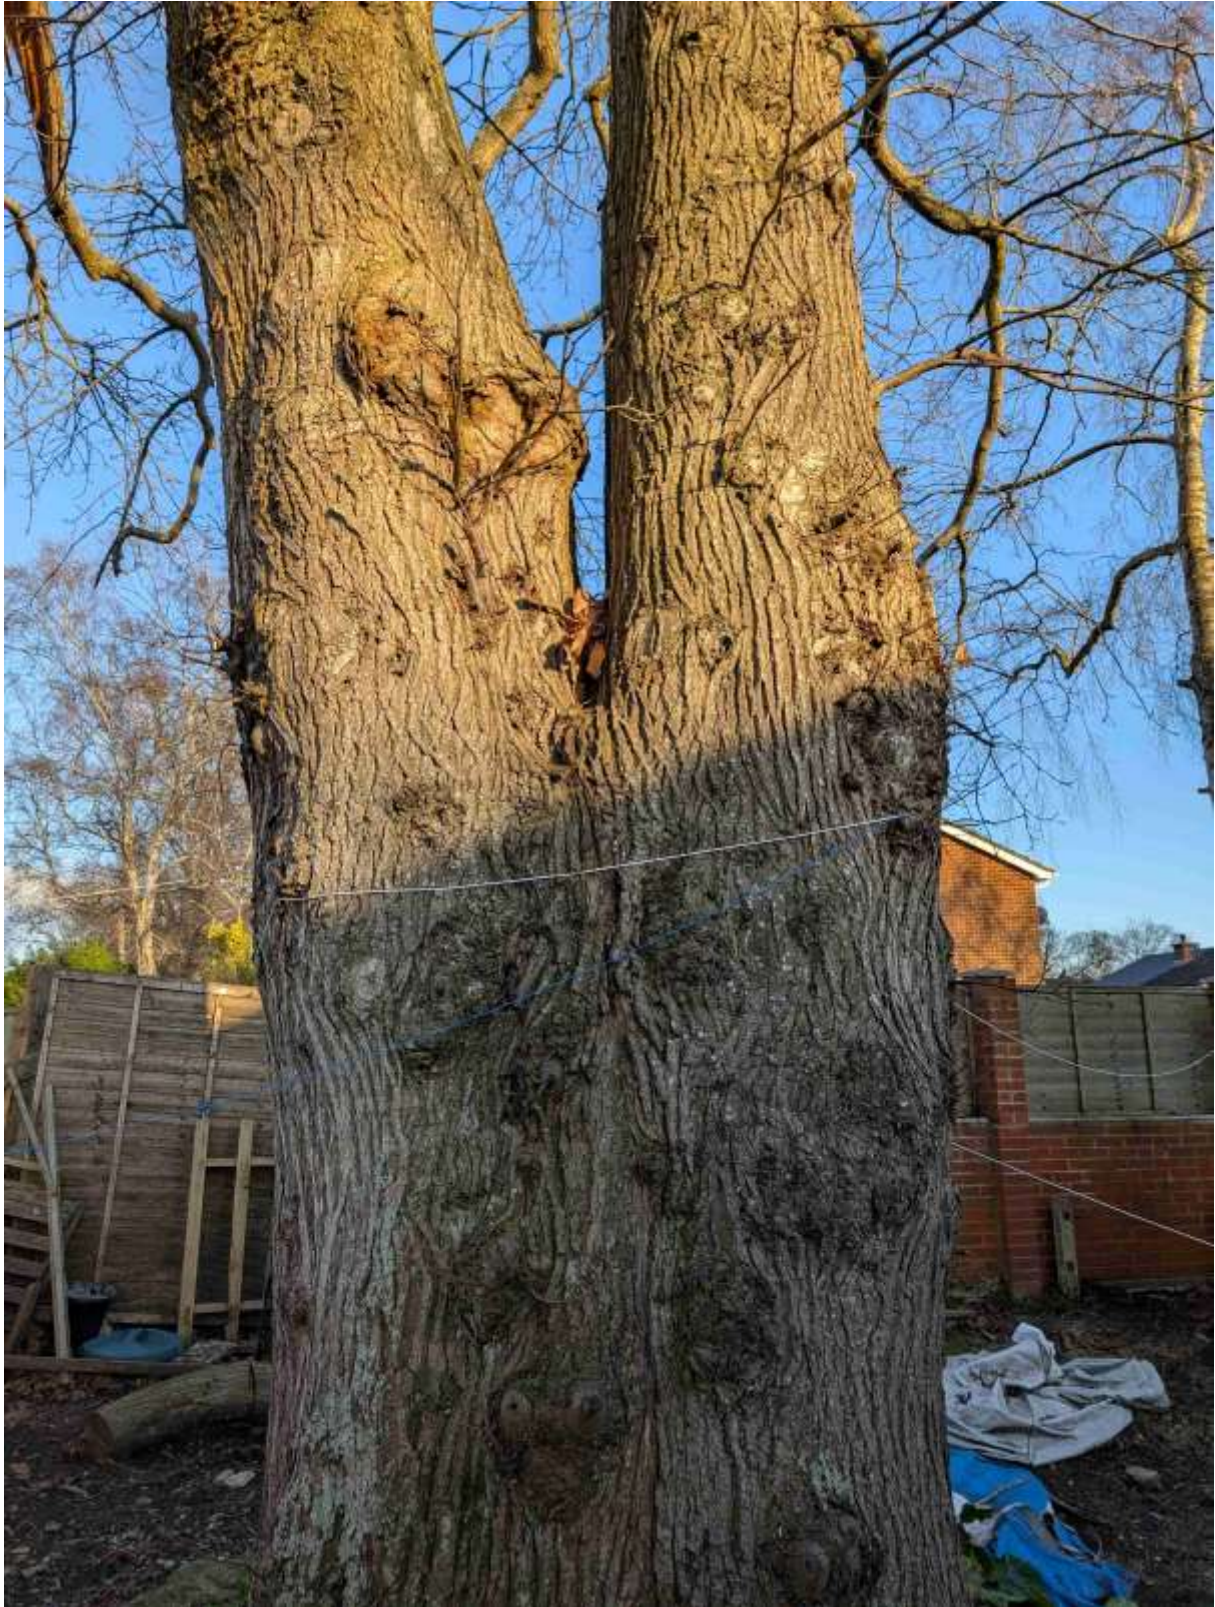
The main union is a compression fork and there is a noticeable gap between the canopies of the north and south main stems, even when not in leaf, suggesting significant load/stress on the main union; however, there is not much evidence of adaptive growth around the union. This could potentially mean that there is not much stress at union (unlikely due to the gap in canopies) or more worryingly, either that the tree does not have the energy/resources required to reinforce this union, or that the decay visible on the east side of the base (directly in line with the main union) has weakened the union sufficiently to result in movement of the stems and the tree has not had time to respond. Given the sheer size of the tree and its target rich environment, if this main union were to fail the results would be catastrophic. The north stem in particular is heavily weighted towards the neighbouring property.

*Figure 5: main union, east side*

*Figure 6: main union, west side*

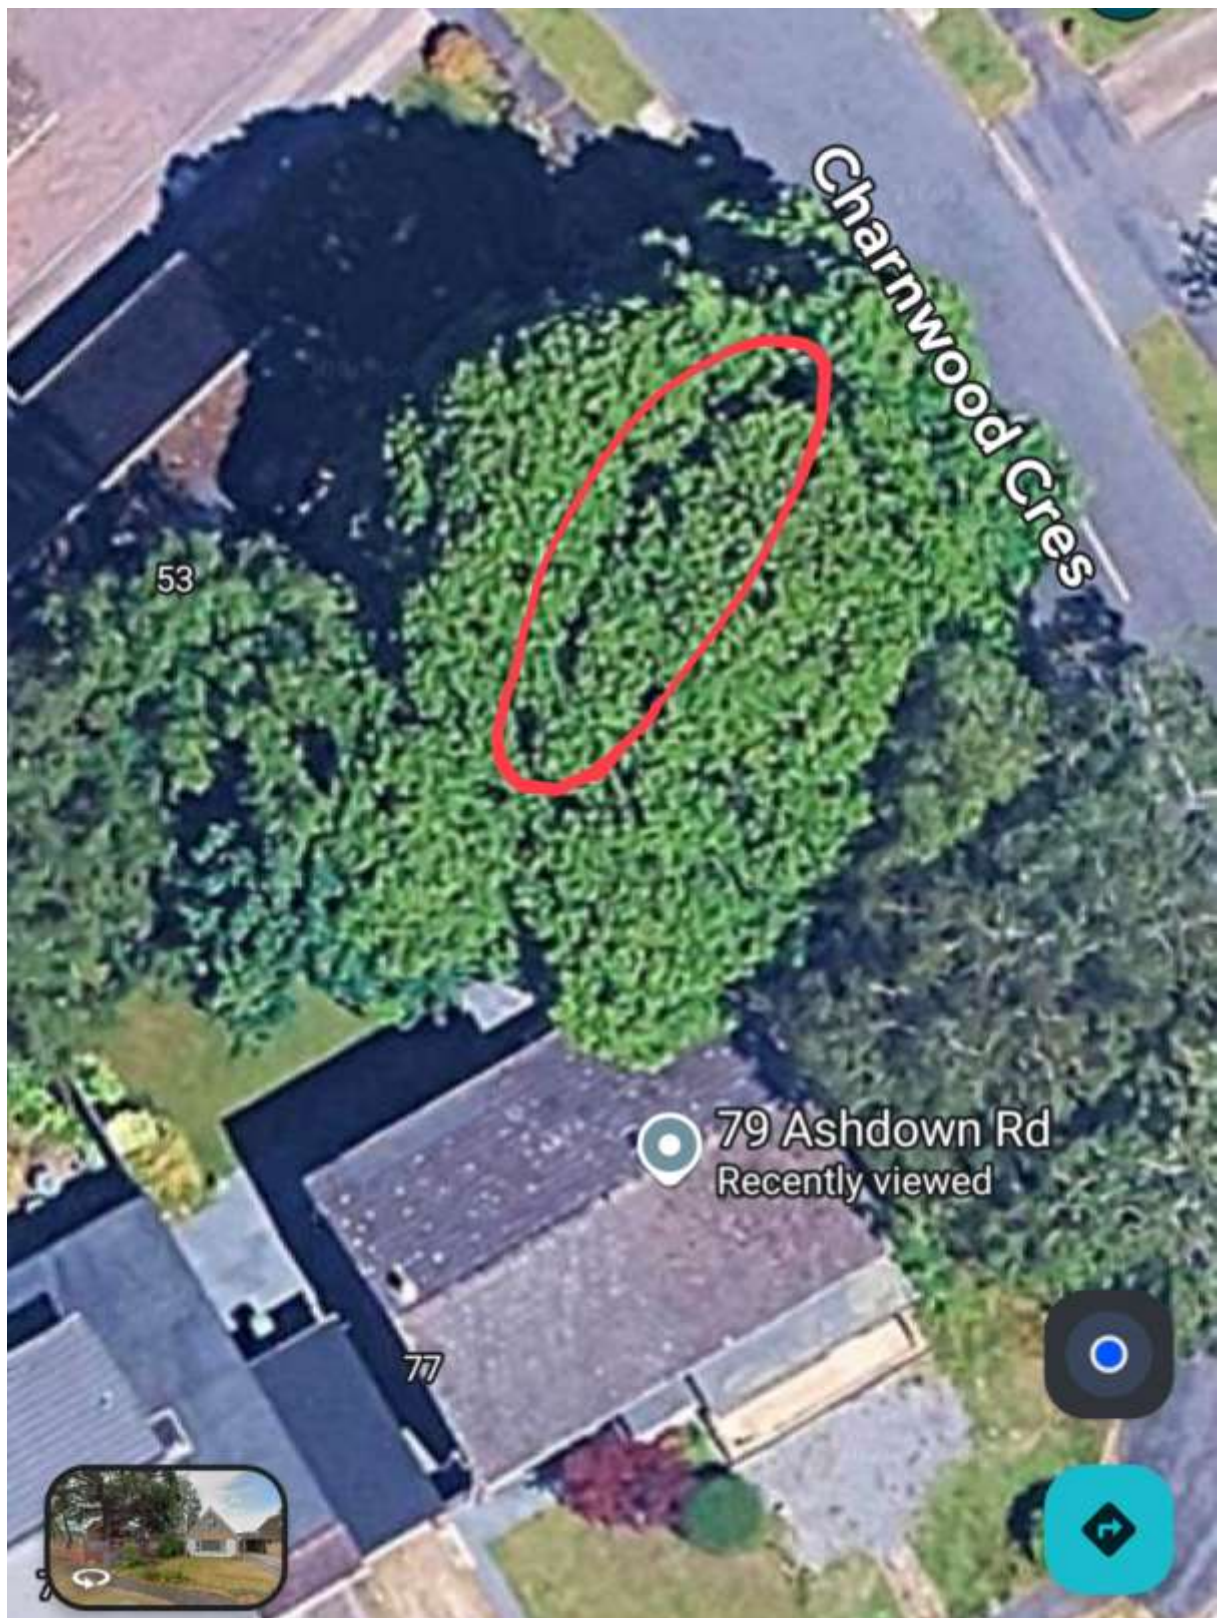
Figure 7: Gap in canopies between main stems evident in historic aerial photo

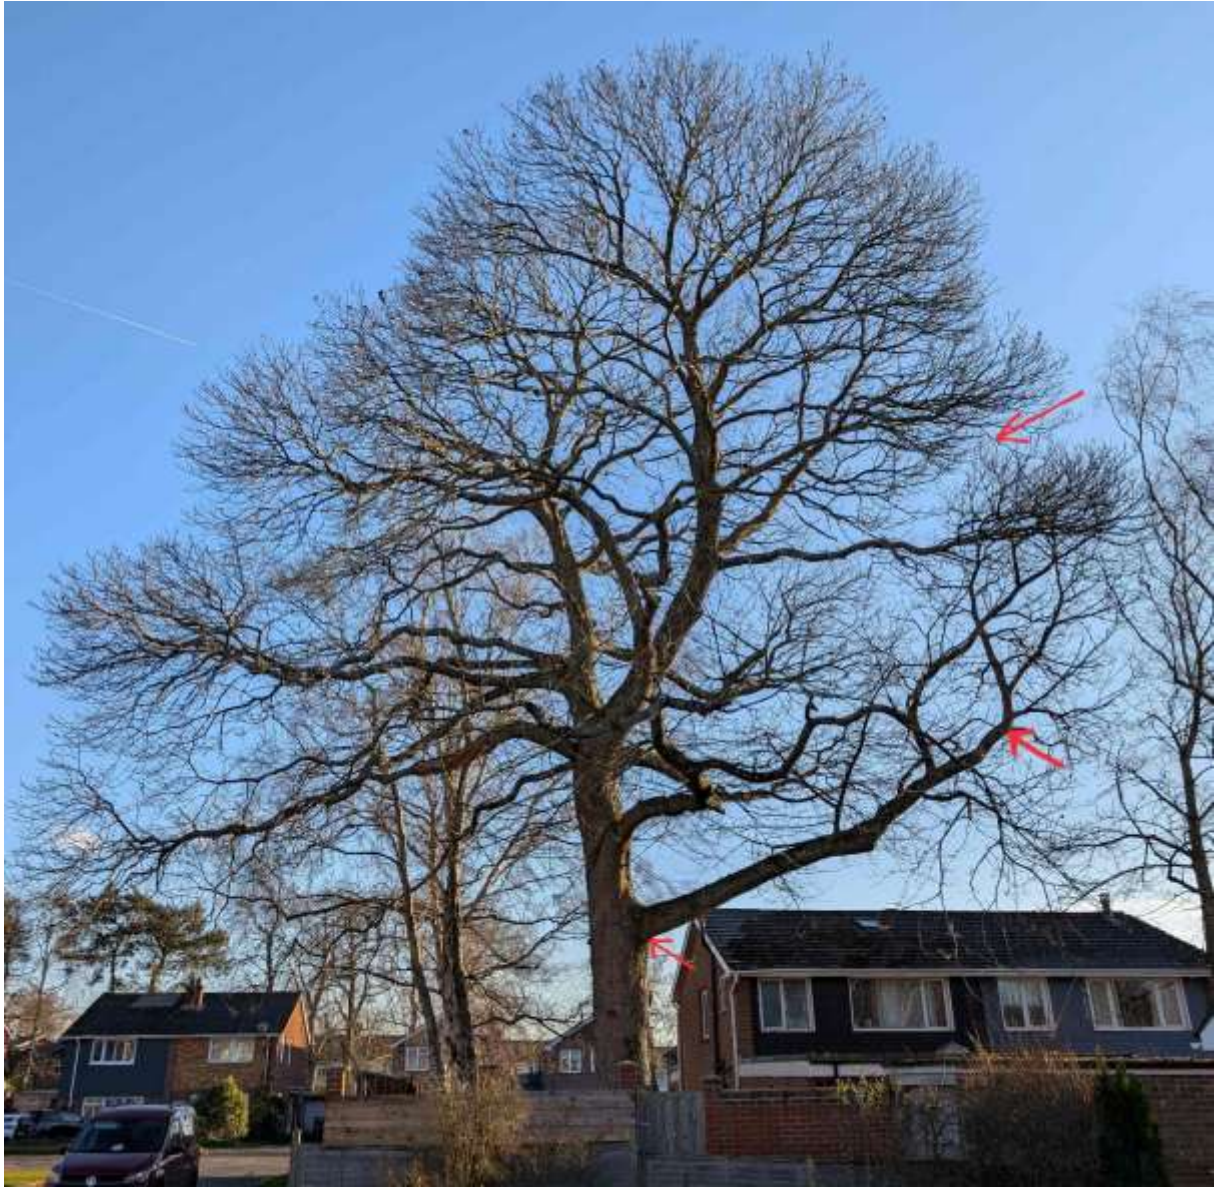
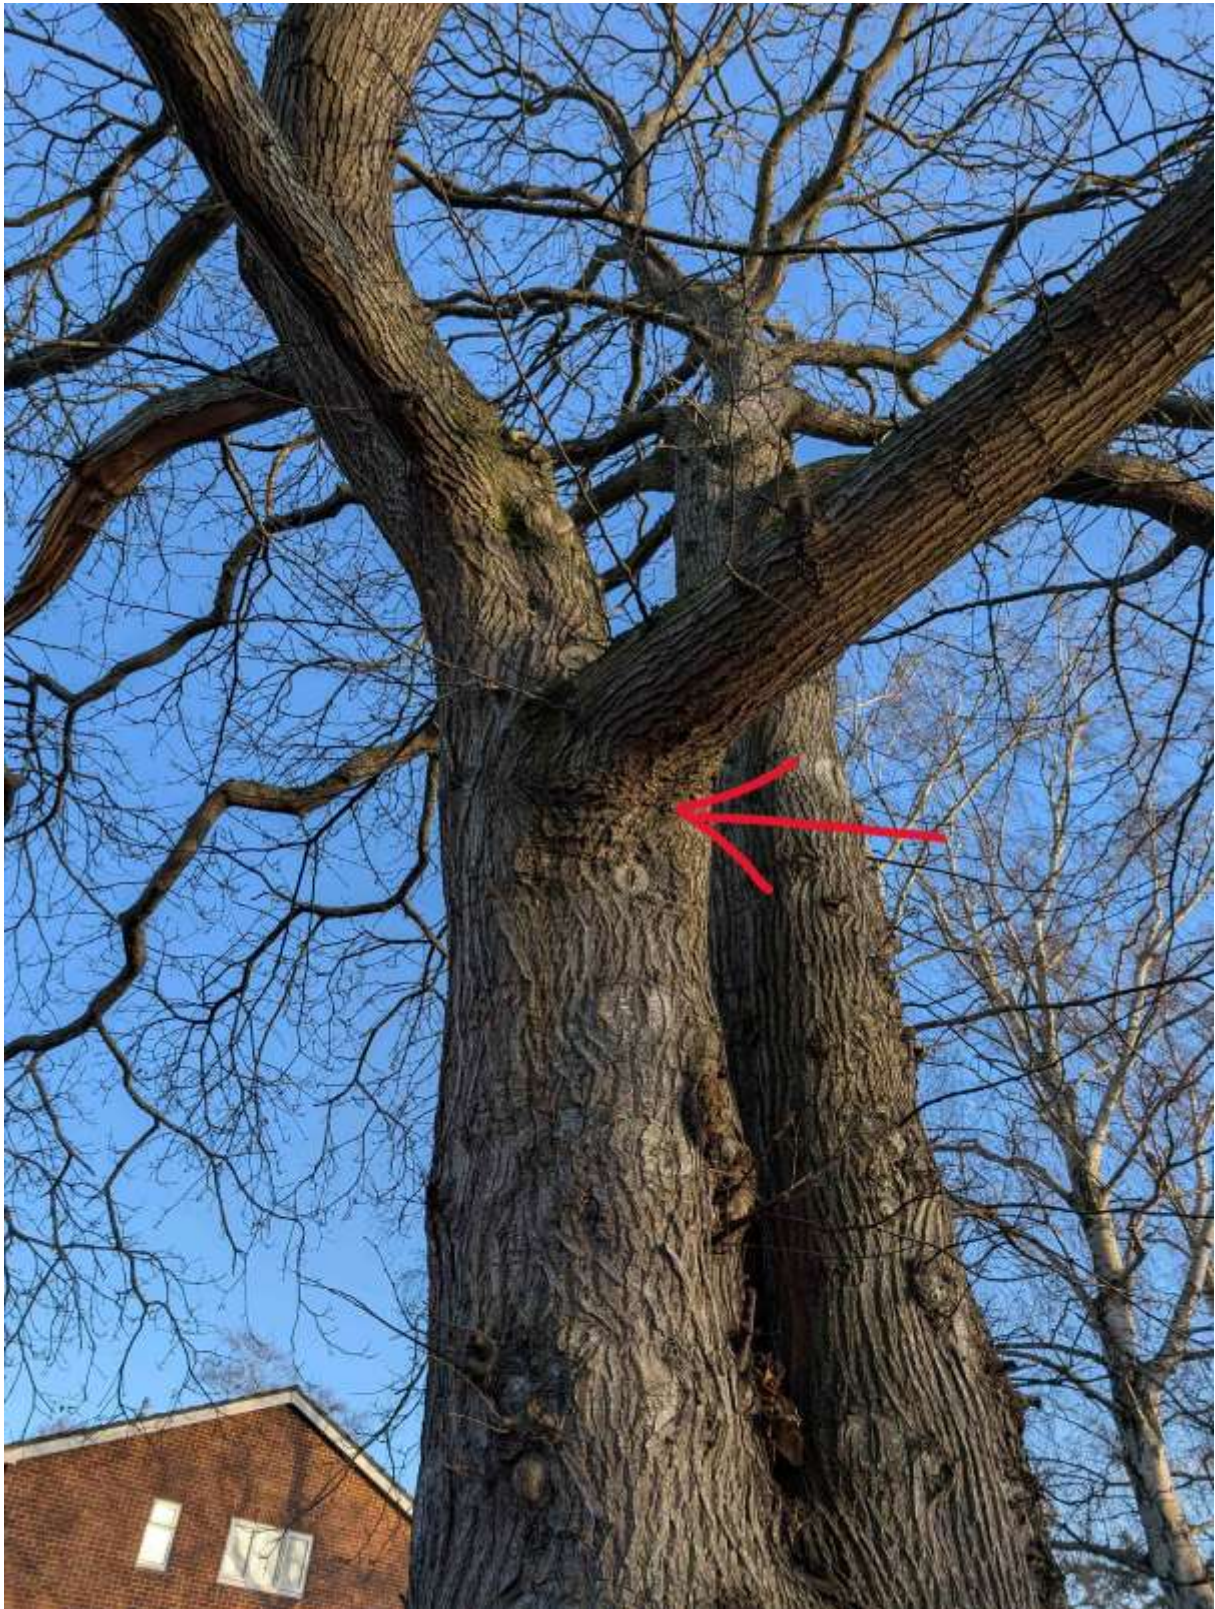
- First major limb on South West side significantly extended with large hazard beam, possible fibre buckling. (see figures 8 & 9)
- 2nd major limb, on North west side, start of branch shedding collar forming. (see figure 10)
- 3rd major limb has suffered a significant failure. (see figure 10)
- Major deadwood in crown.
- Normal vitality.
- Significantly weighted north west towards neighbour's property. (see figure 11)
- Several beginnings of shedding collars

There are several very large, significantly extended limbs with concerning features such as the first major limb on the northern main stem showing fibre buckling at the union, once again due to the significant size, highly likely to damage property or worse in the event of even a partial failure.

*Figure 8: significantly extended major limb with red arrows pointing at fibre buckling, hazard beam and gap between canopies from left to right*

*Figure 9: close up of fibre buckling at base of first major limb on northern main stem*

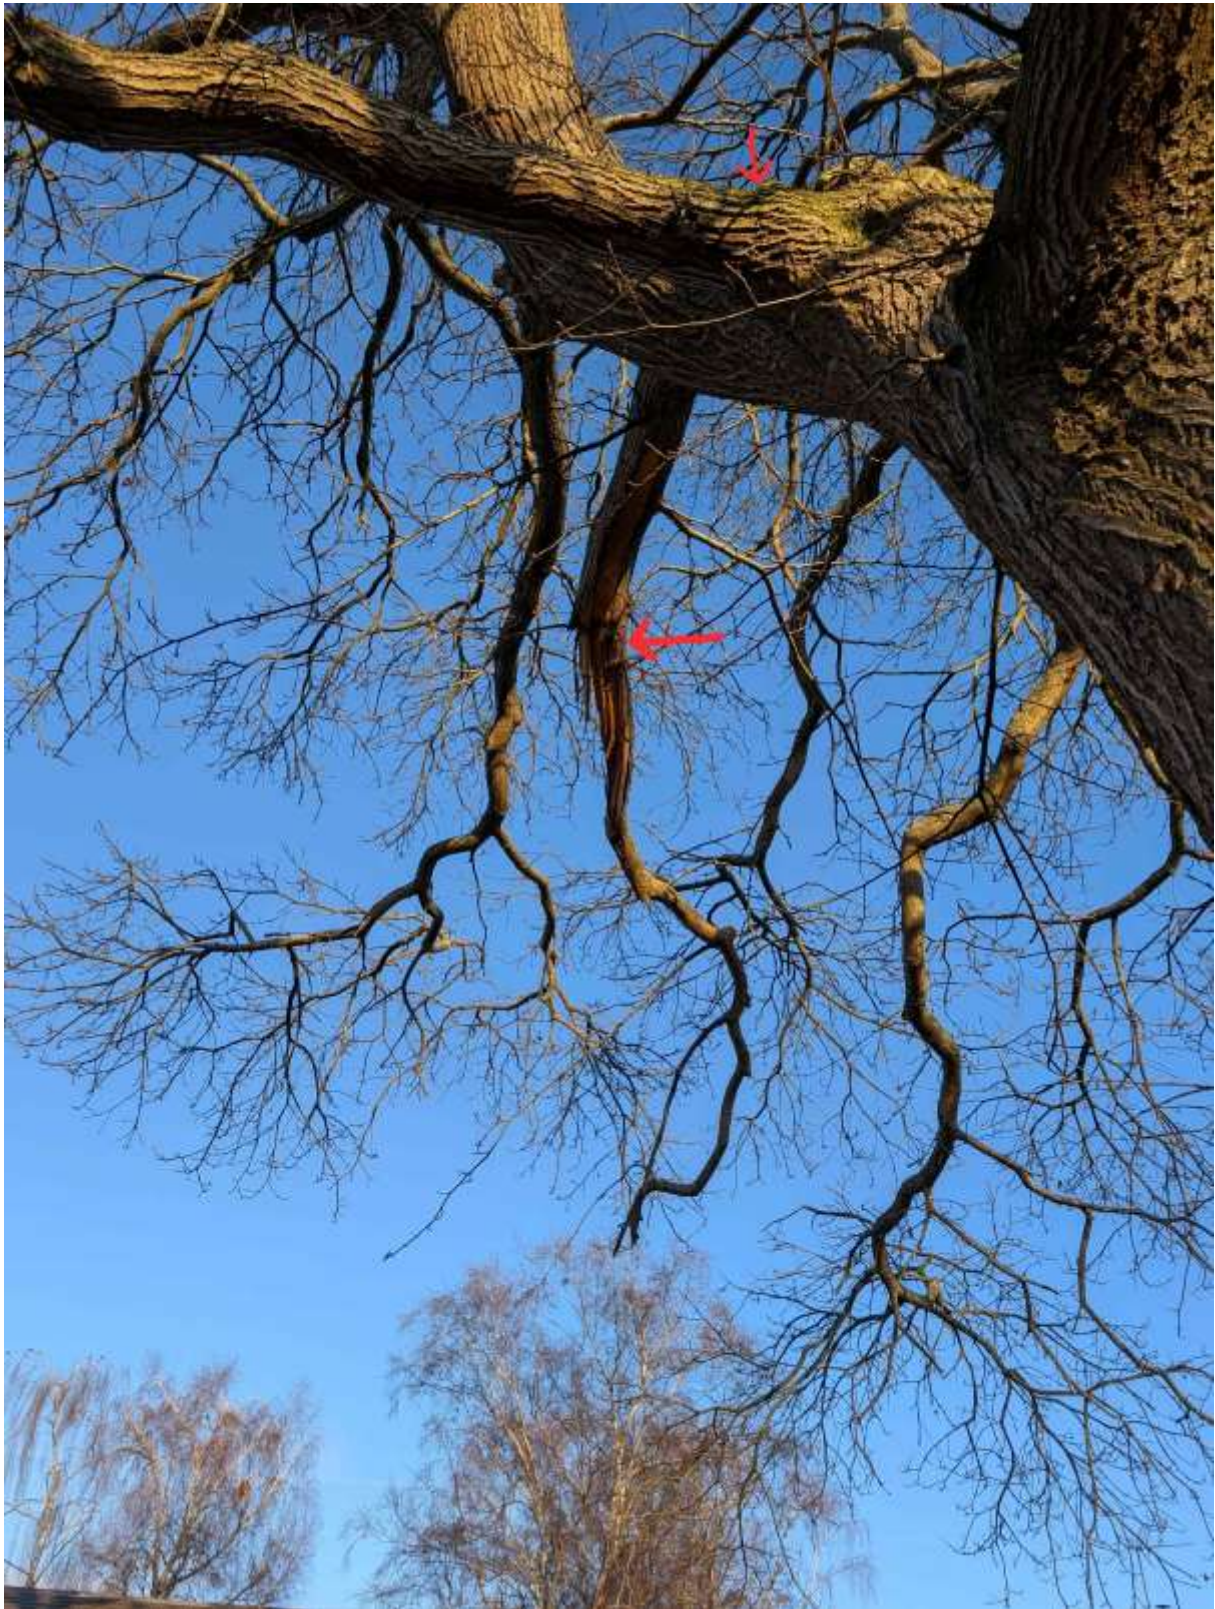
*Figure 10: red arrows pointing out significant recent limb failure and start of branch shedding collar*

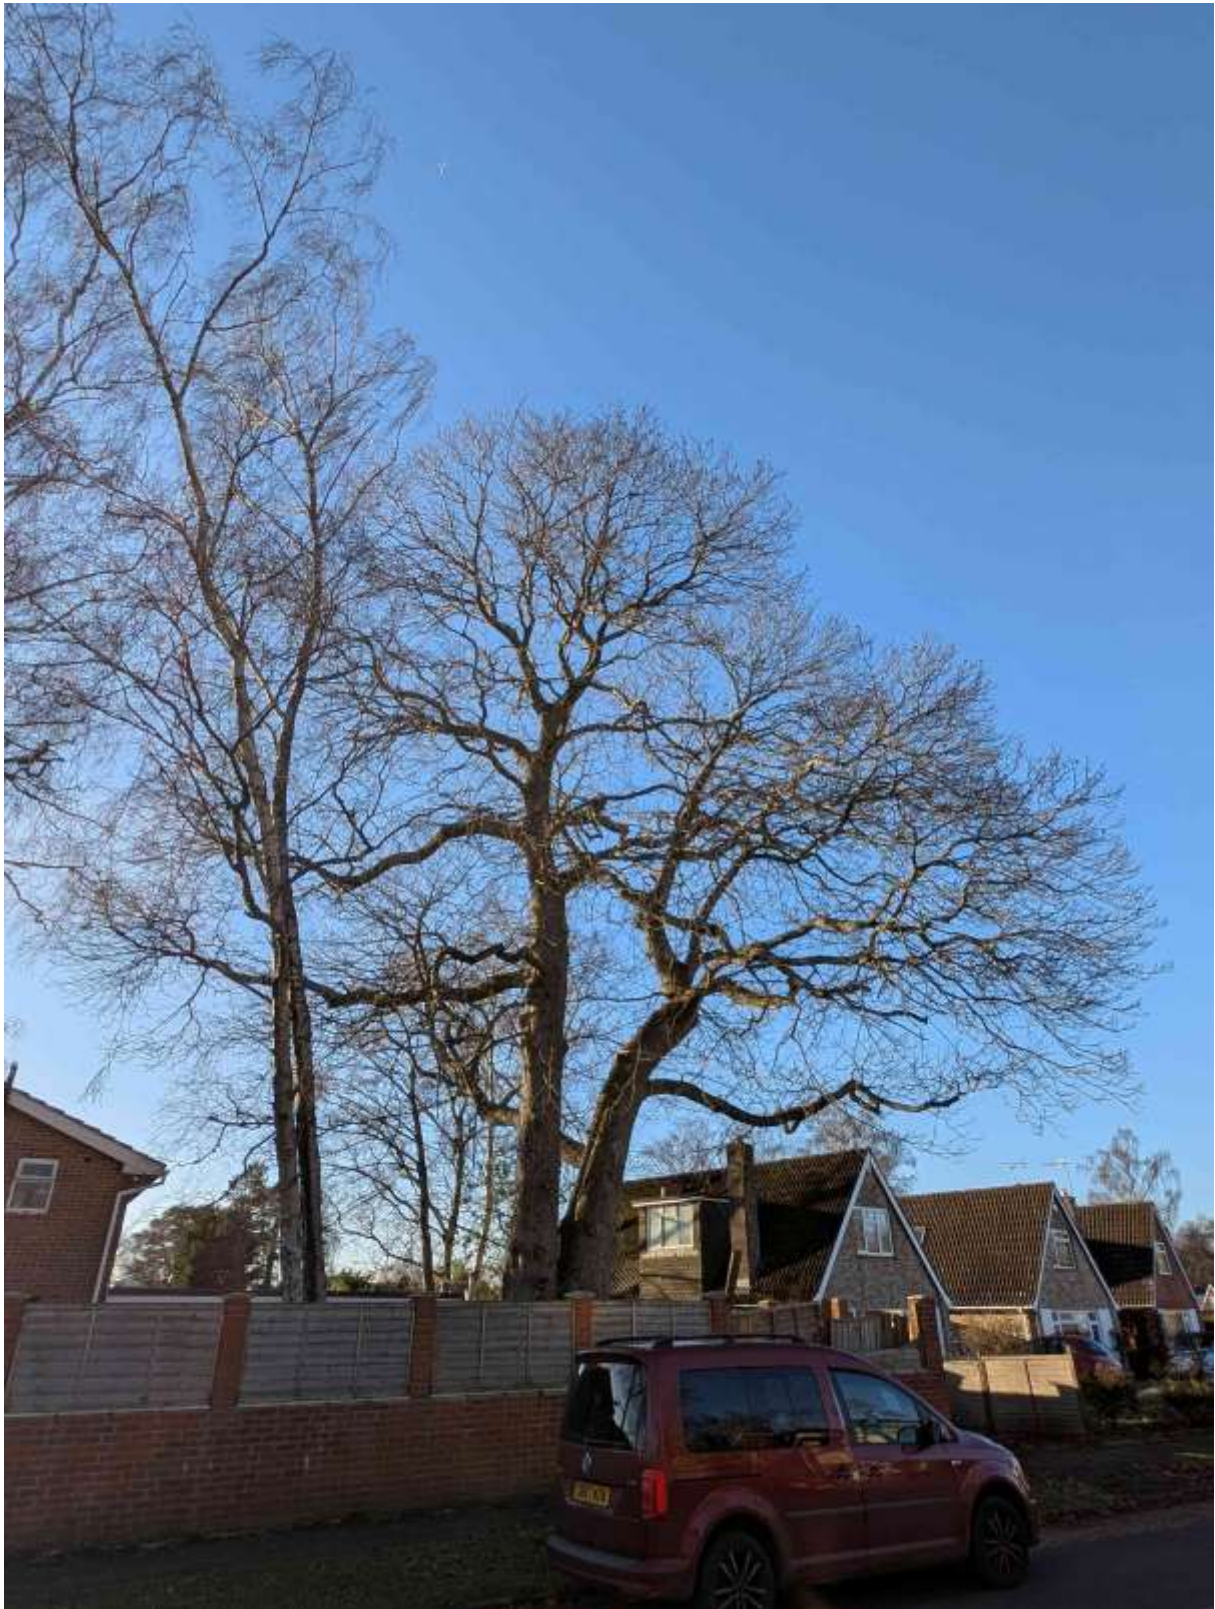
*Figure 11: showing northern main stem significantly weighted/leaning towards neighbouring property*

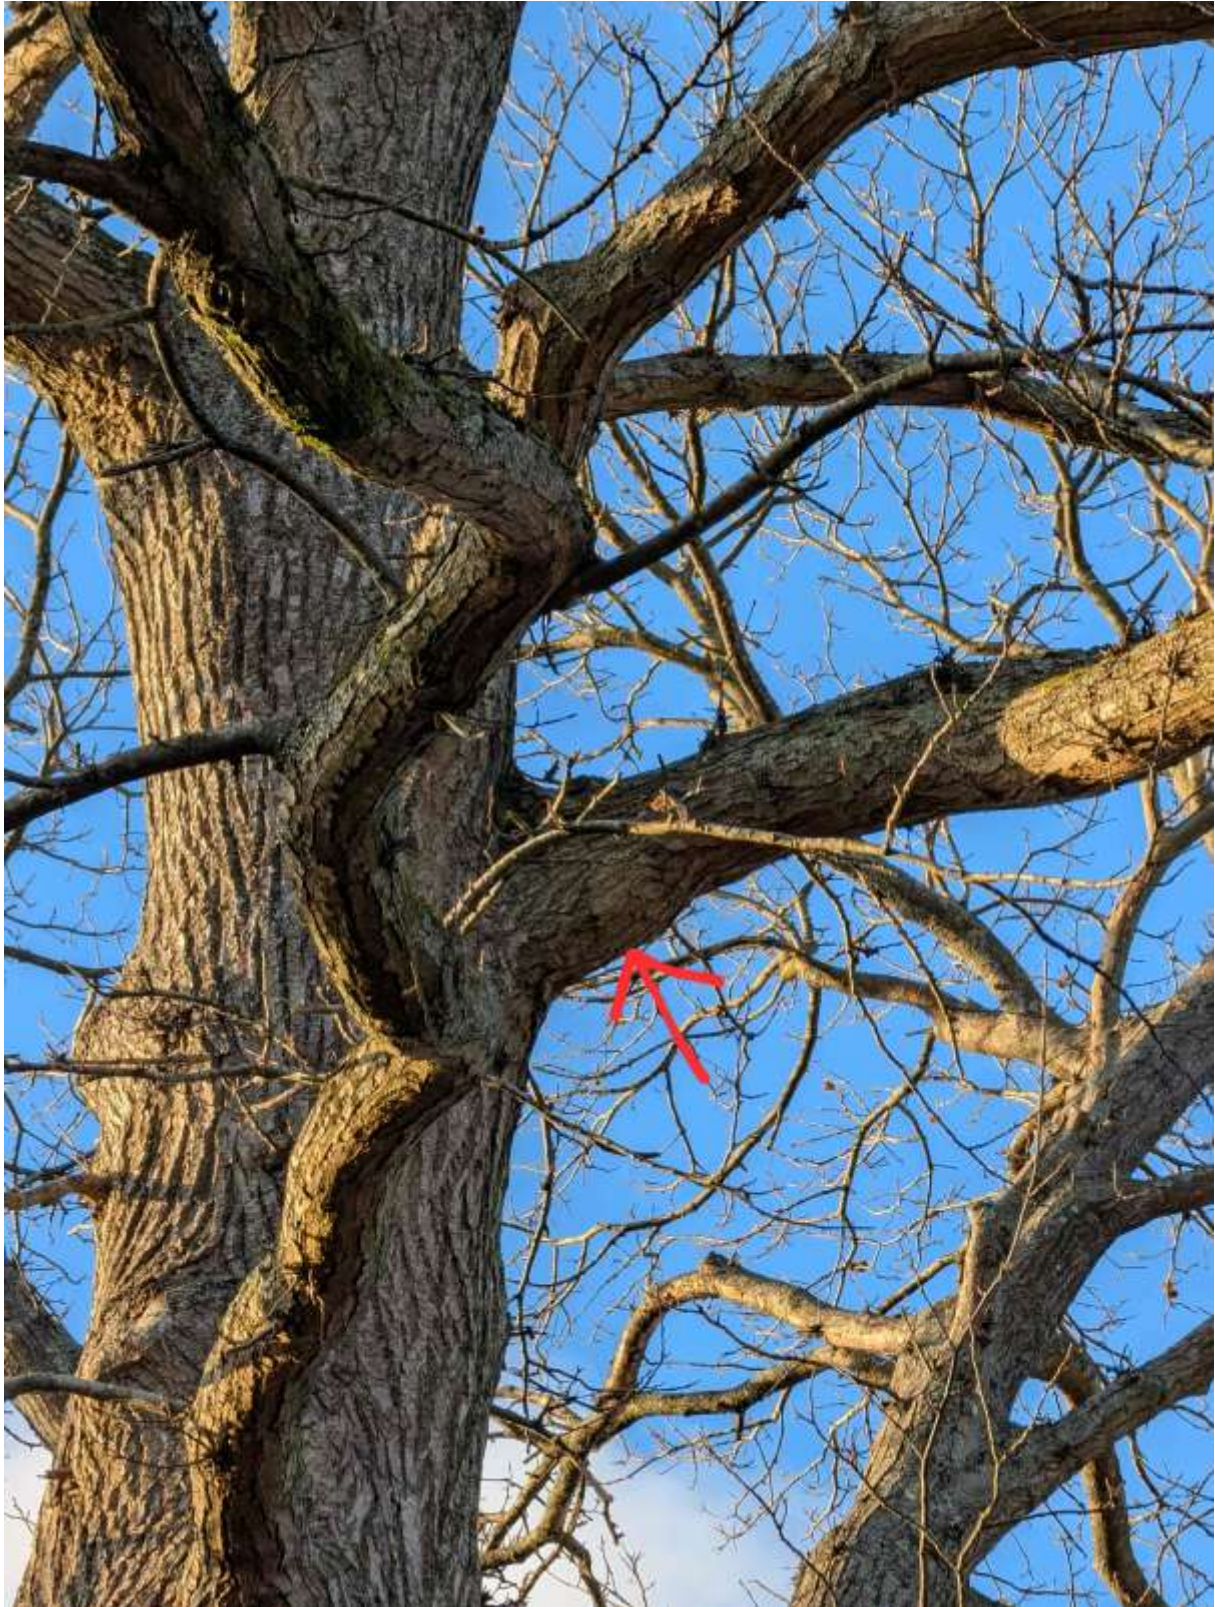
- Similar shedding collars, potentially typical of species.
- First limb on North east side has pronounced rib beneath it with recent rapid expansion growth, possibly suggesting mechanical stress, fibre buckling. (see figure 12)
- Significantly overhanging the roof
- Major deadwood throughout.
- Normal vitality
- Upright form.

*Figure 12: pronounced rib beneath first major limb on North east side*
