# **ARBORICULTURAL REPORT ON TWO OAK TREES**

**233 Hursley Road  
Chandlers Ford  
Eastleigh  
SO53 1JP**

**Date – 7<sup>th</sup> November 2025**

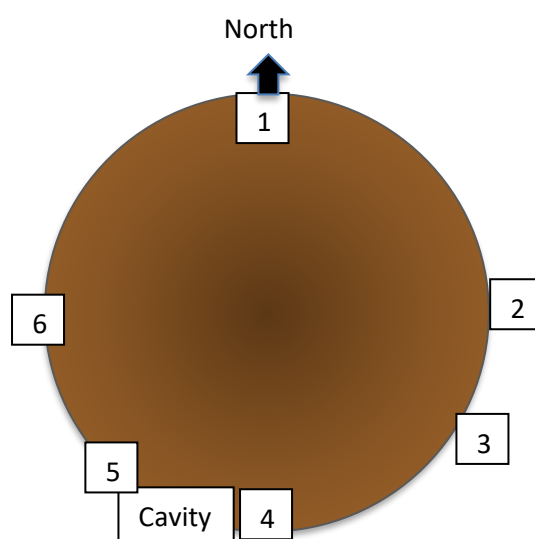
**Image 1:** Indicating location of area of drilling on the trunk at 1.4m above ground level.

The drilling from the southern side gives little resistance for 1 cm where the drill is lining up to meet with the wood tissue. The drilling on the southern side suggests that there is an area of reaction wood at 26-29.5cm, then there is an area of decay to a depth of approximately 38cm

before another area of reaction wood at to 40cm depth. Overall, this reading does not given reasons for concern as the recorded area of decay is relatively small for the size of the tree.

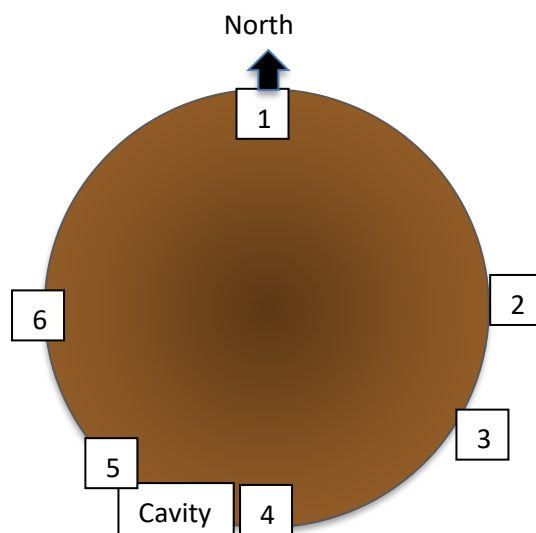
**Image 2:** Indicating location of area of drilling on the trunk at 1.8m above ground level.

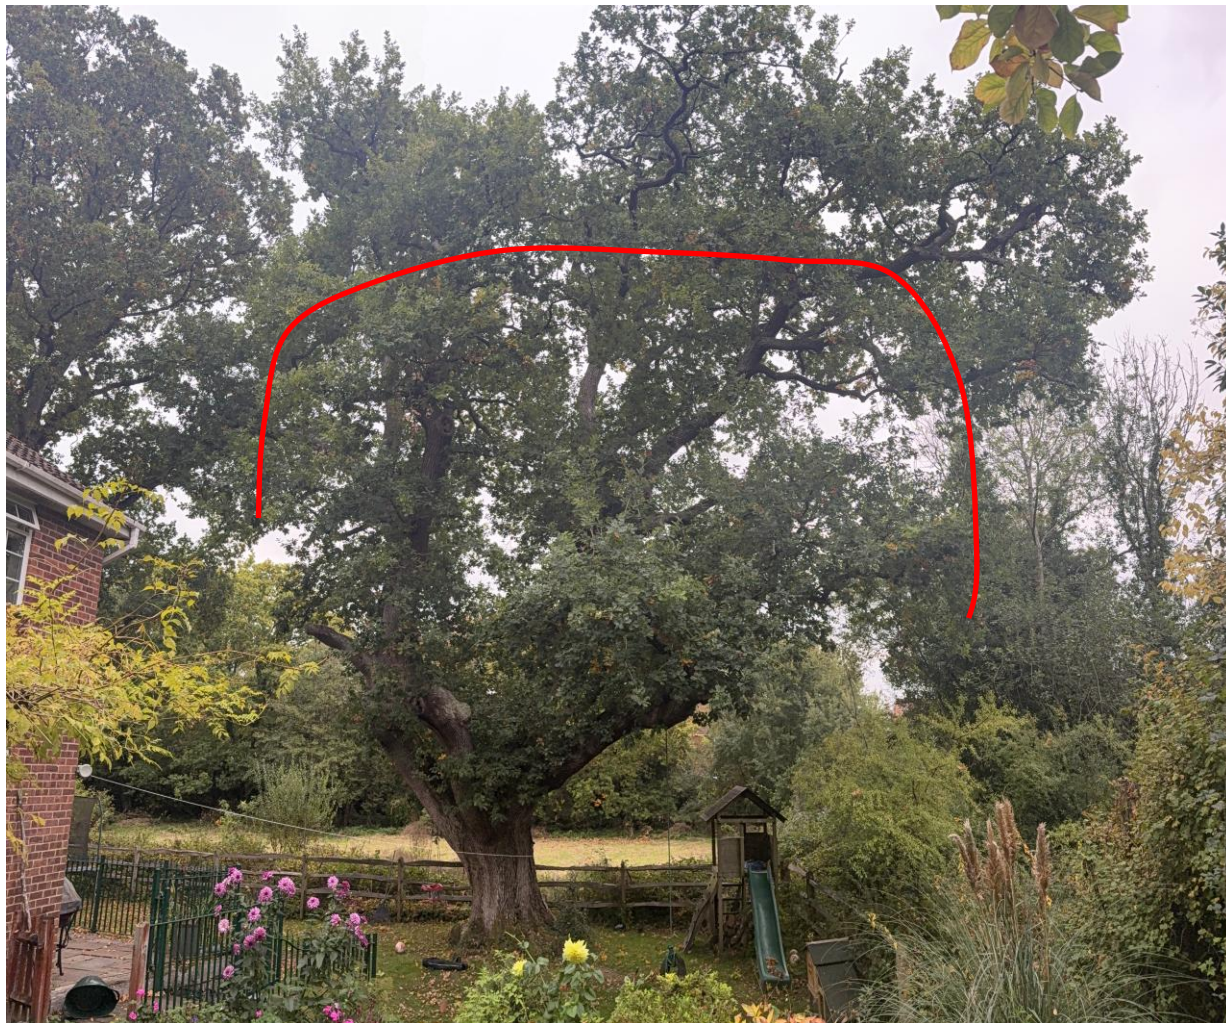
**Photograph 1:** Showing the approximate height of the crown reduction for T2 viewed from the west

- Tree 1 – No works are recommended to this tree currently.
  - Tree 2 – Reduce the crown by approximately 3m all round to provide a more compact and even crown spread to reduce the wind loading on the base of the tree and be proactive in managing the tree by encouraging the lower crown to develop further.

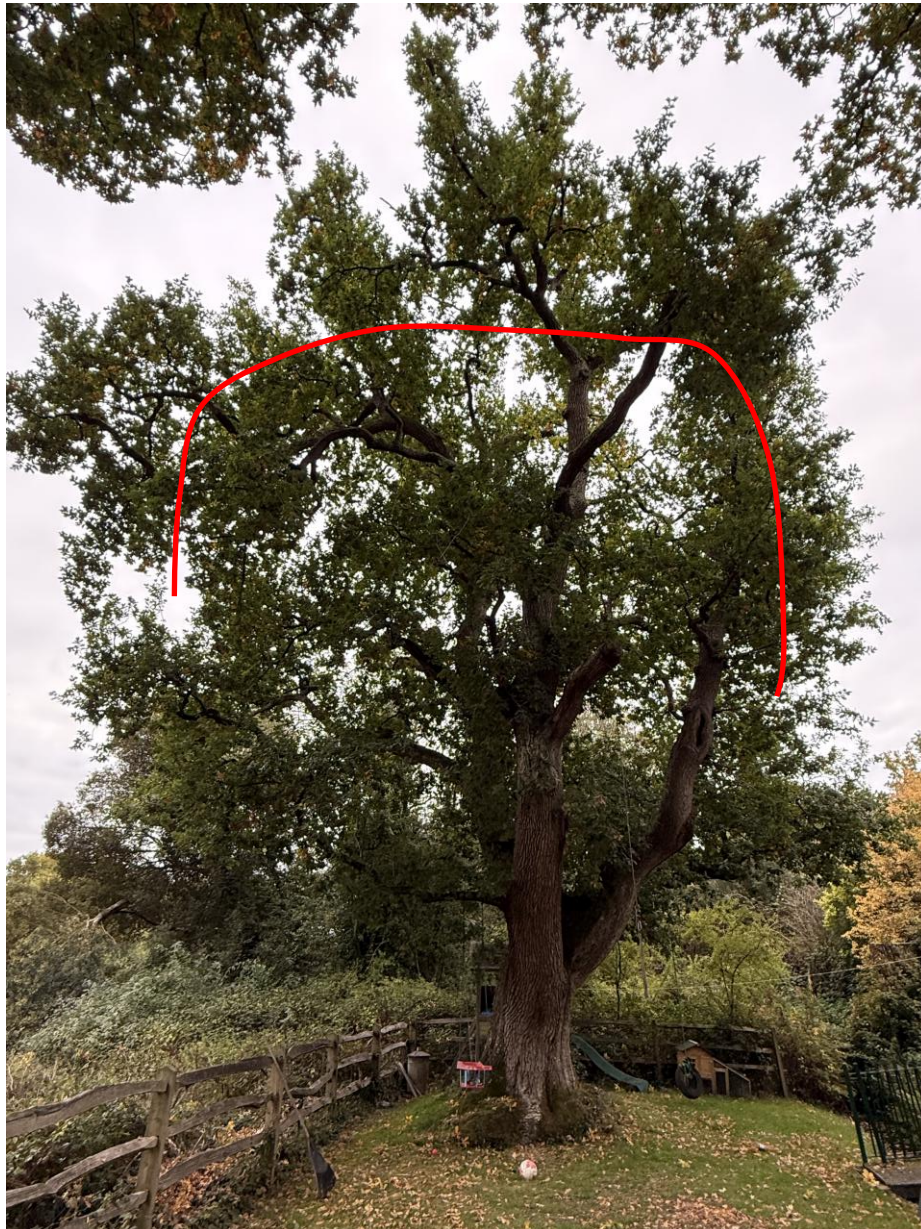
**Photograph 2:** Showing the approximate height of the crown reduction for T2 viewed from the north

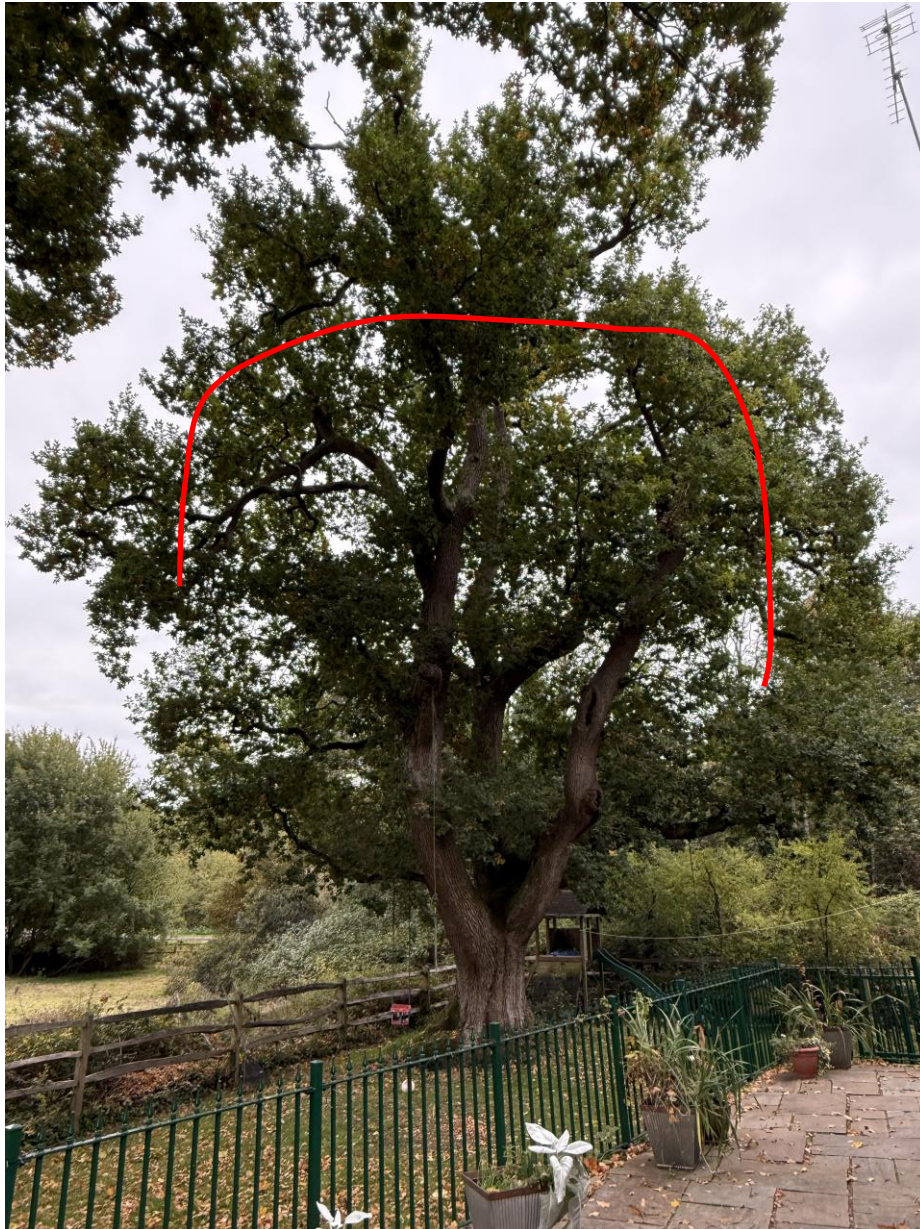
**Photograph 3:** Showing the approximate height of the crown reduction for T2 viewed from the northwest

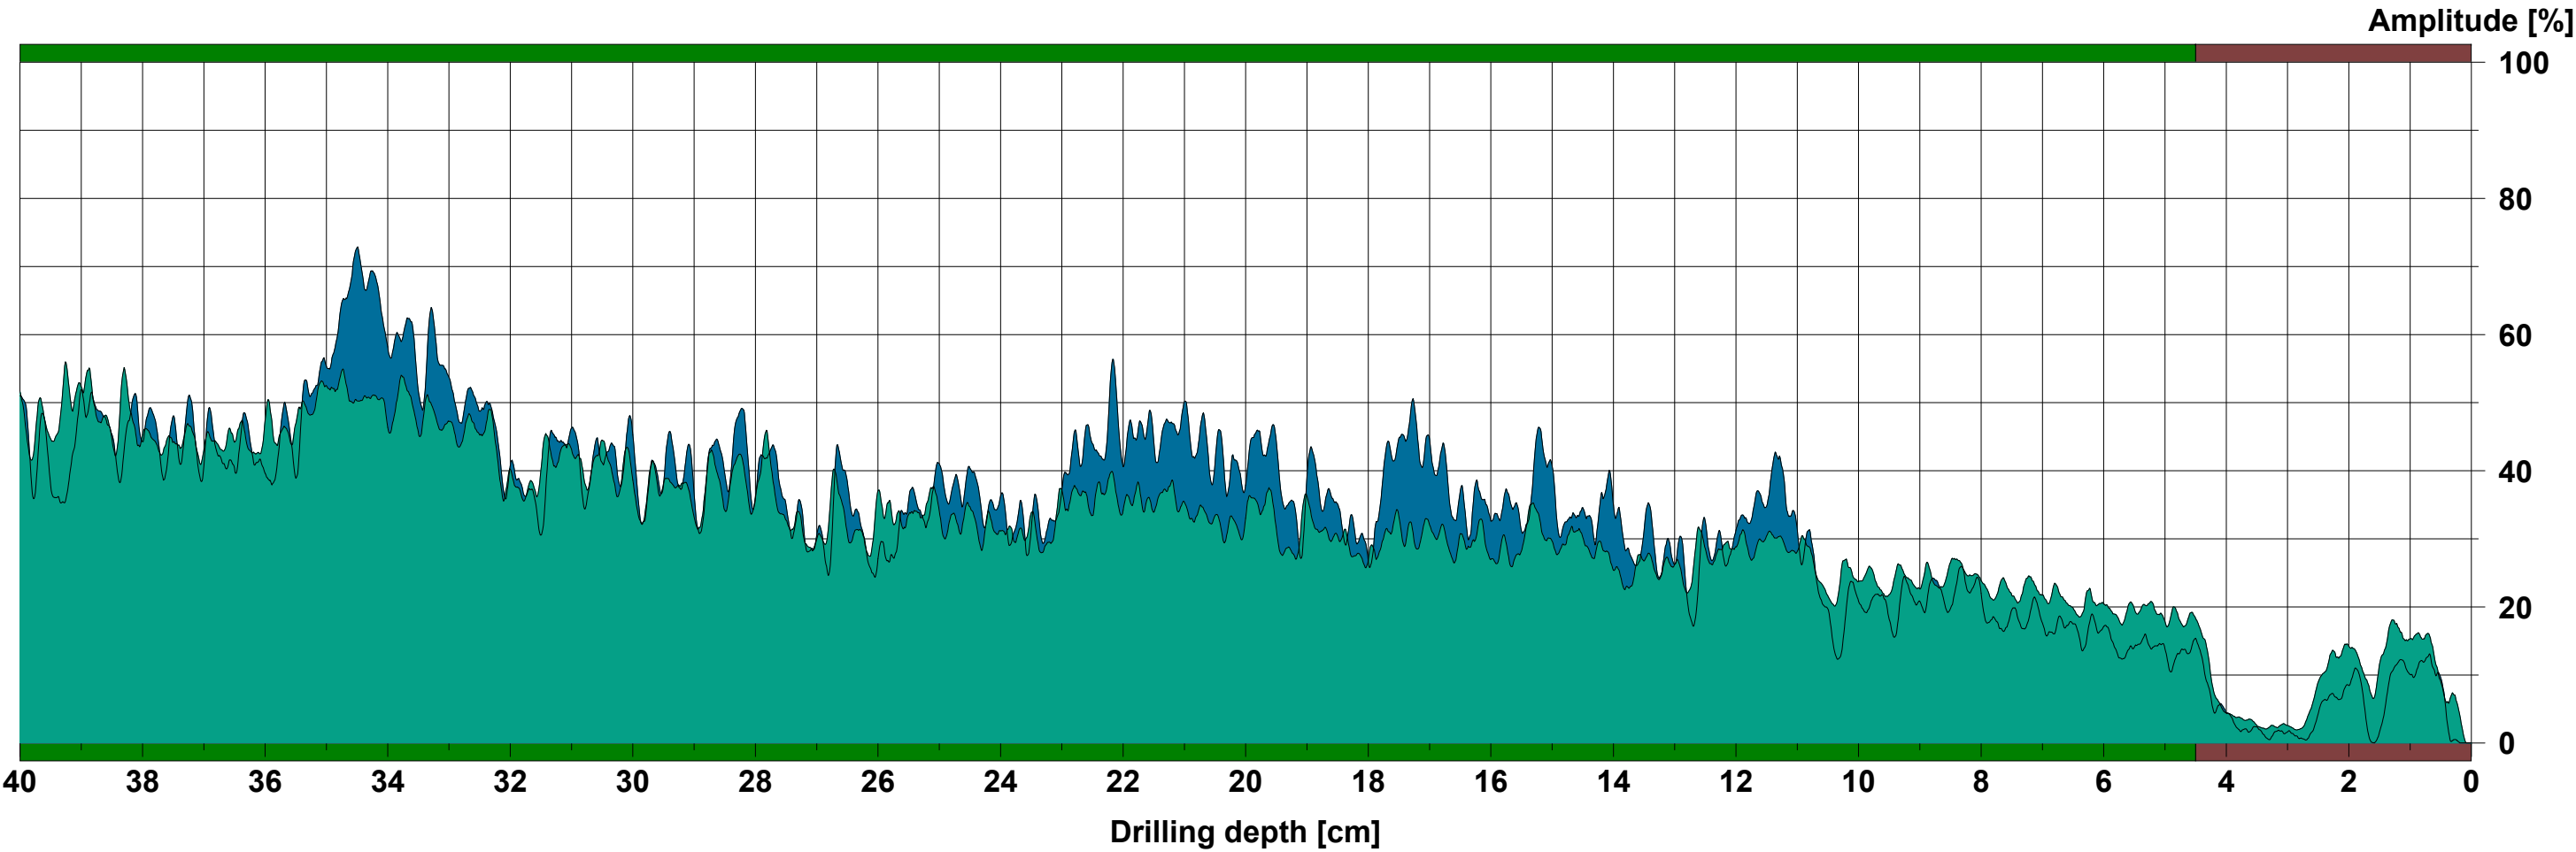
The drilling from the northern side gives little resistance for 4.5cm where the drill is lining up to meet with the wood tissue. The drilling on the northern side suggests that there is sound wood to a depth of 40cm. Overall, this reading does not given reasons for concern.

From 0,00 cm to 4,50 cm : Bark  
From 4,50 cm to 40,00 cm : Sound Wood

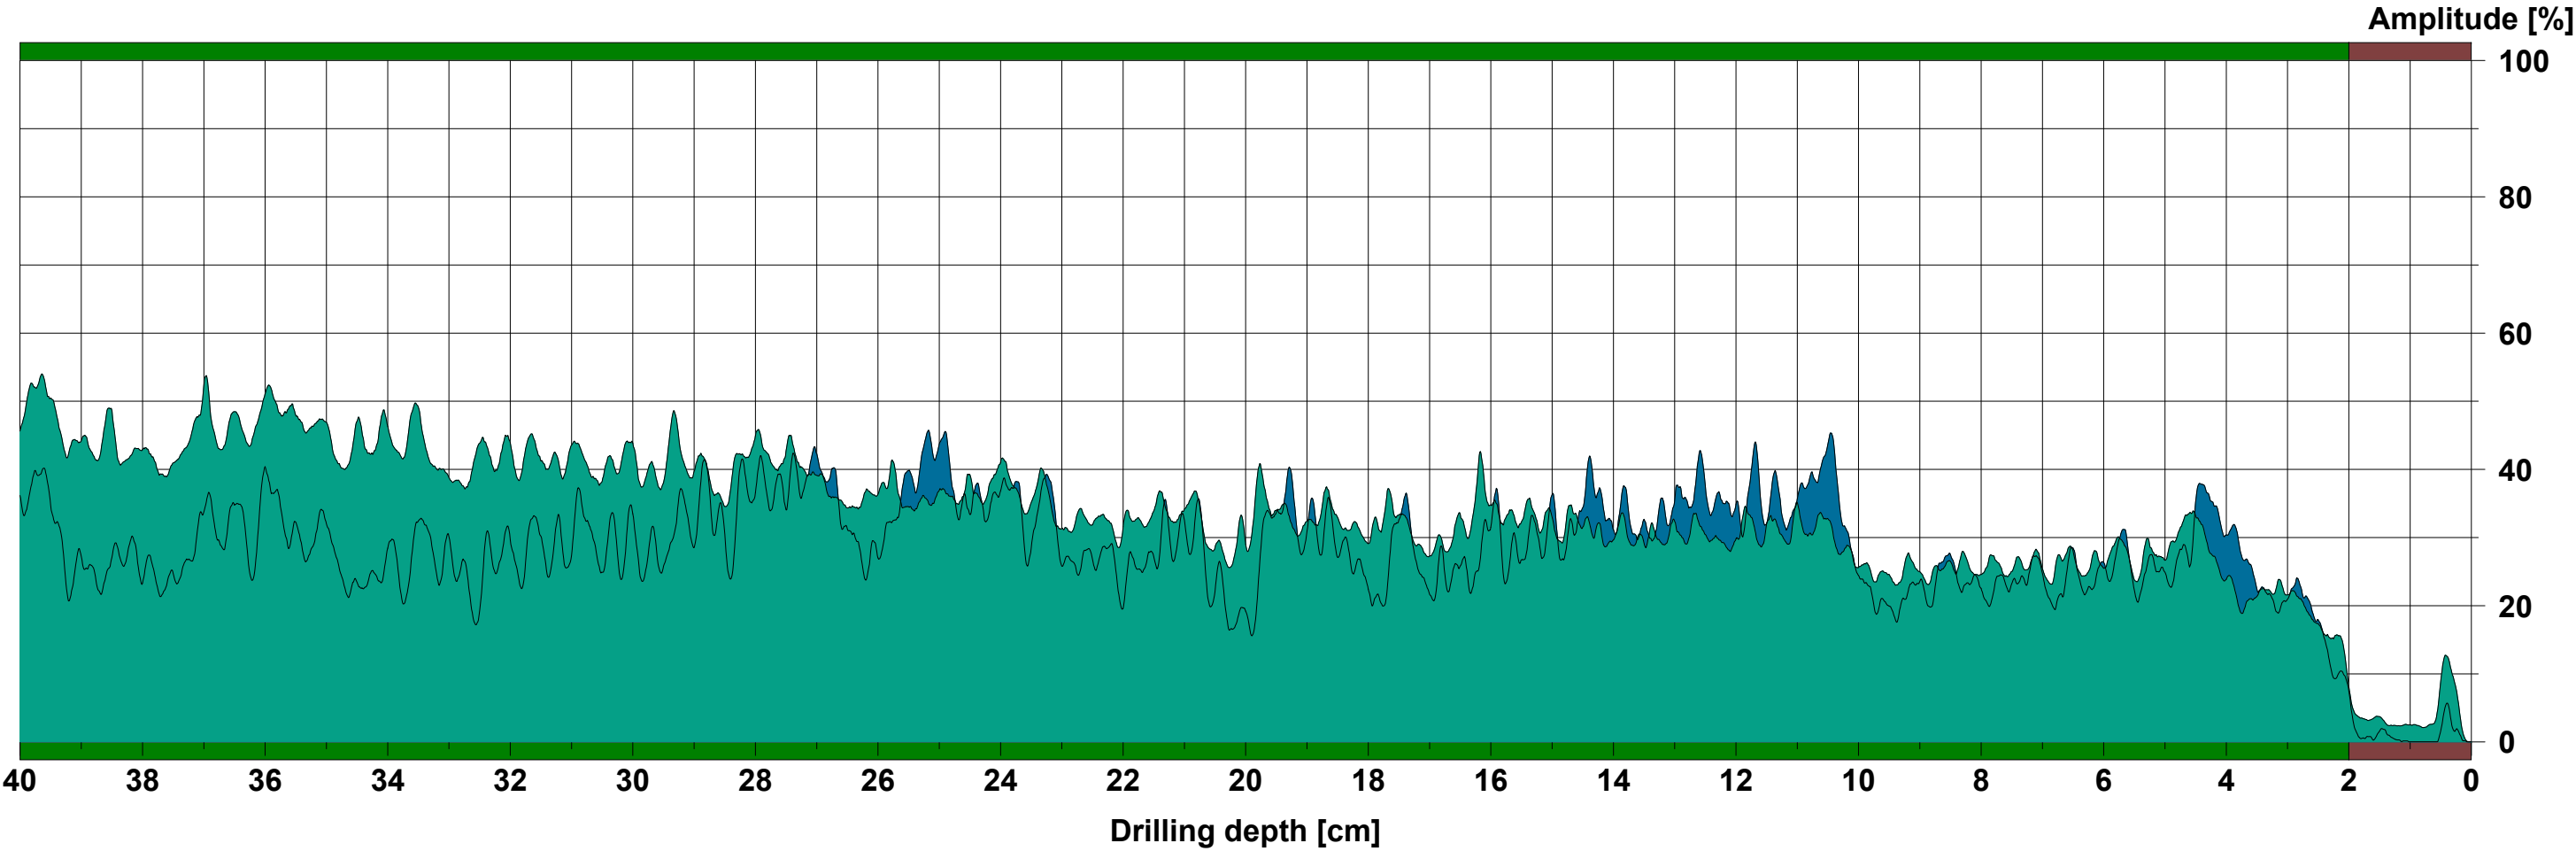
The drilling from the eastern side gives little resistance for 2cm where the drill is lining up to meet with the wood tissue. The drilling on the eastern side suggests that there is sound wood to a depth of 40cm. Overall, this reading does not given reasons for concern.

From 0,00 cm to 2,00 cm : Bark  
From 2,00 cm to 40,00 cm : Sound Wood

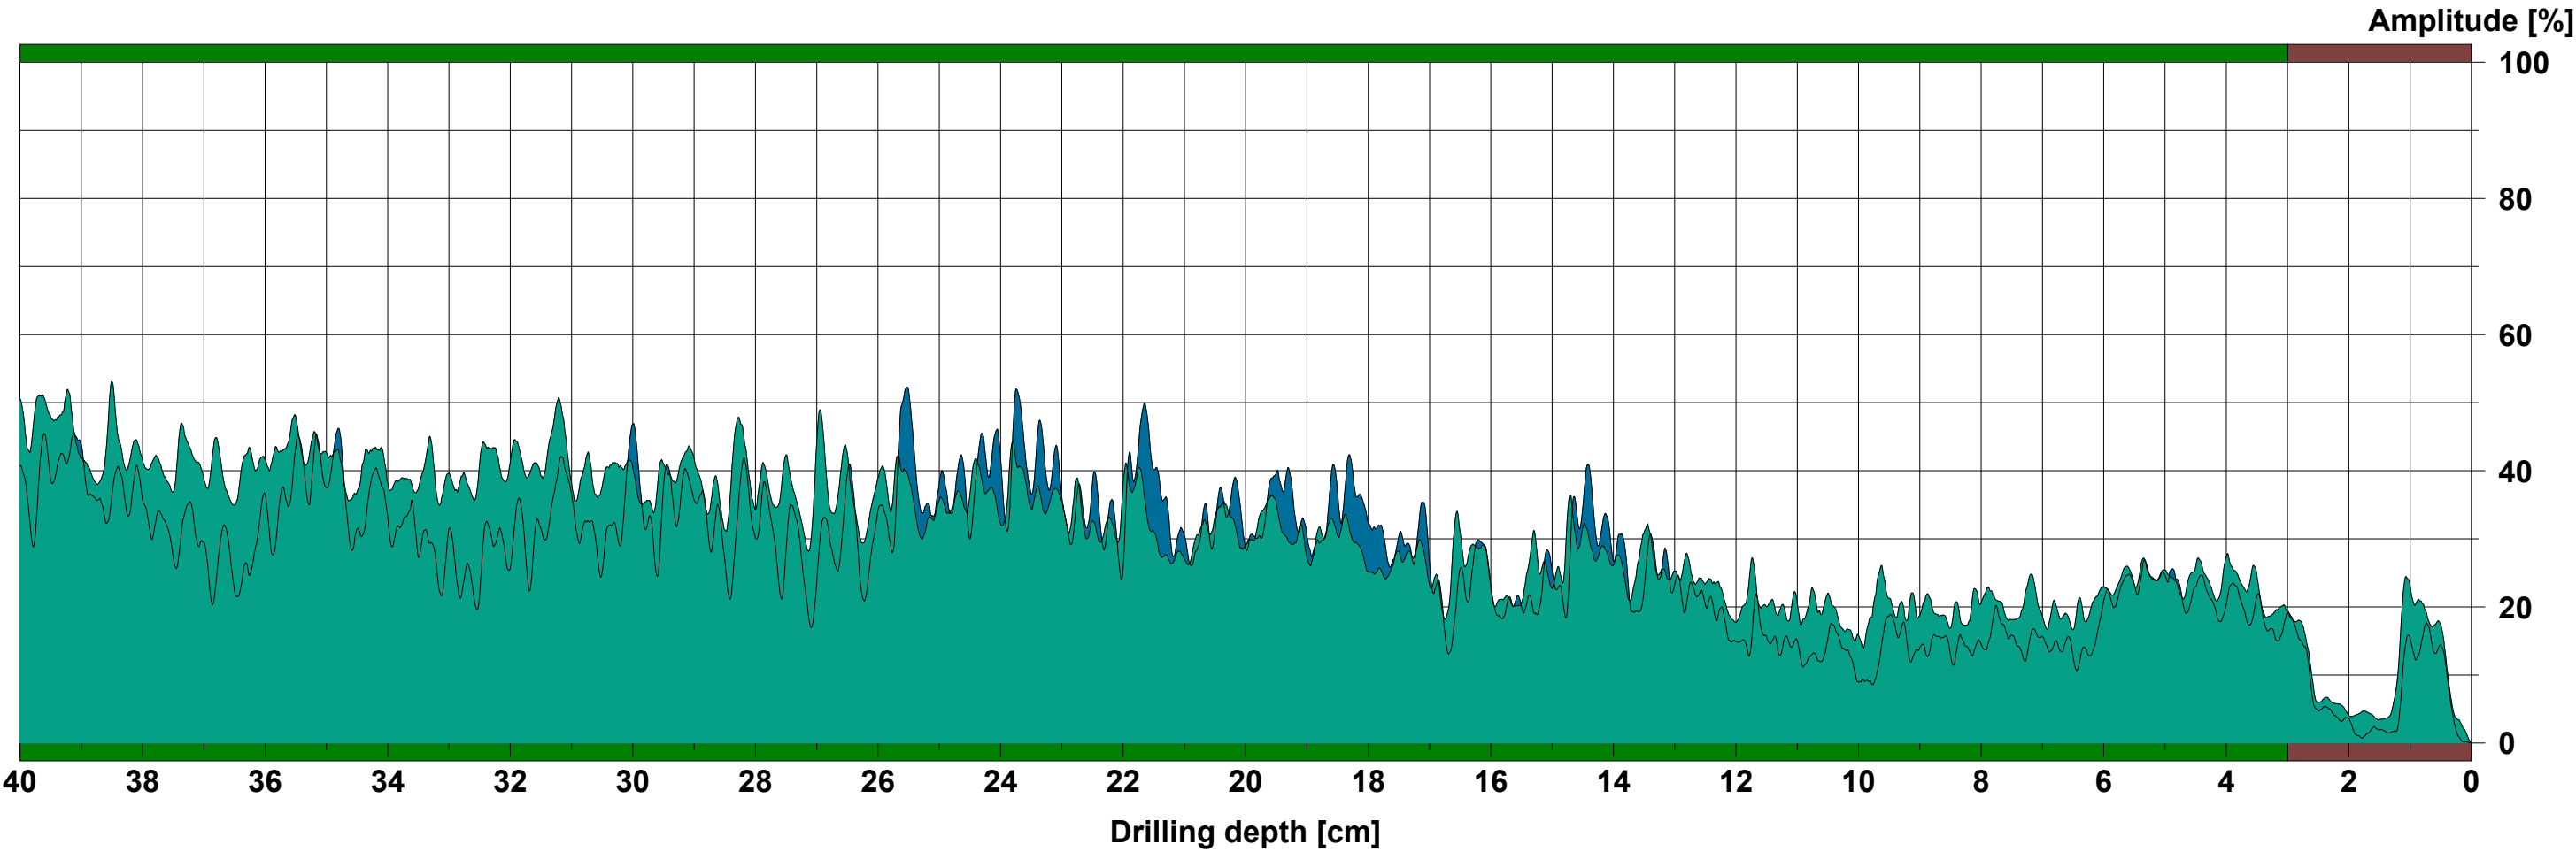
The drilling from the southeastern side gives little resistance for 3cm where the drill is lining up to meet with the wood tissue. The drilling on the southeastern side suggests that there is sound wood to a depth of 40cm. Overall, this reading does not given reasons for concern.

From 0,00 cm to 3,00 cm : Bark  
From 3,00 cm to 40,00 cm : Sound Wood

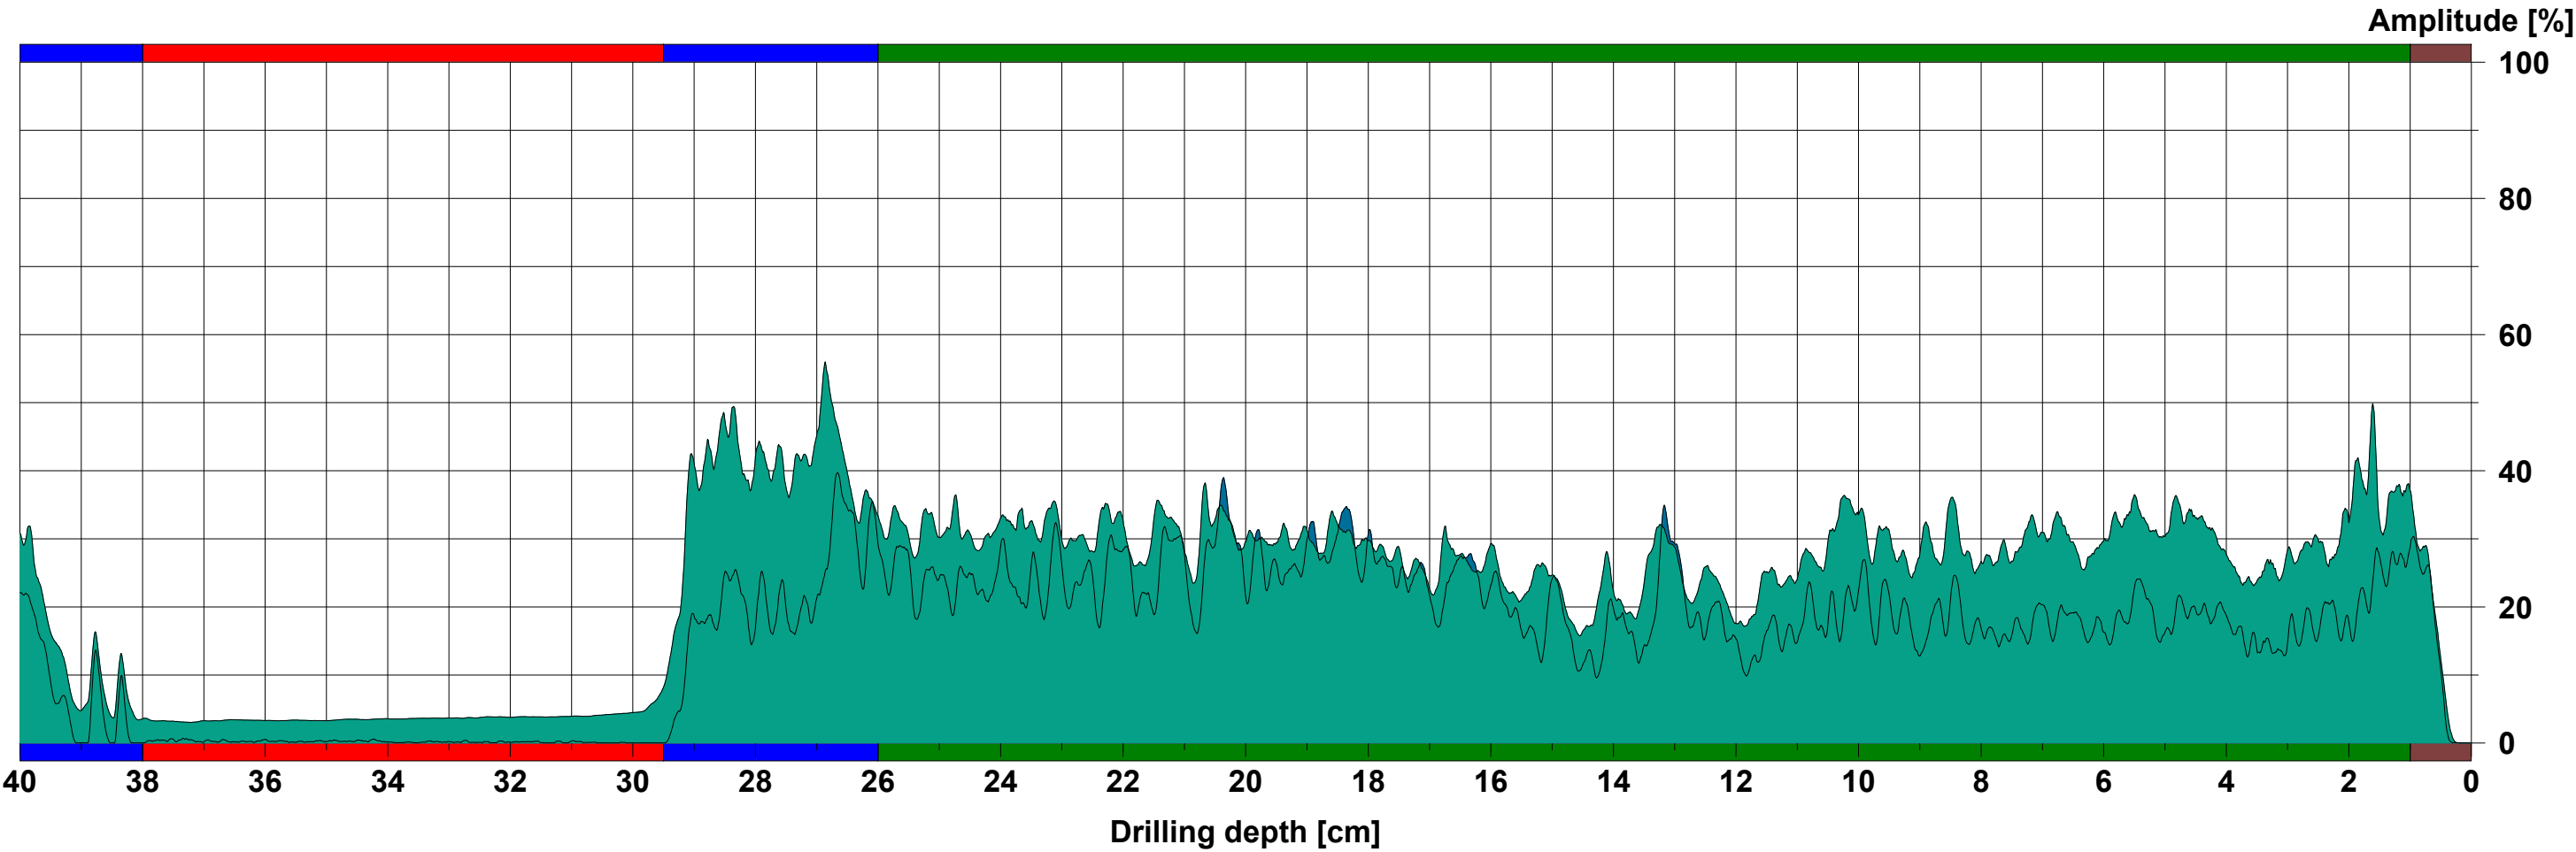
| From | 0,00 cm to | 1,00 cm | : Bark |
| From | 1,00 cm to | 26,00 cm | : Sound Wood |
| From | 26,00 cm to | 29,50 cm | : Reaction Wood |
| From | 29,50 cm to | 38,00 cm | : Decay |
| From | 38,00 cm to | 40,00 cm | : Reaction Wood |

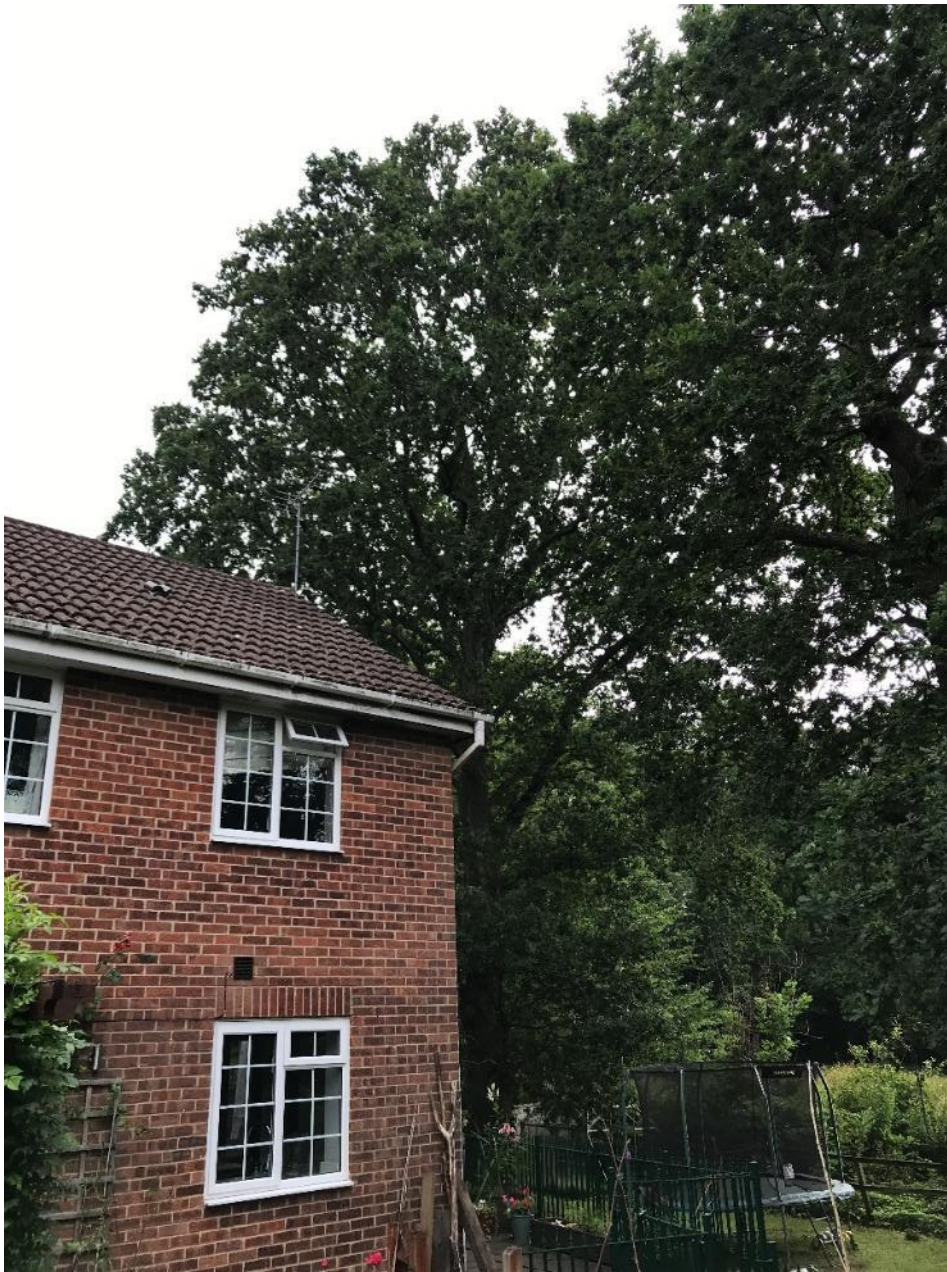
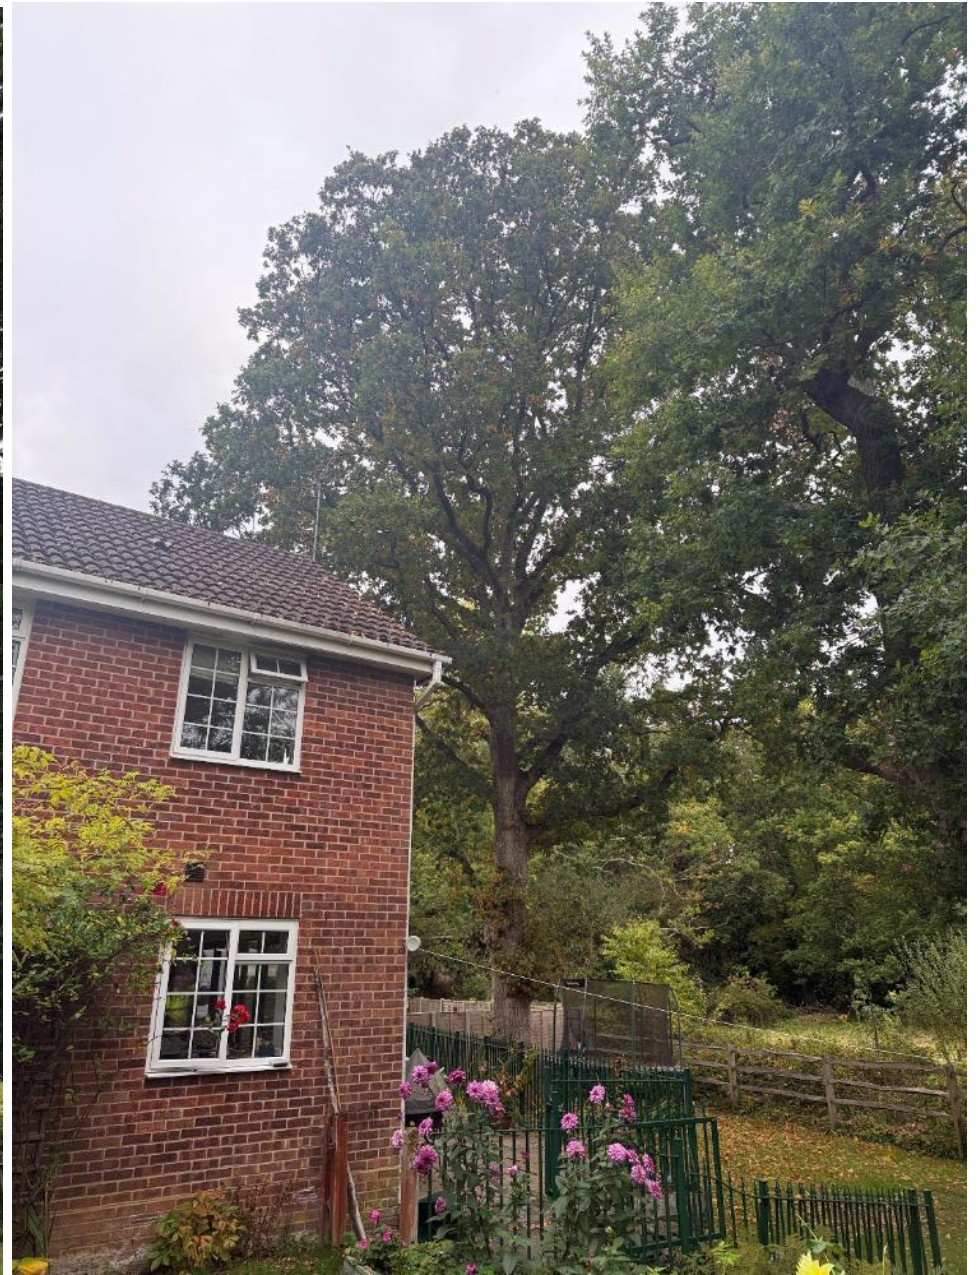
**Photograph 1:** Showing the northern Oak (T1) behind the property comparison between 2021 and 2025

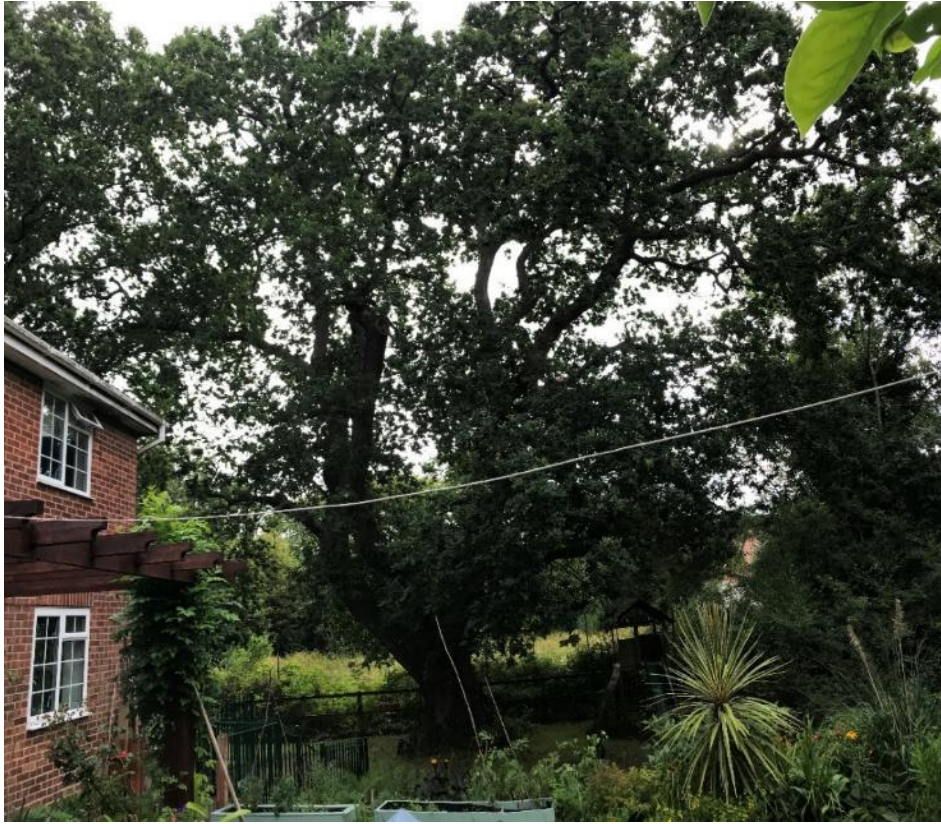
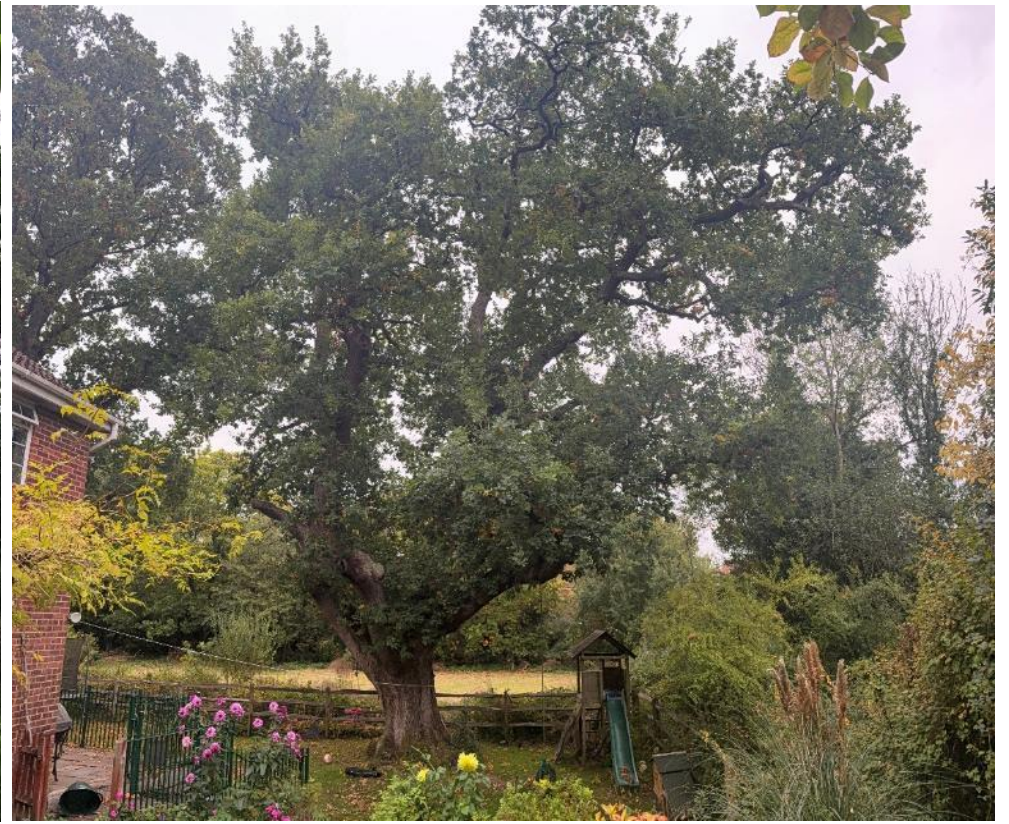
**Photograph 2:** Showing the southern Oak (T2) comparison between 2021 and 2025

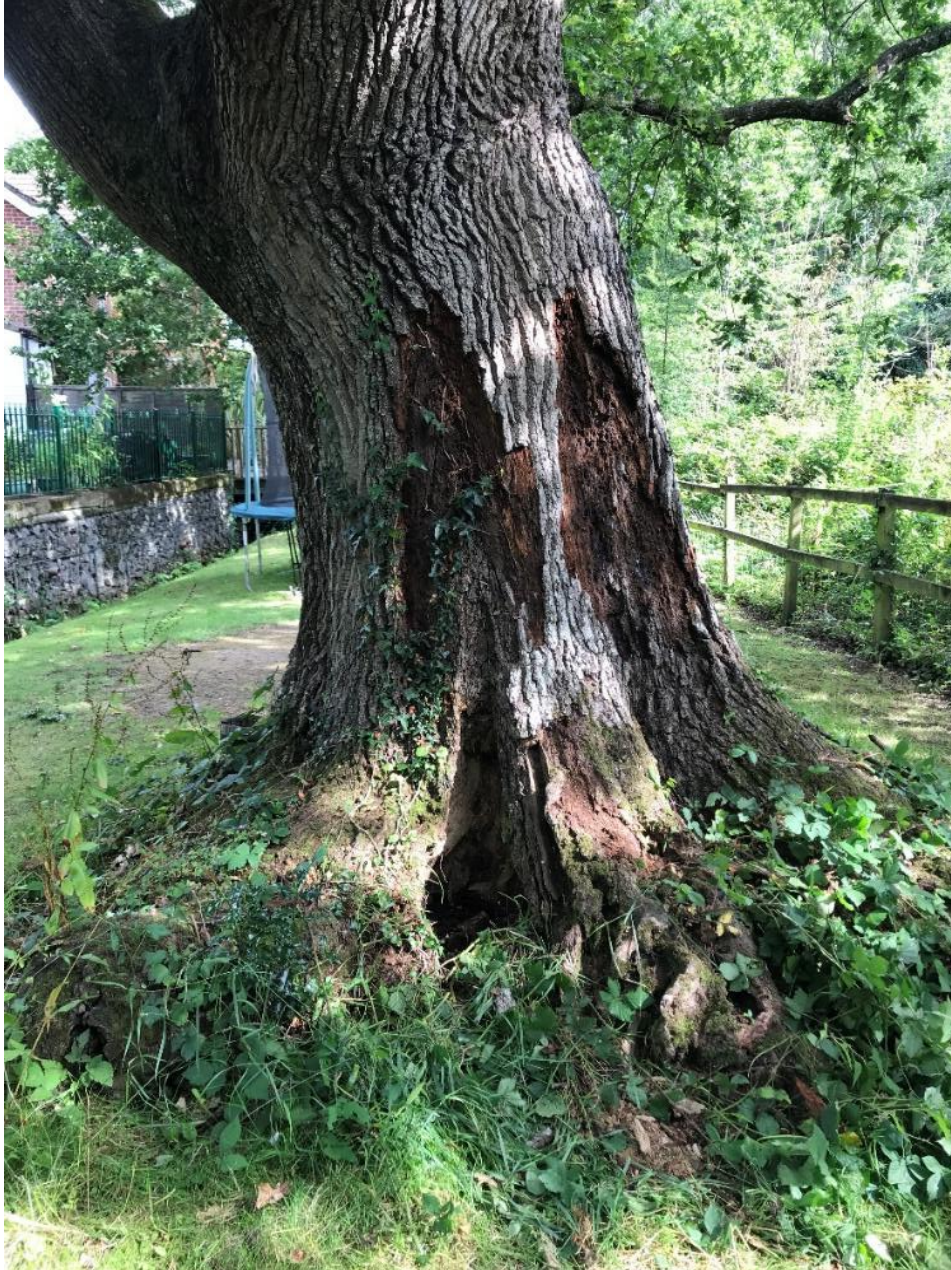
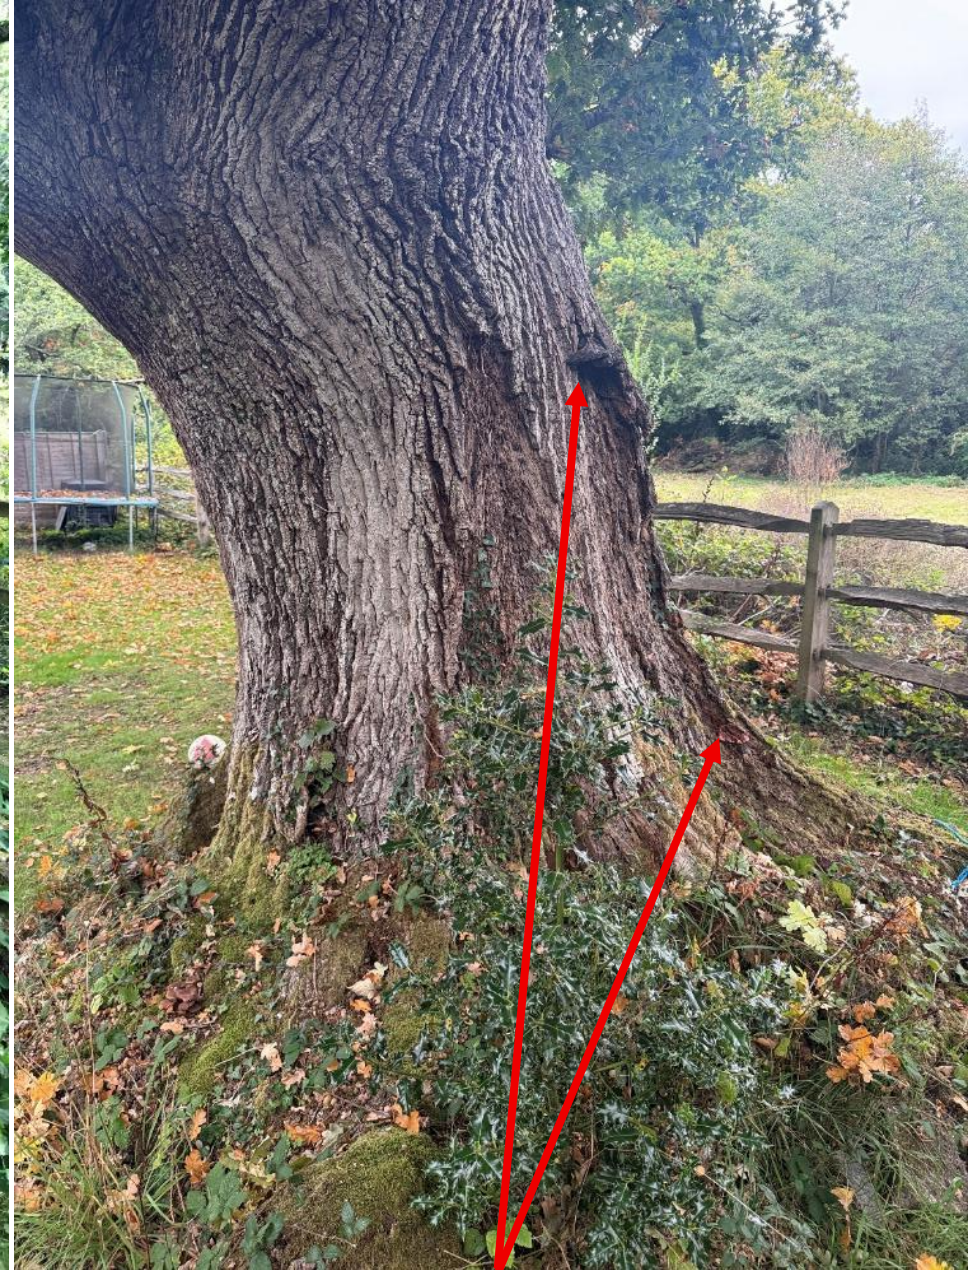
There is a large area of bark necrosis on the southern side of the trunk that extends effectively from ground level up to approximately 1800mm with a width of 850mm at the widest point. This did appear to be that the bark has become loose at this time rather than an area of significantly decayed wood. There are two fungal fruiting bodies in this area on the southeastern side of the wound that are thought to be *Fistulina Hepatica* (Beef Steak fungus), this is a heartwood decay fungus attributed to a brown rot and is not considered to be of structural concern due to the very slow development of advanced decay for a long time. \*

**Photograph 3:** The southern side of the trunk with one of the cavities and the areas of bark necrosis comparison between 2021 and 2025  
Beefsteak fungus on the lower southwest side of the trunk approximately 4-500mm above ground level

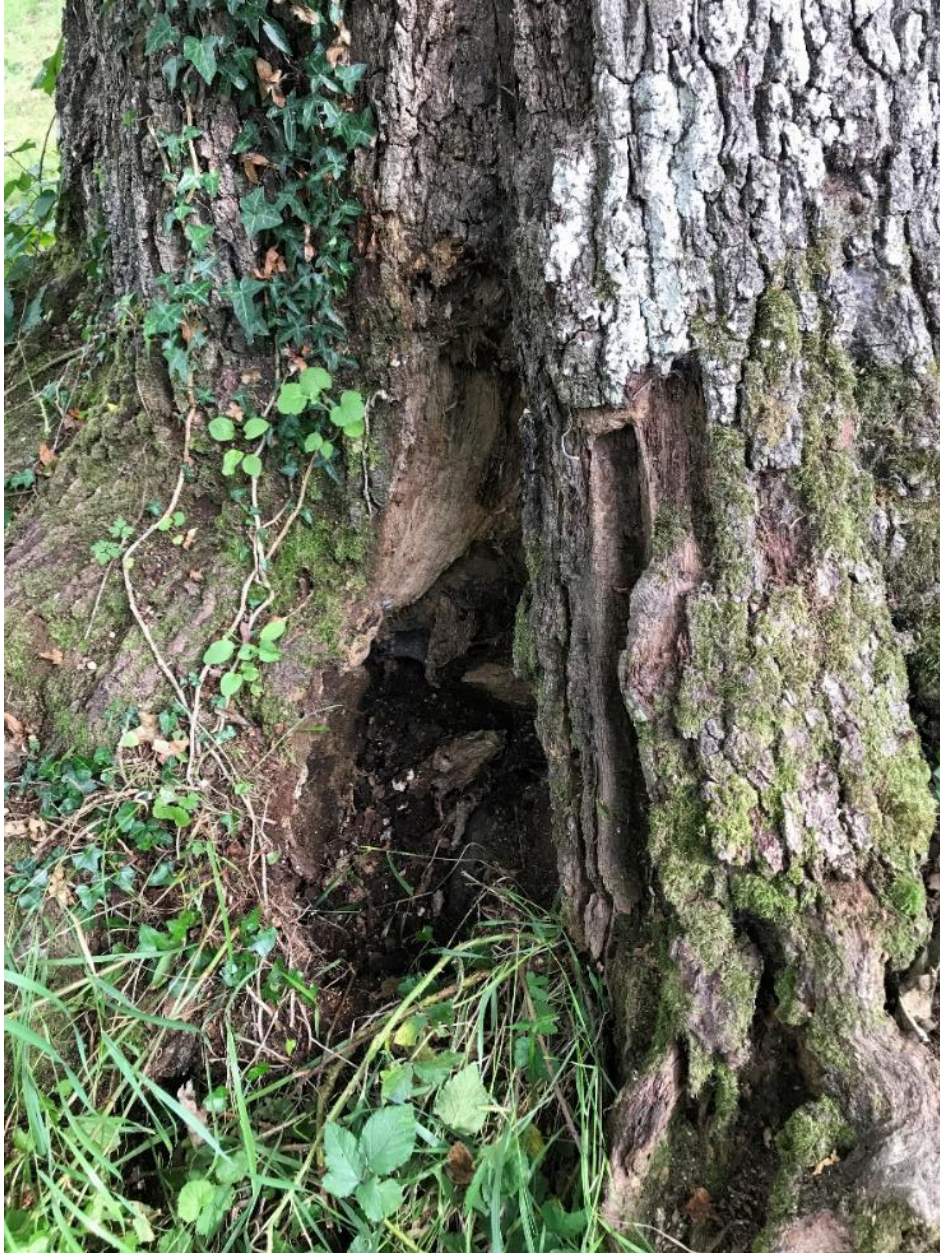
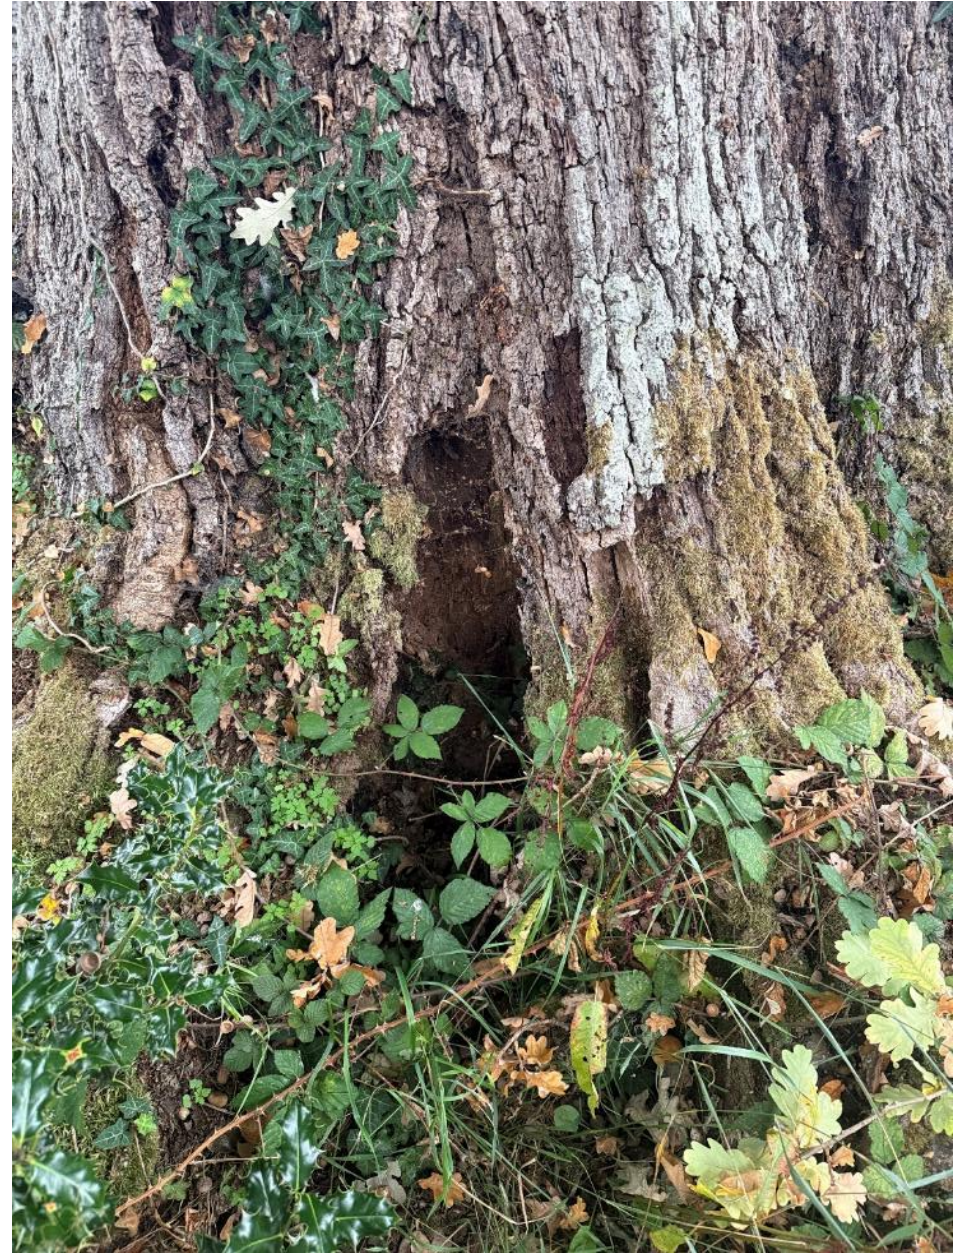
The tree has large buttress roots growing from all round the base. There is an open cavity located between the southeastern and southwestern buttress roots which has an opening of approximately 270mm wide. The cavity is approximately 450mm deep with a probe being easily pushed into the exposed soft wood tissue a further 150mm. A further cavity was noted on the eastern side of the trunk, again between the folds of the buttress roots on this side with the probe going in 330mm.

**Photograph 4:** Showing the larger open cavity on the southern side of the trunk comparison between 2021 and 2025
