# **ARBORICULTURAL REPORT ON TWO OAK TREES**

**233 Hursley Road  
Chandlers Ford  
Eastleigh  
SO53 1JP**

**Date – 7<sup>th</sup> November 2025**

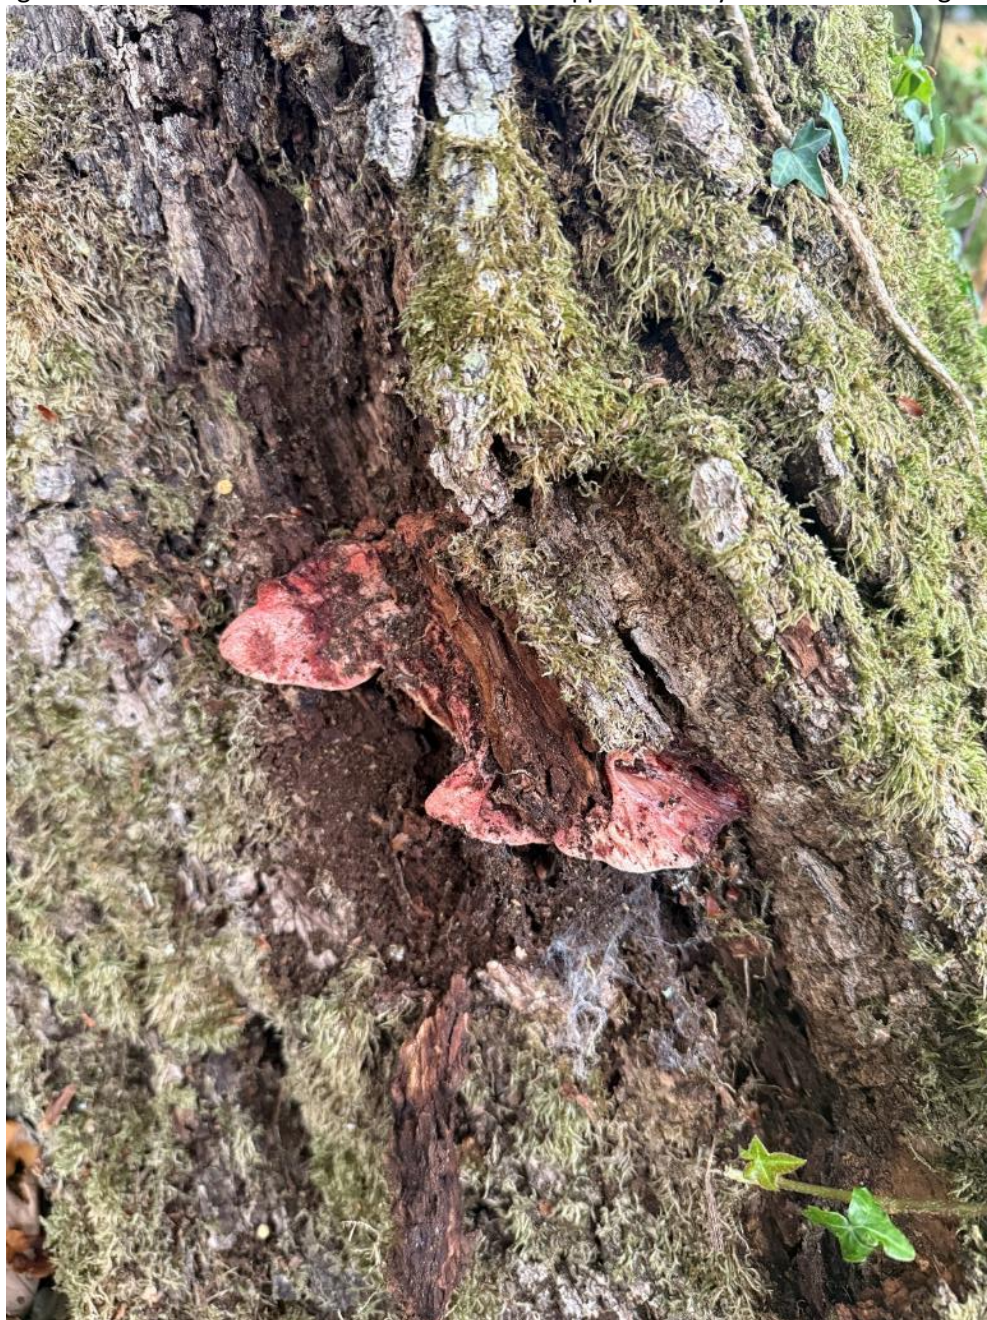
There is also a fungal fruiting body that is thought to be *Fistulina Hepatica* (Beef Steak fungus) on the lower west side of a buttress root to the north side of the trunk. There are several mushrooms present on the west to north side of the trunk; these are thought to be Honey Fungus (*Armillaria spp.*) which can often be thought of as a secondary infection and requires the tree to have a wound to enter the cambium. In advanced decay there is a high chance of windthrow due to the extensive decay of the root system. \*

**Photograph 5:** Showing the Beefsteak fungus on the lower southwest side of the trunk approximately 4-500mm above ground level

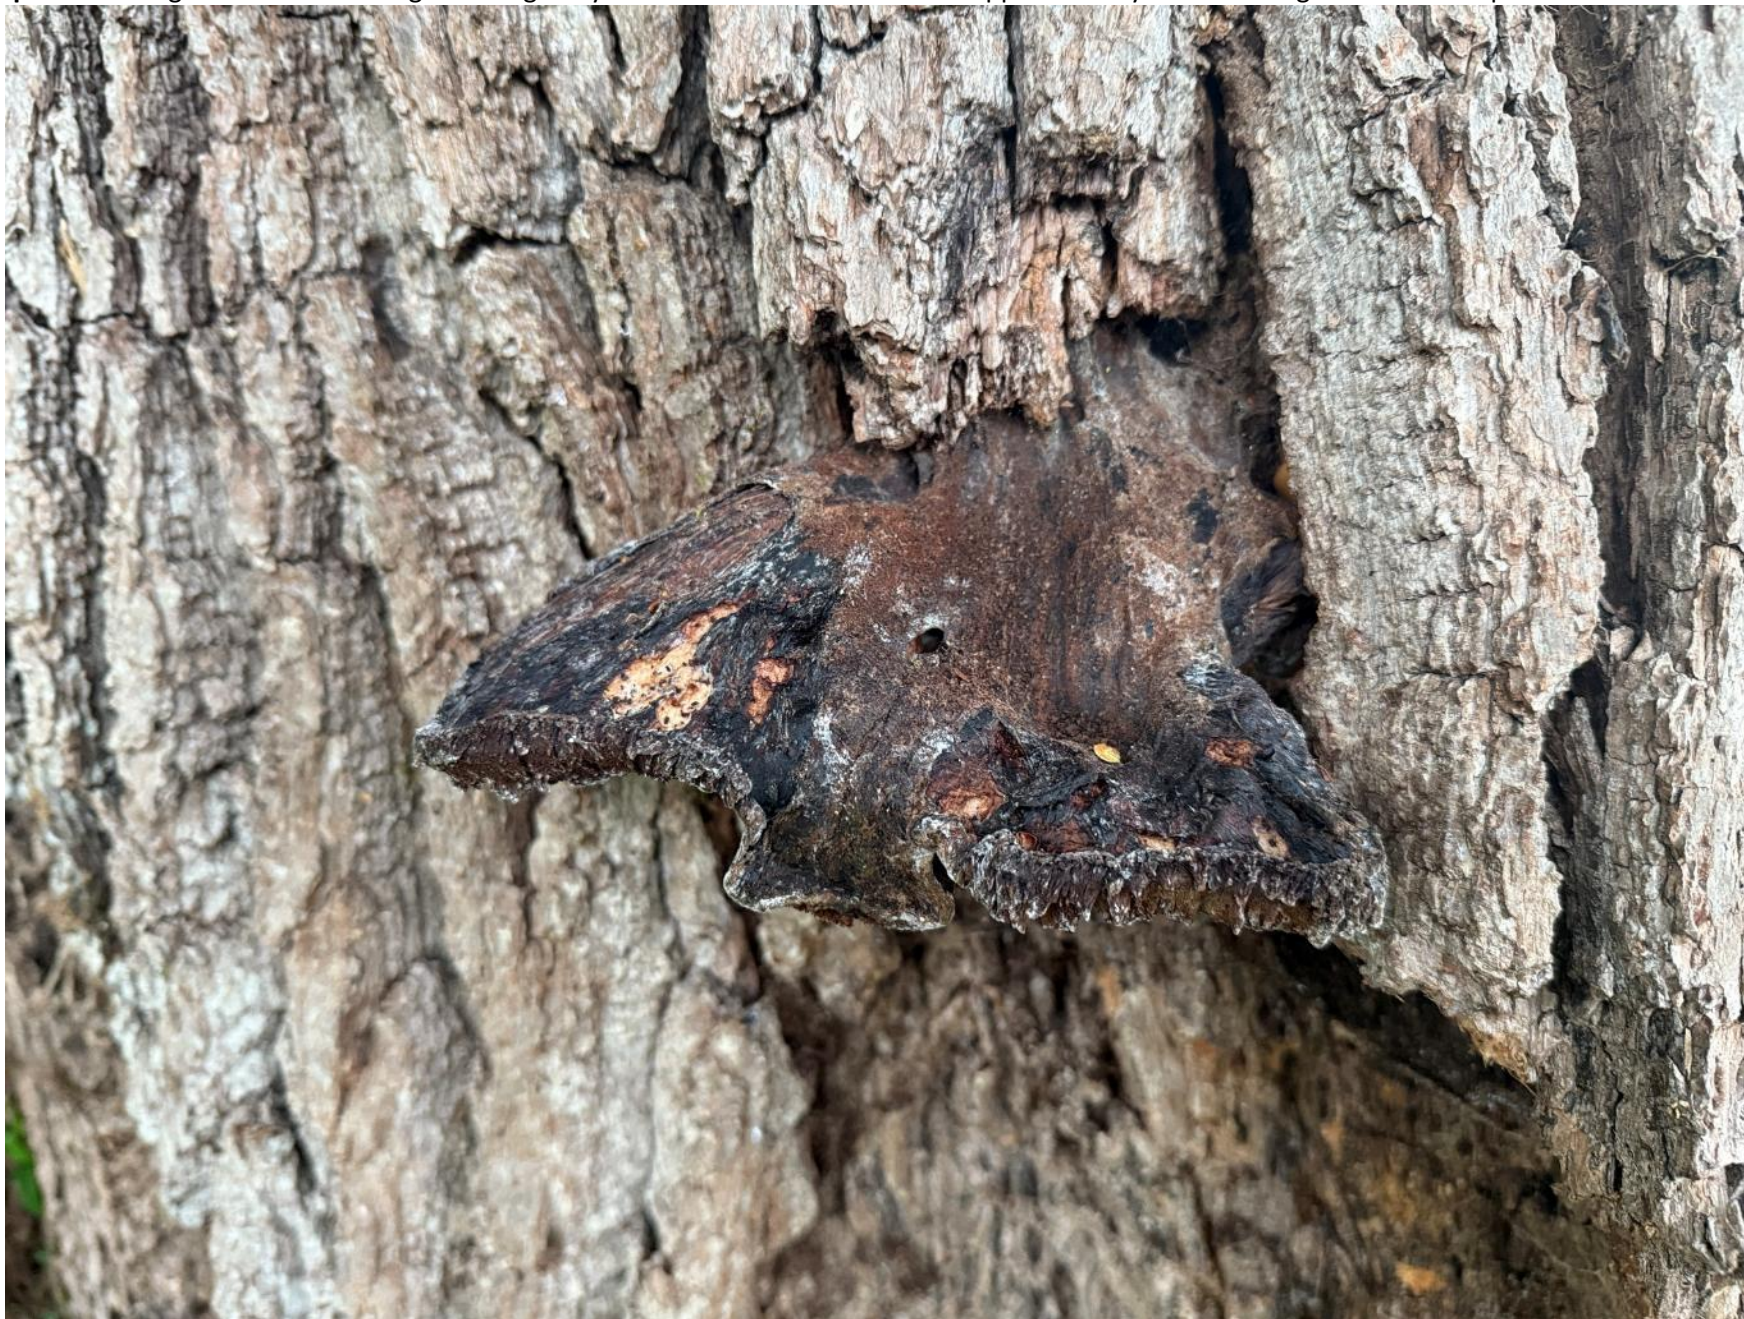
**Photograph 6:** Showing the desiccated fungal fruiting body on the south side of the trunk approximately 1.7m above ground level suspected to be Beef Steak fungus

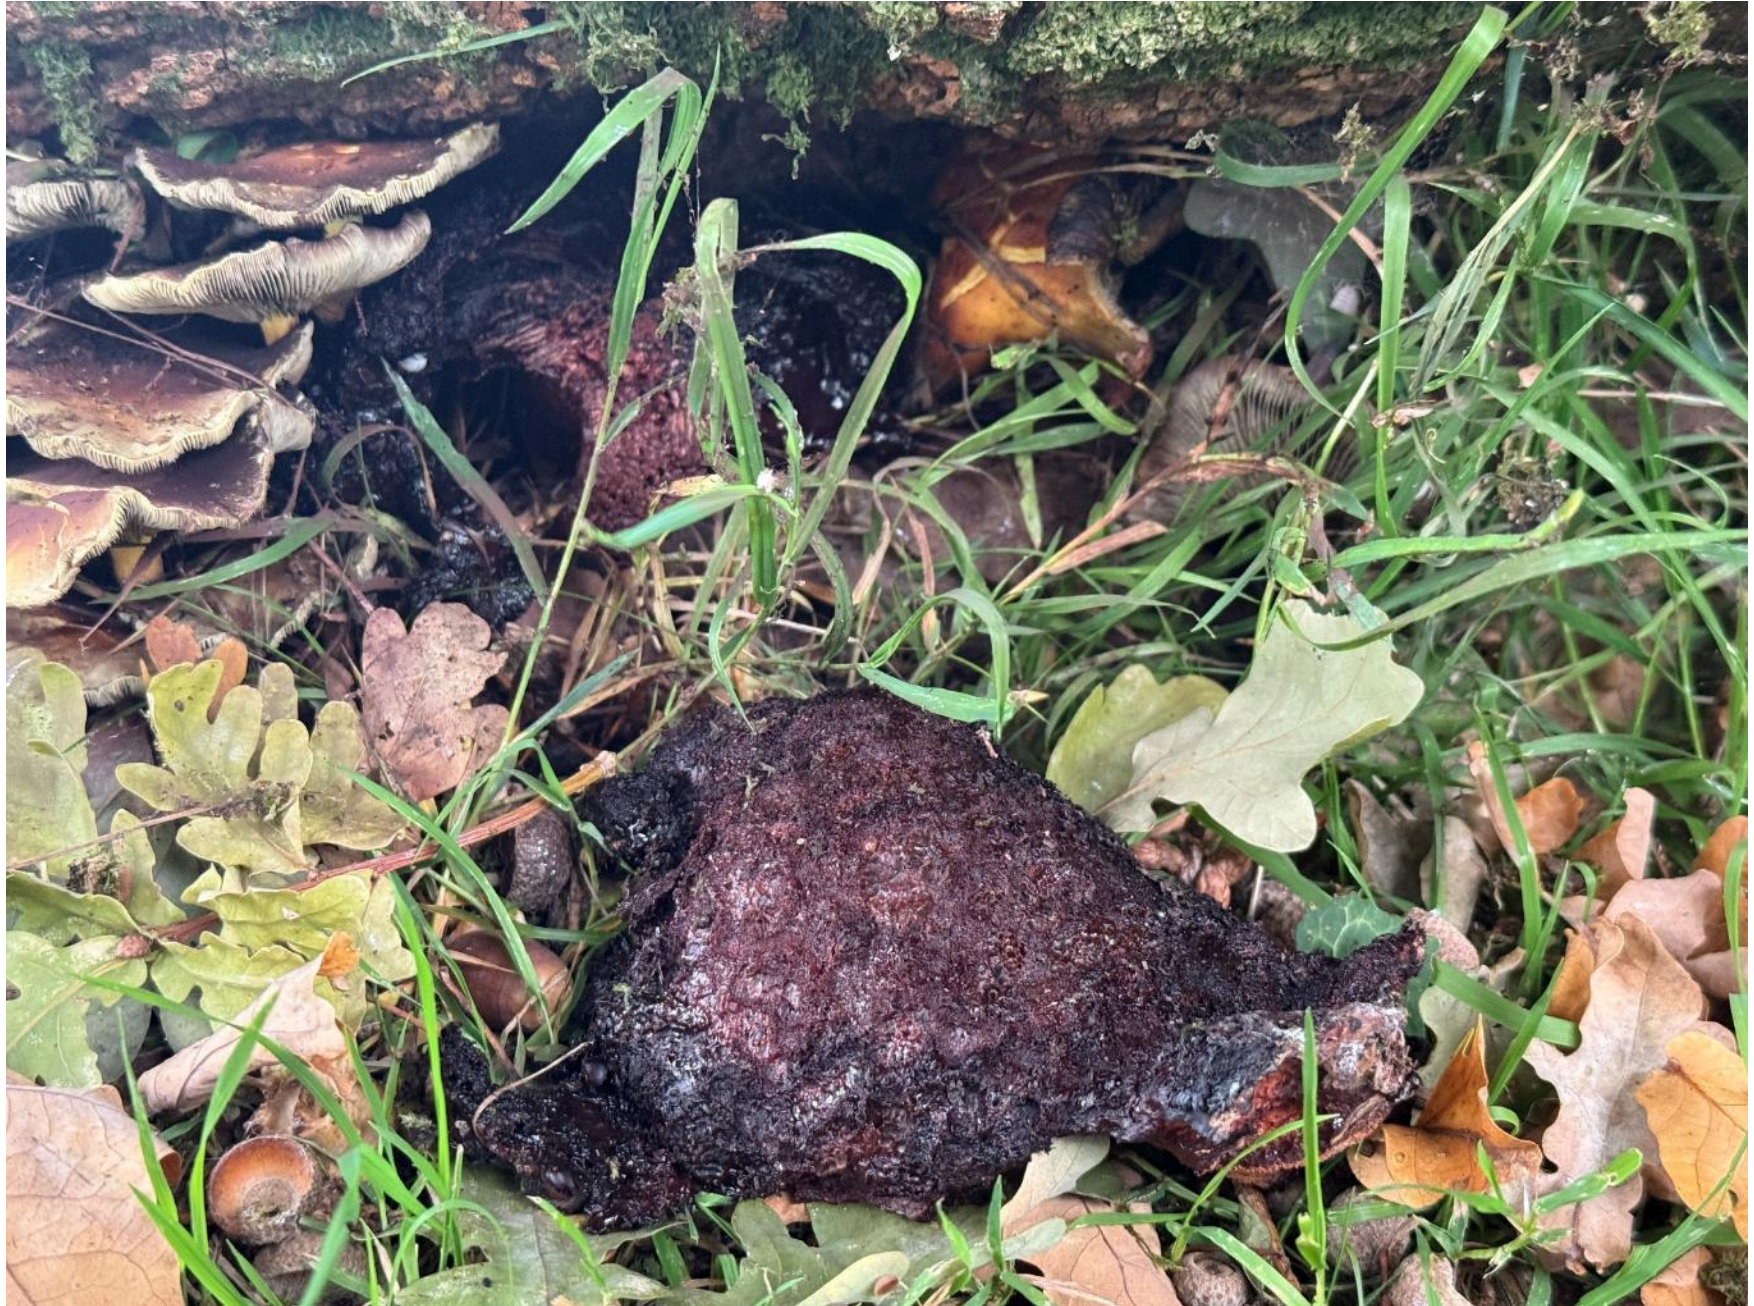
**Photograph 7:** Showing what appears to be a desiccated Beefsteak fungus fruiting body a buttress root on the north side of the T1 with possible Honey fungus mushrooms
