## Arboricultural Report

### Internal and Aerial Tree Inspection

**Report Reference:** AR/IATI26-1057

72 VICTORIA ROAD,

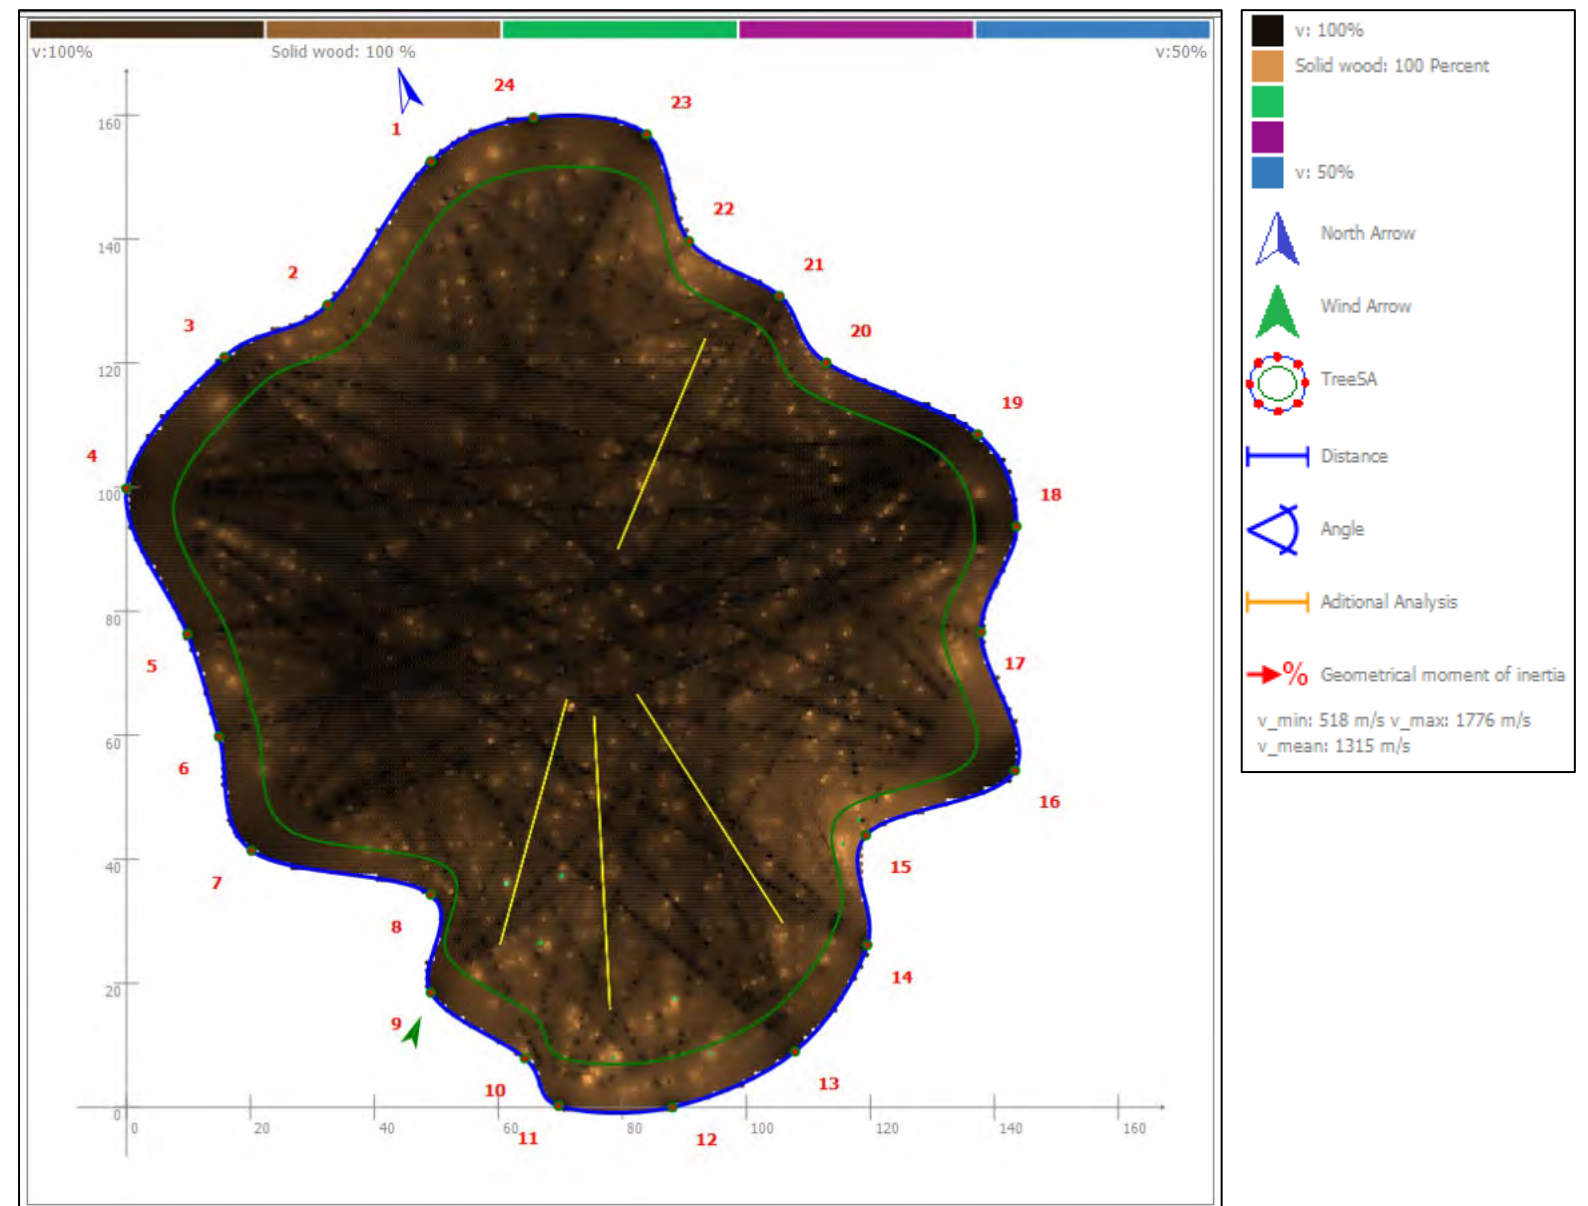
Image 2: SoT.v1 produced at 10cm AGL, 24 measuring points

3.2.3 The four abrupt sound barriers indicated by the yellow lines are noted. The significance of these findings cannot be determined from the sonic data alone and is considered in the integrated assessment alongside ERT.v1 and IML-RESI PD400 measurement curve findings at this height.

3.2.4 A continuous TreeSA line (thin green line) is visible just inside the outer edge, running parallel to the stem geometry and indicating the minimum residual wall thickness, or maximum hollowing, compatible with the calculated stability of the section using the tree statics model.

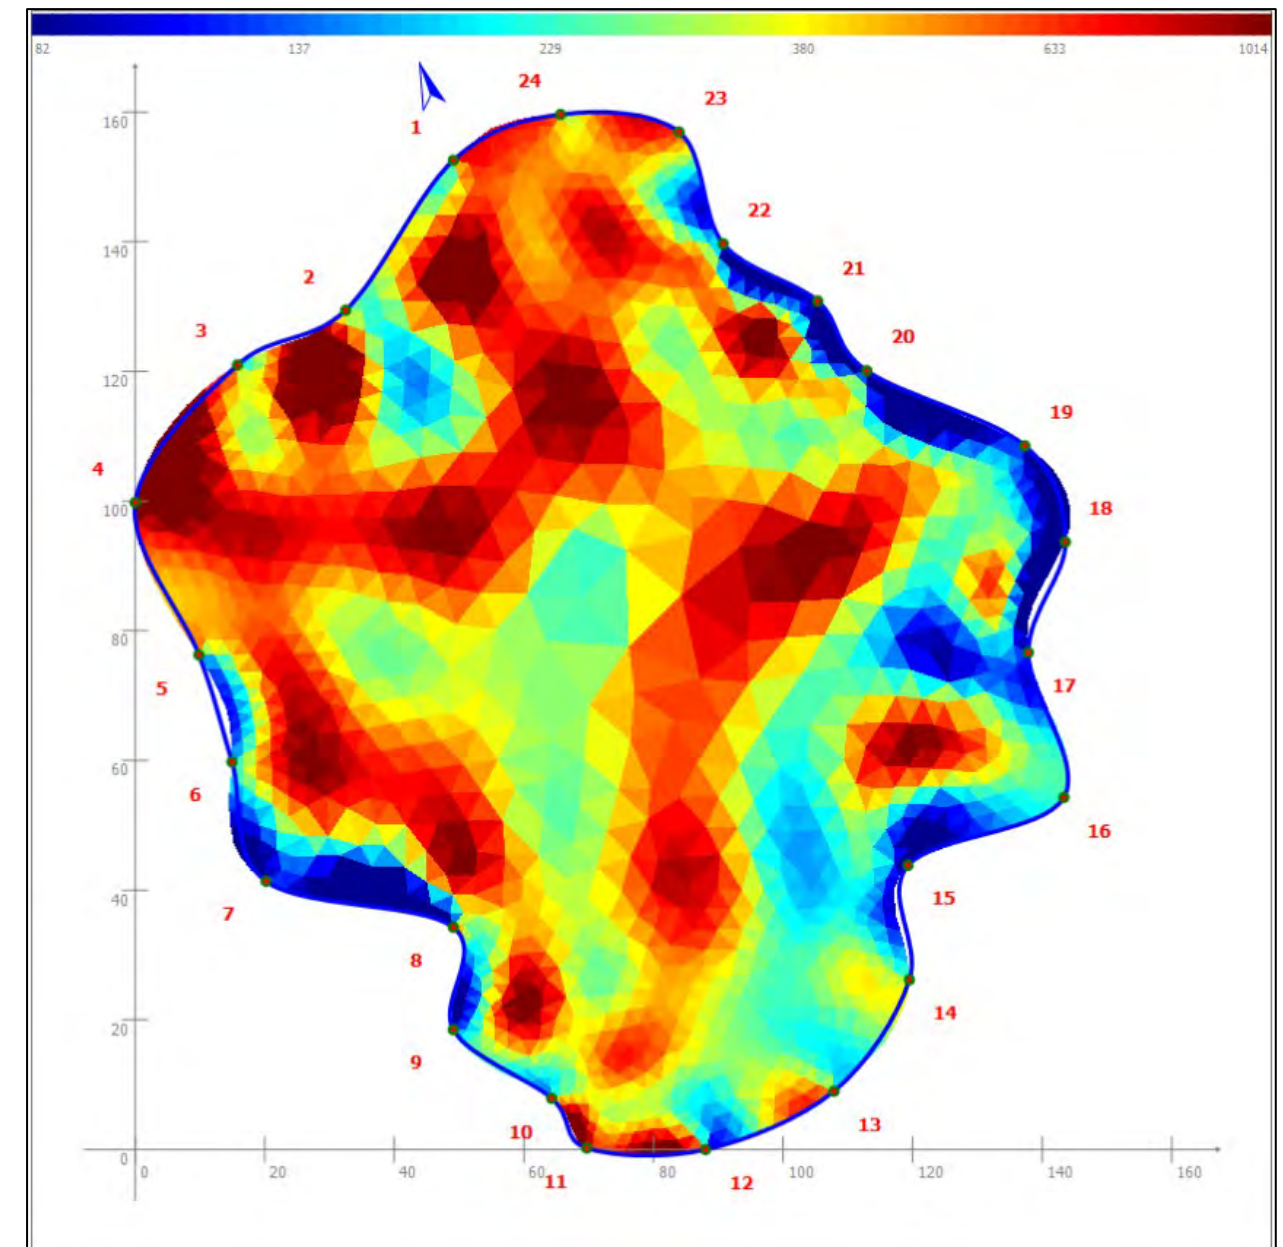
Image 3: ERT.v1 produced at 10cm AGL, 24 measuring points

- 3.3.3 The high-resistance zone to the north, when considered alongside the uniformly high sonic velocity recorded in SoT.v1, is ambiguous — consistent with either dry hard fungi or desiccated wood, or alternatively with adaptive or reaction wood associated with buttress root development at this measurement height. The low-resistance zone toward the western/south-western aspect is consistent with elevated moisture content.

- 3.3.4 The nature of these findings cannot be determined from the tomographic data alone; targeted drilling measurements were therefore undertaken using the IML-RESI PD400 to investigate and resolve the observed anomalies.

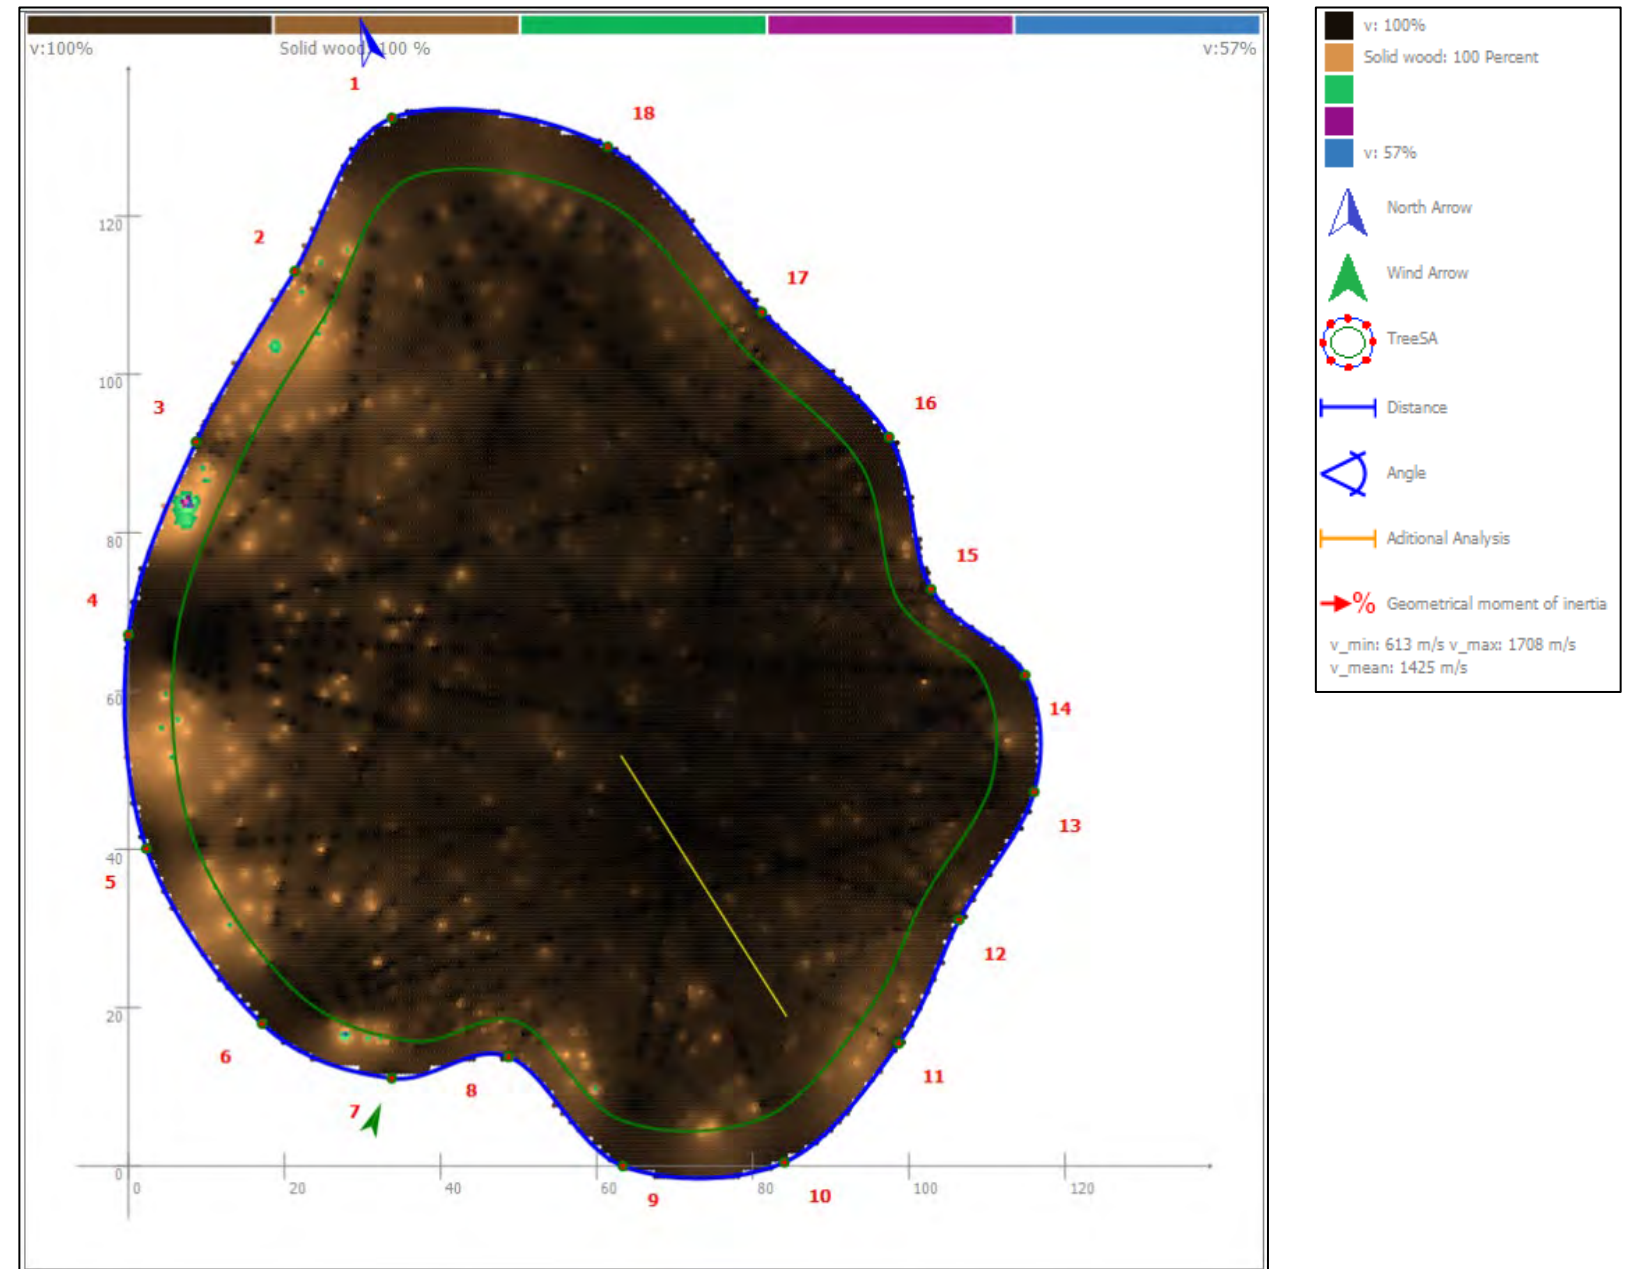
Image 4: SoT.v2 produced at 120cm AGL, 18 measuring points

- 3.5.3 The small area of reduced velocity toward the north-west aspect and the abrupt sound barrier indicated by the yellow line in the lower-right sector are noted.

- 3.5.4 A continuous TreeSA line (thin green line) is visible just inside the outer edge, running parallel to the stem geometry and indicating the minimum residual wall thickness, or maximum hollowing, compatible with the calculated stability of the section using the tree statics model.

- 3.5.5 The significance of these findings cannot be determined from the sonic data alone and is considered in the integrated assessment alongside the ERT.v2 and IML-RESI PD400 measurement curve findings at this height.

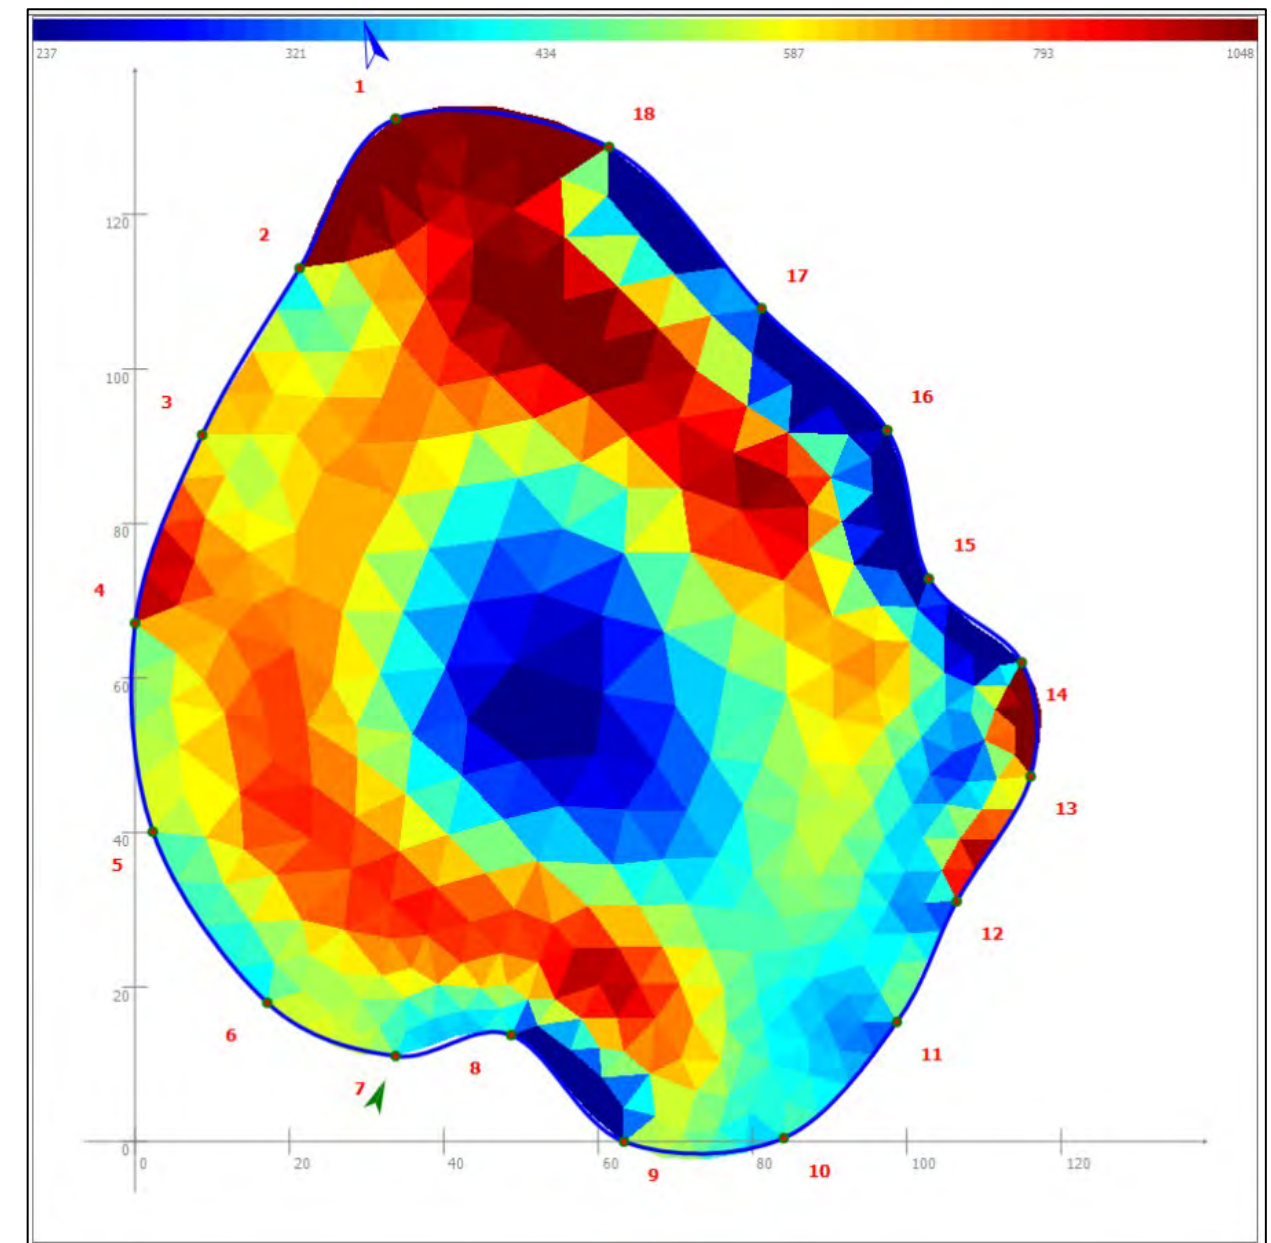
Image 5: ERT.v2 produced at 120cm AGL, 18 measuring points

- 3.6.3 The central blue zone indicates that the wood in this area has a higher moisture content than the surrounding wood. The greater spatial extent of this zone relative to the small sonic anomaly in SoT.v2 may indicate early internal change not yet detectable in the sonic data. However, given that this is a high water-demand species measured in May during active growth, elevated moisture content cannot be attributed to dysfunction alone without further corroborating evidence.

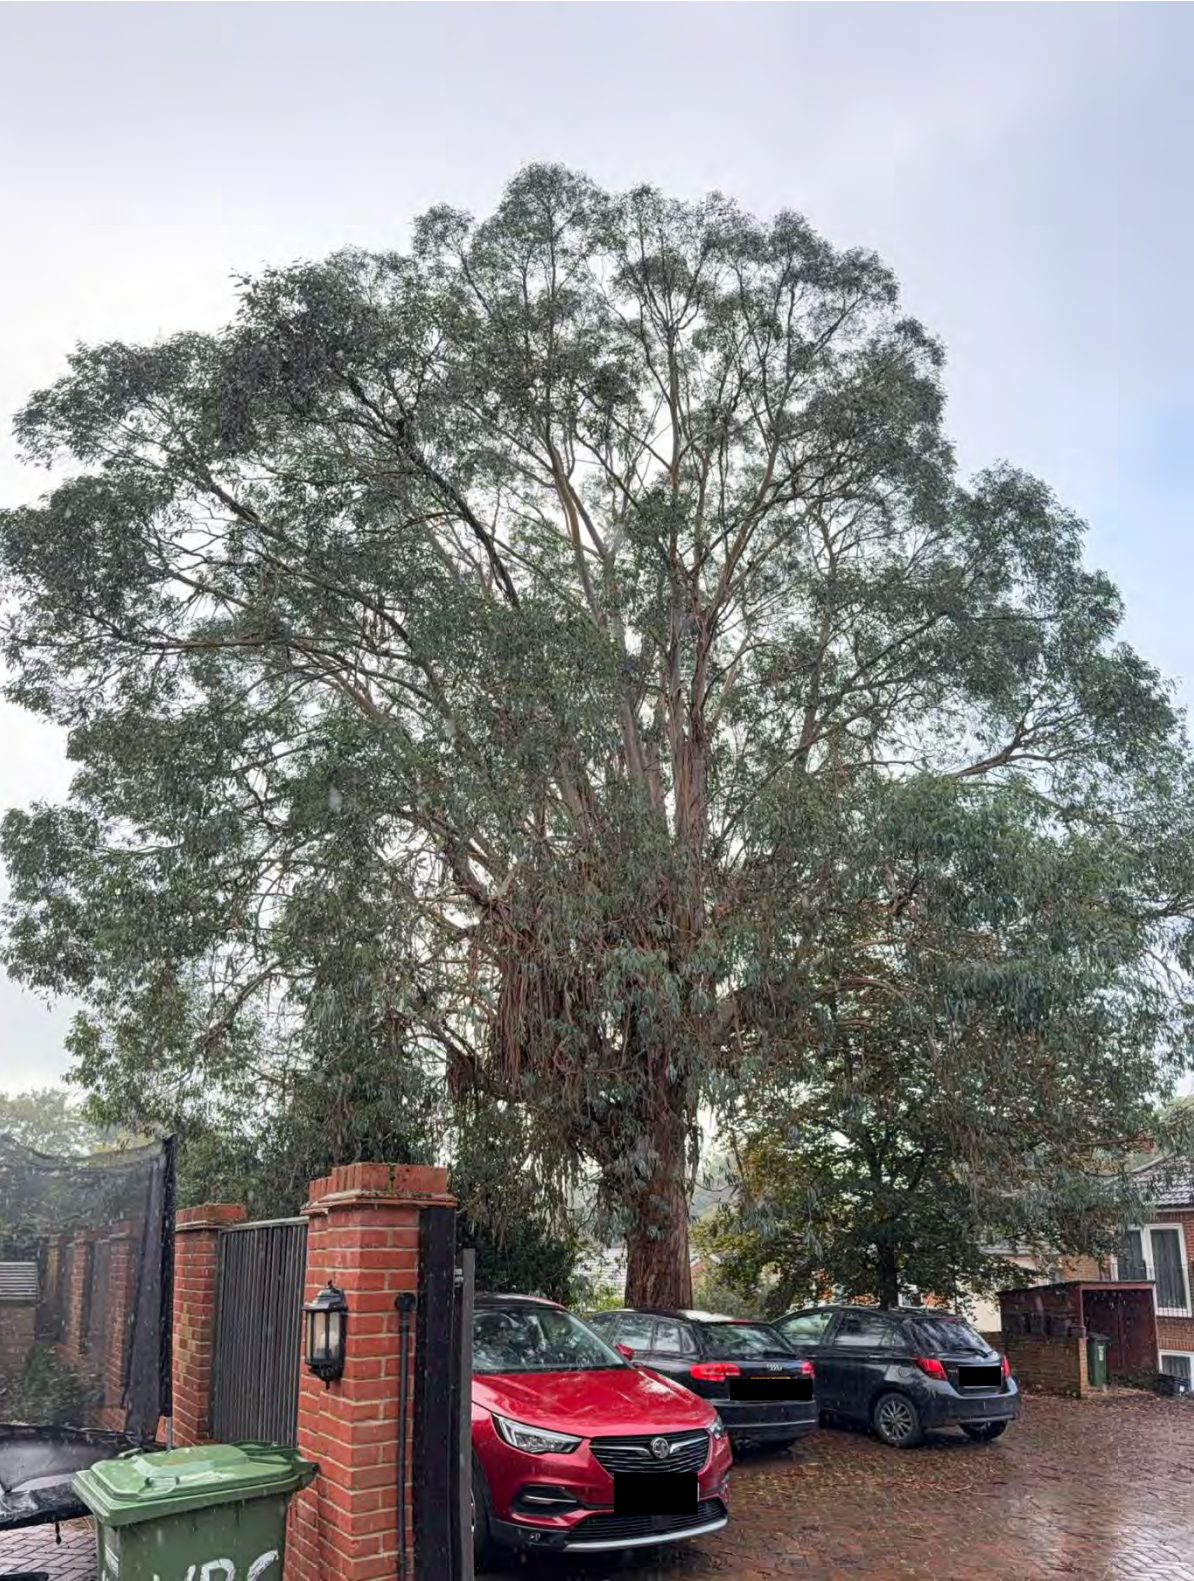
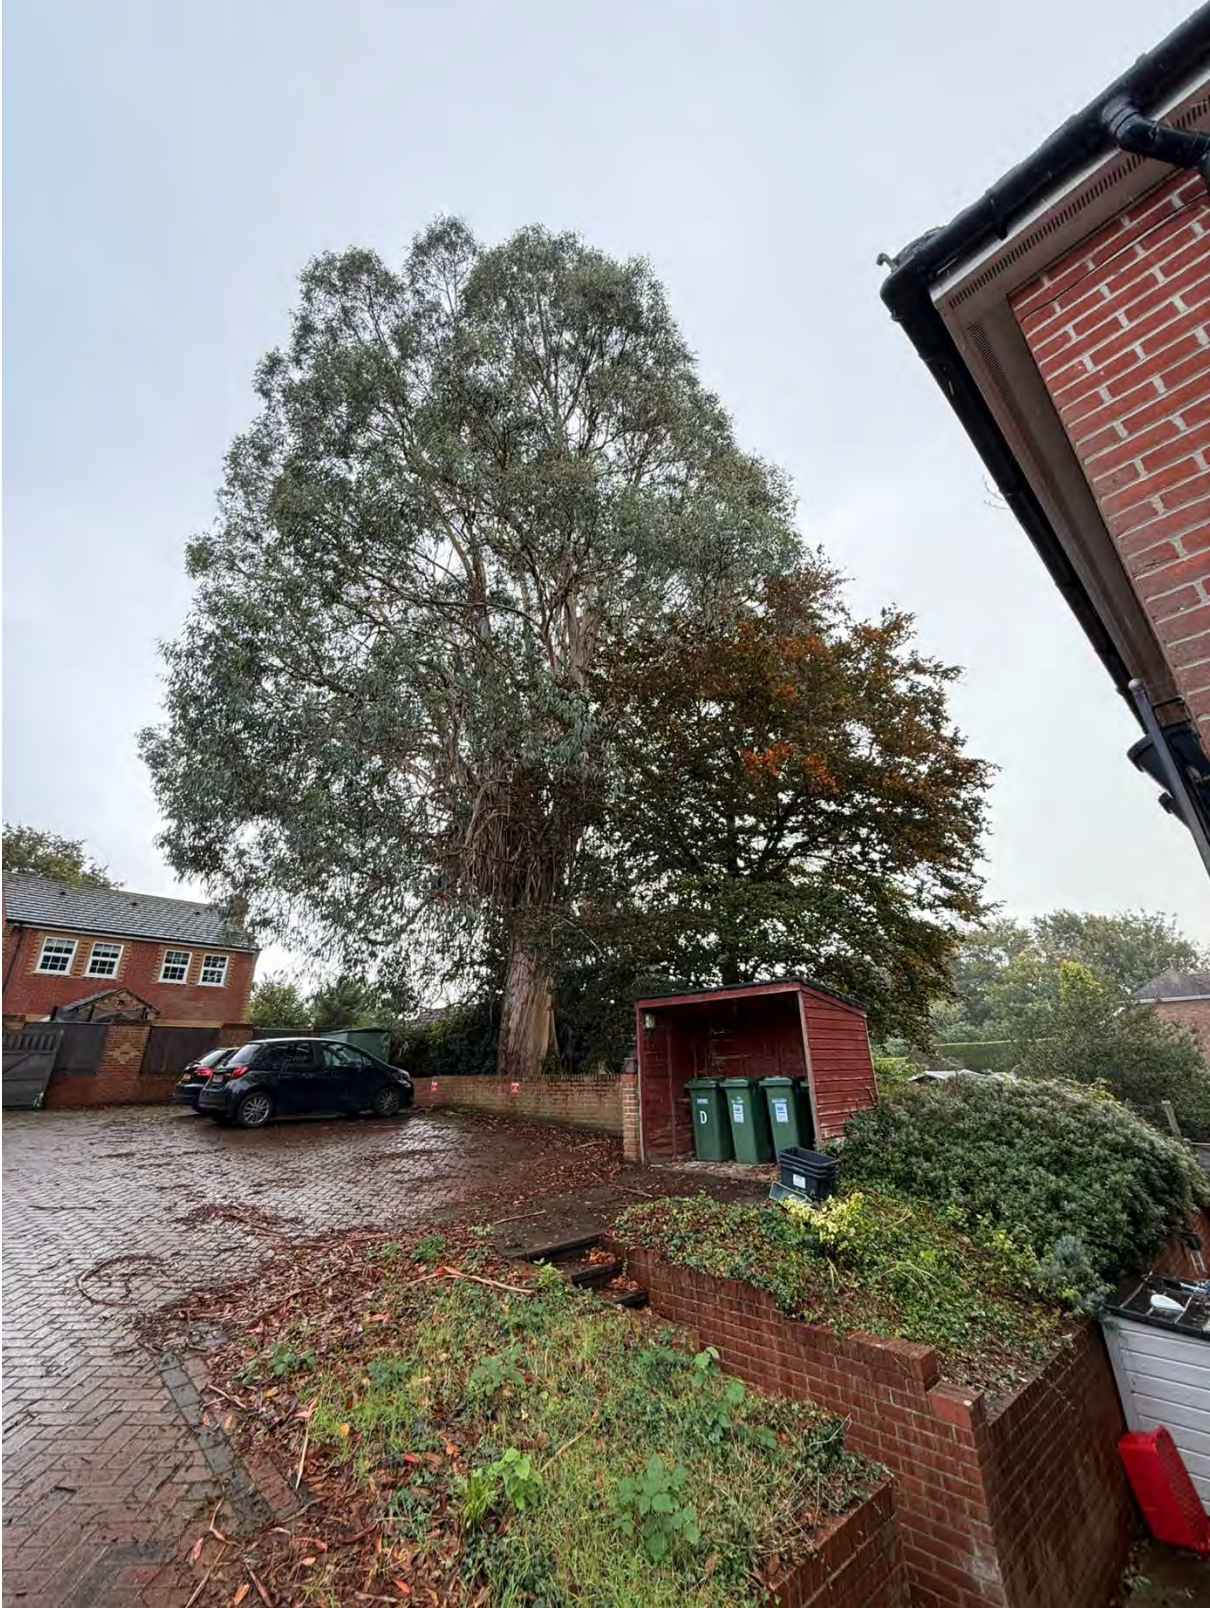
*Image1 & 2: Whole tree from car park, October 2024. Full crown in leaf demonstrating extent and density. The co-dominant tension union at approximately 3.5m is almost visible at the base of the crown break. The car park, brick boundary wall, and adjacent parking bays visible in foreground.*

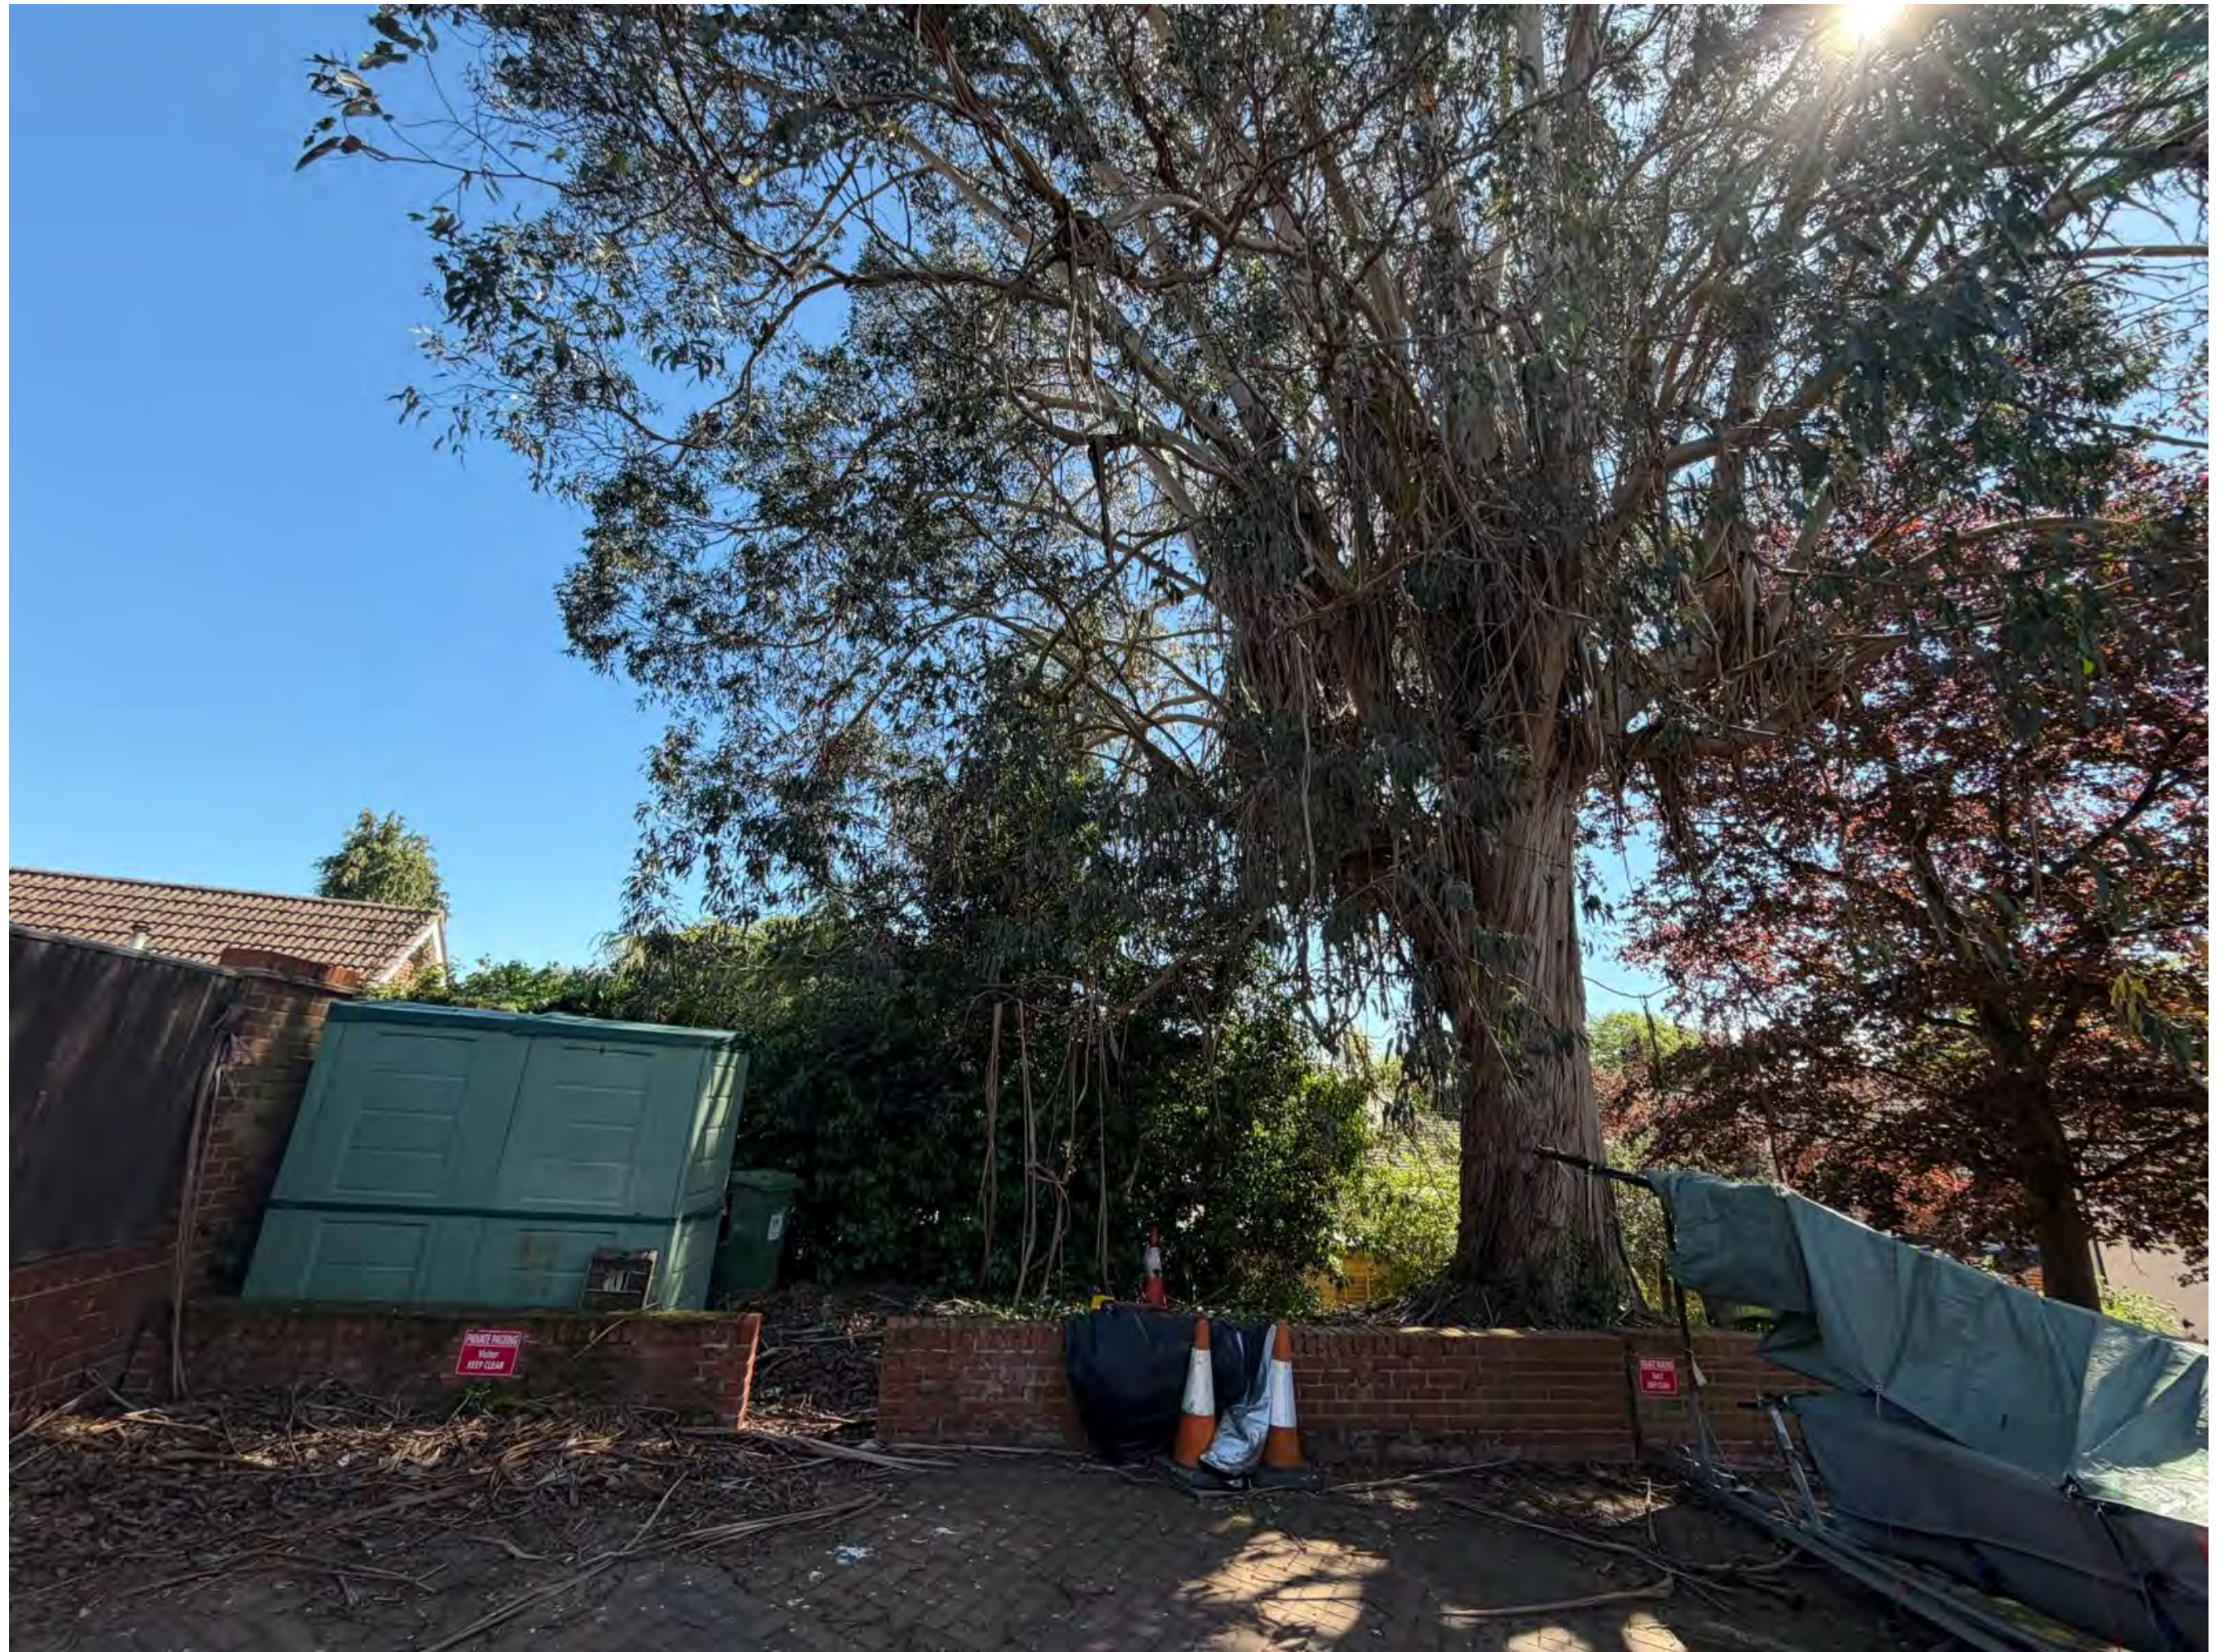
**Image 3:** General view from north-northwest aspect, October 2024 (prior to exfoliating bark removal). The overextended primary SSE limb is almost visible extending to the left of the crown. The proximity of the crown to neighbouring properties is evident.

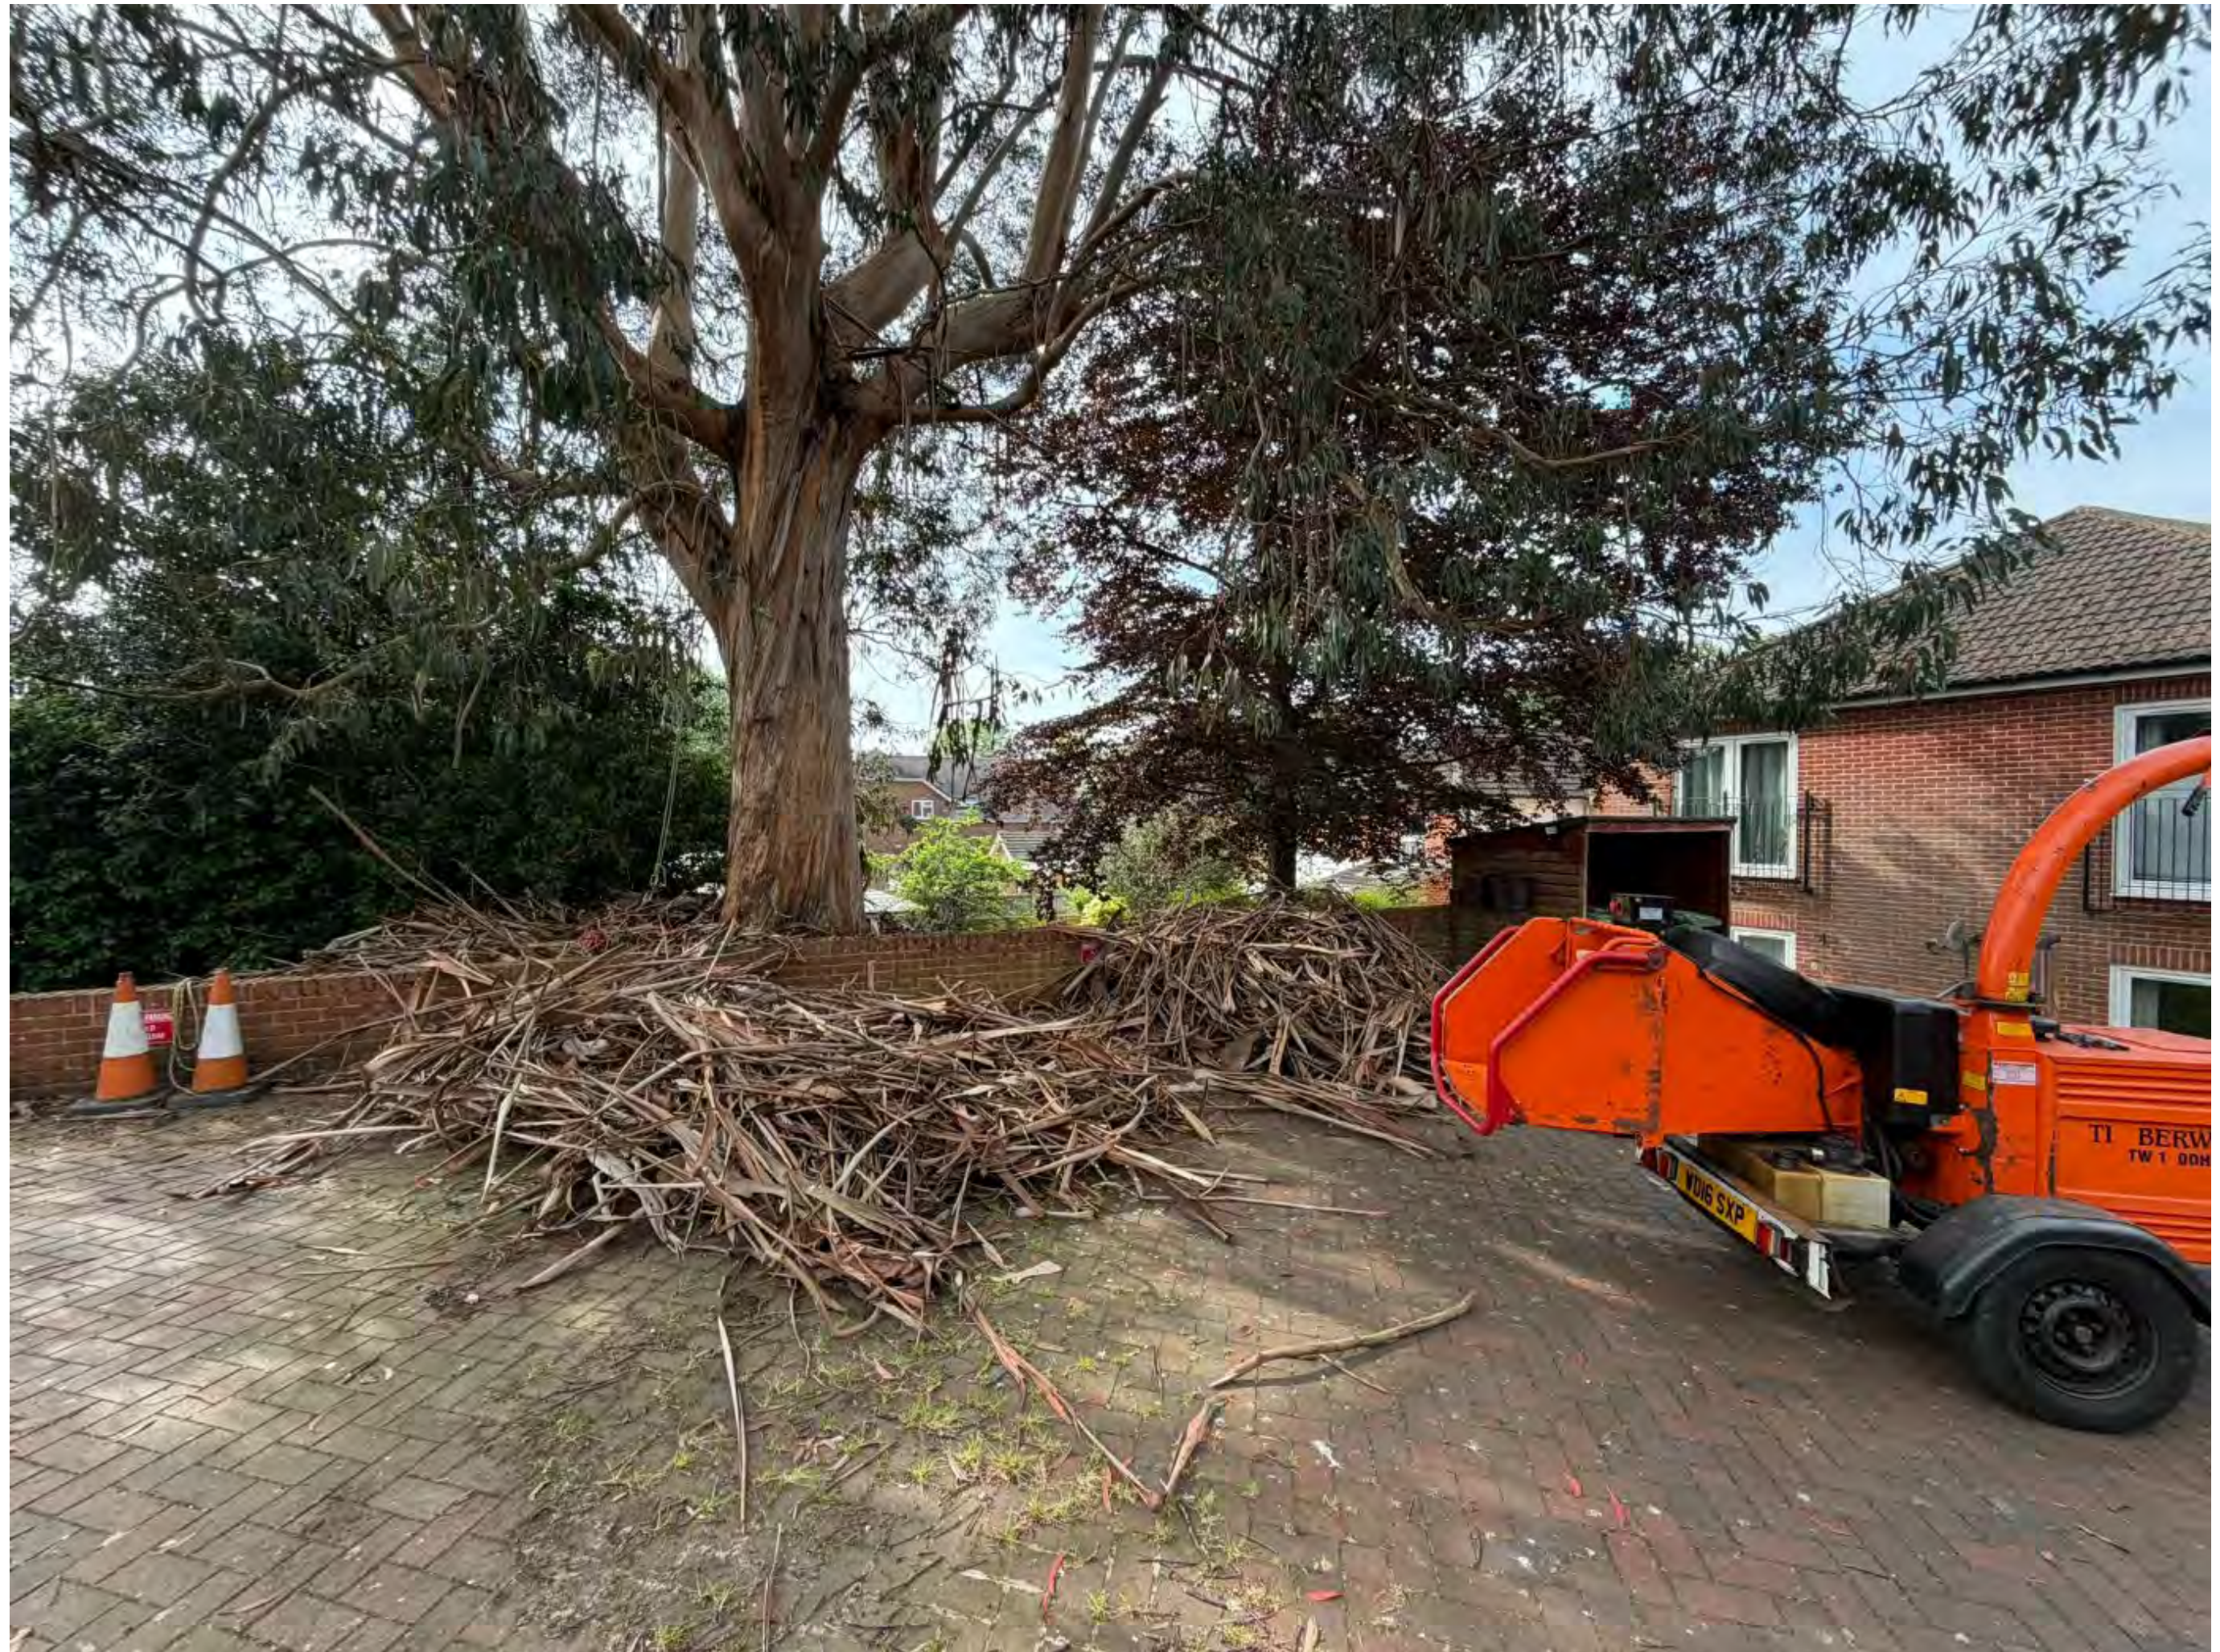
**Image 4:** General view, north-northwest aspect, June 2026, mid exfoliating bark removal. The volume of shed bark strips and plates visible illustrates the scale of annual bark exfoliation typical of the species — a normal physiological feature of the genus.

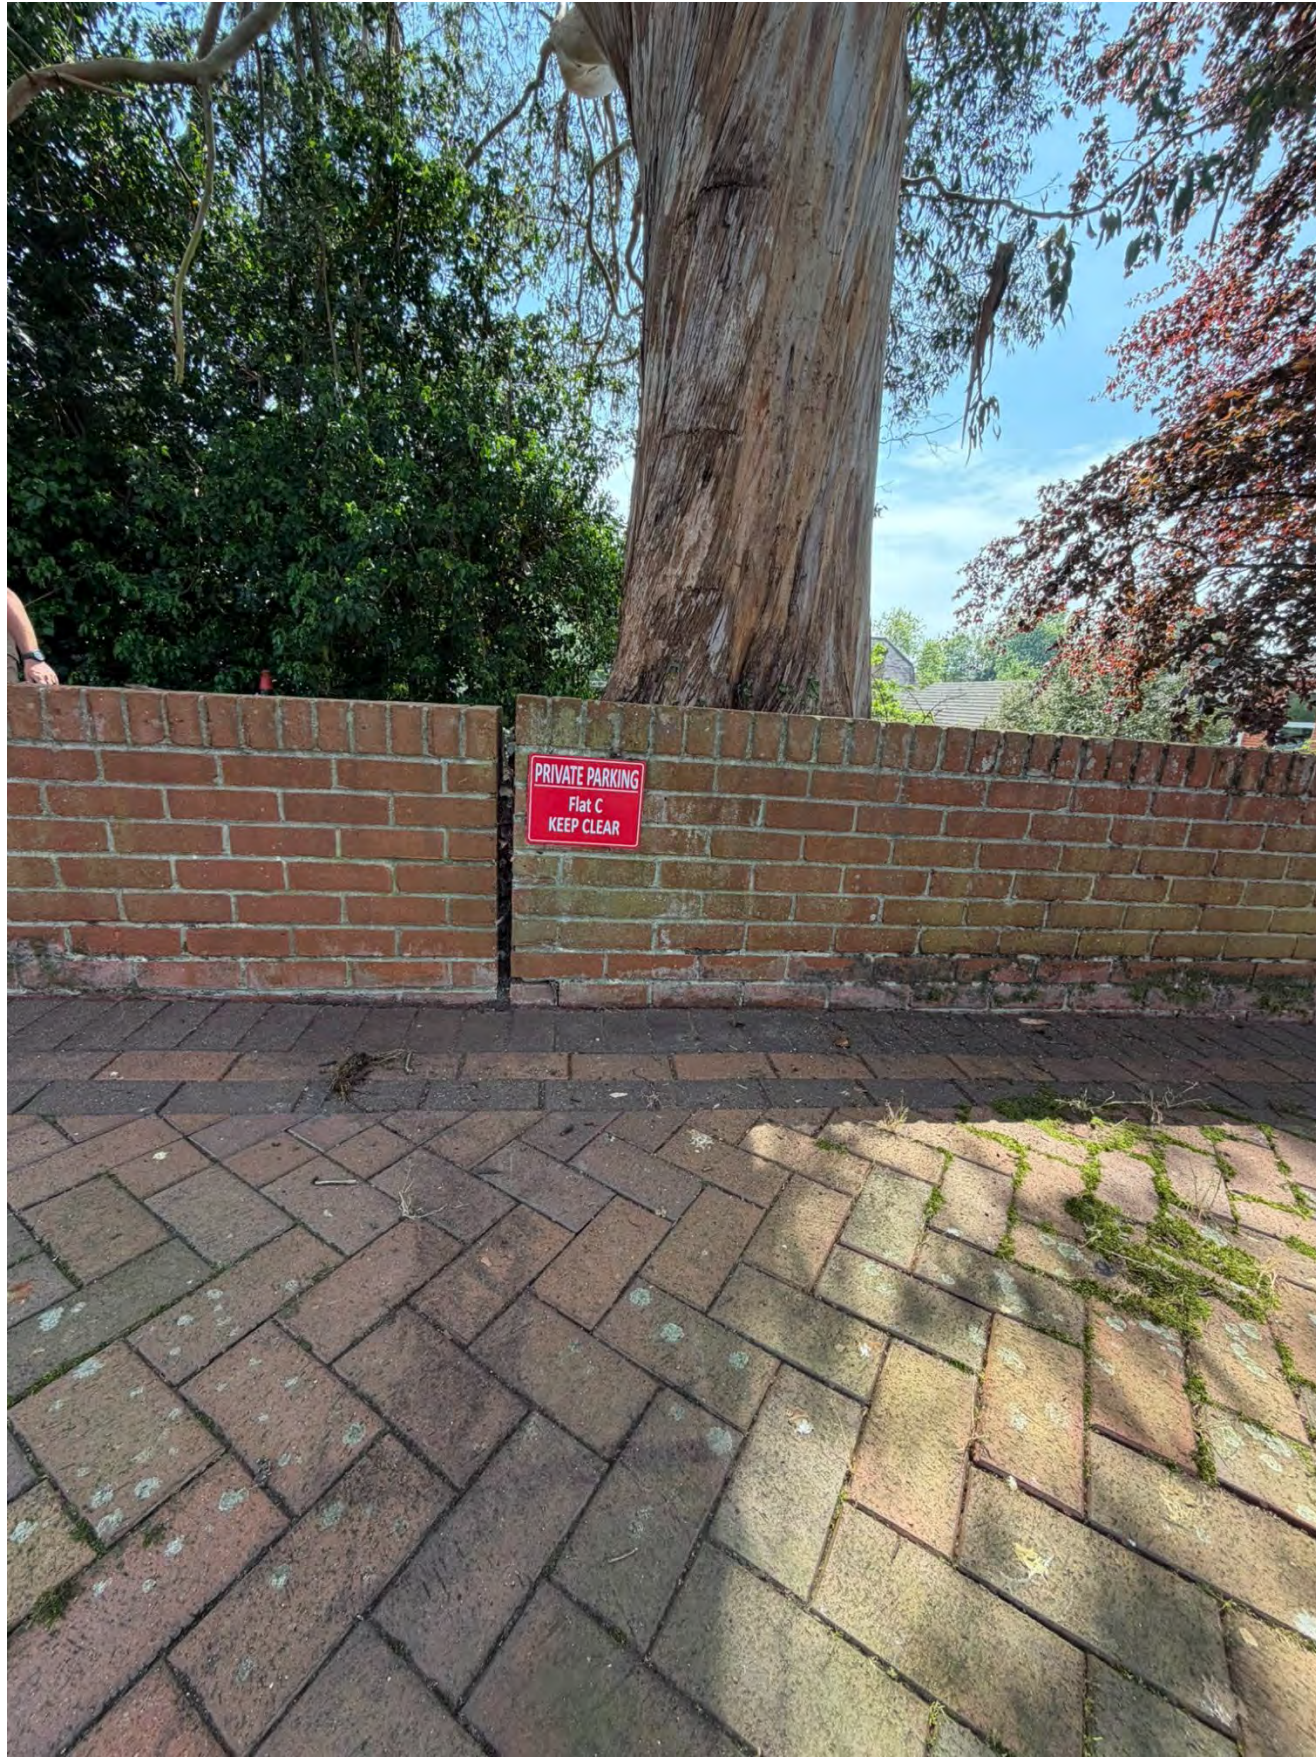
- 4.1.1 Localised soil displacement was recorded at Section 2.2.1.
- 4.1.2 The site presents an approximately 3m grade differential to the adjoining property to the southeast, retained in part by a historic wall, the structural condition and founding depth of which were not assessed as part of this inspection.

Image 5: Low brick wall separating carpark on NNW aspect showing vertical gap and displacement consistent with root-related ground movement. The subject Eucalyptus stem is visible in the background.
