## Arboricultural Report

### Internal and Aerial Tree Inspection

**Report Reference:** AR/IATI26-1057

72 VICTORIA ROAD,

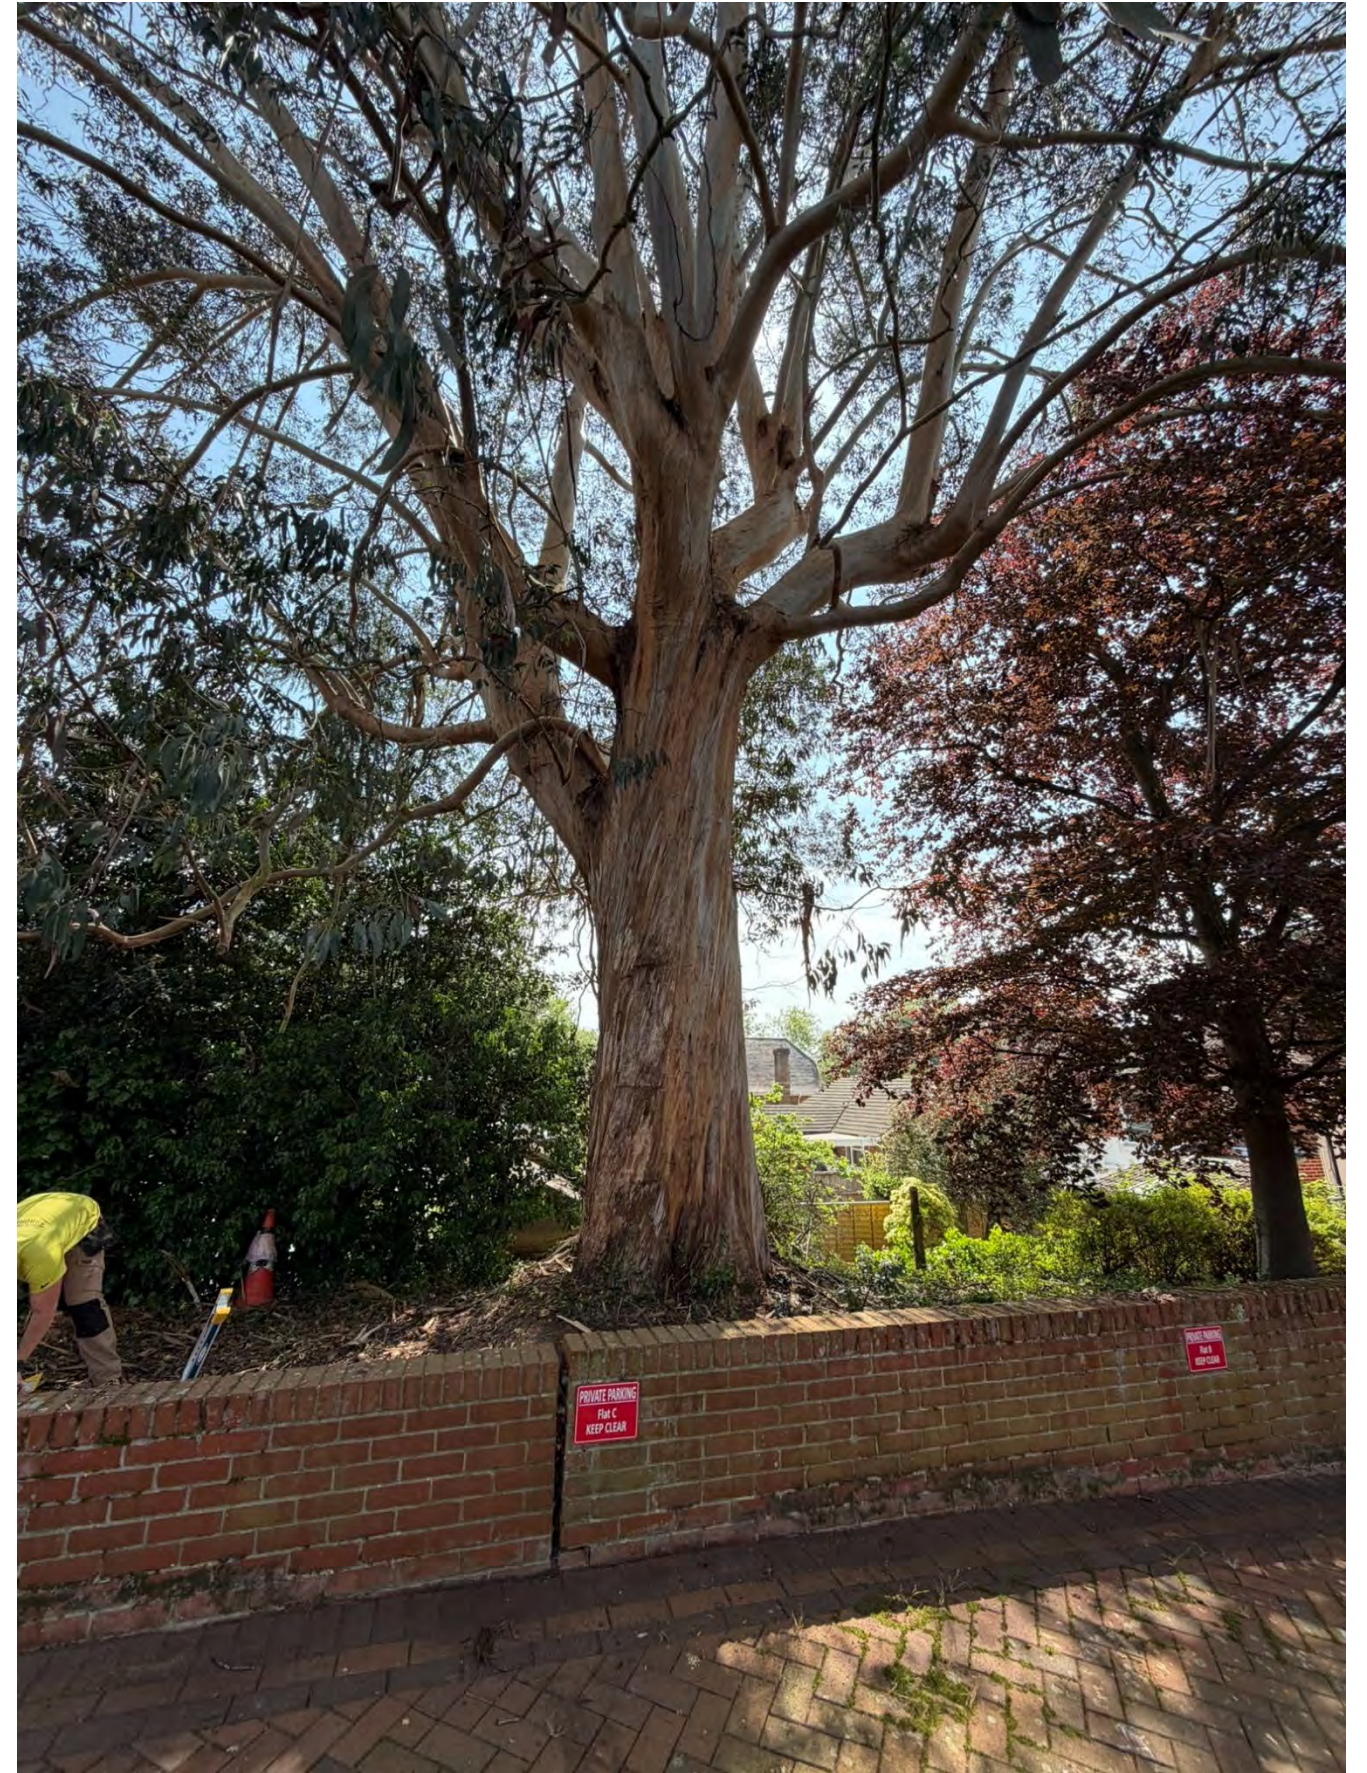
Image 6: General view of tree from car park (NNW aspect), June 2026, following exfoliating bark clearance. Post-clearance the stem form is clearly visible. The transition from the single main stem to the multi-stemmed upper crown at approximately 5-6m, at the historic topping union zone, is apparent. The overextended primary limb is visible to the left of the crown.

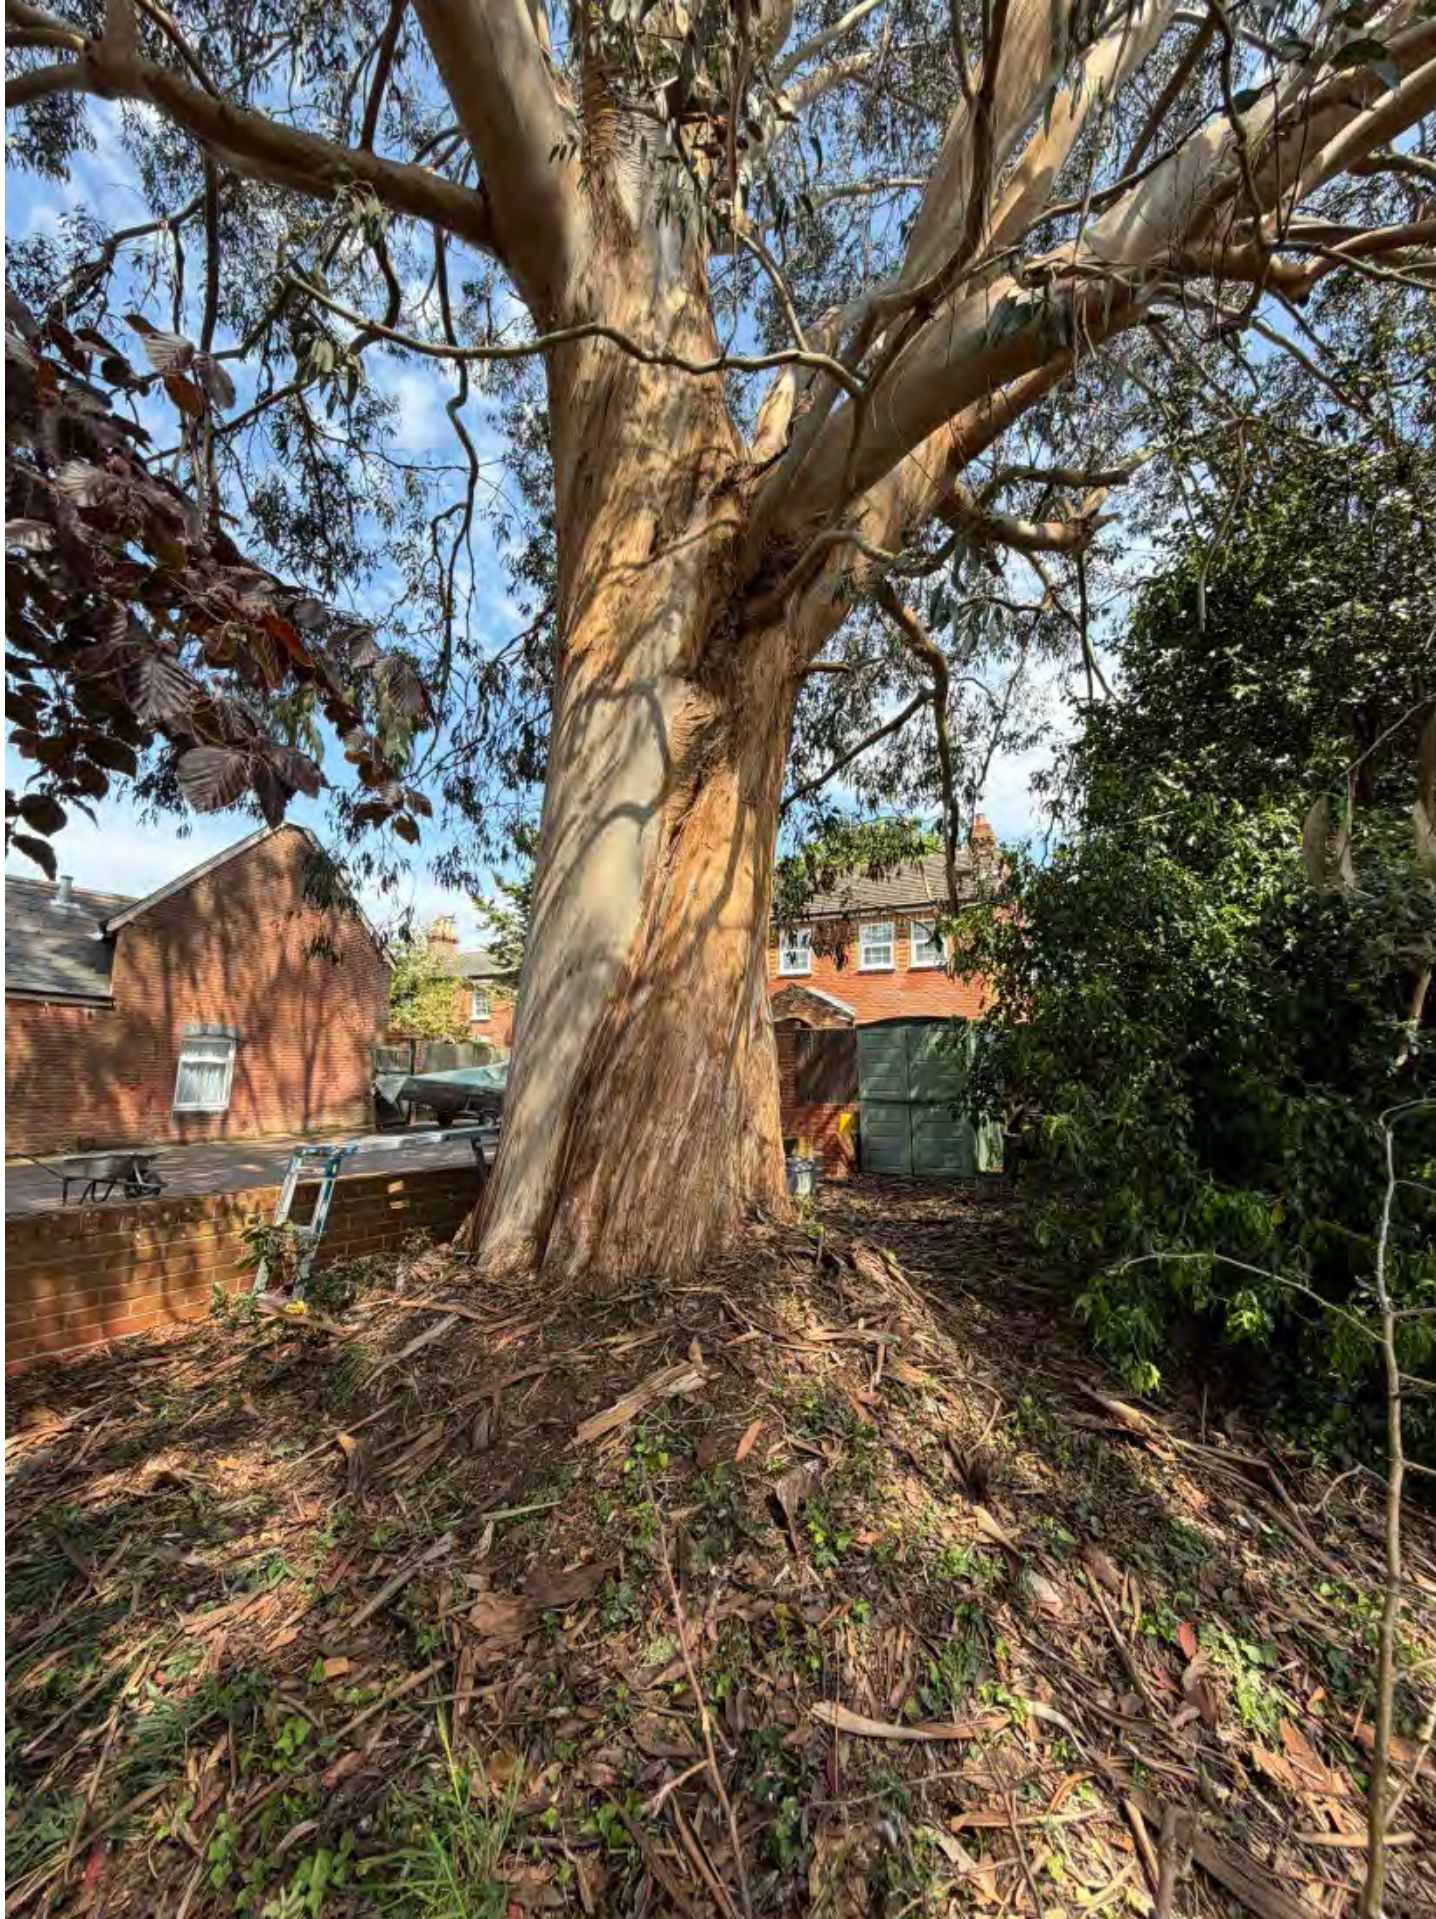
Image 7: NE aspect, June 2026. The overextended primary SSE limb is visible. From this aspect the union presents a comparatively integrated appearance.

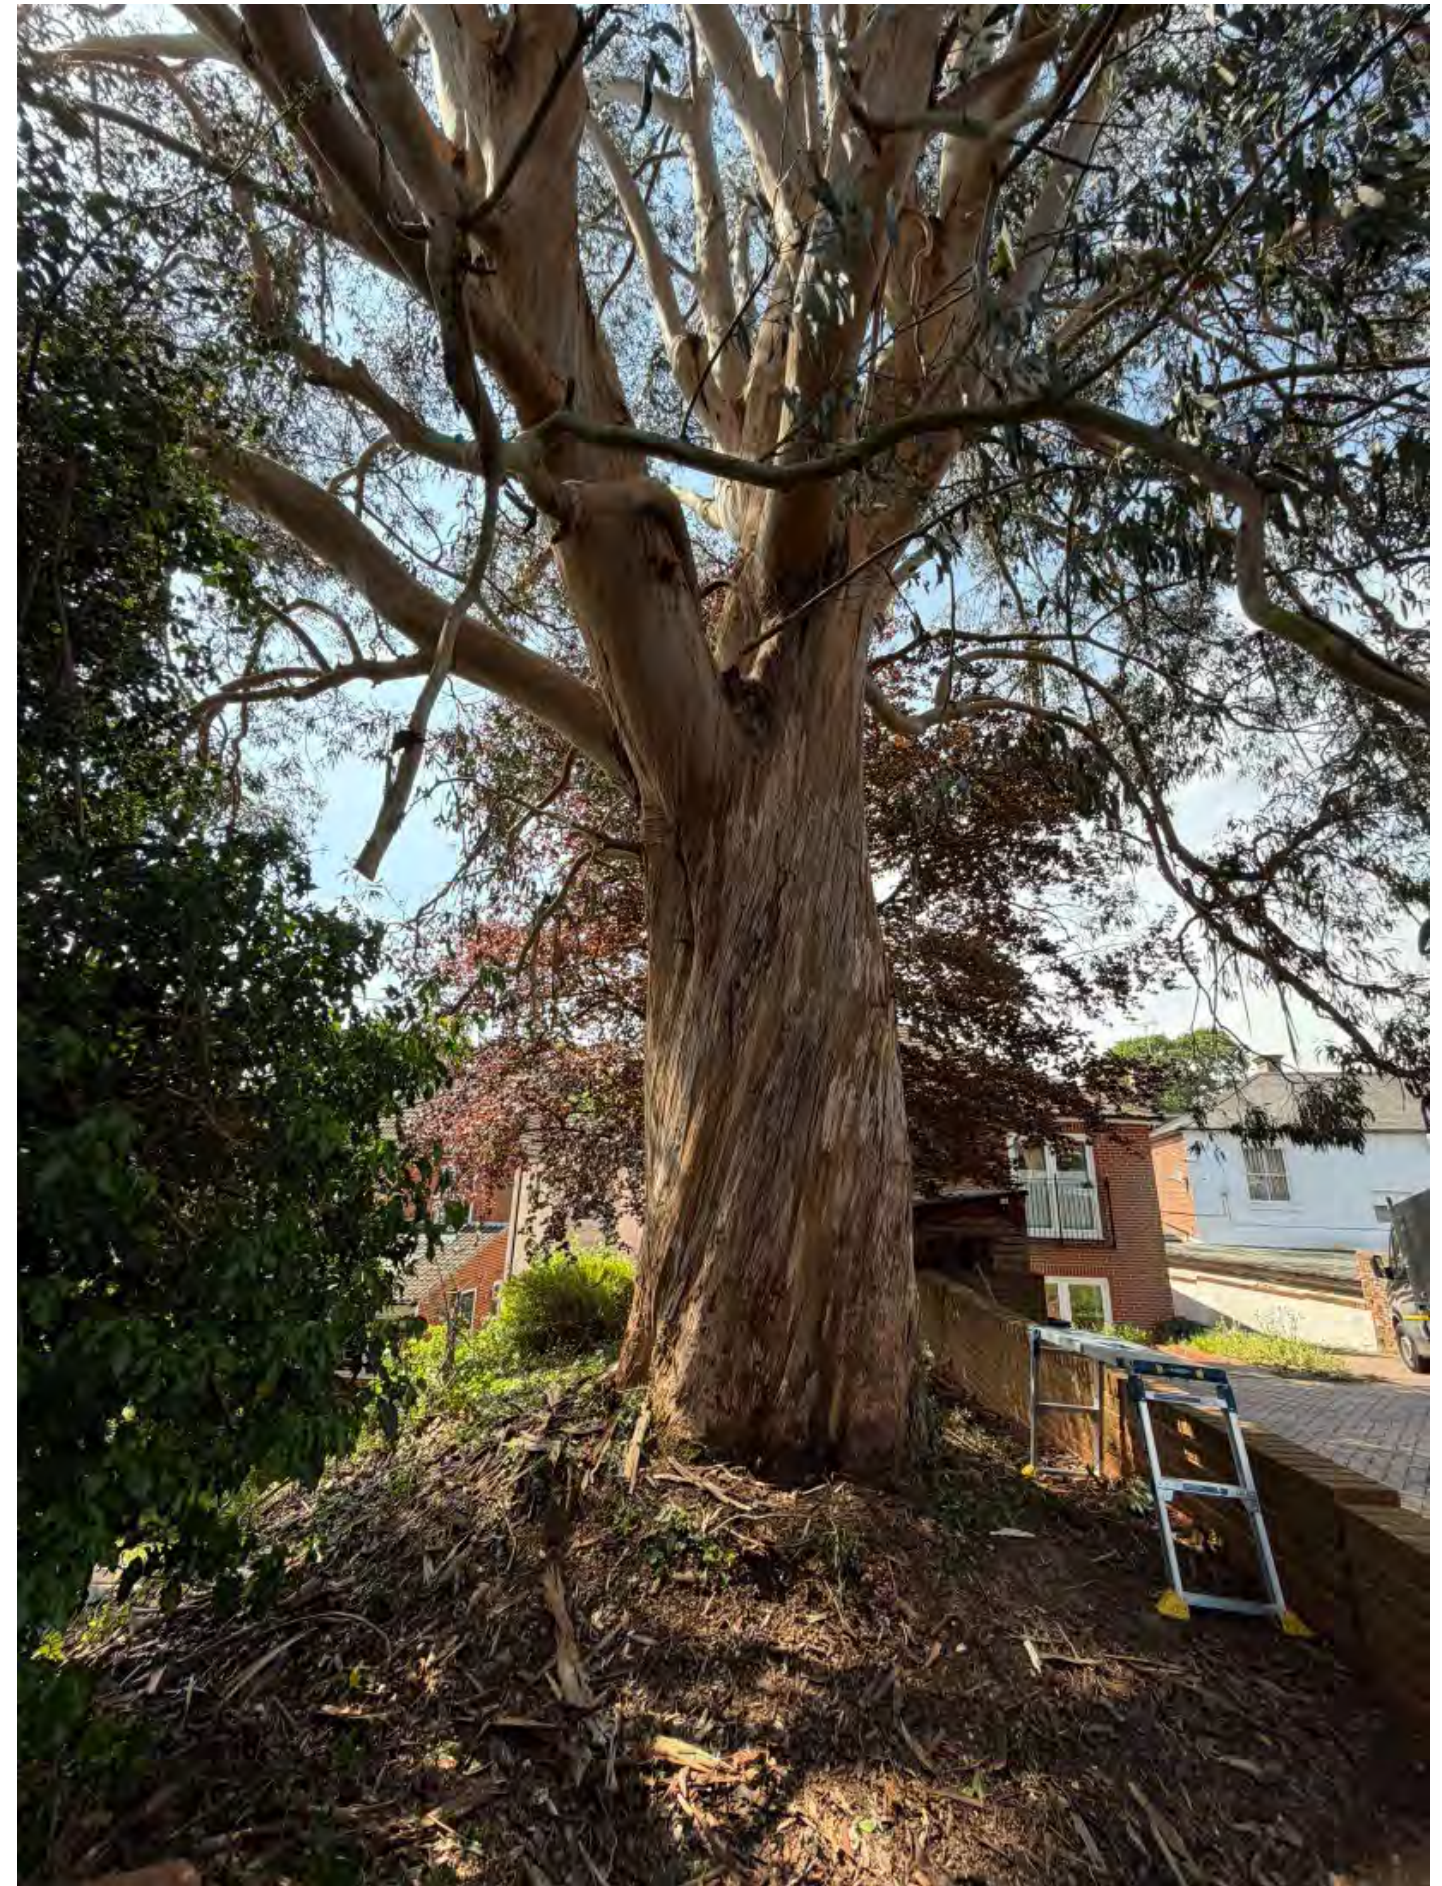
- 2.2.3 The bark exhibits a distinct twisting growth habit. On the south-west aspect, a helical indentation is observed that terminates where the stem divides with a tension union at approximately 3.5m AGL. Three unintegrated branches featuring compression unions are located in close proximity to this union.

- 4.2.1 The helical indentation observed at Section 2.2.3, terminating at the co-dominant tension union at approximately 3.5m, is interpreted as external evidence of torsional loading transmitted to the main stem from the overextended primary limb described at Section 2.2.4. The indentation itself is a genuine concavity, confirmed during the aerial inspection referenced at Section 2.4.

Image 8: SW aspect, June 2026. The helical indentation is visible as a continuous groove tracking upward-right from approximately ground level toward the 3.5m union zone. Three subordinate limbs are visible in the mid-frame; the primary SSE limb is out of frame to the right.

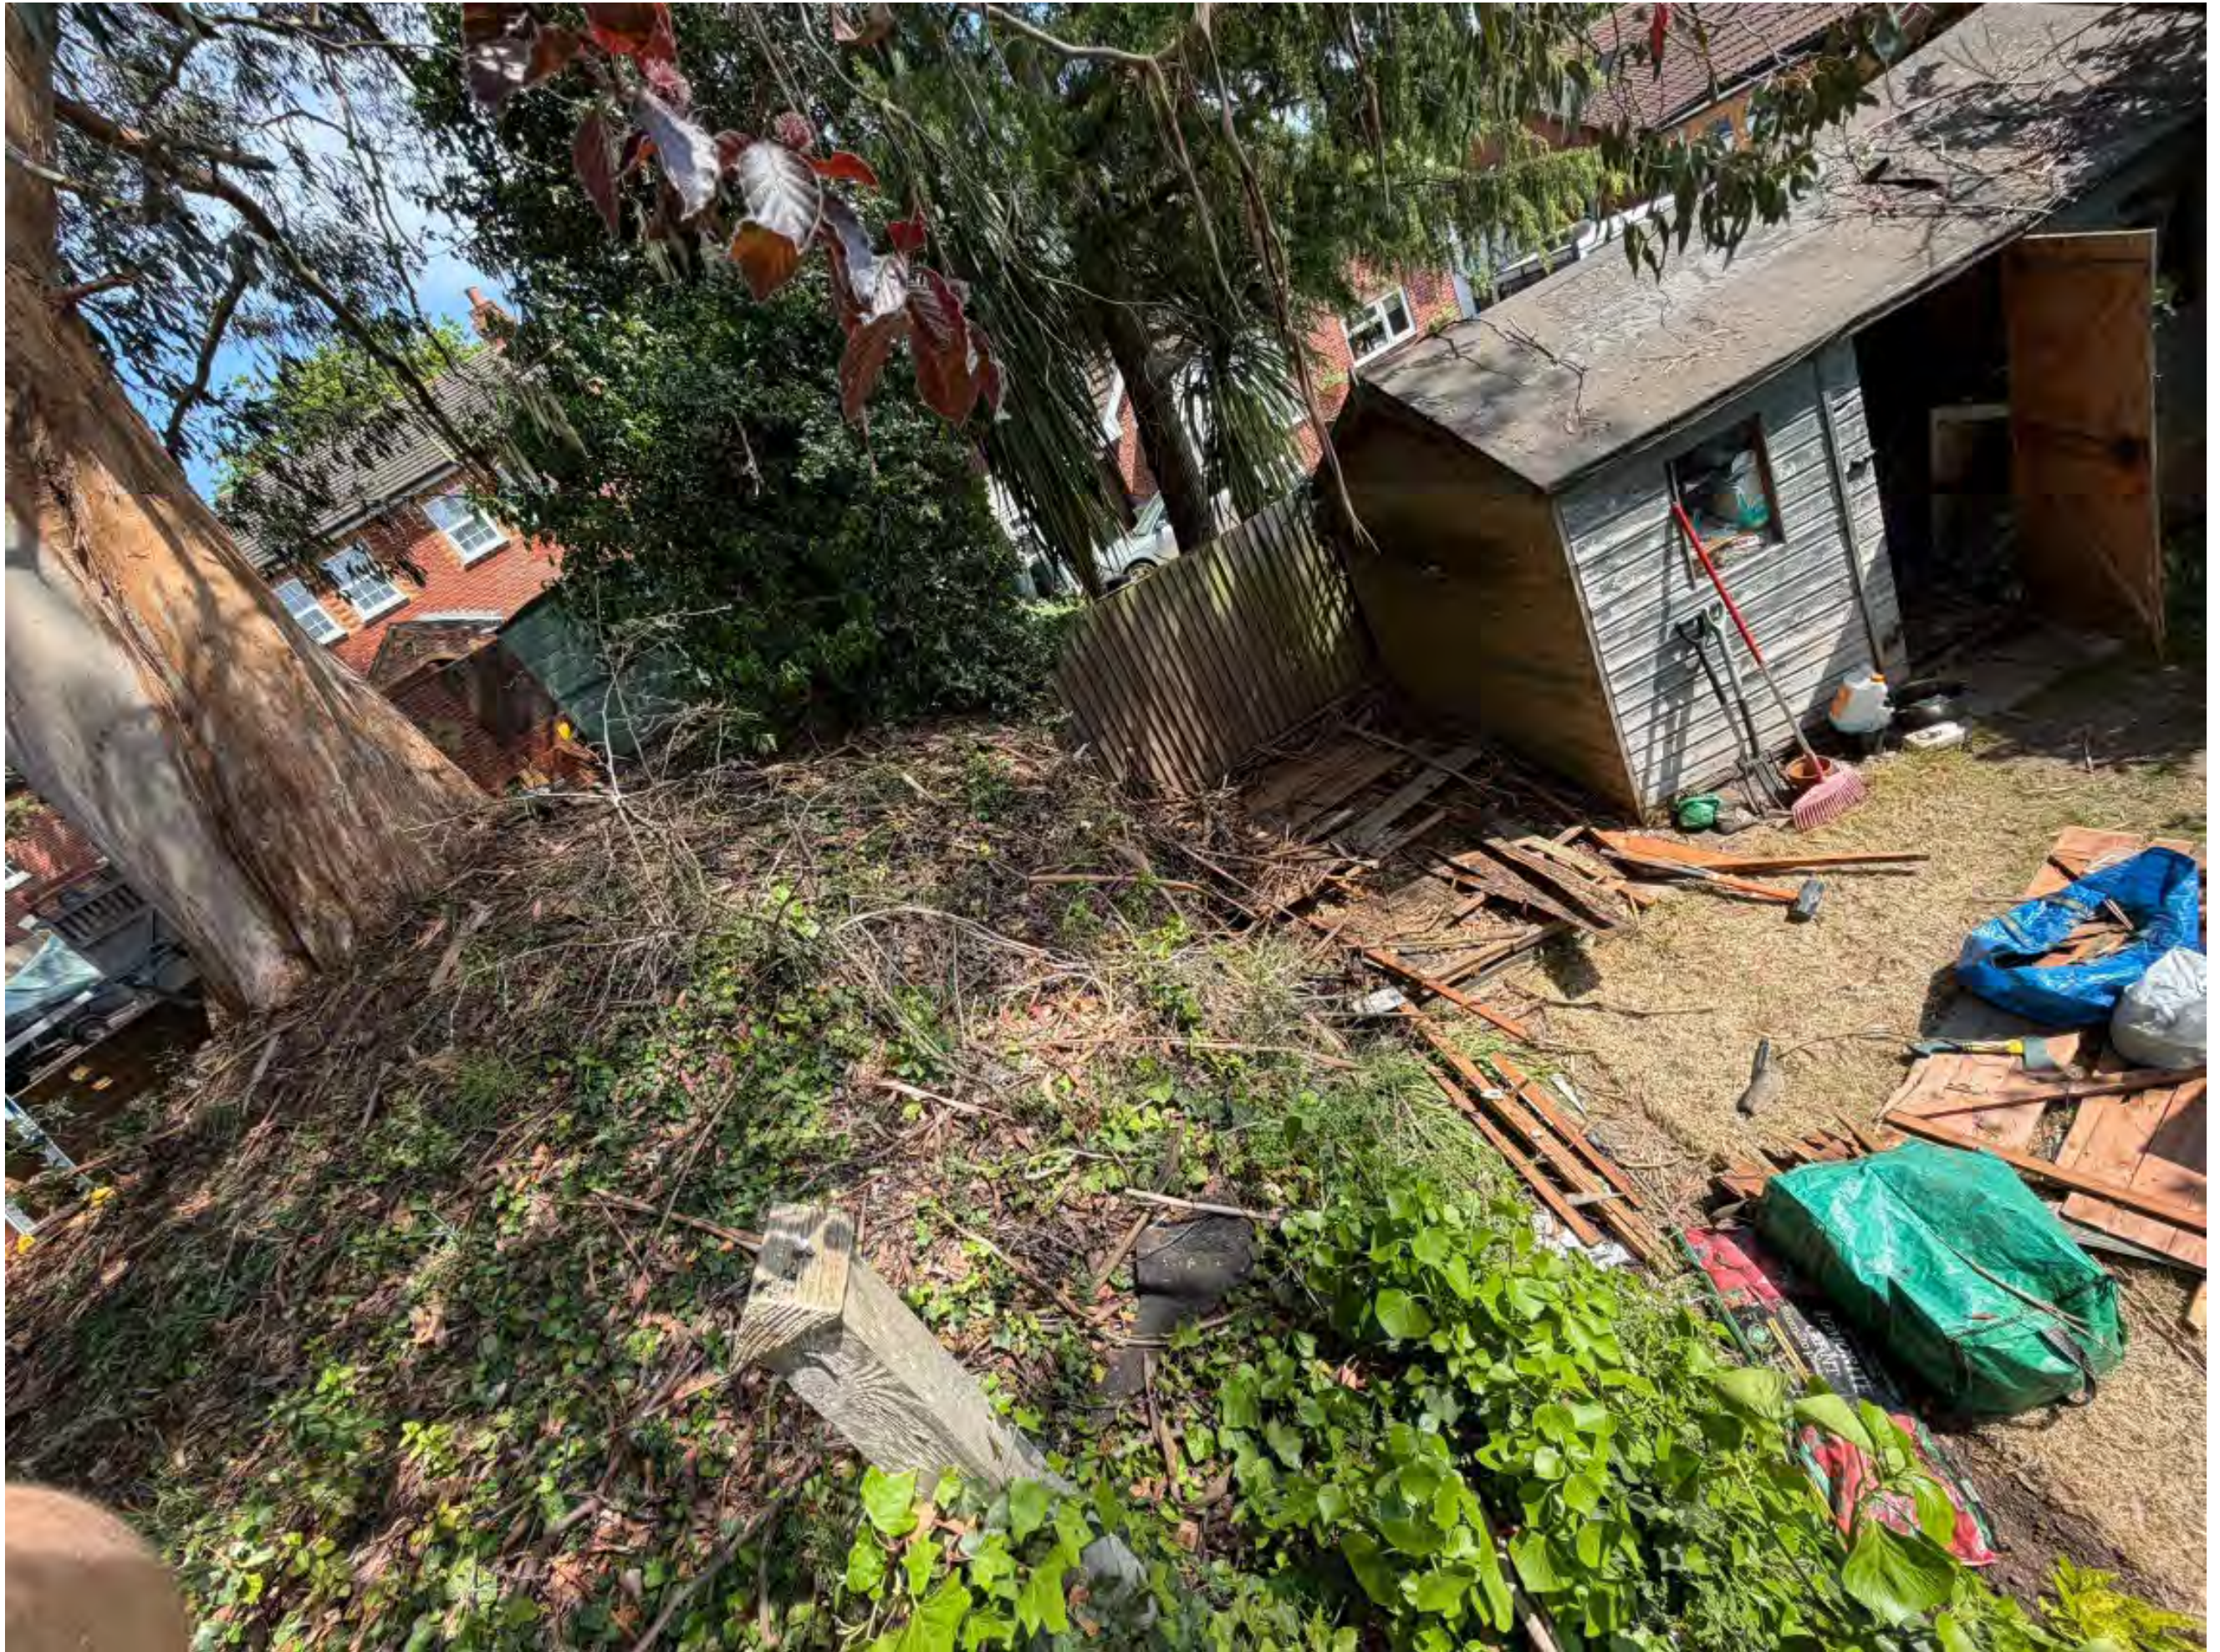
*Image 9: View from within the subject property south-eastward, showing the approximate 3m step-down to the neighbouring property boundary. The retaining wall, which lies out of frame to the right, separates the two levels. The extent of the crown's southward spread over this level.*

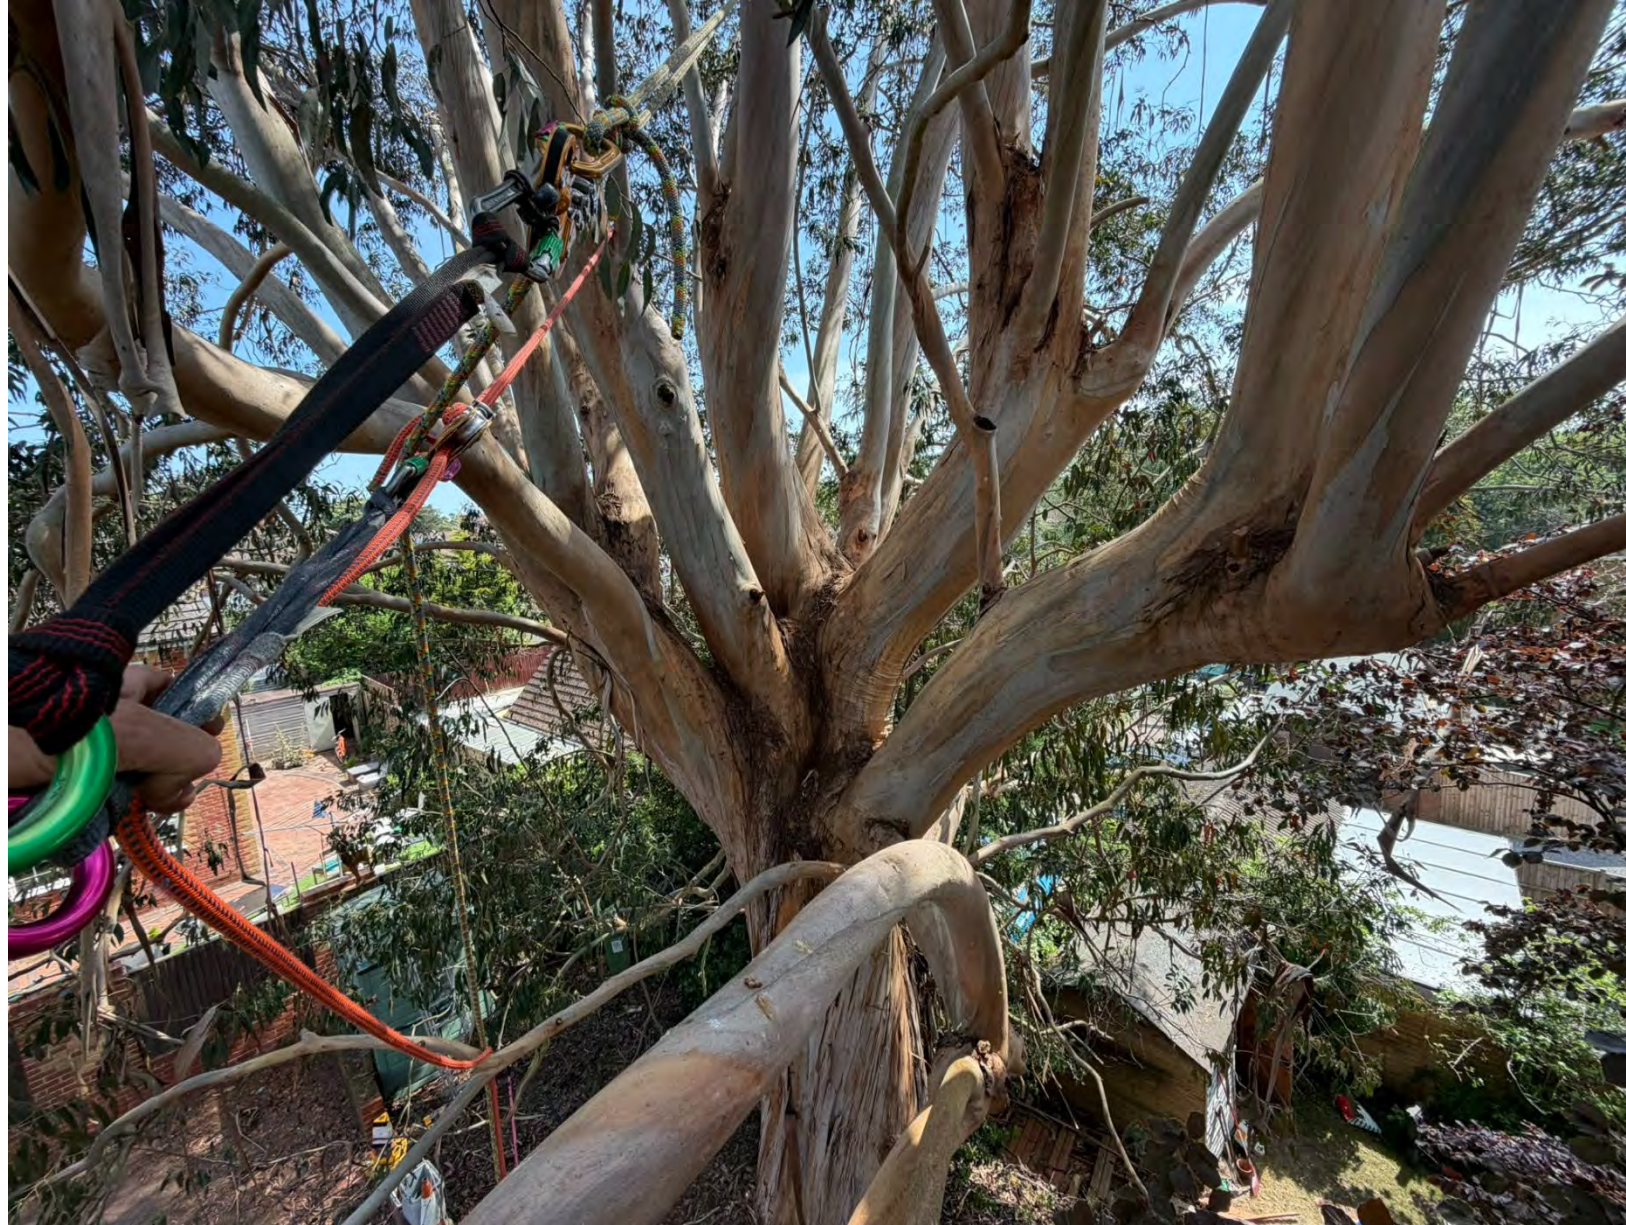
*Image10: Looking at the central multi-stemmed crown structure arising from the union zone is clearly visible, with numerous co-dominant and sub-dominant stems. Dark staining and bark compression at several junctions, and the absence of branch bark ridges, are consistent with compression union morphology at multiple points. Taken from the climbing position at approximately 8m AGL.*

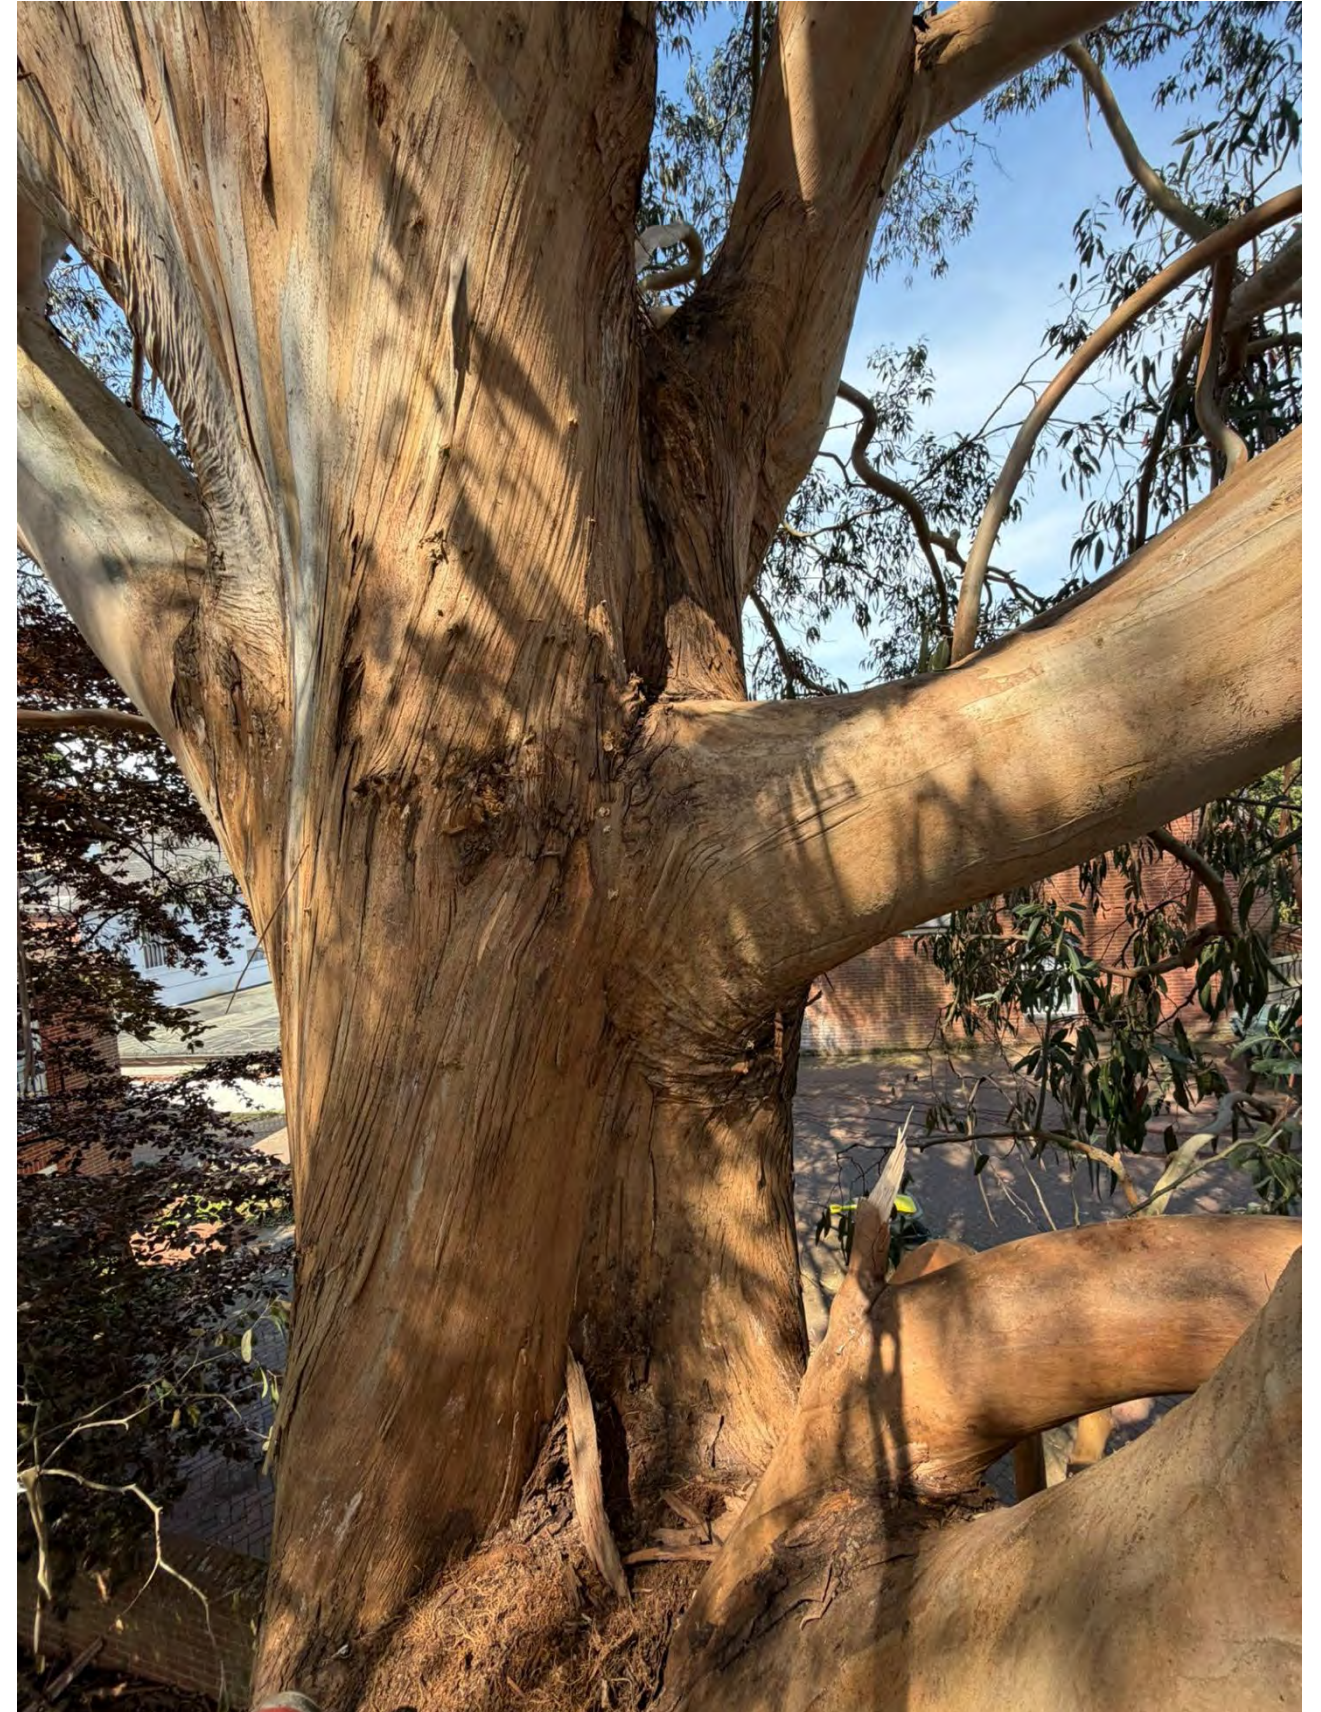
*Image11: Close-range view from the primary SSE aspect, at approximately 5–6m AGL. The SSE limb is visible tracking lower-right. Co-dominant stems, compression unions with fibre buckling is visible.*

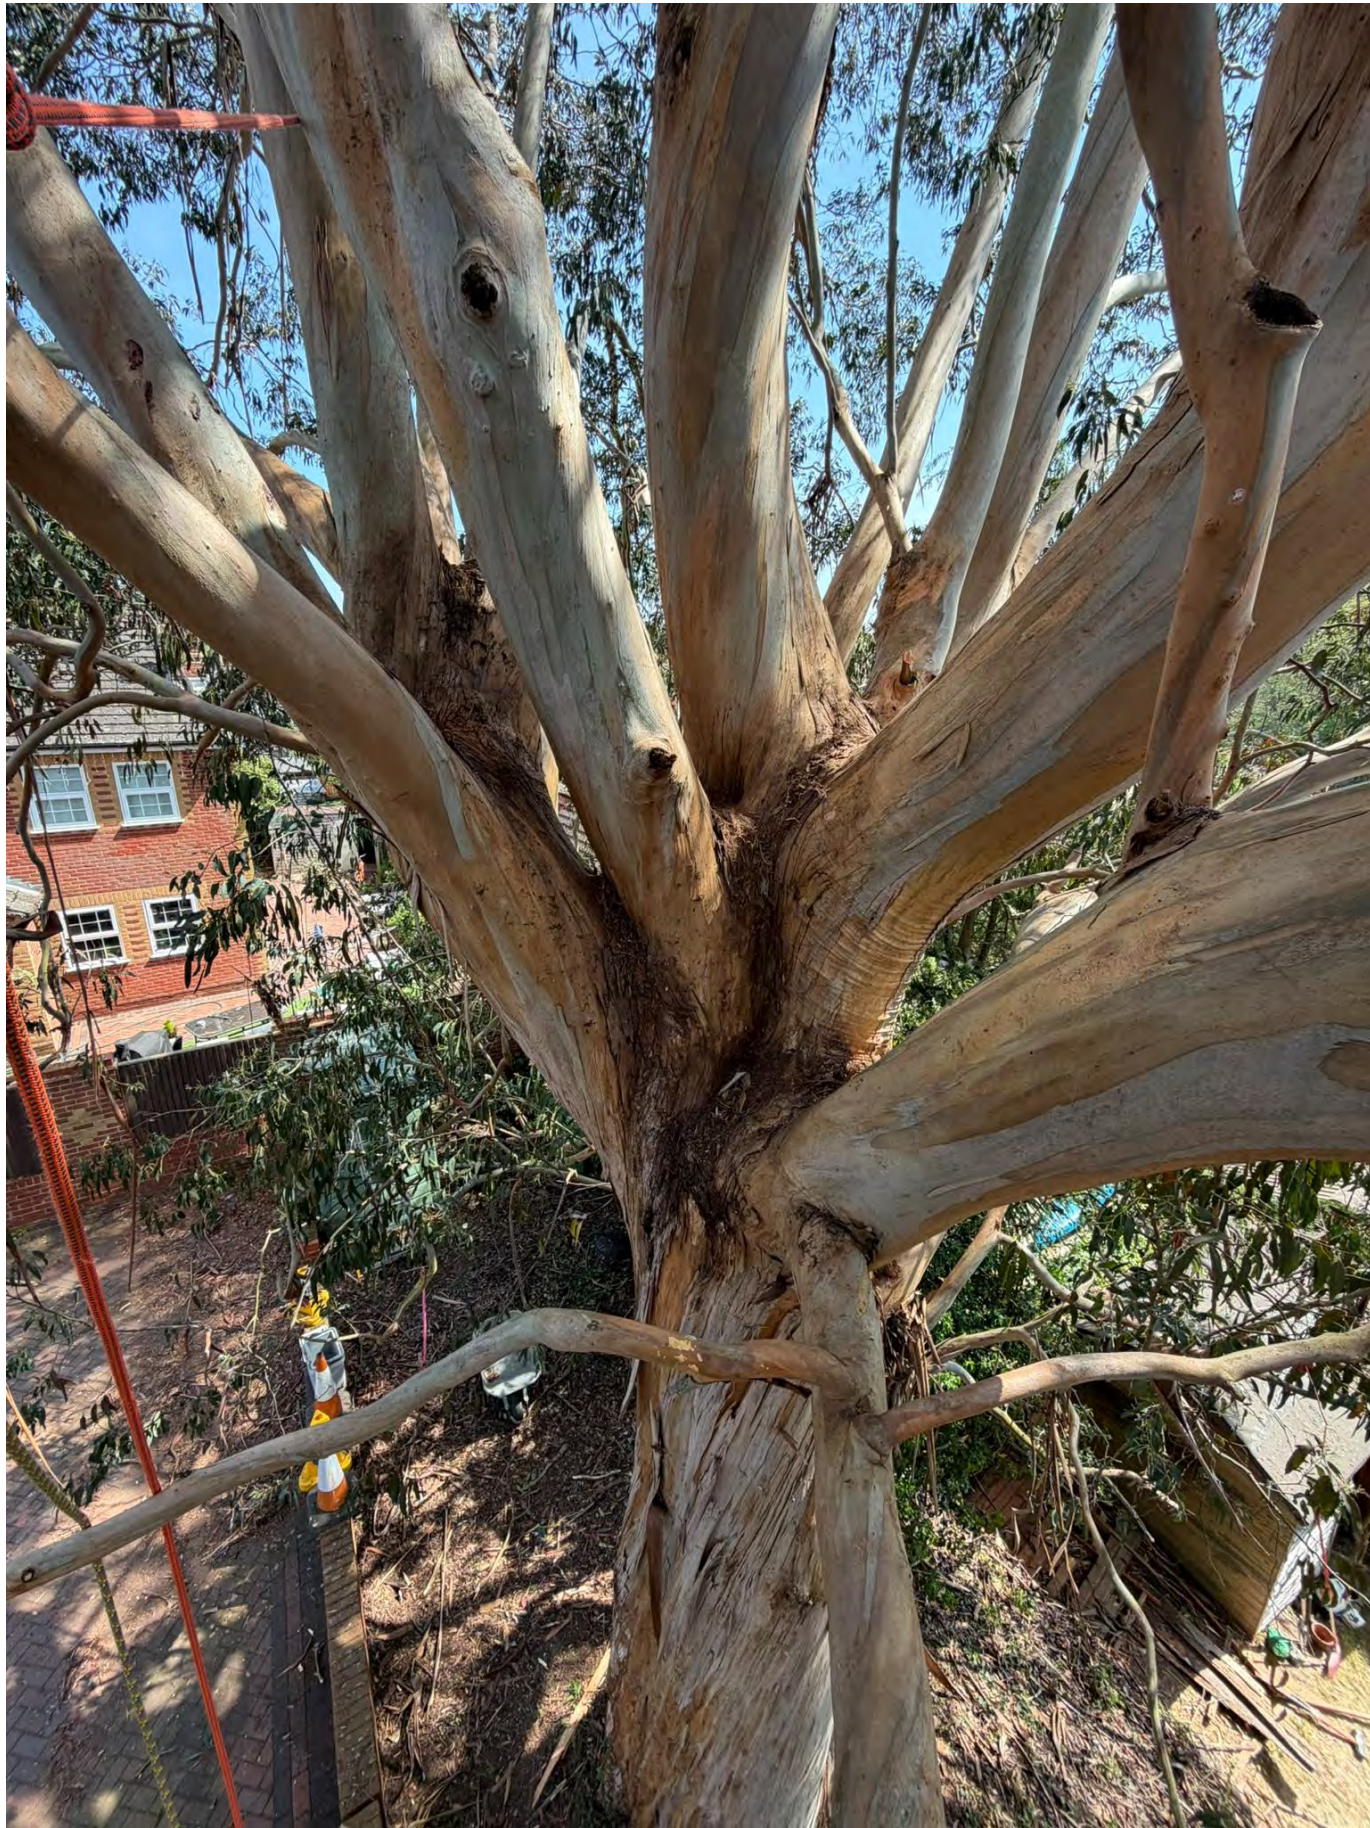
Image 12: Close-range view of upper crown compression union zone at approximately 8–10m AGL. Multiple co-dominant stems visible arising from the historic topping union level. The dark staining and compressed bark, confirms the presence of structurally unintegrated compression unions at this level. Fibre buckling is visible on the underside of several limbs.

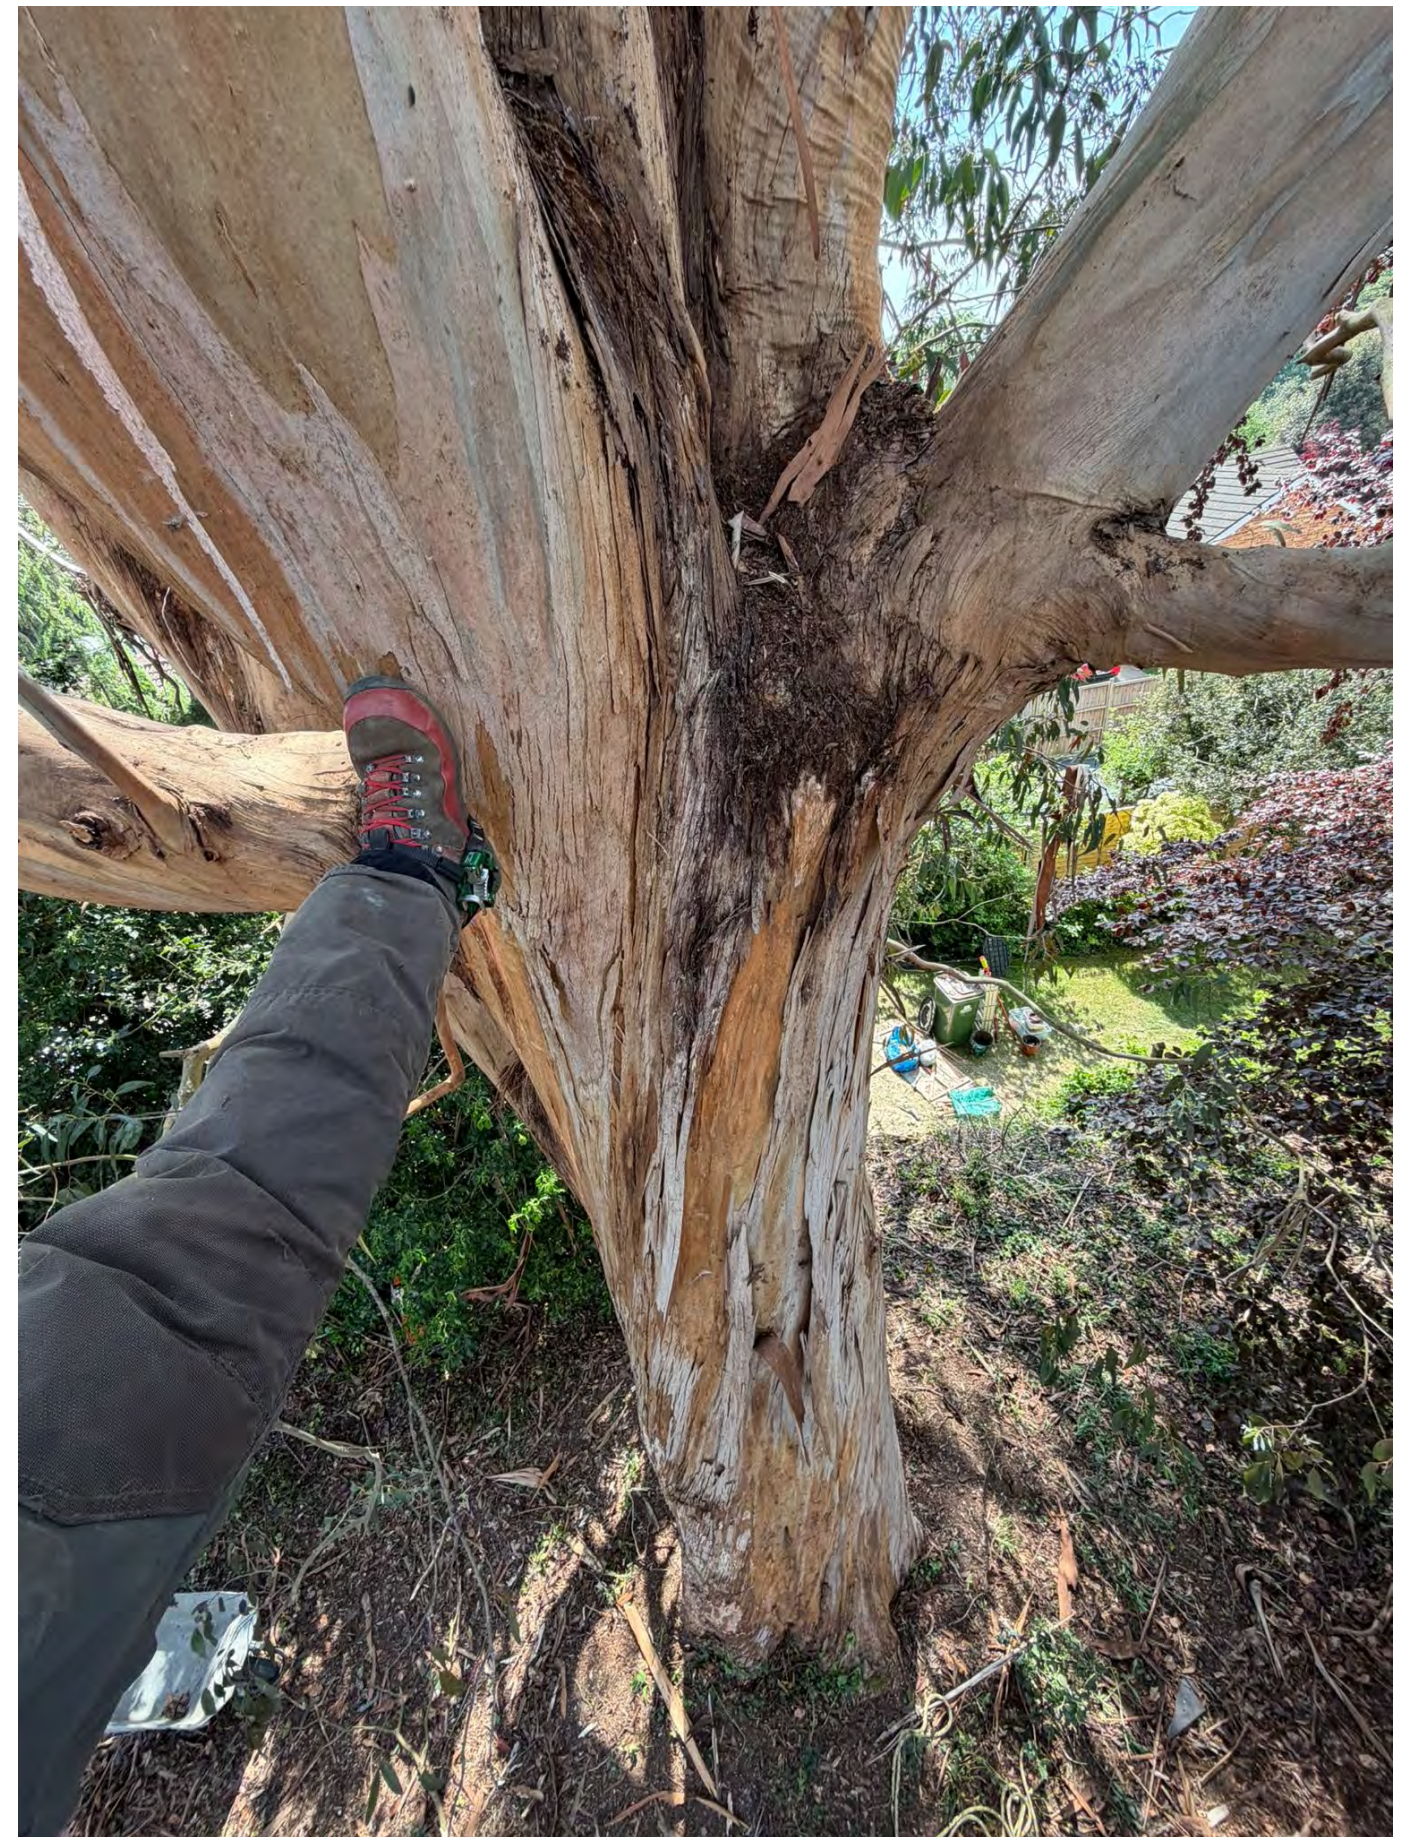
Image 13: Close-range view of the lower union zone at approximately 5–6m AGL showing the condition of the stem between the co-dominant leaders. The boot provides scale. The bark disruption, and darkly stained zone between the stems are clearly visible at this range. The adjacent property no53 garden is visible below in the background.
