## Arboricultural Report

### Internal and Aerial Tree Inspection

**Report Reference:** AR/IATI26-1057

72 VICTORIA ROAD,

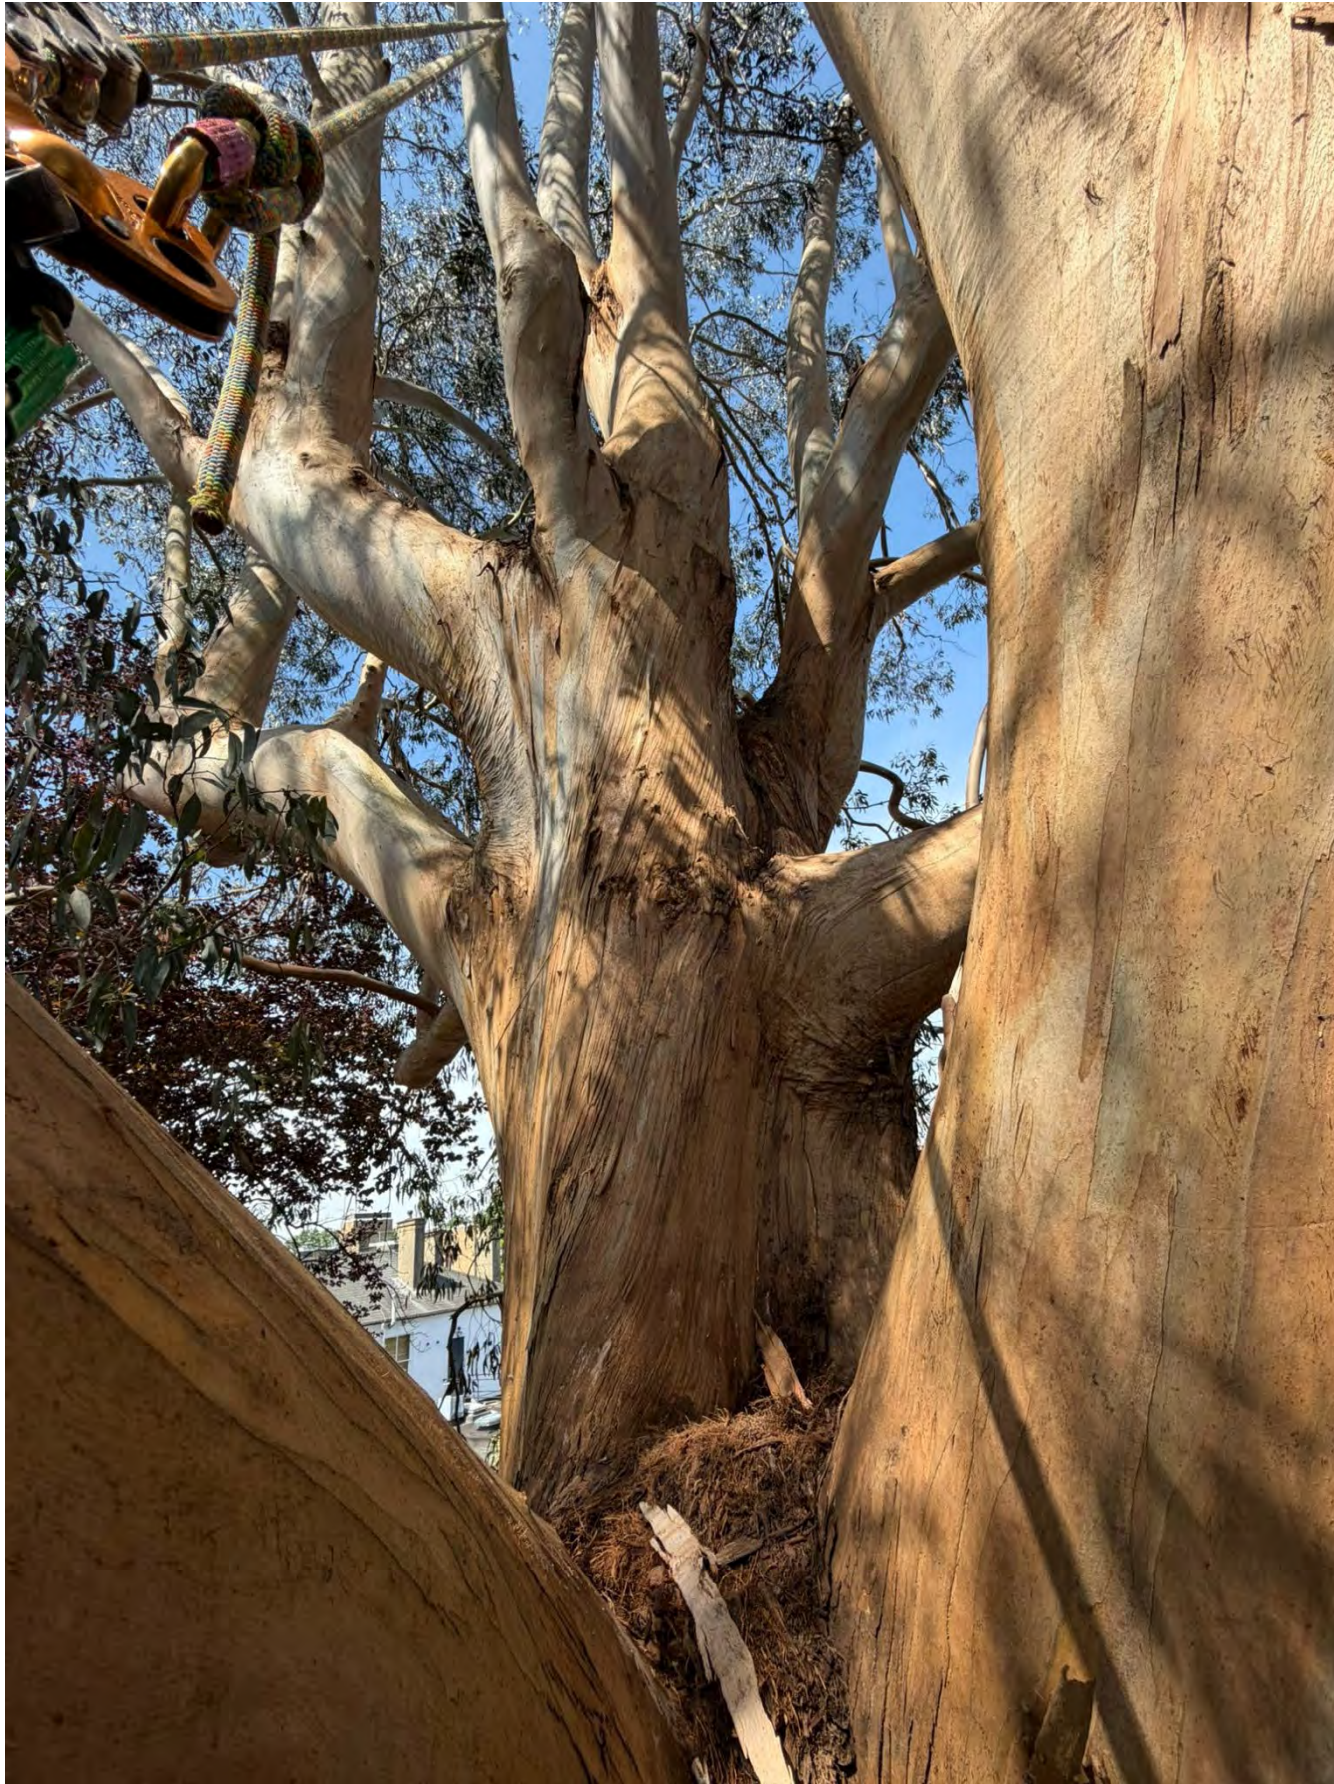
*Image 14: View looking upward through the union zone from approximately 6m AGL, showing the multiple stems arising from the topping union level and the open crown architecture above. The debris accumulated in the union zone (dried bark, detritus) is consistent with the enclosed, compressed nature of the union geometry and is typical of compression unions in Eucalyptus where the stems have grown tightly together from a historic cut margin.*

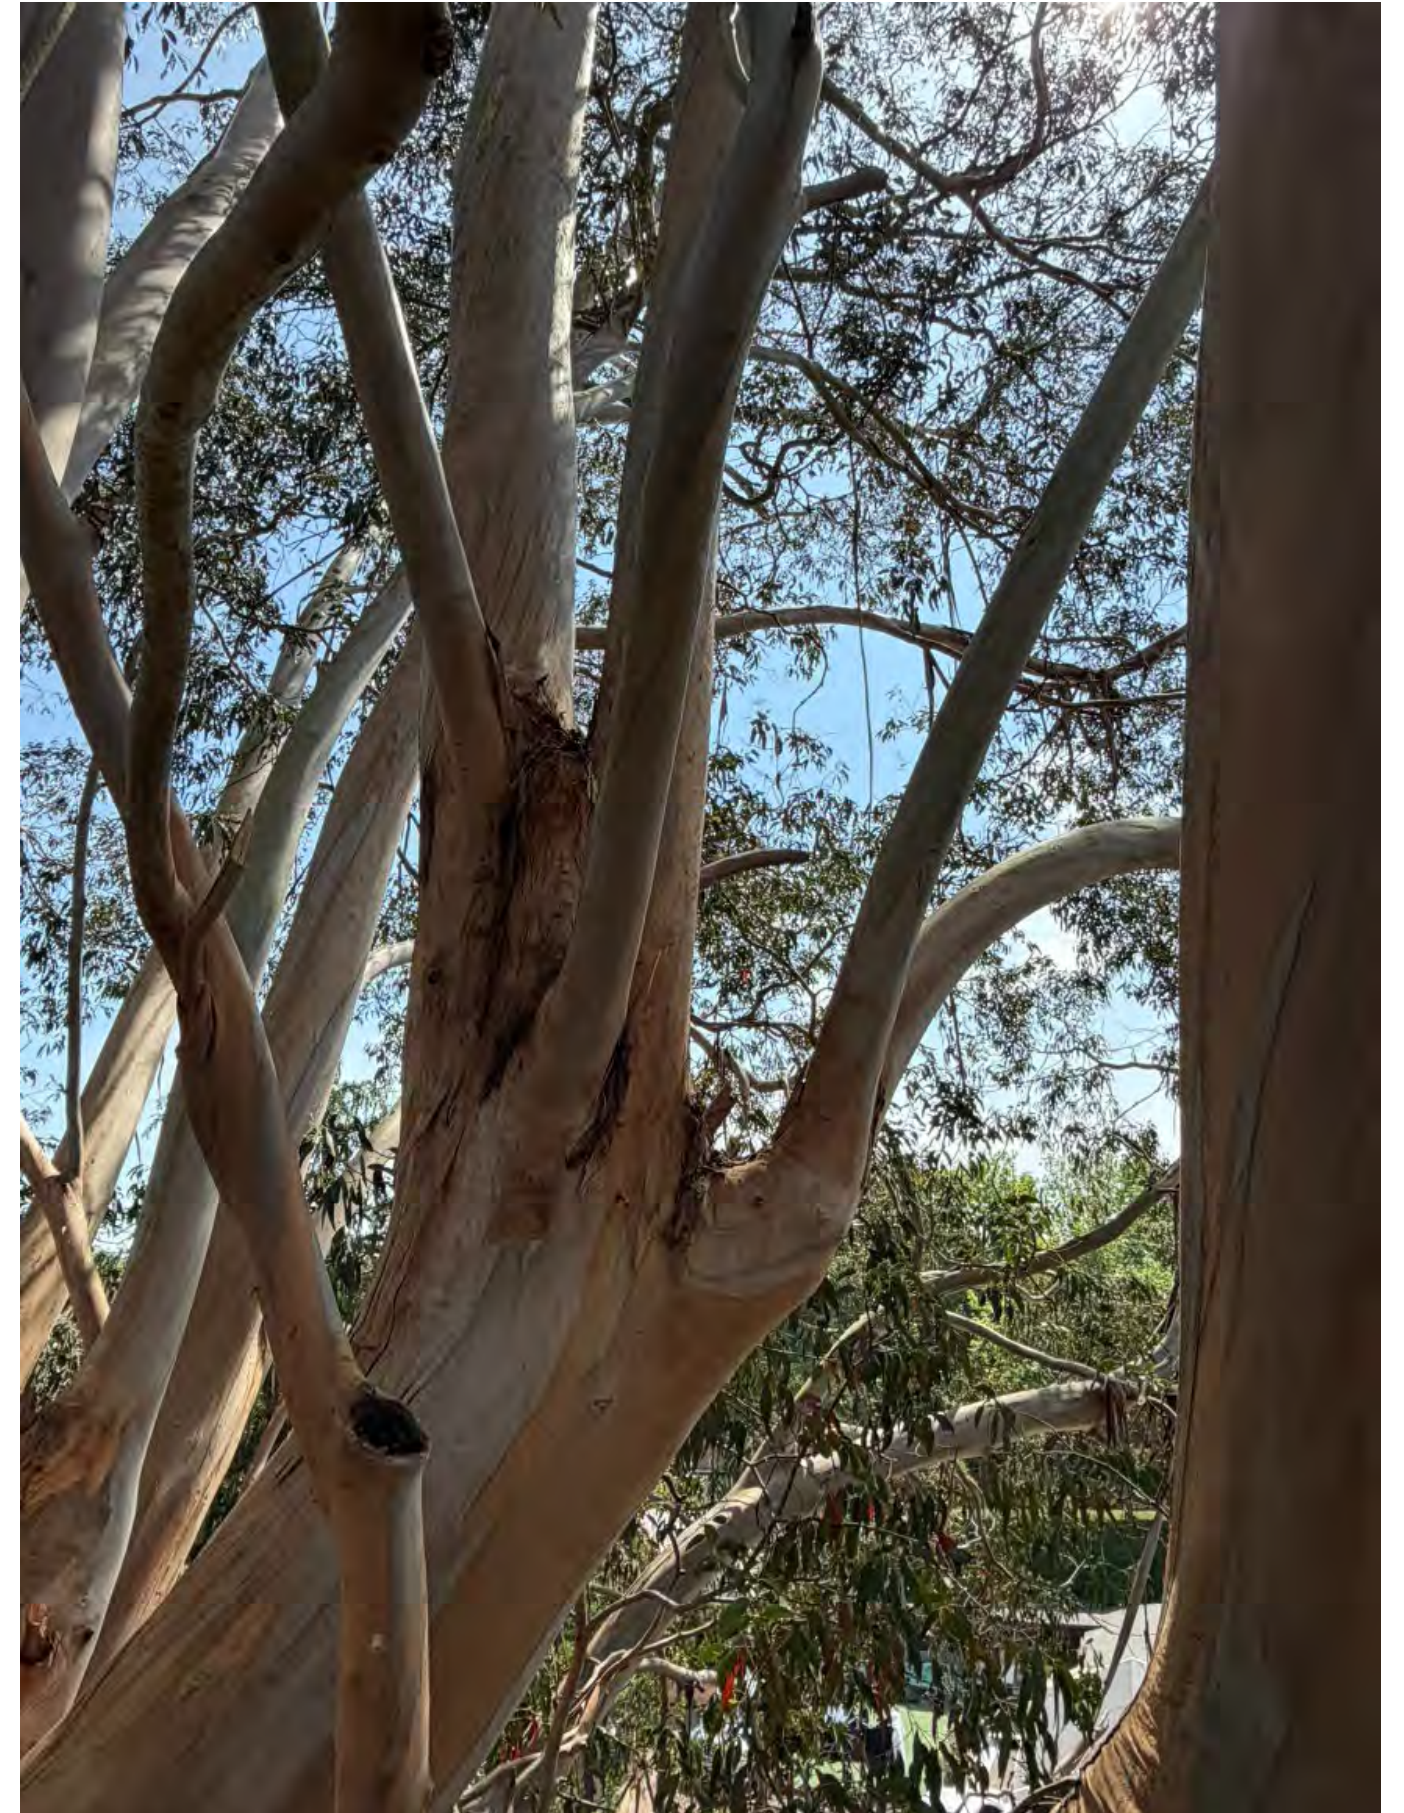
*Image 15: View of mid-upper crown at approximately 10–12m AGL showing multiple sub-dominant stems arising from secondary branching above the topping union zone. Fibre bucking. Dark staining at individual sub-union junctions is visible, confirming compression union morphology is not confined to the primary topping union level but is present at secondary branching points throughout the re-grown crown framework*

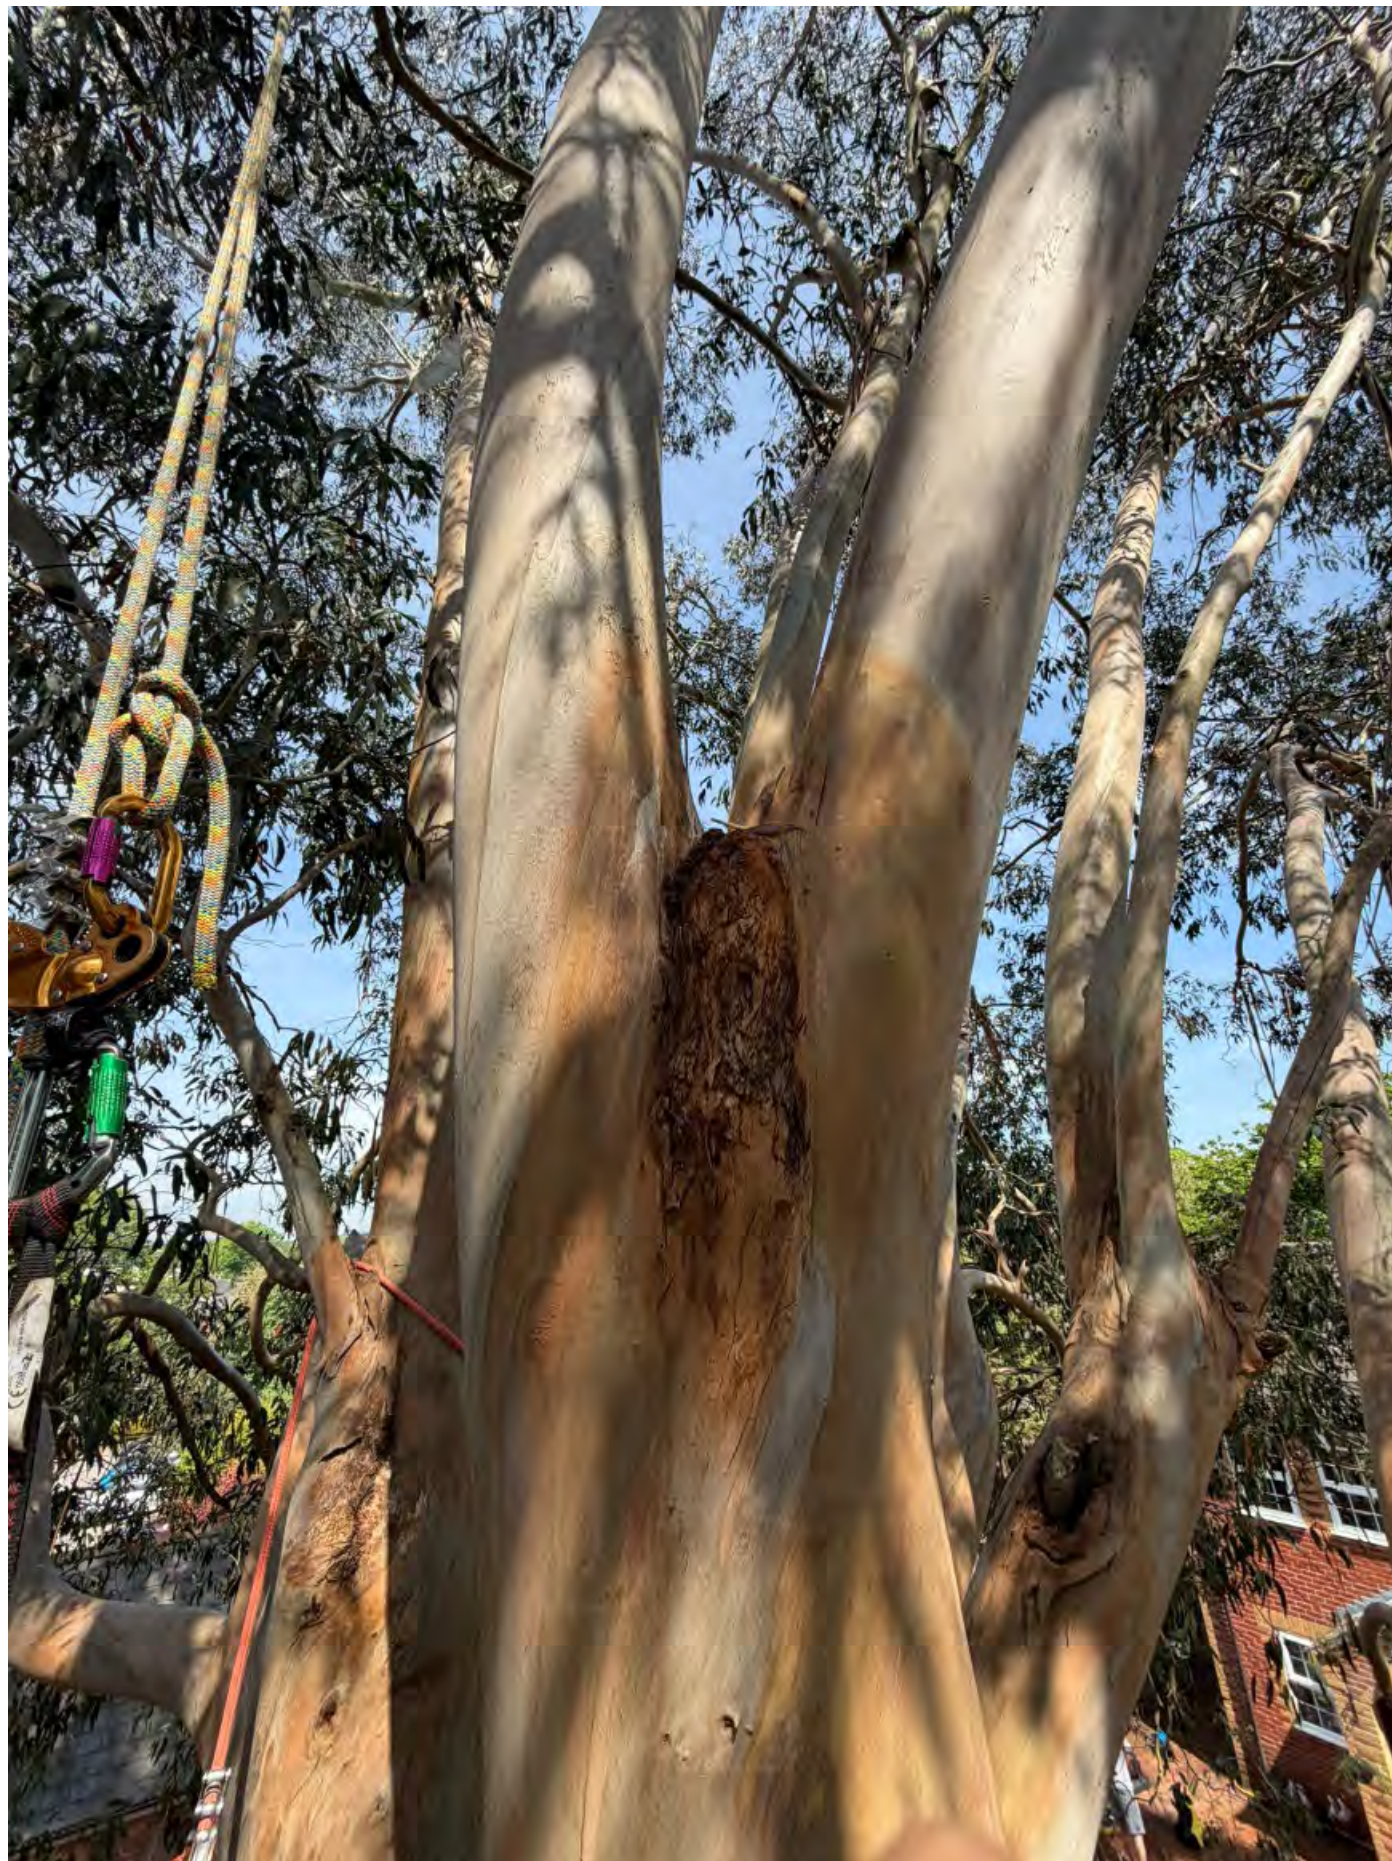
*Image 16: Close-range view of a specific compression union at approximately 8m AGL. The extended, elongated dark-stained zone between two co-dominant stems is clearly visible. The angle of the branch bark ridge and the presence of this staining zone, extending vertically downward from the union, are diagnostic of a compression union in which bark has been occluded between the stems under prolonged compressive loading.*

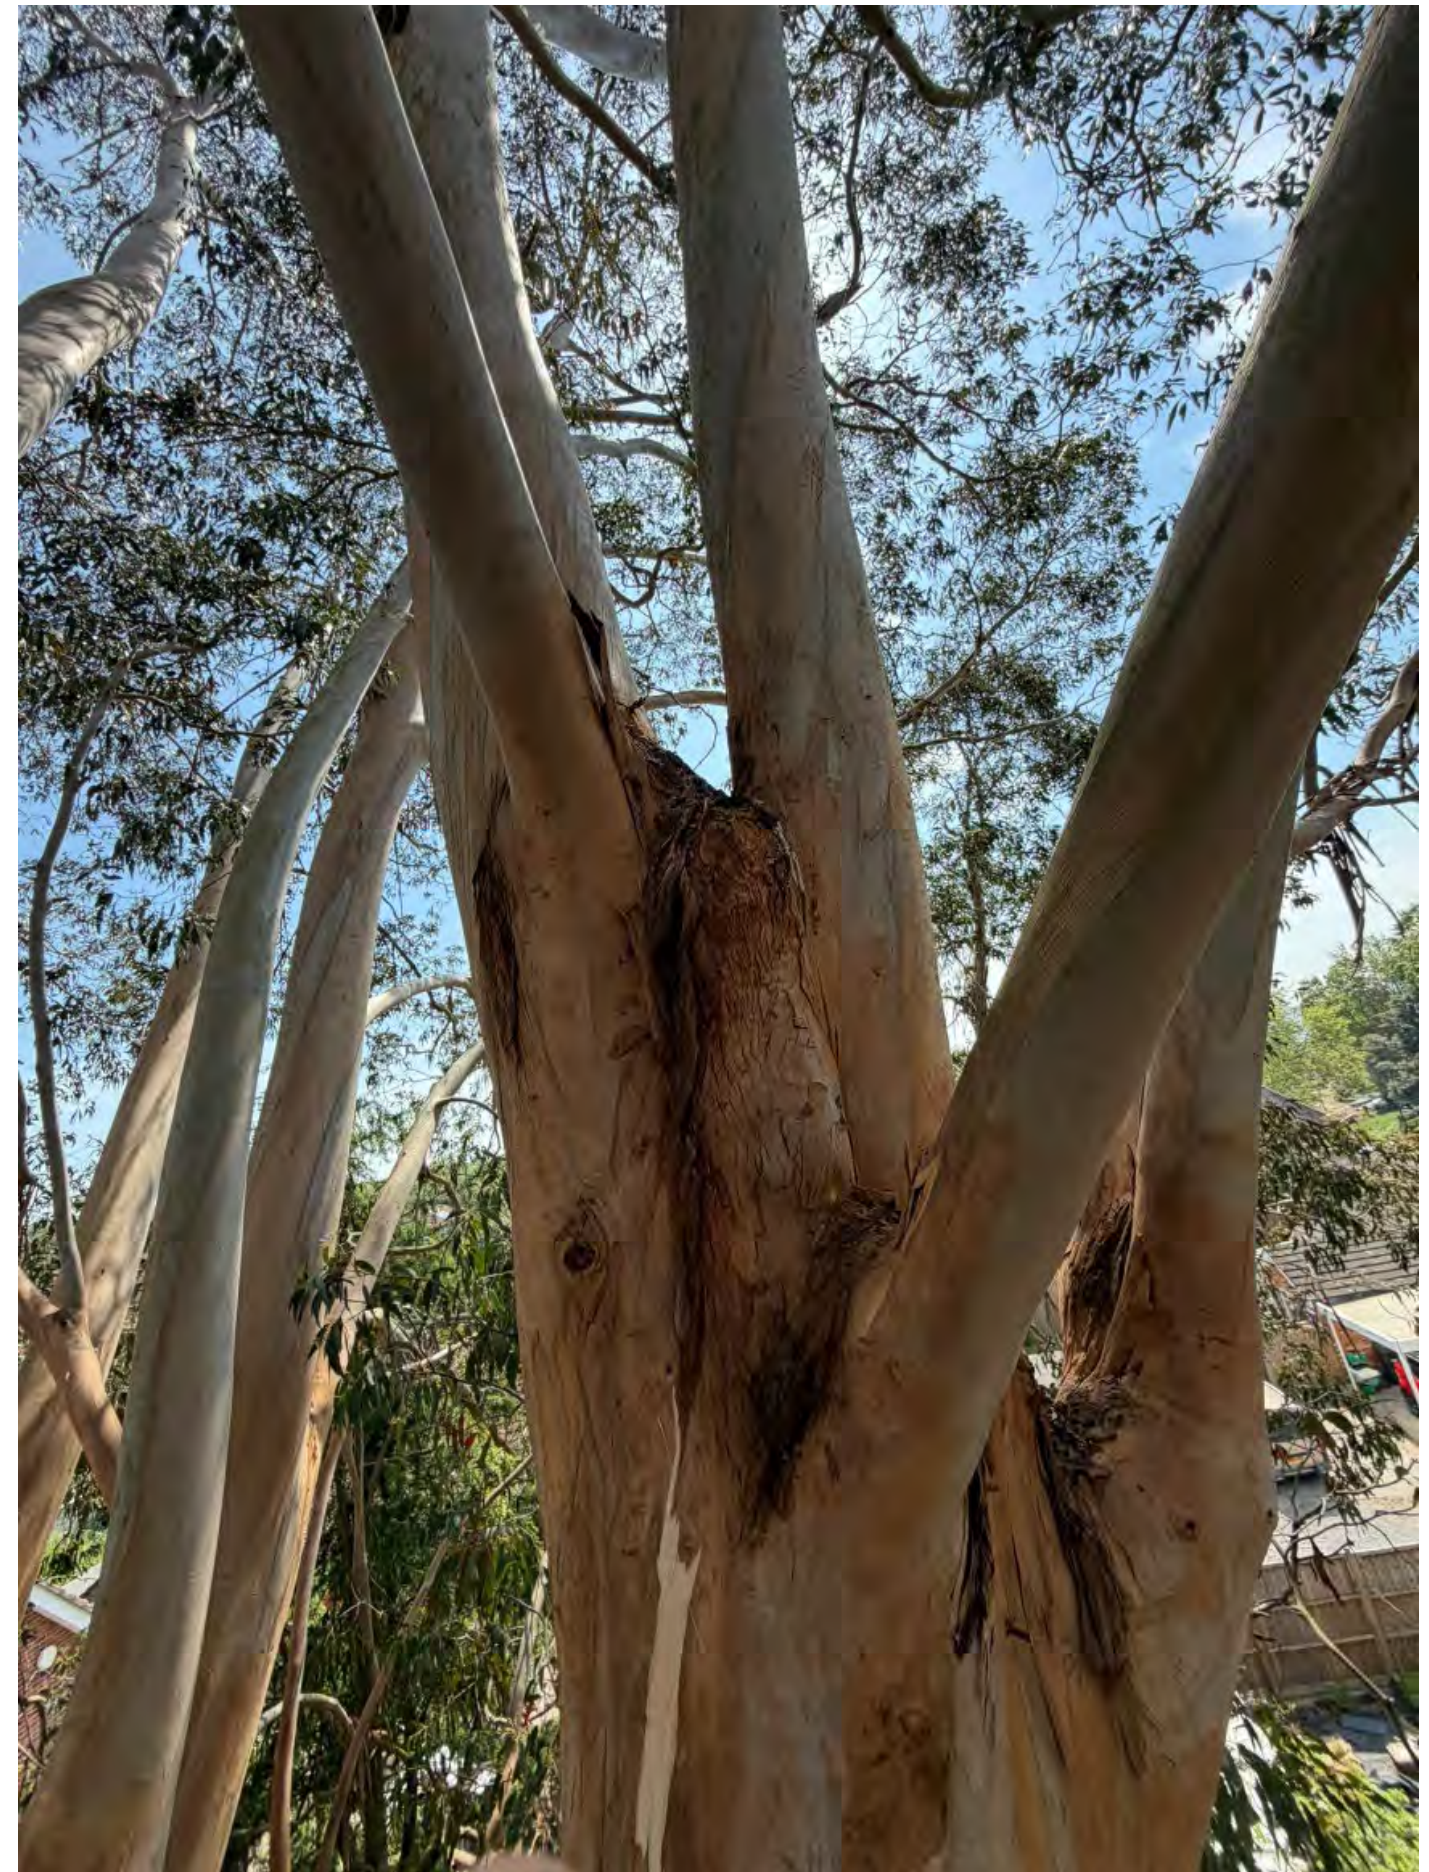
*Image 17: Further close-range view of compression union zones at approximately 8–10m AGL. Two separate dark-stained compression zones are visible between three co-dominant stems, with the characteristic elongated staining pattern running vertically below each union.*

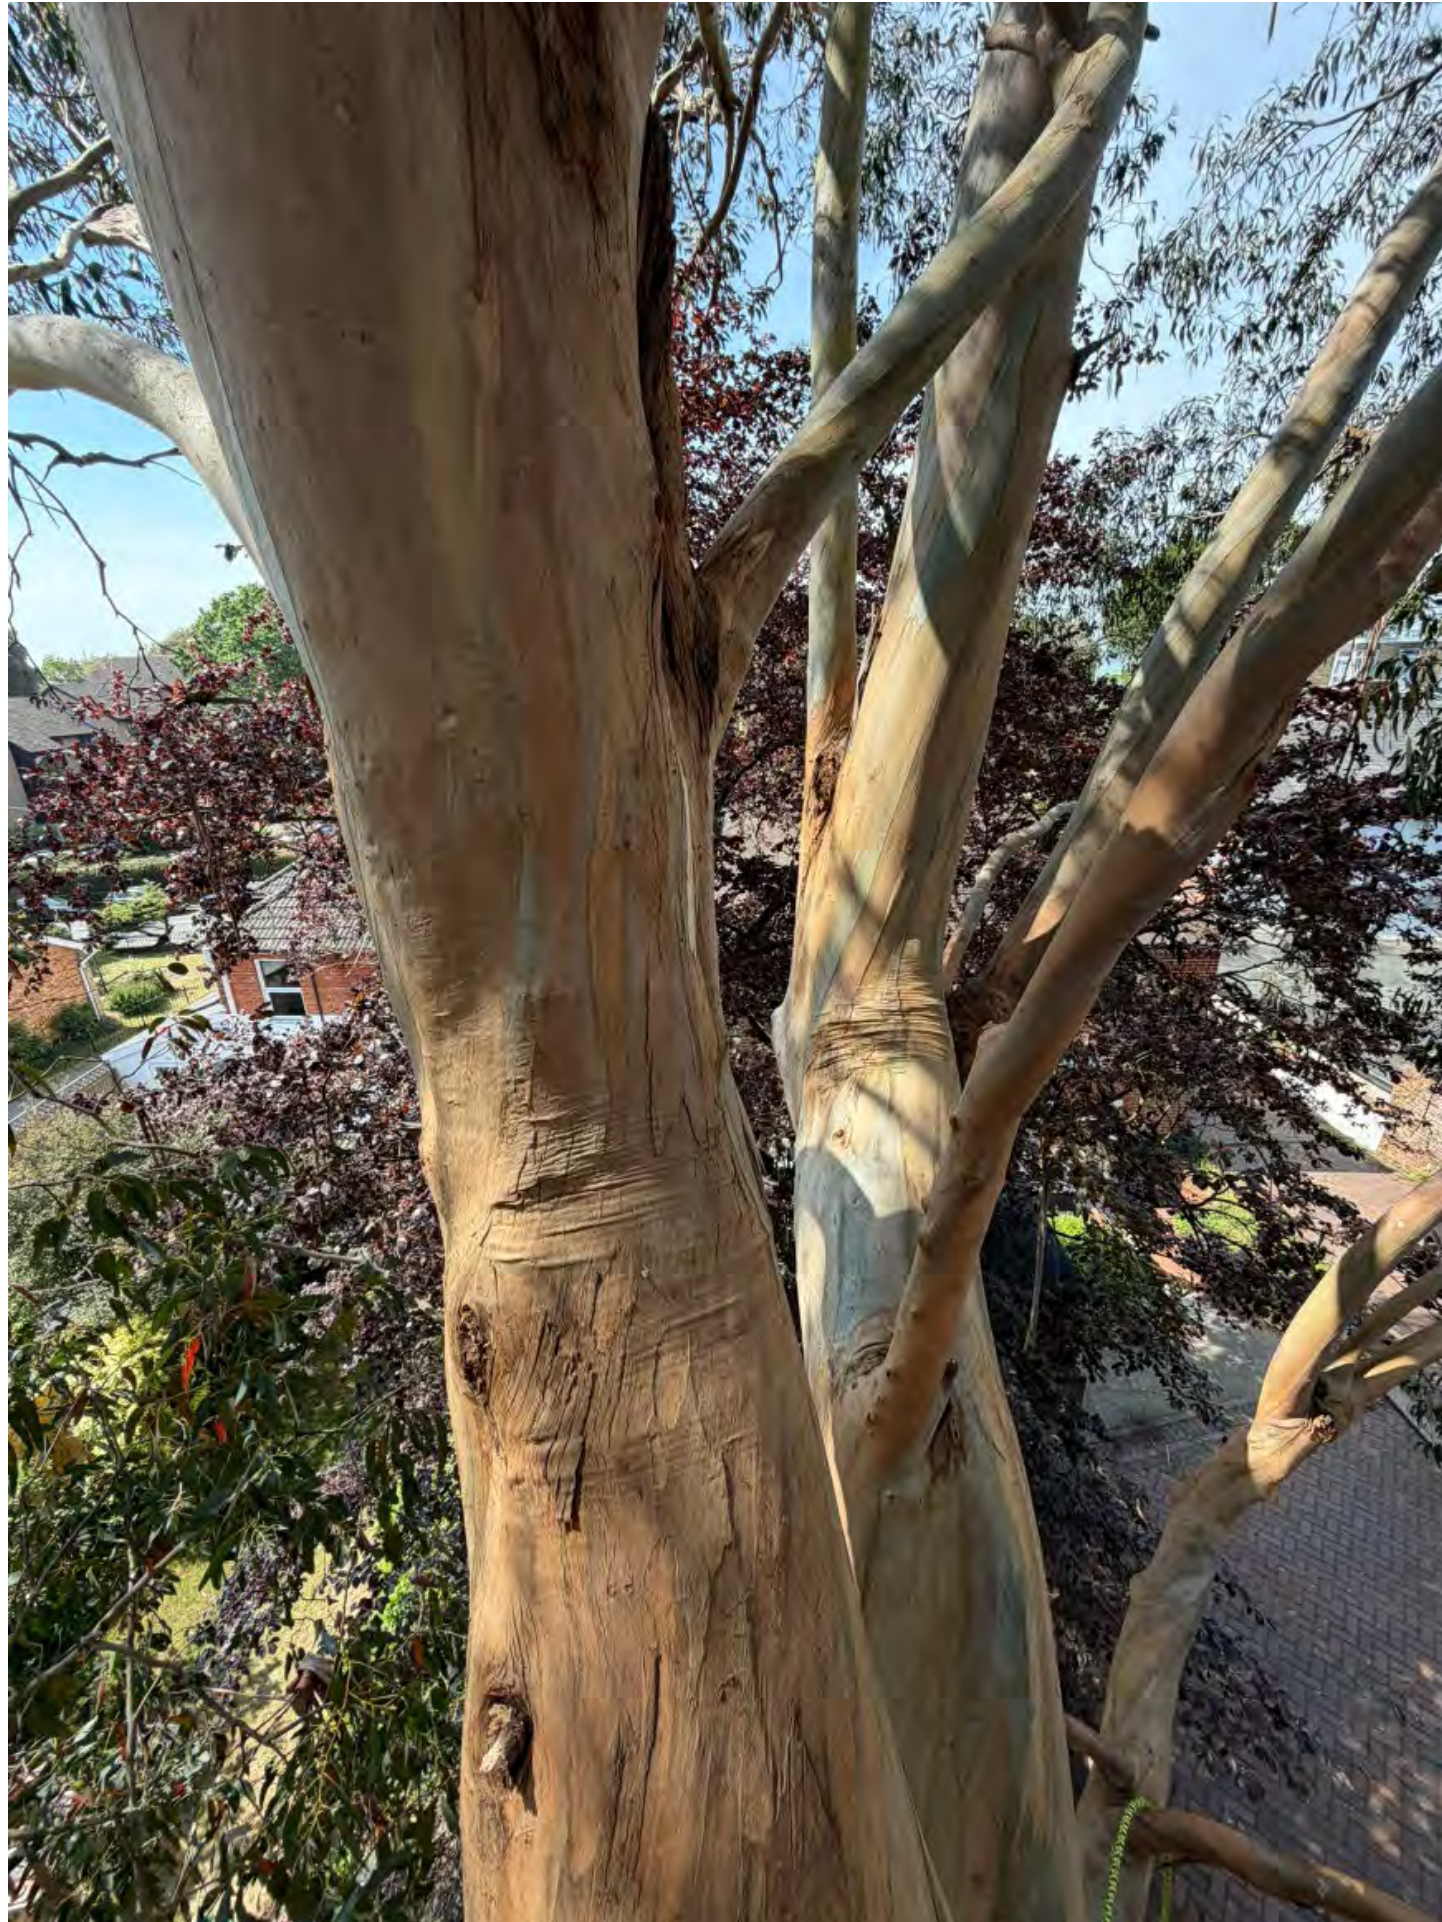
Image 18: Aerial view of the mid-stem at approximately 7-8m AGL showing fibre buckling

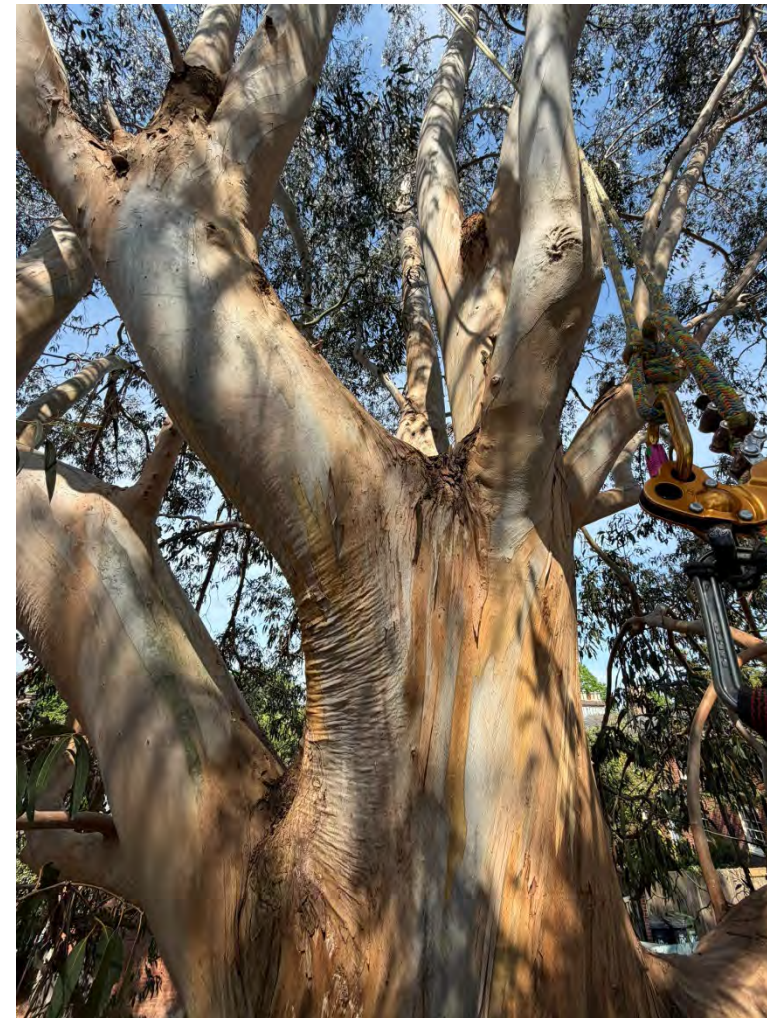
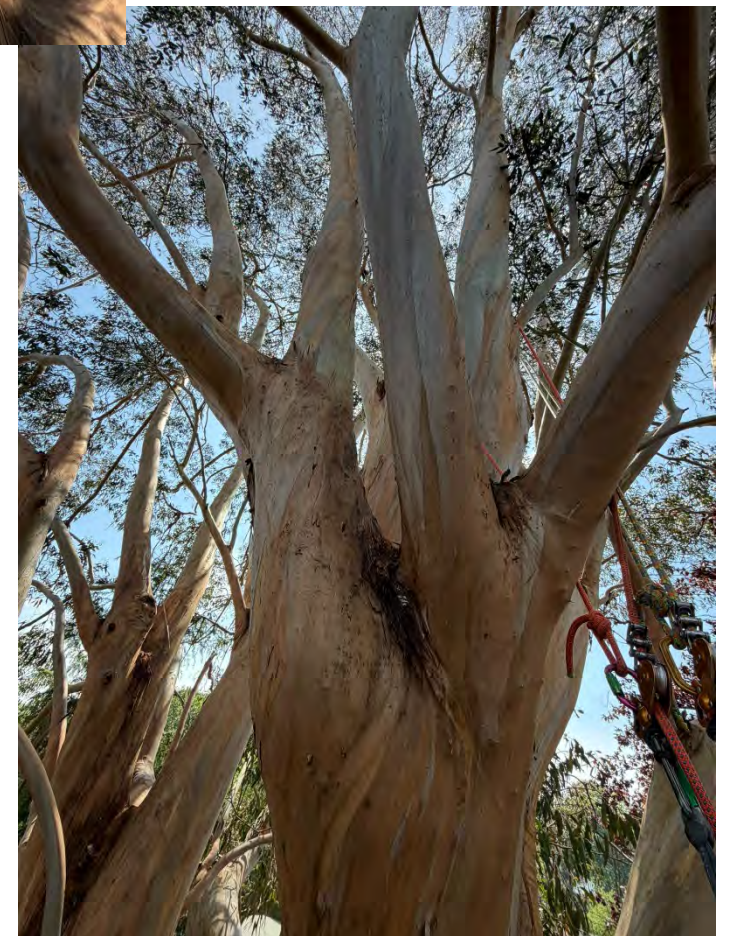
Image 19 & 20: Close-range view of compression unions, fibre buckling at approximately 6-7m AGL from the aerial inspection position.

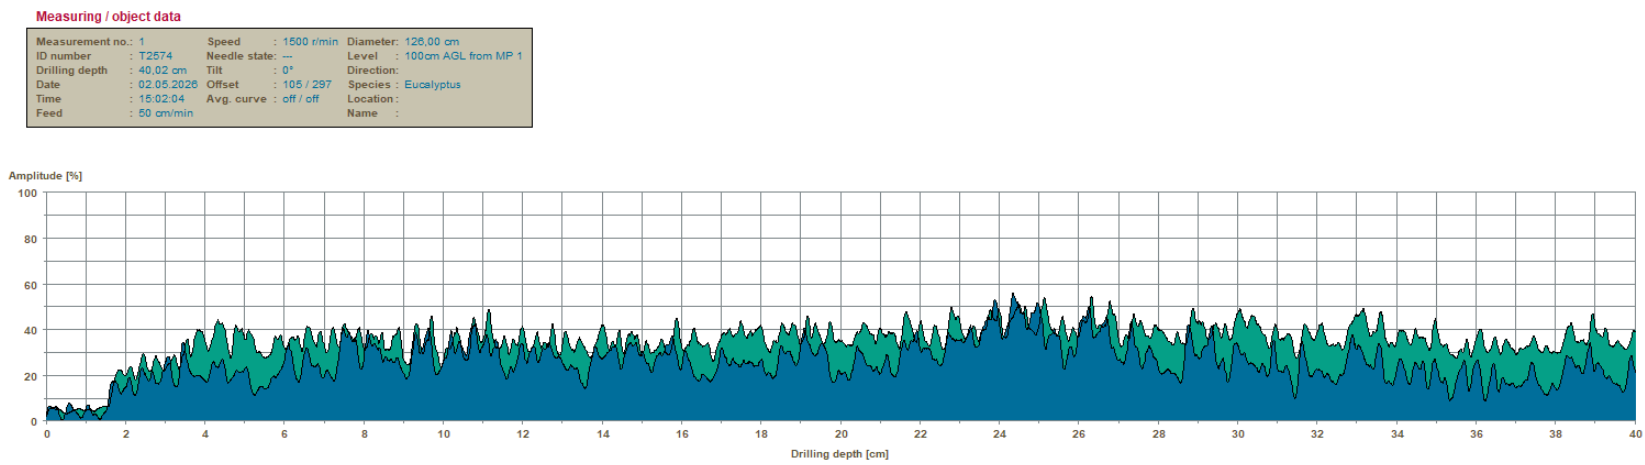
E2.1 Figure F1: Measurement 1(Reference Drill) — 100cm AGL, up from MP 1 | Date: 02.05.2026 | Diameter: 126.00cm

The drilling curve showed a short low-amplitude zone in the outer 1.5cm, consistent with the bark transition, followed by sustained, fluctuating amplitude to the full 40cm drilled depth, consistent with sound wood. This measurement was taken at a height not coincident with either tomographic measuring plane, and is presented as an independent reference finding.

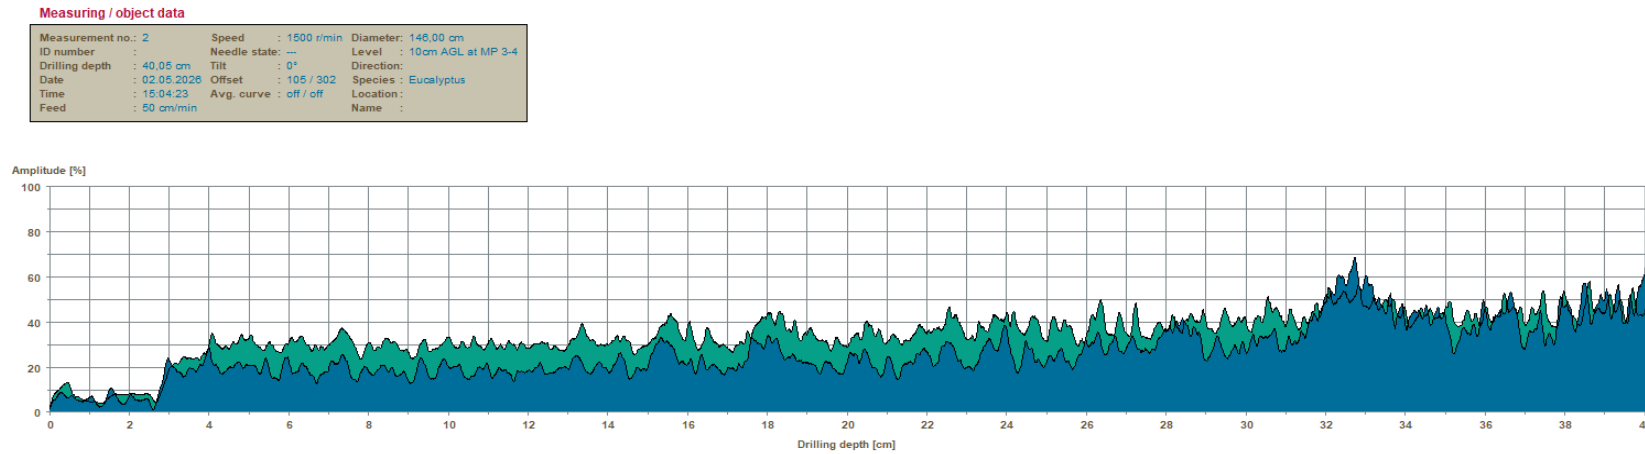
E2.2 Figure F2: Measurement 2 — 10cm AGL, at MP 3-4 | Date: 02.05.2026 | Diameter: 146.00cm

A short low-amplitude zone was recorded in the outer 0-2cm, consistent with the bark transition, followed by sustained, fluctuating amplitude to the full 40cm drilled depth, consistent with sound wood. A gradual increase in amplitude was noted in the latter third of the trace.

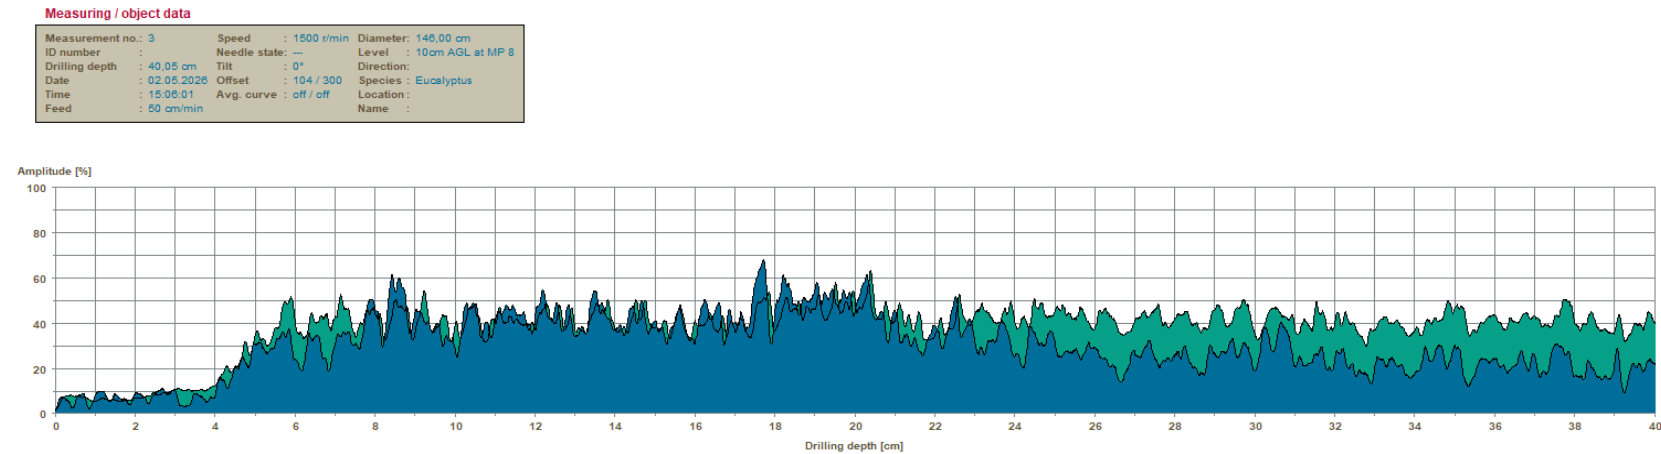
A short low-amplitude zone was recorded in the outer 0–4cm, consistent with the bark transition, followed by sustained, fluctuating amplitude up to 17cm. A discrete elevated zone was recorded at approximately 17–20.5cm, characterised by a brief spike of elevated resistance followed by a stepped reduction in amplitude. This feature is assessed as consistent with a localised inclusion or density discontinuity rather than the progressive, sustained reduction indicative of active decay, and is interpreted in the context of the SoT1 and ERT1 findings at this plane: MP 8 flanks the zone of abrupt sound barriers identified by SoT1 between MPs 9 and 13, and the measurement curve finding at this point is accordingly treated as a significant corroborative finding rather than a standalone diagnostic conclusion.

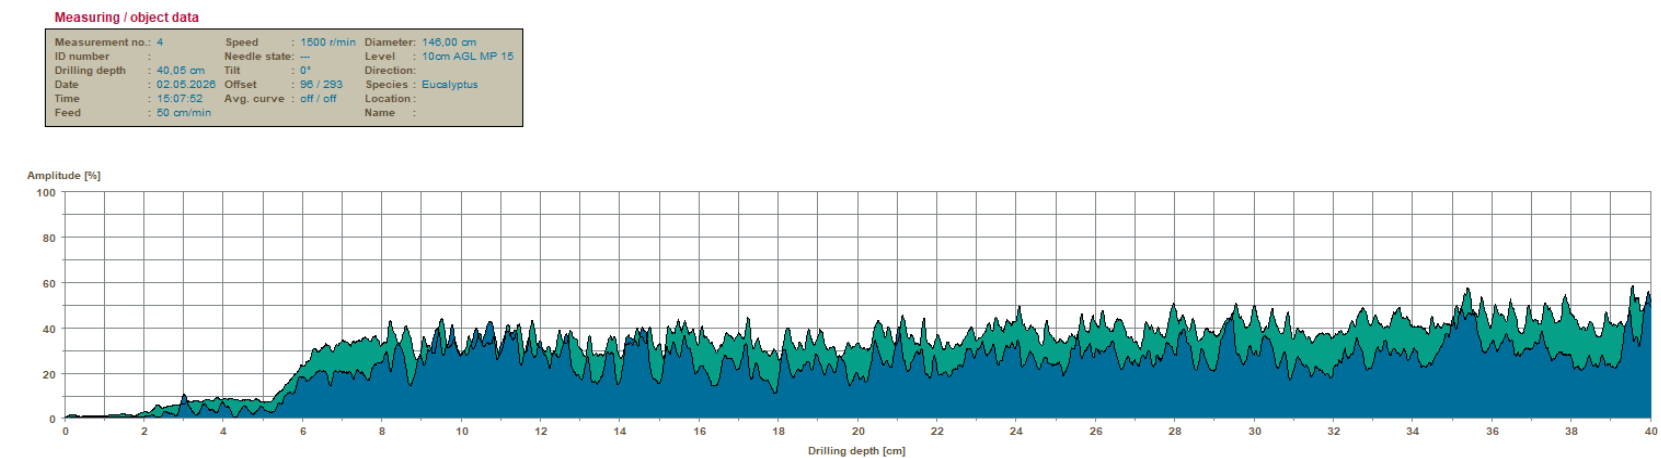
E2.4 Figure F4: Measurement 4 — 10cm AGL, at MP 15 | Date: 02.05.2026 | Diameter: 146.00cm

A short low-amplitude zone was recorded in the outer 0–5cm, consistent with the bark transition, followed by sustained, fluctuating amplitude to the full 40cm drilled depth, consistent with sound wood. MP 15 flanks the zone of abrupt sound barriers and the extended outer low-amplitude zone at this point is consistent with the evidence in SoT1 and ERT1. This finding is accordingly assessed as a significant corroborative finding on the opposite flank of the defect.

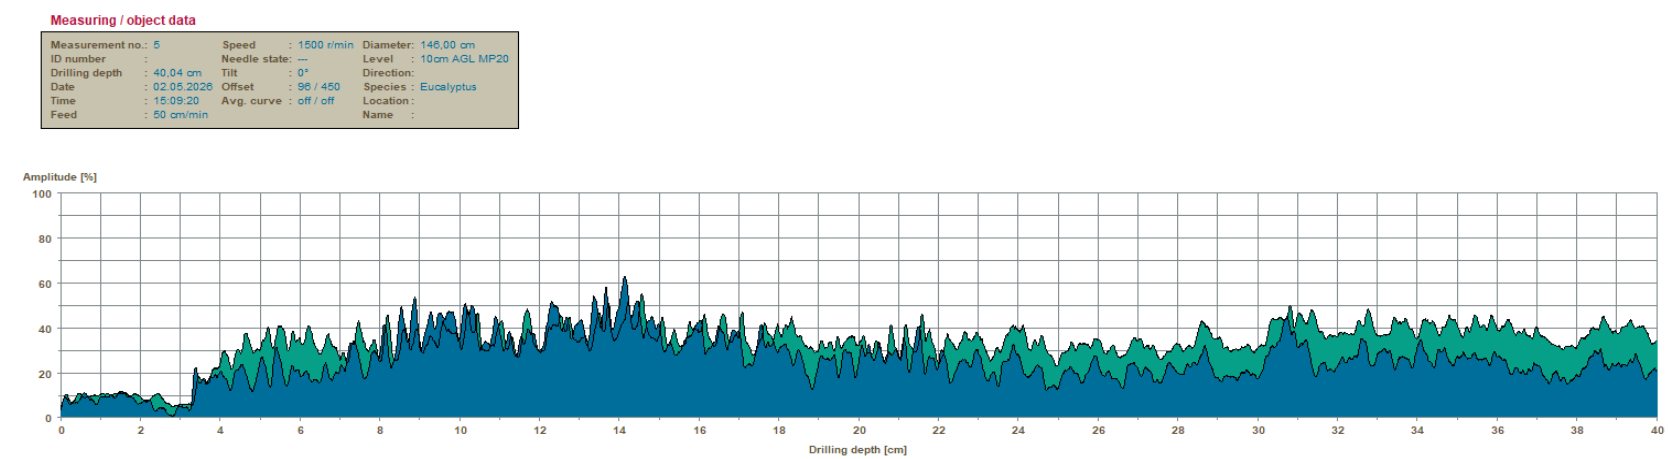
E2.5 Figure F5: Measurement 5 — 10cm AGL, at MP 20 | Date: 02.05.2026 | Diameter: 146.00cm

A short low-amplitude zone was recorded in the outer 0–3cm, consistent with the bark transition, followed by sustained fluctuating amplitude to 14cm. A possible minor echo of the feature recorded at MP 8 was noted, though without the discrete amplitude reduction. The possibility that this measurement has encountered the margin of the same feature cannot be entirely excluded on the trace data alone, MP 20 flanks the zone of abrupt sound barriers identified by SoT1 between MPs 21 and 22, and the measurement curve finding at this point is accordingly treated as a significant corroborative finding rather than a standalone diagnostic conclusion.

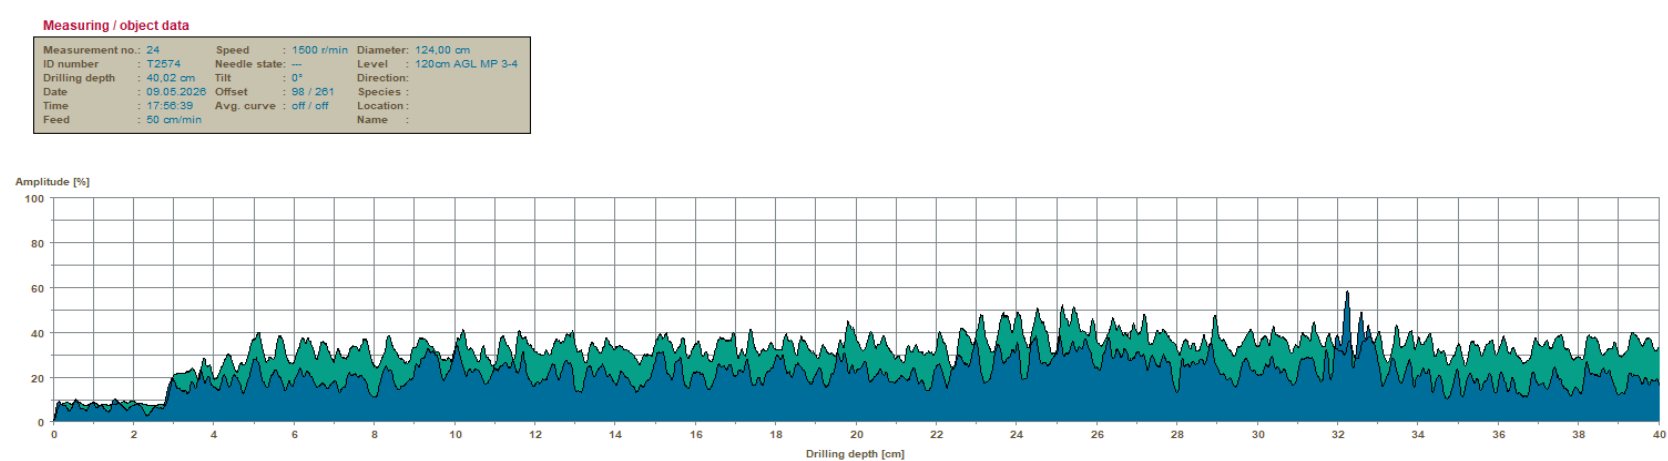
E2.6 Figure F24: Measurement 24 — 120cm AGL, at MP 3–4 | Date: 09.05.2026 | Diameter: 124.00cm

A short low-amplitude zone was recorded in the outer 3cm, consistent with the bark transition, followed by sustained, fluctuating amplitude to the full 40cm drilled depth, consistent with sound wood. A brief cluster of sharper peaks was noted at approximately 32–33cm, with no sustained reduction in amplitude indicative of decay identified at any point. This measurement was taken to investigate a small area of pink/green colouration visible on the SoT2 tomogram in the vicinity of MP 2–3; no corroboration of a defect at this position was found, and the SoT2 colour variation is not considered to indicate structural compromise at this location.

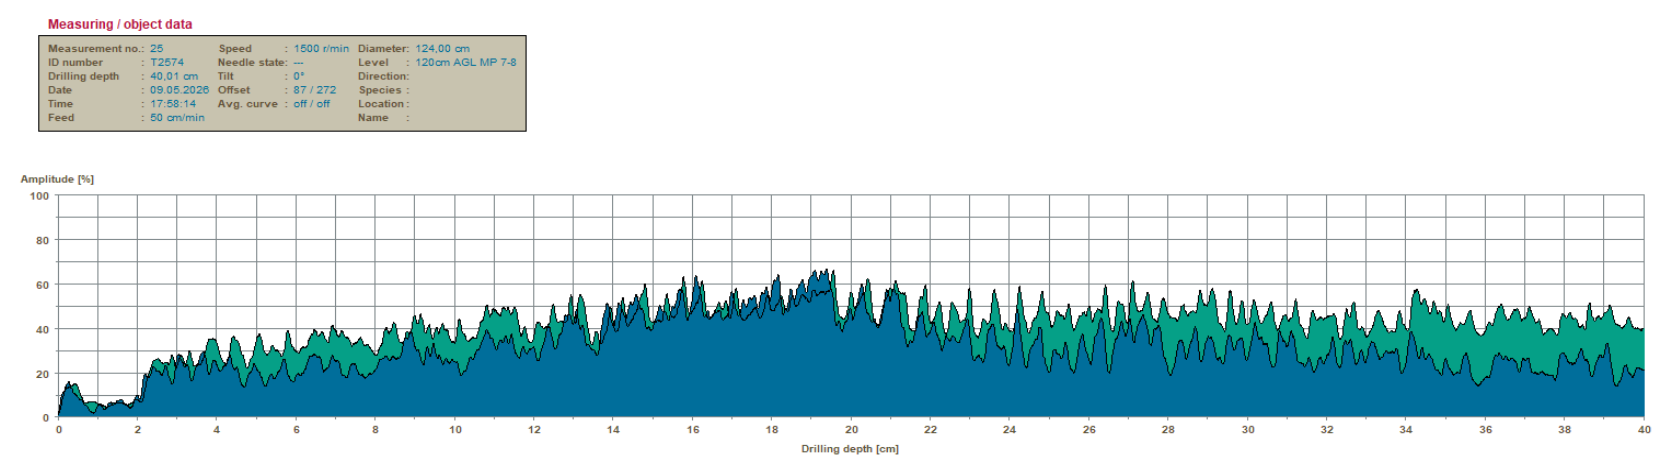
E2.7 Figure F25: Measurement 25 — 120cm AGL, at MP 7–8 | Date: 09.05.2026 | Diameter: 124.00cm

A short low-amplitude zone was recorded in the outer 2cm, consistent with the bark transition. From approximately 4cm, amplitude rose into a sustained, elevated zone, with a pronounced cluster of peaks recorded between approximately 14 and 20cm reaching 60–65% amplitude — the highest sustained elevated zone recorded across either tomographic plane. From approximately 22cm, amplitude settled into a lower, steadier fluctuating band continuing to the full 40cm drilled depth. Measurement curve 25 is the closest of the four measurement curves taken at this plane to the single abrupt sound barrier identified by SoT2 in the lower-centre sector. In the professional opinion of the author, the sustained elevated zone recorded at this point represents localised reaction wood or altered density associated with mechanical stress proximal to the loading point of the primary overextended SSE limb. This is the most significant measurement curve obtained at the 1.2m plane.

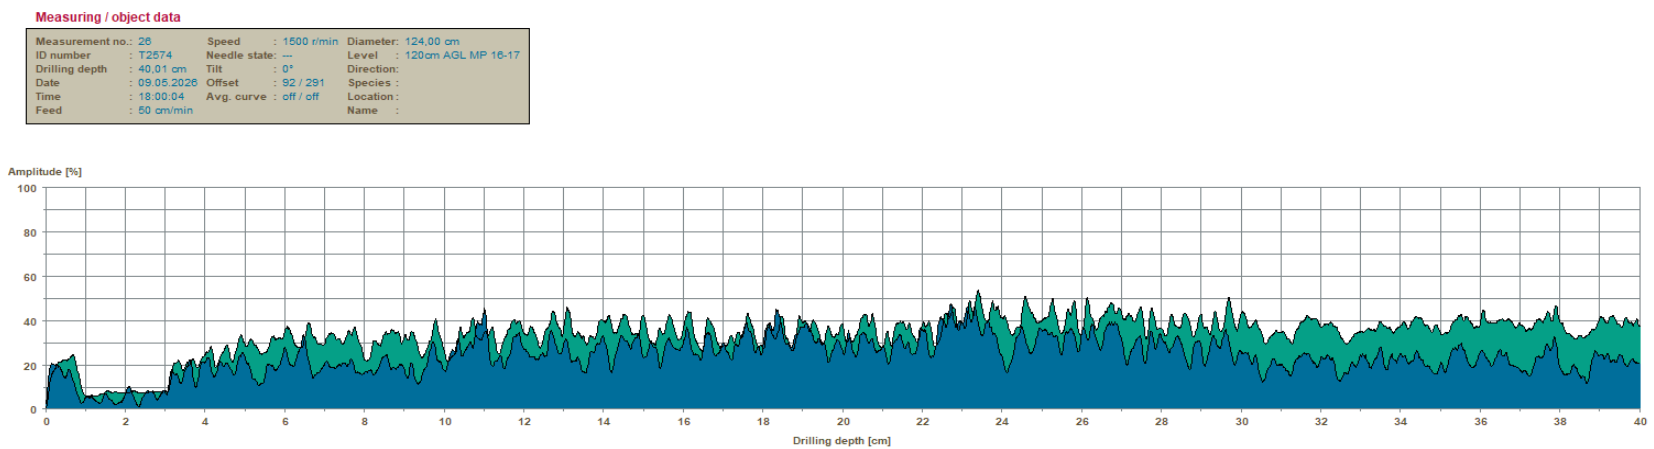
E2.8 Figure F26: Measurement 26 — 120cm AGL, at MP 16–17 | Date: 09.05.2026 | Diameter: 124.00cm

A low-amplitude zone was recorded in the outer 3cm, including a brief flat shelf at approximately 1–2% amplitude between approximately 1 and 2.5cm, distinct in character from the smoother bark-transition curve recorded at other points on this plane. From approximately 3cm, amplitude rose into a sustained, fluctuating pattern continuing to the full 40cm drilled depth, with no sustained reduction in amplitude indicative of decay identified at any point.
