## Arboricultural Report

### Internal and Aerial Tree Inspection

**Report Reference:** AR/IATI26-1057

72 VICTORIA ROAD,

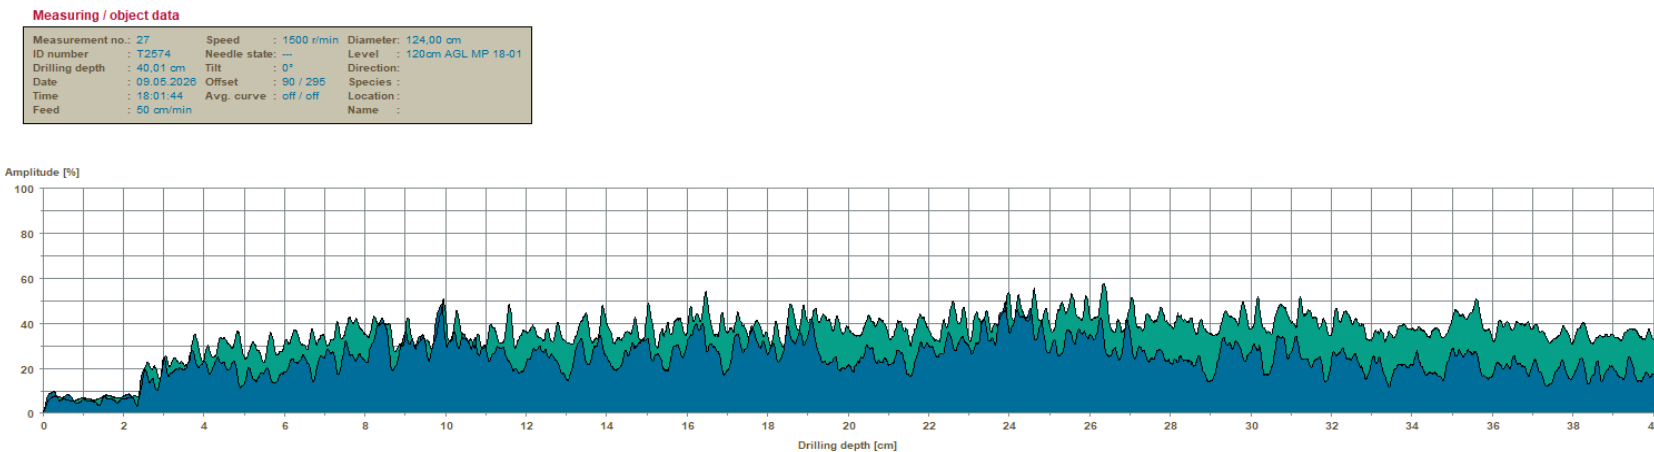
E2.9 Figure F27: Measurement 27 — 120cm AGL, at MP 18–1 | Date: 09.05.2026 | Diameter: 124.00cm

A short low-amplitude zone was recorded in the outer 2cm, consistent with the bark transition. Sustained, fluctuating amplitude was recorded from approximately 2cm to the full 40cm drilled depth, with no sustained reduction in amplitude indicative of decay identified at any point.

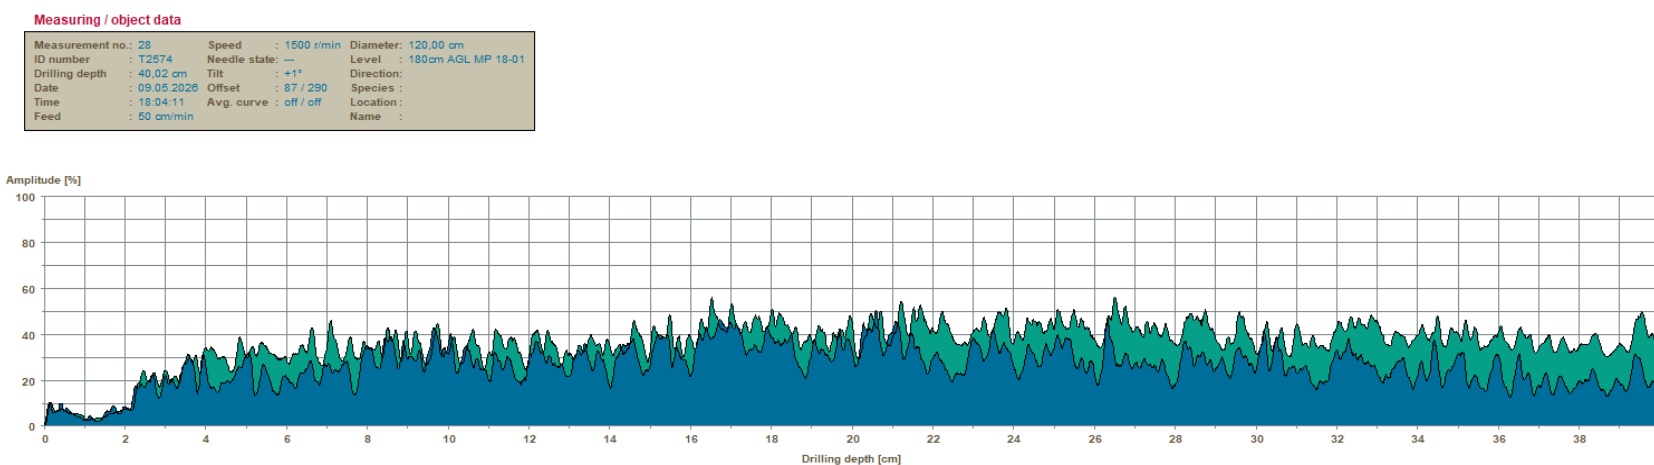
This measurement was taken at the height of the upper of the two horizontal lacerations recorded on the north aspect of the stem (at approximately 2.0m AGL). A short low-amplitude zone was recorded in the outer 2cm, consistent with the bark transition. Sustained, fluctuating amplitude was recorded from approximately 2cm to the full 40cm drilled depth, with a brief peak of approximately 55–60% recorded at approximately 16–17cm. No sustained reduction in amplitude indicative of decay was identified, and the trace is not considered to corroborate a structural anomaly at this height. This finding does not preclude the laceration itself representing a point of historic mechanical injury, but indicates that the internal wood condition at this drilled position, at this height, is consistent with sound wood.
