# Arboricultural Assessment of 9 Merdon Close, Chandler's Ford, EASTLEIGH, SO53 1EF

Carried out by Matthew Rowden on behalf of Romsey Tree  
Surgeons Ltd for the prospective buyer.

**10. Findings (please see appendix 1 for specific details)****Tree 1 – *Chamaecyparis lawsoniana***

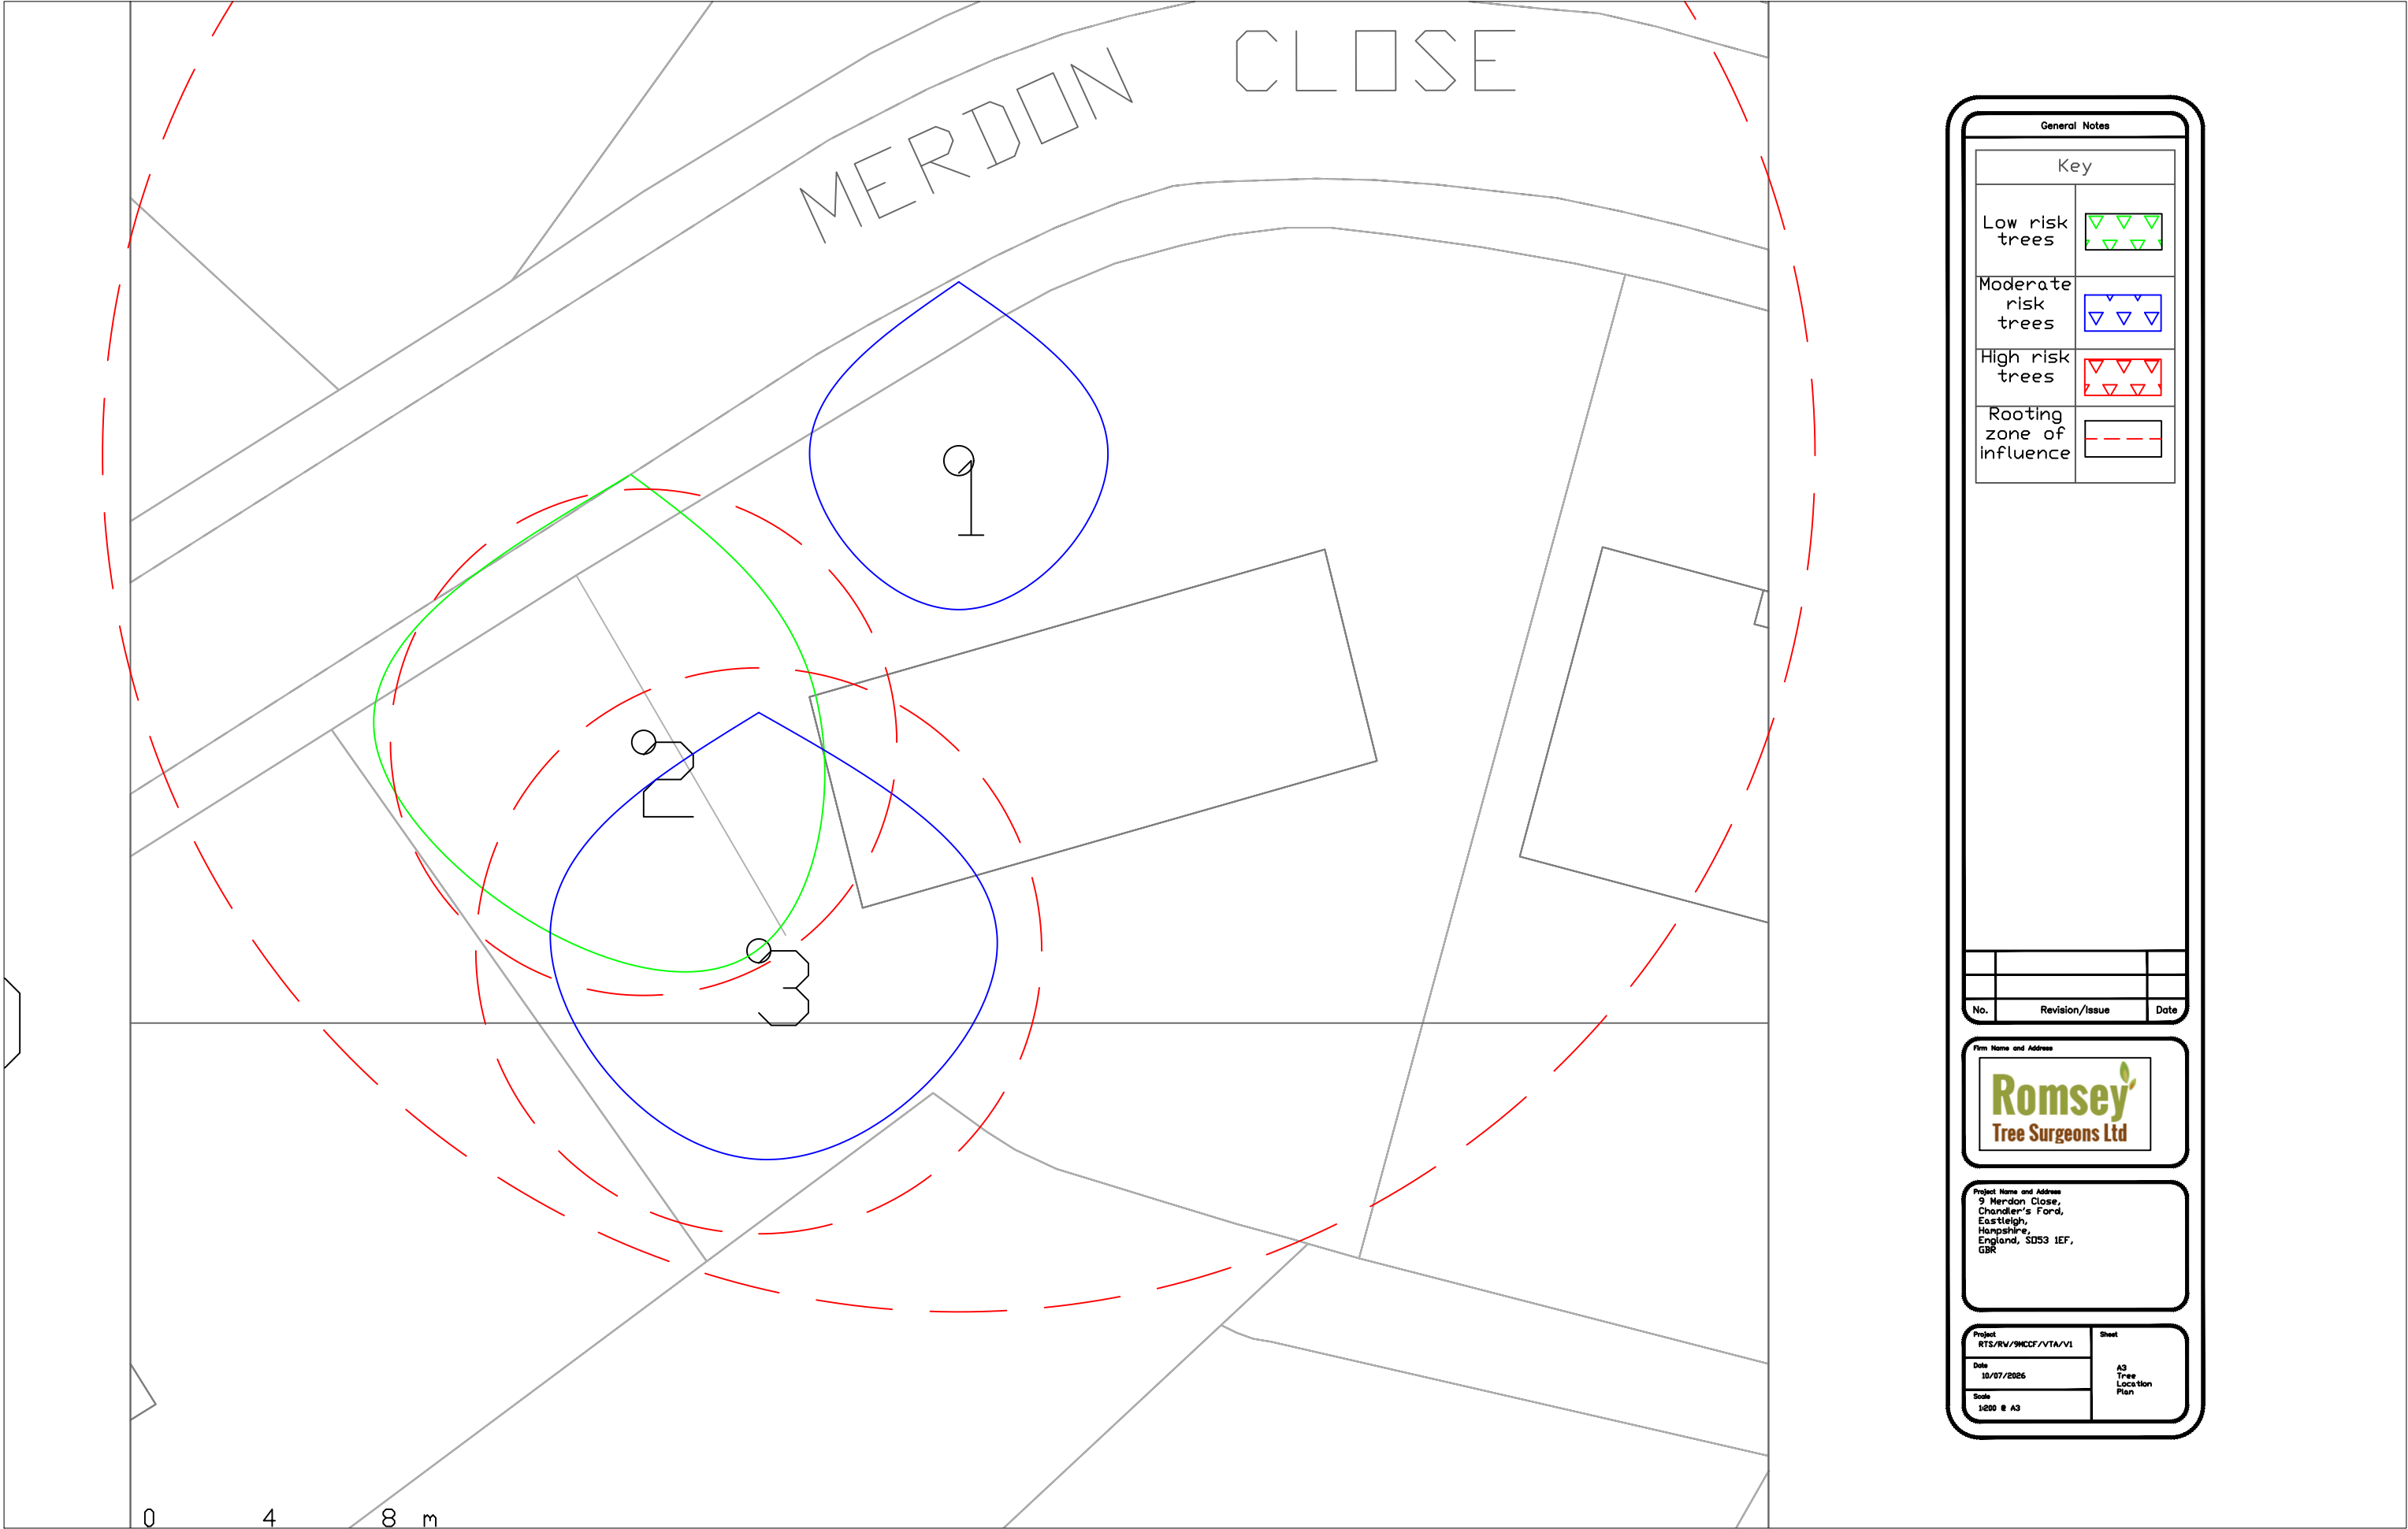
| Date<br>10/07/2026 | A3<br>Tree<br>Location<br>Plan |

| Tree no. on plan | Species | Ht (M) | Crown spread (M)<br>N<br>E<br>S<br>W | Stem dia.<br>@1.5m (mm)<br><br>Zone of influence (m radius)<br><br>NHBC water demand classification. | Life stage | Estimated remaining contribution in years | General observations<br><br>Physiological condition- P<br><br>Structural condition - S | Preliminary management recommendations | Priority |
|---|---|---|---|---|---|---|---|---|---|
| 1 | <i>Chamaecyparis lawsonia</i> | 23 | 6<br>5<br>5<br>5 | 780<br><br>28.75<br><br>High | M | <20 | P- Fair<br><br>S- Fair<br><br>Zone of influence overlaps property structure and due to property's age and location on London clay soil, there is a foreseeability of subsidence damage.<br><br>Although publicly visible, the tree is not particularly high value. | Fell | Moderate |
| 2 | <i>Taxus baccata</i> | 17 | 9<br>6<br>8<br>9 | 980<br><br>8.5<br><br>Low | M | >40 | P- Good<br><br>S- Good<br><br>Canopy too low over footpath.<br>High value tree, but amenity could be improved by reducing long, leggy growth to N aspect to retain a more uniform shape.<br>Lower canopy has previously been reduced. | Reduce in height and spread by 2-3m to balance canopy. | Low |
| 3 | <i>Taxus baccata</i> | 19 | 8<br>8<br>7<br>7 | #850<br><br>9.5<br><br>Low | OM | <5 | P- Poor<br><br>S- Poor<br><br>Yew tree in rear garden in advanced state of decline, suggestive of <i>Cryptocline taxicola</i> infection due to poor airflow in this densely wooded area. In order to preserve the integrity of the higher value tree 2, this should be felled. | Fell | Moderate |
