# SUPPLEMENTARY TOMOGRAPHIC ASSESSMENT REPORT

## T1 and T3 - mature Douglas firs

**Site:** 28 Lakewood Road, Eastleigh  
**Survey reference:** A0012-2026  
**Inspection date:** 27 July 2026  
**Test conditions:** Fine weather  
**Test level:** Approximately 0.10 m above ground level  
**Method:** PiCUS sonic tomography and visual observations/ **Model PiCUS 3 Software Expert Q74**  
Assessment undertaken by Kim Gifford Arboricultural Consultant see profile page 14.

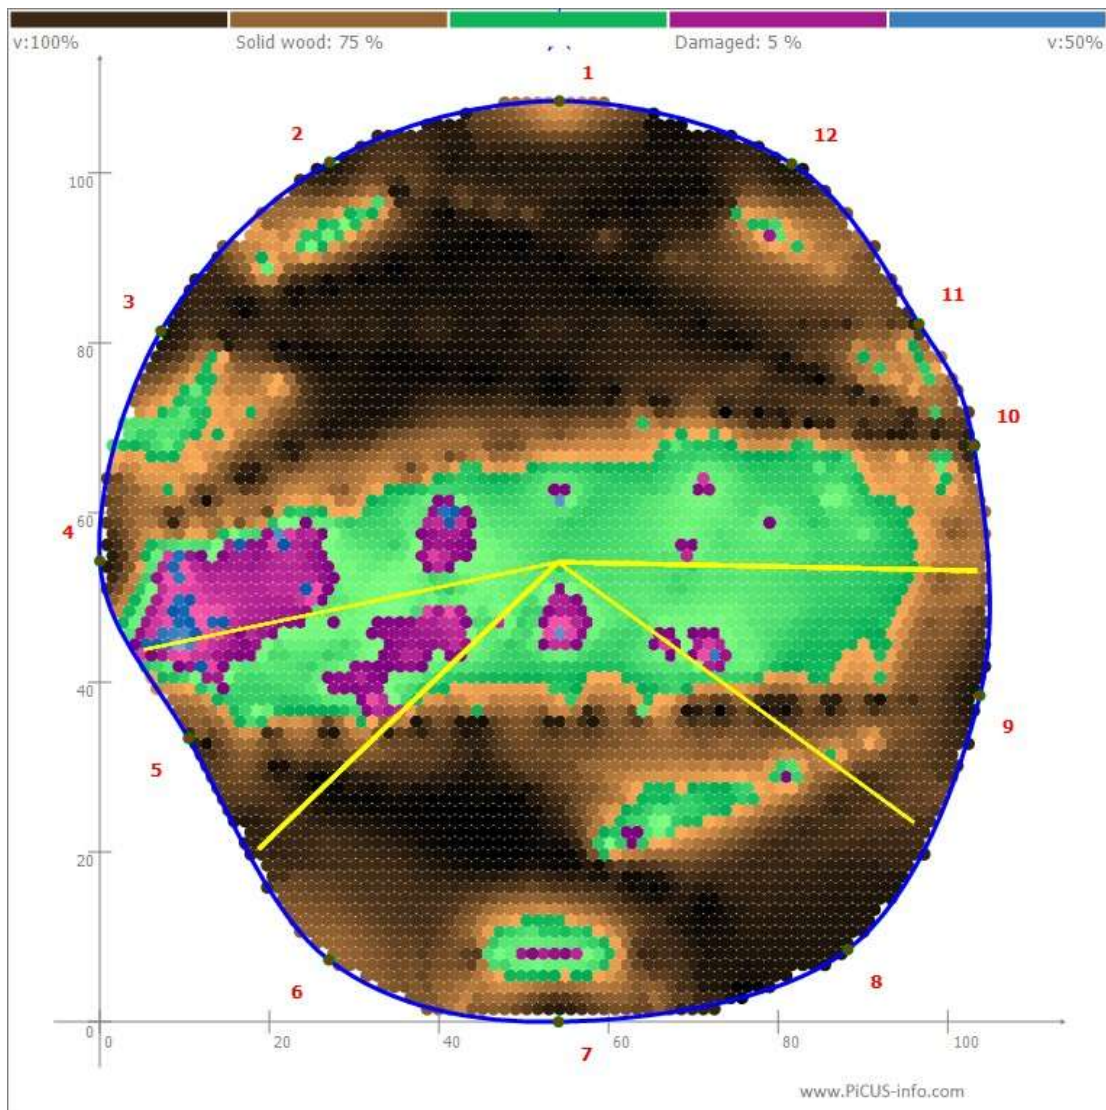
Figure 1. T1 PiCUS tomogram, test level approximately 0.10 m, 27 July 2026.

**Risk status: HIGH / urgent action** Extensive altered timber and associated external symptoms indicate a significant and progressing structural defect. Complete removal is recommended.

- The current tomogram displays extensive areas of altered acoustic response through the test cross-section, with the software summary indicating approximately 75% solid wood and 5% damaged response.
- The distribution is materially different from the 2011 test, which was described as showing a localised area of decay near the northern root buttress. The 2026 result indicates progression beyond a localised defect.
- The most pronounced anomalous response is concentrated around the sector adjacent to test points 3 to 5, with further altered zones extending across the central and lower portions of the test area.

- A fungal bracket was found at the base of T1 adjacent to test points 3 to 5. Its position and appearance are consistent with the historically reported *Phaeolus schweinitzii*; this is a field identification unless subsequently confirmed by microscopy or laboratory analysis.
- The Tree Assist survey report records: “Historical reports of *Phaeolus schweinitzii* forming on the northeast side of the stem” and notes that symptoms appeared to have increased since the previous report.
- Sap exudation extends from approximately 8 m to ground level on two sides of the stem. The length and bilateral distribution are consistent with a major longitudinal dysfunction or structural fault.
- The combination of progressive internal alteration, basal fungal evidence and extensive exudation materially reduces confidence in the residual load-bearing capacity of the lower stem.

*Phaeolus schweinitzii* (Dyer’s mazegill) is a significant root- and butt-decay fungus of conifers, including Douglas fir. The Tim Moya Associates TMA Fungi resource states that it is usually found at the base or on structural roots and attributes it to cubical brown rot of the heartwood, cavity formation, and both stem and root failure. Brown rot preferentially degrades the cellulose and hemicellulose that contribute substantially to wood strength; advanced decay can therefore cause a serious reduction in bending strength while an apparently intact outer shell and a vigorous crown remain.

In this case, the basal bracket is not considered in isolation. Its significance is increased by the adverse change from the 2011 tomogram, the widespread altered acoustic response at the 2026 test level, and extensive sap exudation on two sides of the stem. These mutually supporting findings indicate that the fungal association is accompanied by a material and progressing structural defect. This supports the recommendation for complete removal.

- Arrange complete removal of T1 as a high-priority safety operation. Given the evidence of progression and significant failure potential, the work should be completed as soon as reasonably practicable and should not be deferred beyond the high-priority period stated in the original survey.

- Pending removal, restrict avoidable occupation within the potential fall zone. Review access arrangements and increase precautions during high winds or severe weather.

- The removal should be planned and undertaken by a competent, insured arboricultural contractor using a site-specific risk assessment and method statement. The suspected basal and stem defect should be considered when selecting climbing, rigging and dismantling methods.

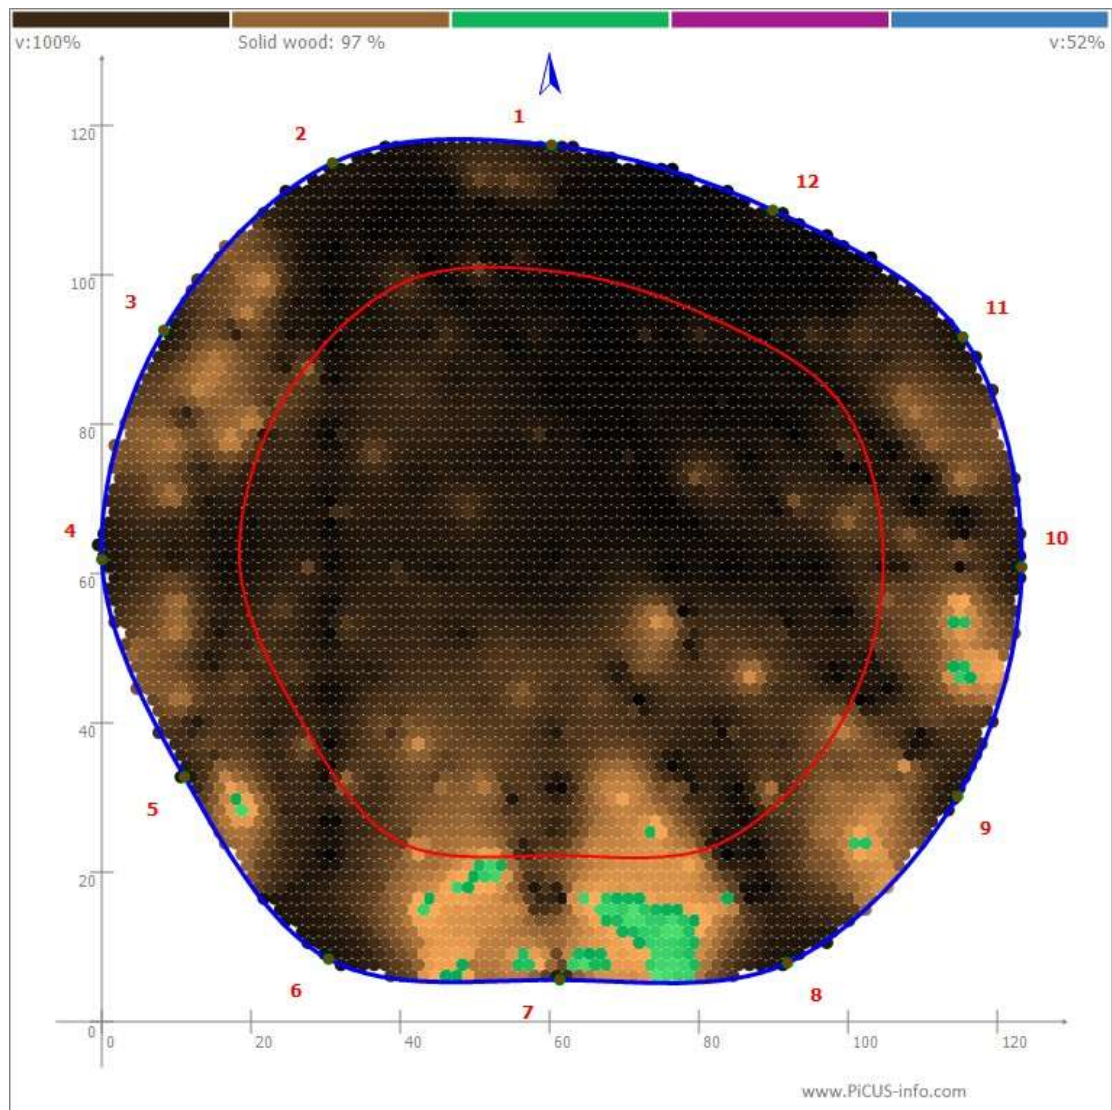
Figure 2. T3 PiCUS tomogram, test level approximately 0.10 m, 27 July 2026.

**Risk status: monitor** The tested cross-section appears substantially sound. No remedial work is recommended solely on the basis of this tomogram.

- The tomogram is predominantly consistent with sound timber at the tested level, with the software summary indicating approximately 97% solid wood.
- Small areas of slower acoustic response are present, principally toward the lower and lower-right perimeter, but they do not form an extensive or continuous defect in this cross-section.
- The result does not presently indicate a material loss of load-bearing wood at the test level.

- Retain T3 and continue routine inspection.
- Reinspect sooner if new fungal fruiting bodies, cracking, increasing exudation, cavities, root-plate movement, crown decline or other material changes are observed.

- Retain T3. Continue visual monitoring as part of the site's normal tree-risk management programme.
- Undertake a formal arboricultural inspection within 12 months, and after exceptional storms or any significant site change affecting the root zone.
- Repeat tomography only if clinical signs develop or a future inspection identifies a reason to quantify change. In the absence of new symptoms, a precautionary repeat test in approximately three years would provide a useful comparison.

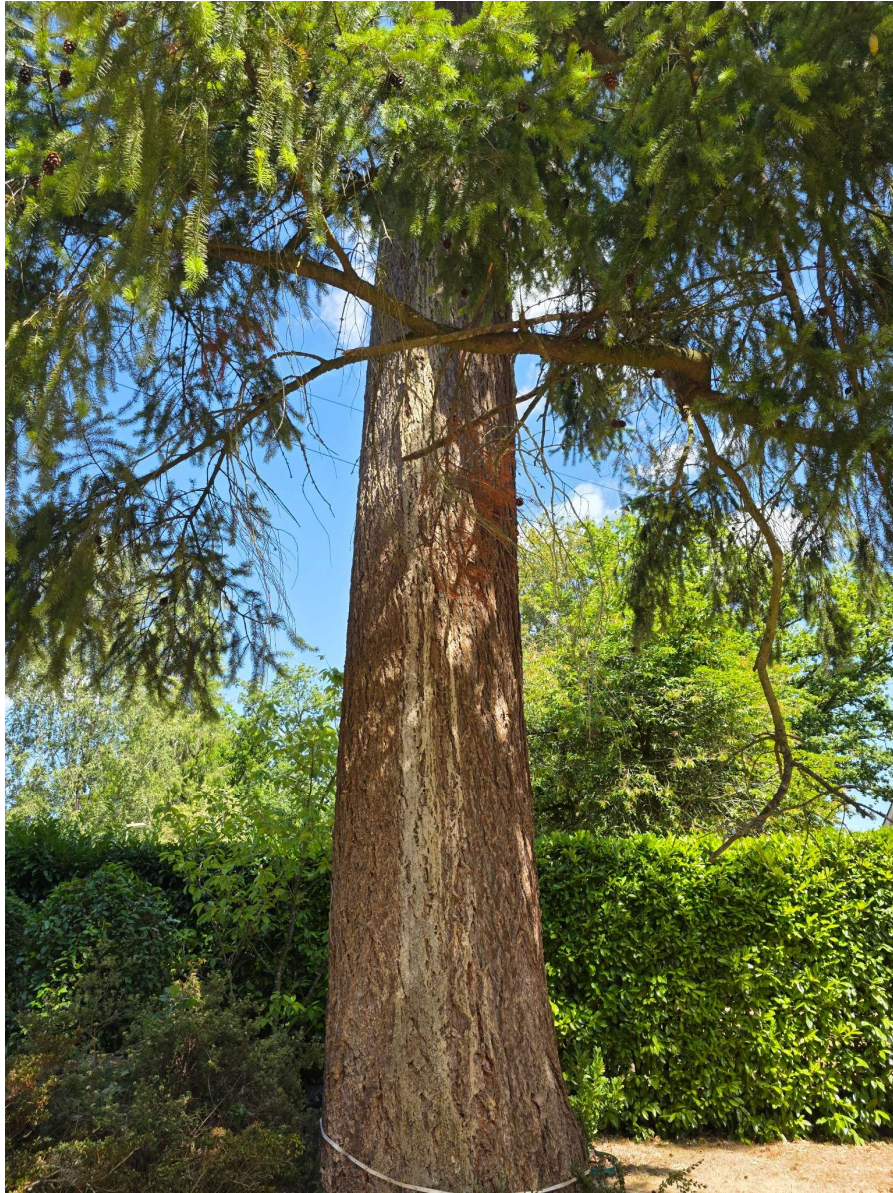
*Figure 3. T1 stem showing extensive vertical sap exudation.*

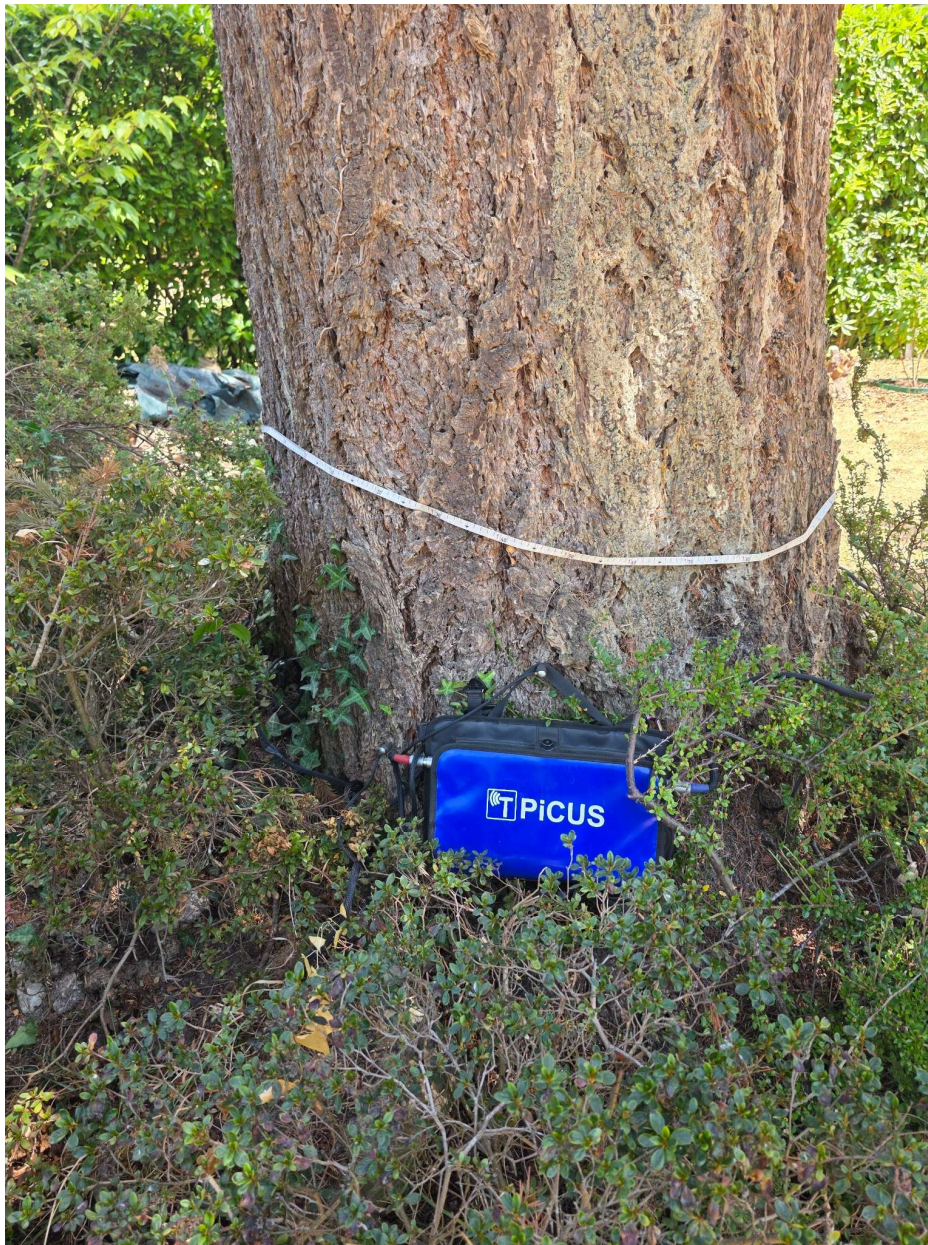
*Figure 4. T1 base and tomography equipment at the test level.*

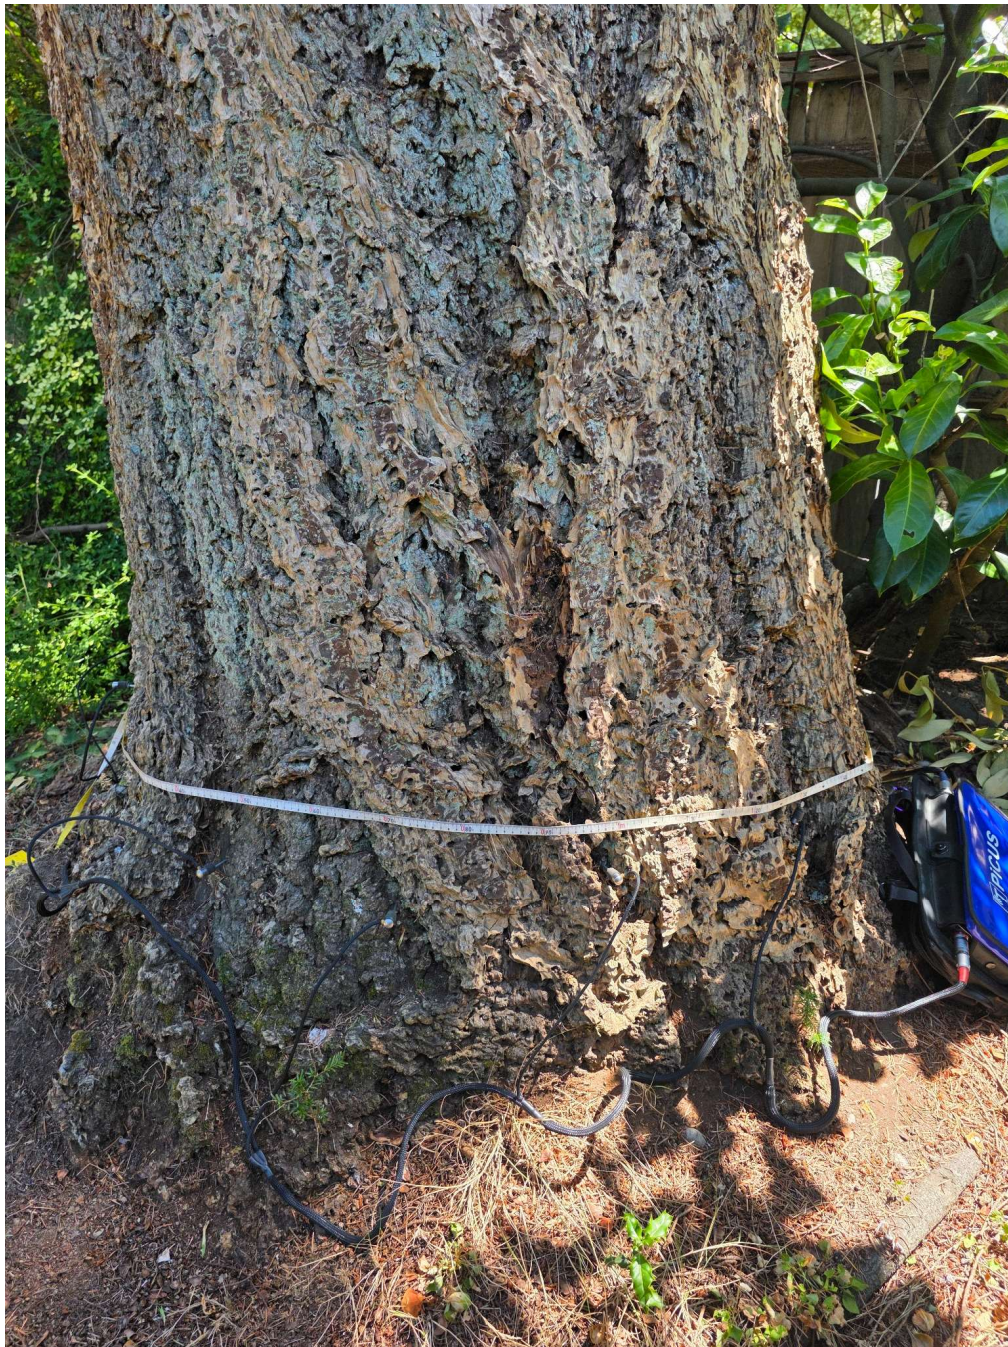
*Figure 5. T3 lower stem during tomography.*

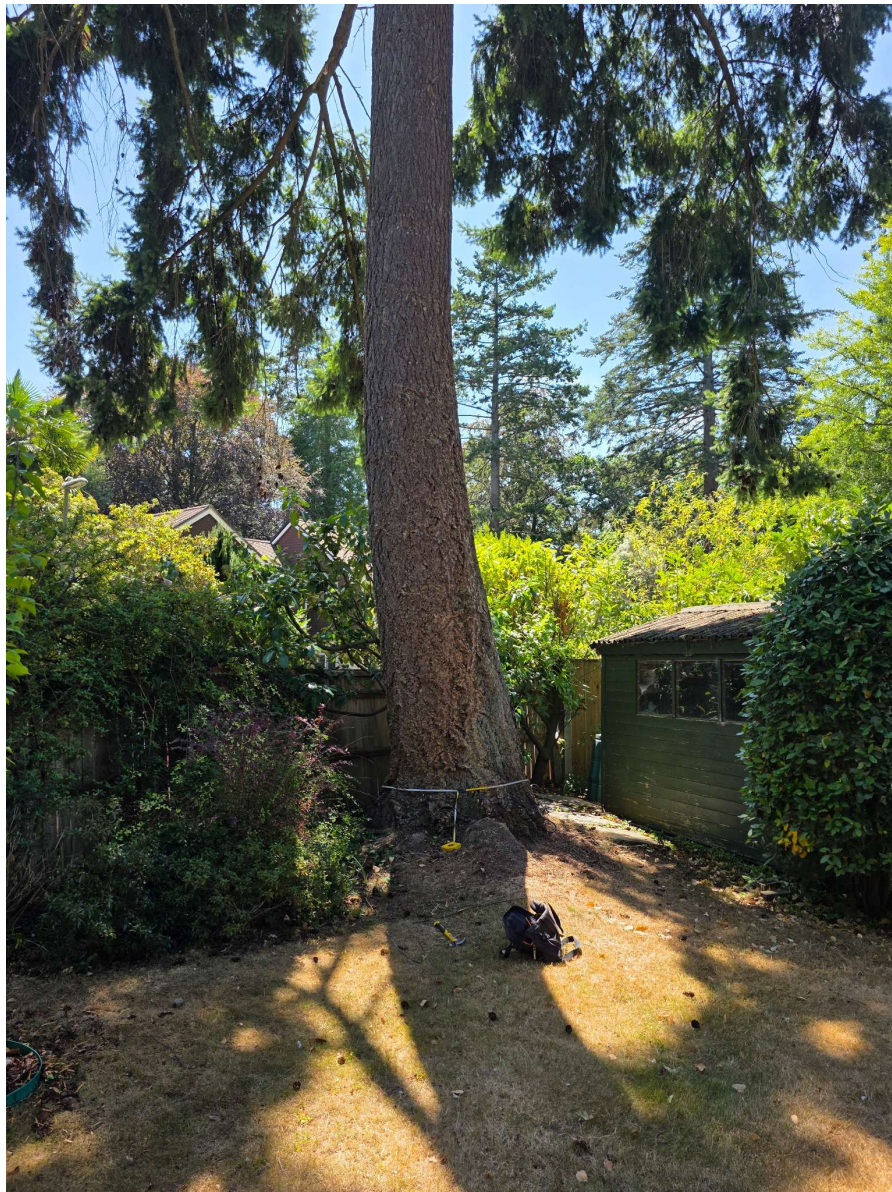
*Figure 6. T3 site context and lower stem.*
