# A0012 – 2026 – 28 Lakewood Road, Eastleigh

## Tree Survey Document

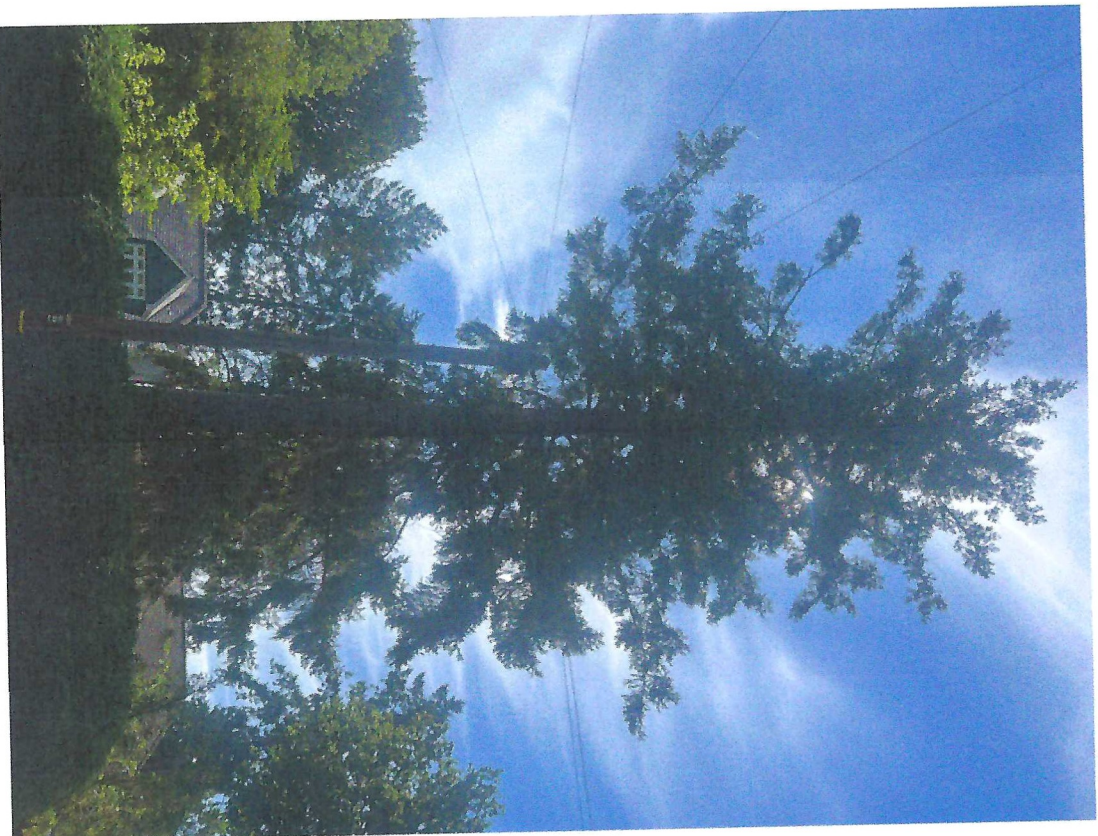
T2 - Photo

| Tree No. | Species | Height (M) | Crown Spread (M) | DBH Stem Diameter (Estimated due to access) | Age Class | Condition | Observations | Recommended works | Priority |
|---|---|---|---|---|---|---|---|---|---|
| T2 | T2 - Pedunculate Oak - <i>Quercus Robur</i><br>*Neighbouring tree - off site | 24m | N - 8m<br>S - 8m<br>E - 8m<br>W - 10m | 1 Meter | Mature | Good | Tree seems to be in good vitality. Single Straight stem with strong unions at around 12m from ground level. No obvious signs of decay within the stem from the base to 12 m from ground level. Deadwood forming within the crown, in line with the species natural cycle. Foliage remains green and dense throughout with no obvious signs of dieback. Sounding and root inspection not possible due to no access to base of the tree. Old pruning stubs showing decay throughout that could potentially be moving into the stem heartwood at around 13 m on the eastern side. Epicormic growth forming on the main stem to around 12 m in height. | Remove major deadwood and carry out further climbing inspection of the decay pockets to see the extent of decay. Remove the epicormic growth from the stem of the tree. Inspect the base of the tree if possible. | Medium<br>6 Months |

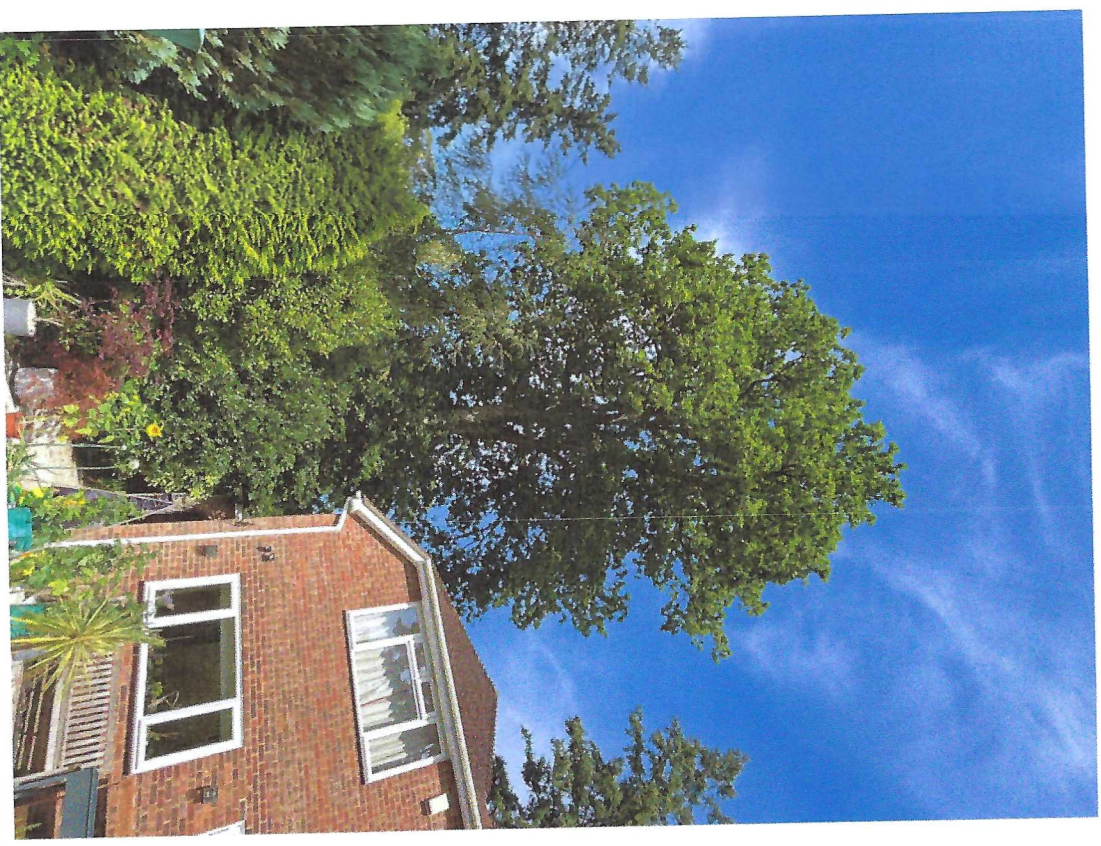
**TREE|ASSIST**  
T3 - Photo

| Tree No. | Species | Height (M) | Crown Spread (M) | DBH Stem Diameter | Age Class | Condition | Observations | Recommended works | Priority |
|---|---|---|---|---|---|---|---|---|---|
| T3 | Douglas Fir – <i>Pseudotsuga Meziesii</i> | 33.5M | N - 7m<br>S - 8.5m<br>E - 6m<br>W - 6.5m | 1 Meter (estimated) | Mature | Good | <p>Tree seems to be in good vitality. Single Straight stem from ground level with no obvious signs of decay within the stem from the base to the top of the tree observed using binoculars. Relatively even weighting of crown - longer branches to the south but a slight bow in the stem towards the North showing self-optimisation of balance. Deadwood forming within the crown throughout but not an abnormal amount for this size and age of tree. Foliage remains green and dense. Some rubbing branches within the crown, no major limbs affected.</p> <p>Bore holes from beetles (unidentified) around the base of the tree from the base to roughly 3 metres. Dark coloured dust below bore holes no visibly negative effects noted within crown other than production of dead tips throughout crown, especially lower 15 metre portion of the tree.</p> <p>Sounding and root inspection results showed a light knocking sound around the bottom 3 meters of timber, suggesting further investigation may be required due to the beetle presence.</p> <p>Inspection of surface roots found slight decay in south most extruding root, combi spanner showed little resistance of press test and 3-inch insertion of spanner into root area.</p> | <p>Tomograph - further investigation.</p> <p>Deadwood removal if Tomograph report shows sufficient holding wood for the tree to remain in situ</p> | Medium<br>6 Months |

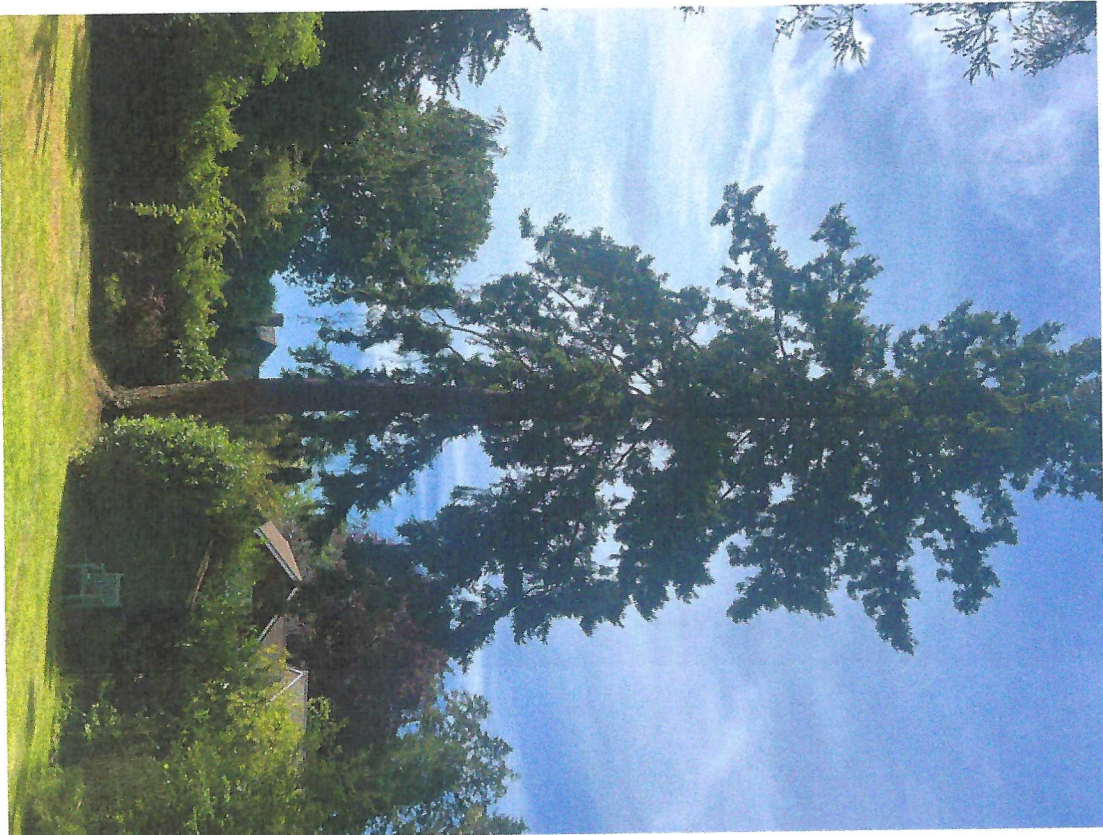
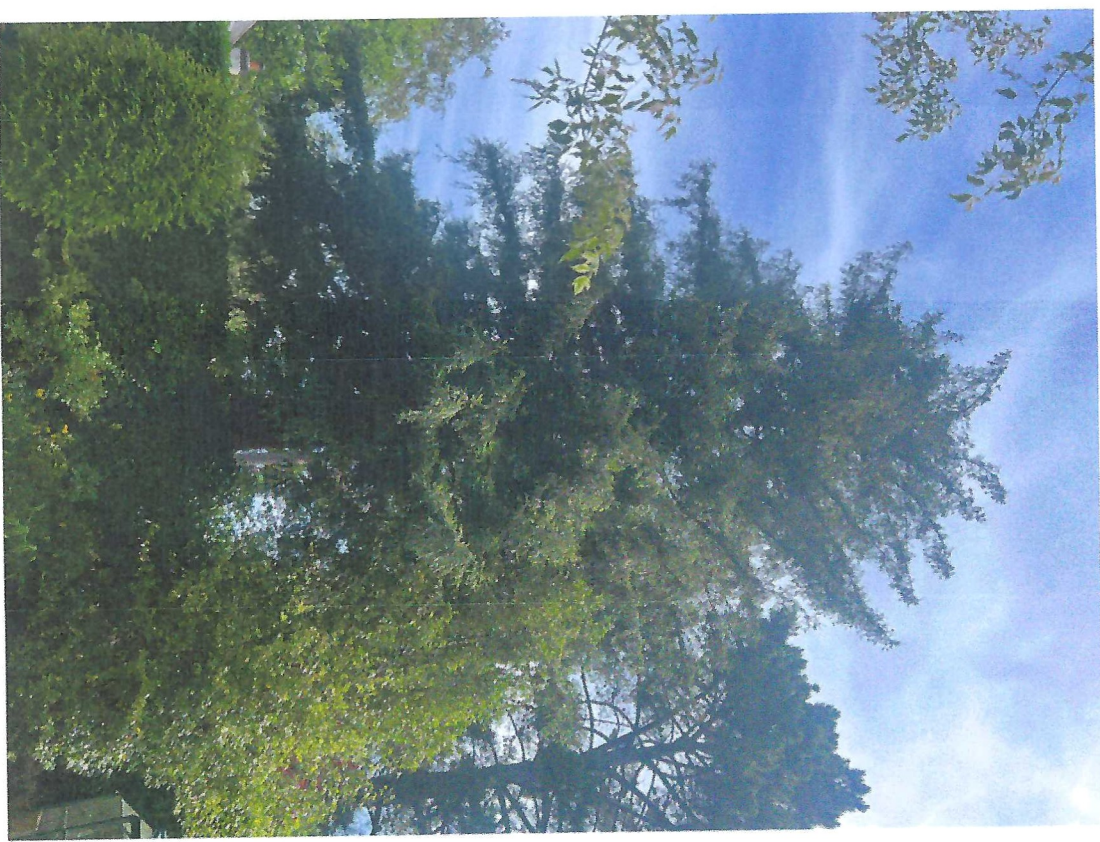
T4 - Photo

| Tree No. | Species | Height (M) | Crown Spread (M) | DBH Stem Diameter – 1.1 Meters (Estimated) | Age Class | Condition | Observations | Recommended works | Priority |
|---|---|---|---|---|---|---|---|---|---|
| T4 | Coast Redwood - <i>Sequoiadendron sempervirens</i><br>*Neighbouring tree - off site | 26M | N – 5M<br>S – 6M<br>E – 5M<br>W - 6.5m (estimated lengths) | | Mature | Good | The tree crown seems to be in good vitality.<br>Single Straight stem with historical recordings of snapped outtop or lightning strike causing damage to leading stem. This removal of the apical meristem seems to have pushed growth out laterally causing a wider growth that one would see in typical examples of the tree.<br>No signs of decline since the breakout.<br><br>Client has mentioned light being an issue. As mentioned, I do not believe any reasonable use of pruning other than crown lift will add more light to the property.<br>A heavy reduction will only reduce the value that the tree adds and could cause serious damage to the trees health. | Remove major deadwood from the side that overhangs 28 Lakewood Road rear garden and crown raise to 8m above ground level, removing the lowest nine limbs to allow light into the property from beneath the tree. | Low<br>12 Months |
