# Tree Condition Assessment

**Oak**

**1 Marsh Gardens, Hedge End**

Report reference number: **TCA-KC/1MARSH/001**

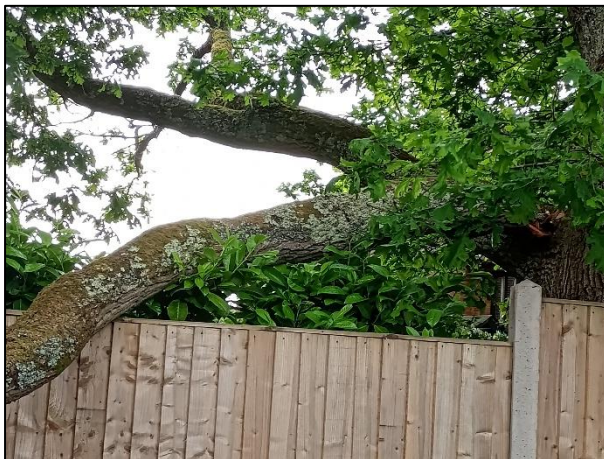
**Photograph one** (below) - client photo of failed limb

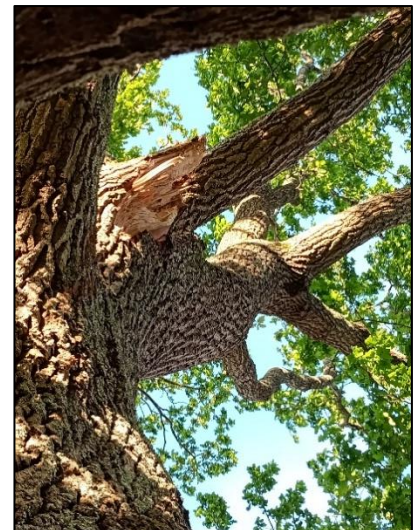
**Photograph two** (above) - client photo of failure point on tree

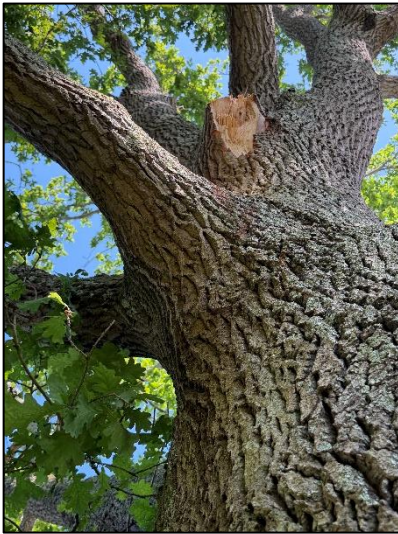
**Photograph three** (below) - photo of failure point at time of survey.

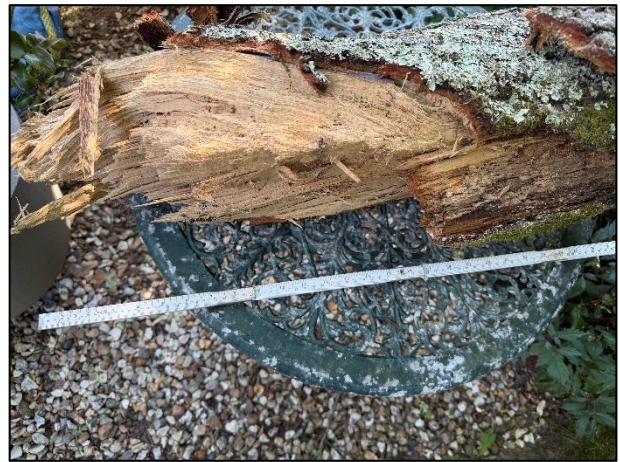
**Photograph four** (above) - remnant end of failed limb

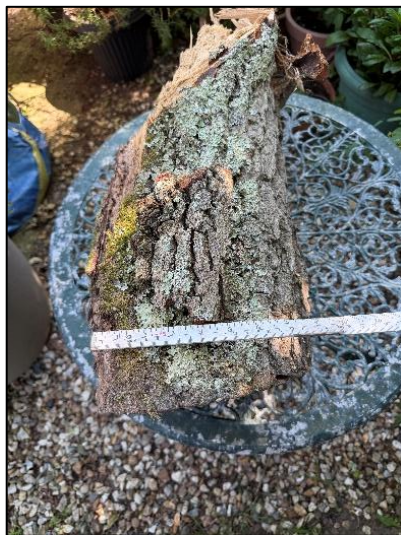
**Photograph five** (below) - remnant end with tape to indicate size.

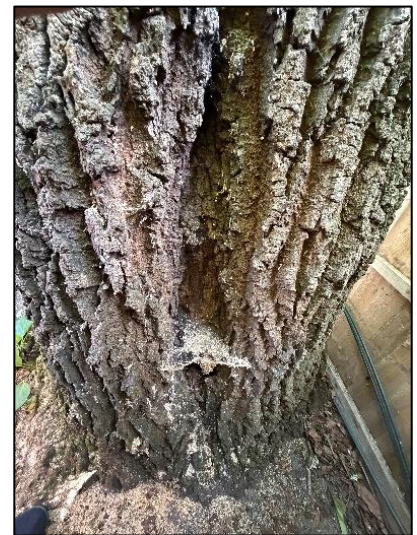
**Photograph six** (above) - showing cavity and exposed heartwood.

| Tree No | Condition Comments |
|---|---|
| Common name | <u>Buttress/lower stem</u><br>Lateral wound on S side from 200mm to 1100mm by 150mm at widest. Exposed heartwood with limited internal degradation. Good wound wood <sup>9</sup> response in both sides. No other reason to probe <sup>10</sup> . Sounding with a mallet <sup>11</sup> indicates no decay or degradation. |

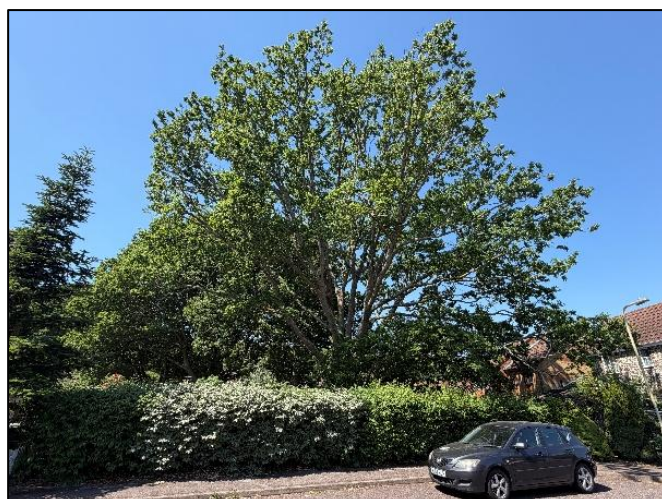
**Photograph seven** (below) showing tree crown.

- 8.4 The level of risk in respect of the Oak is considered to be **UNACCEPTABLE** at the present time as there is a residual risk of failure of limbs.

| Tree No | Condition Comments |
|---|---|
| Oak | <u>Stem</u><br>Historic prune wounds to 300mm diameter with good wound wood occlusion to full extent of stem.<br><br><u>Crown and Branches</u><br>Significant branch over-extension to client and 3rd Party gardens.<br>Crown dieback on branch ends with minor (<25mm dia.), moderate (25-100mm dia.) and major (>100mm dia.) deadwood throughout crown.<br>Recent failure of 200mm dia. living branch from attachment at 5m on S side. Some minor degradation visible on top of remnant branch closest to attachment point otherwise no obvious reason for failure.<br>Notable degradation on tops of lower limbs.<br><br><u>Foliage</u><br>Density: abnormal.<br>Colour: Normal. |

- 10.1 I recommend the height and spread of the tree be reduced as a means to reduce sail area. All deadwood should be removed at the same time to allow future surveys to monitor crown health.
- 10.2 I recommend that future surveys are carried out to monitor the response to pruning and to determine feasibility and extent of possible future reductions to further limit the size of the tree, often called retrenchment pruning<sup>8</sup>. It would be prudent to resurvey the tree in two years.

Crown reduce by 3-4m in all directions.  
Reduce height by 4m.  
No greater than 75mm prune wound diameter.  
Remove deadwood.  
Monitor recovery of crown.
