**Subsidence  
Monitoring  
Services**

Monitoring visit 10 of tbc

## Monitoring Plus Report

| Address | 27 The Foxgloves<br>Hedge End<br>Southampton<br><br>SO30 0UG | Principal area of damage | to be advised | Installed | 09/06/2023 |

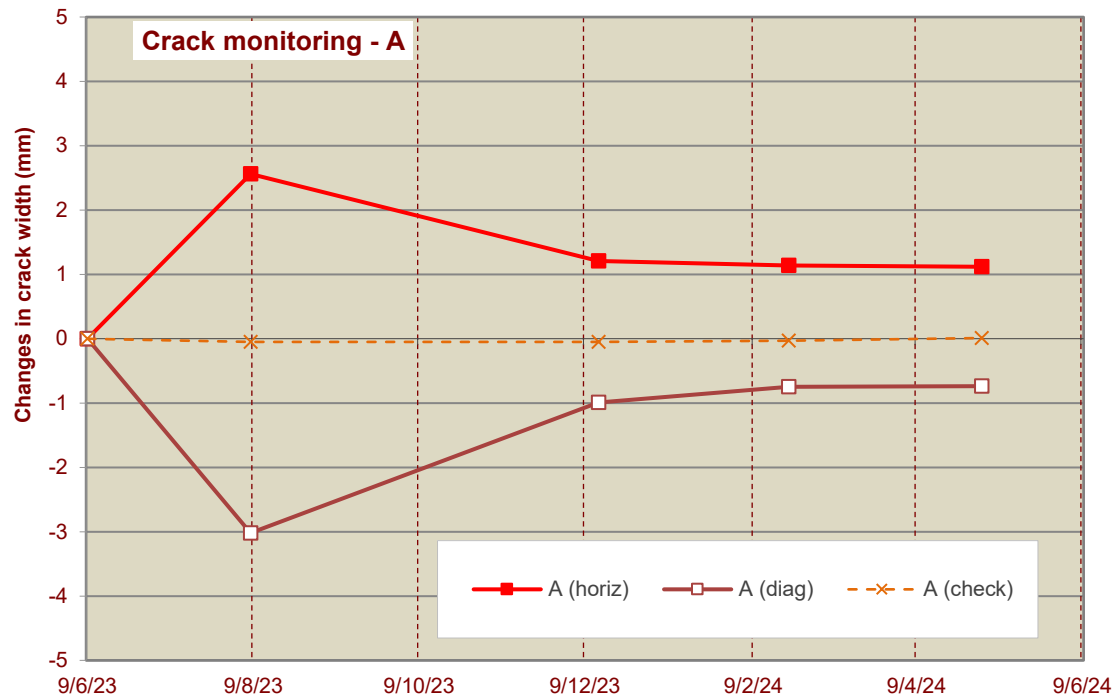
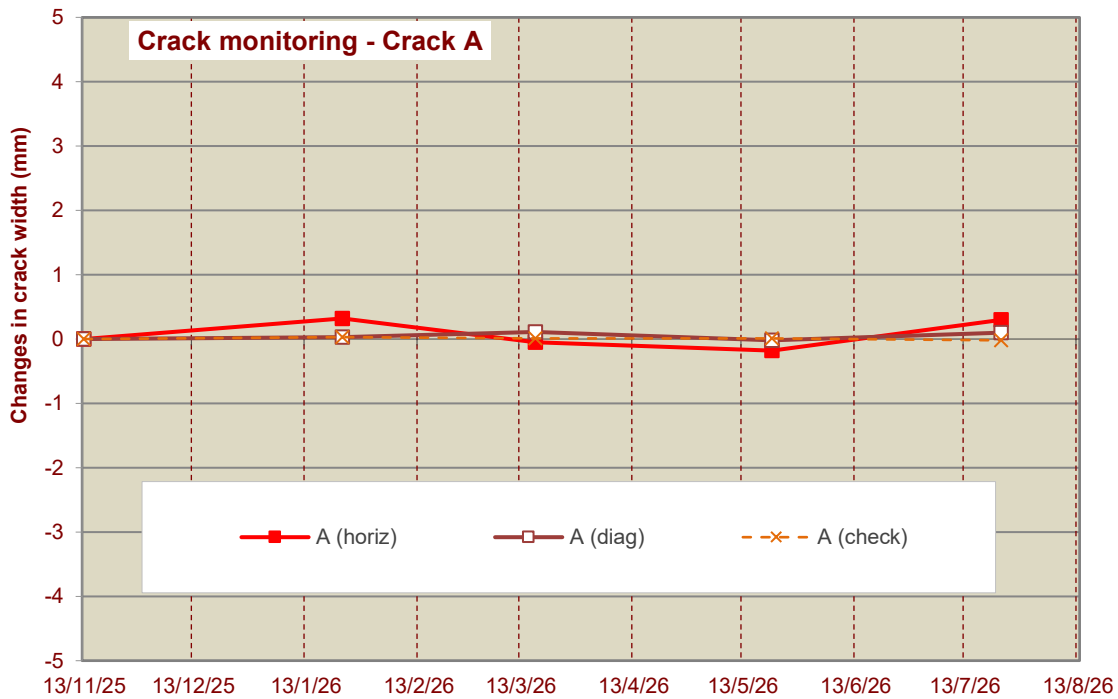
## Crack monitoring

A (horiz) Demec triplet, internal, conservatory.

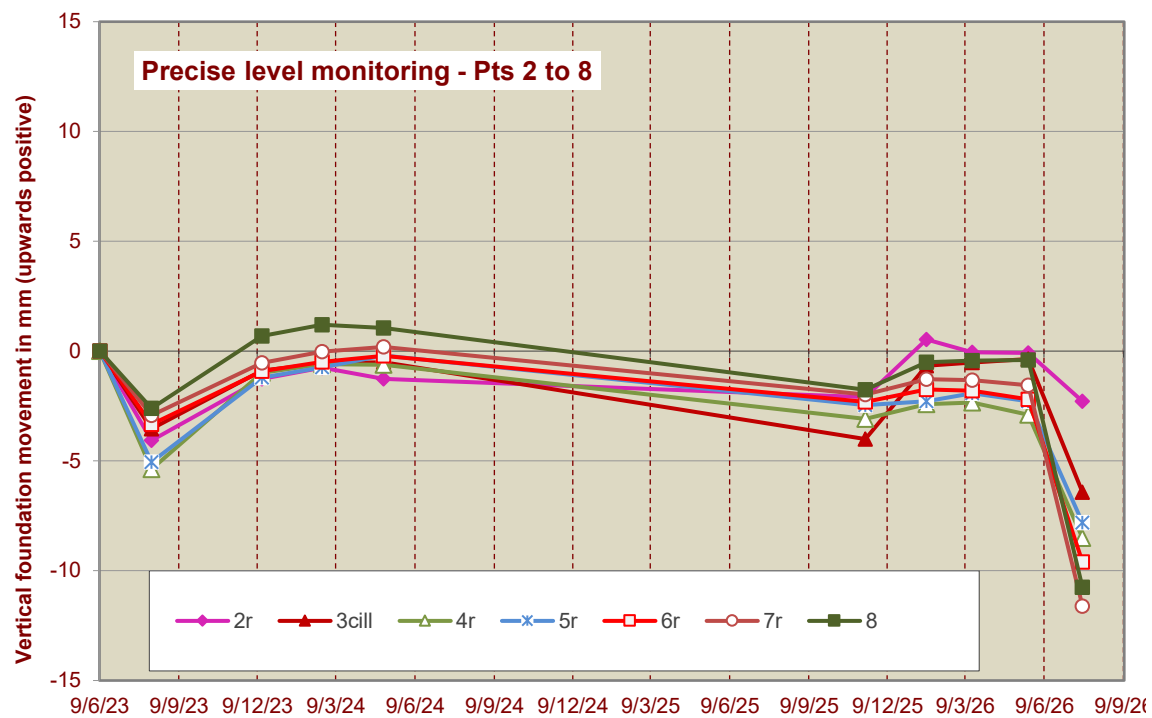
Precise level monitoring related to Point 1

| Max moveme 12.0 mm | no feedback for this visit | | | | |
| Focal area Pts 4r, 5r, 6r, 7r, 8, | | | | | |
