## Engineers Report

**Risk Address** 27 The Foxgloves  
Hedge End  
Southampton  
SO30 0UG

**360 Reference** LIV-SN-22-005467  
**Claim Refence** 100-50-197091  
**Policy Holder** Ms. Sarah Berrett

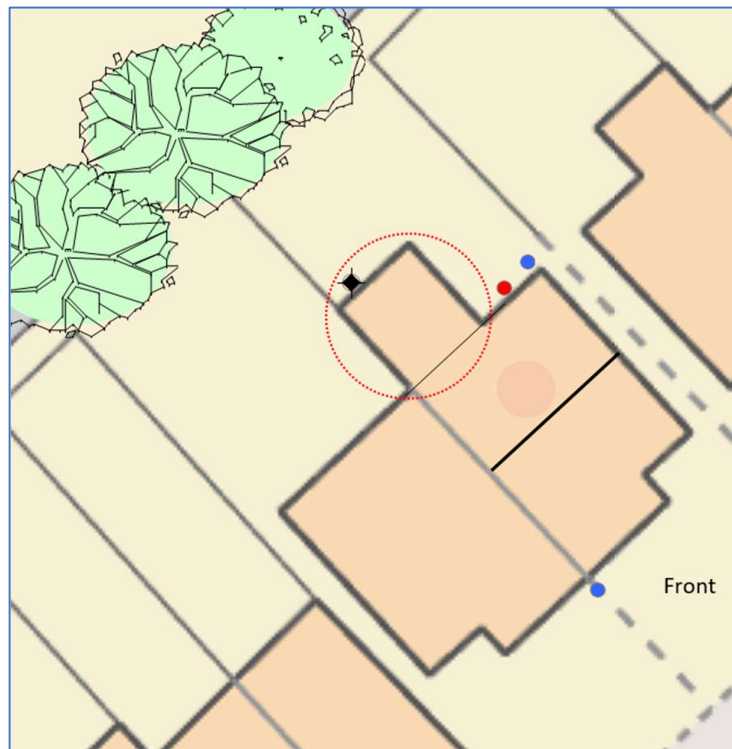
This document addresses damage notified to insurers in relation to cracking focused and localised to the rear conservatory.

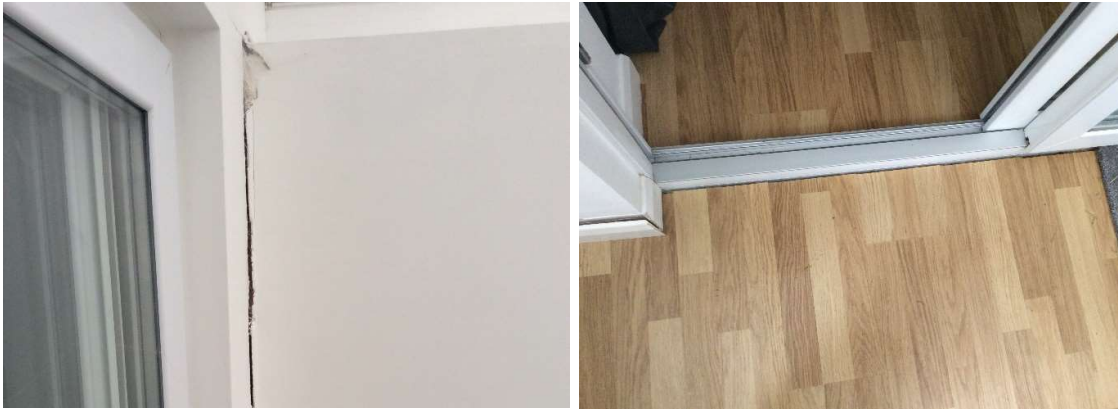
Slight cracking was noted at the wall and floor junction between the conservatory and main house. A gap was also noted between the skirting board and floor.

The pattern and nature of the cracks is indicative of an episode of subsidence to rear conservatory.

The cause of movement appears to be clay shrinkage possibly exacerbated by root activity from nearby trees.

- Instruct site investigations as detailed above.

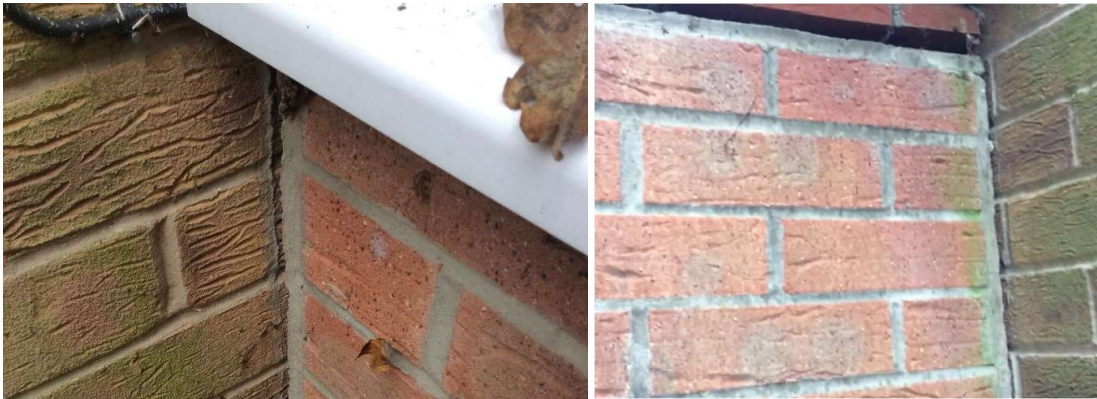
Slight cracking was noted at the wall junction between the conservatory and main house.
