**ARBORICULTURAL REPORT**  
**at**  
**27 The Foxgloves**  
**Hedge End**  
**Southampton**  
**SO30 0UG**

**Insured:**  
Ms S Berrett

**Claim Number:**  
LIV-SN-22-005467

**JCA Ref:**  
23439/AJB

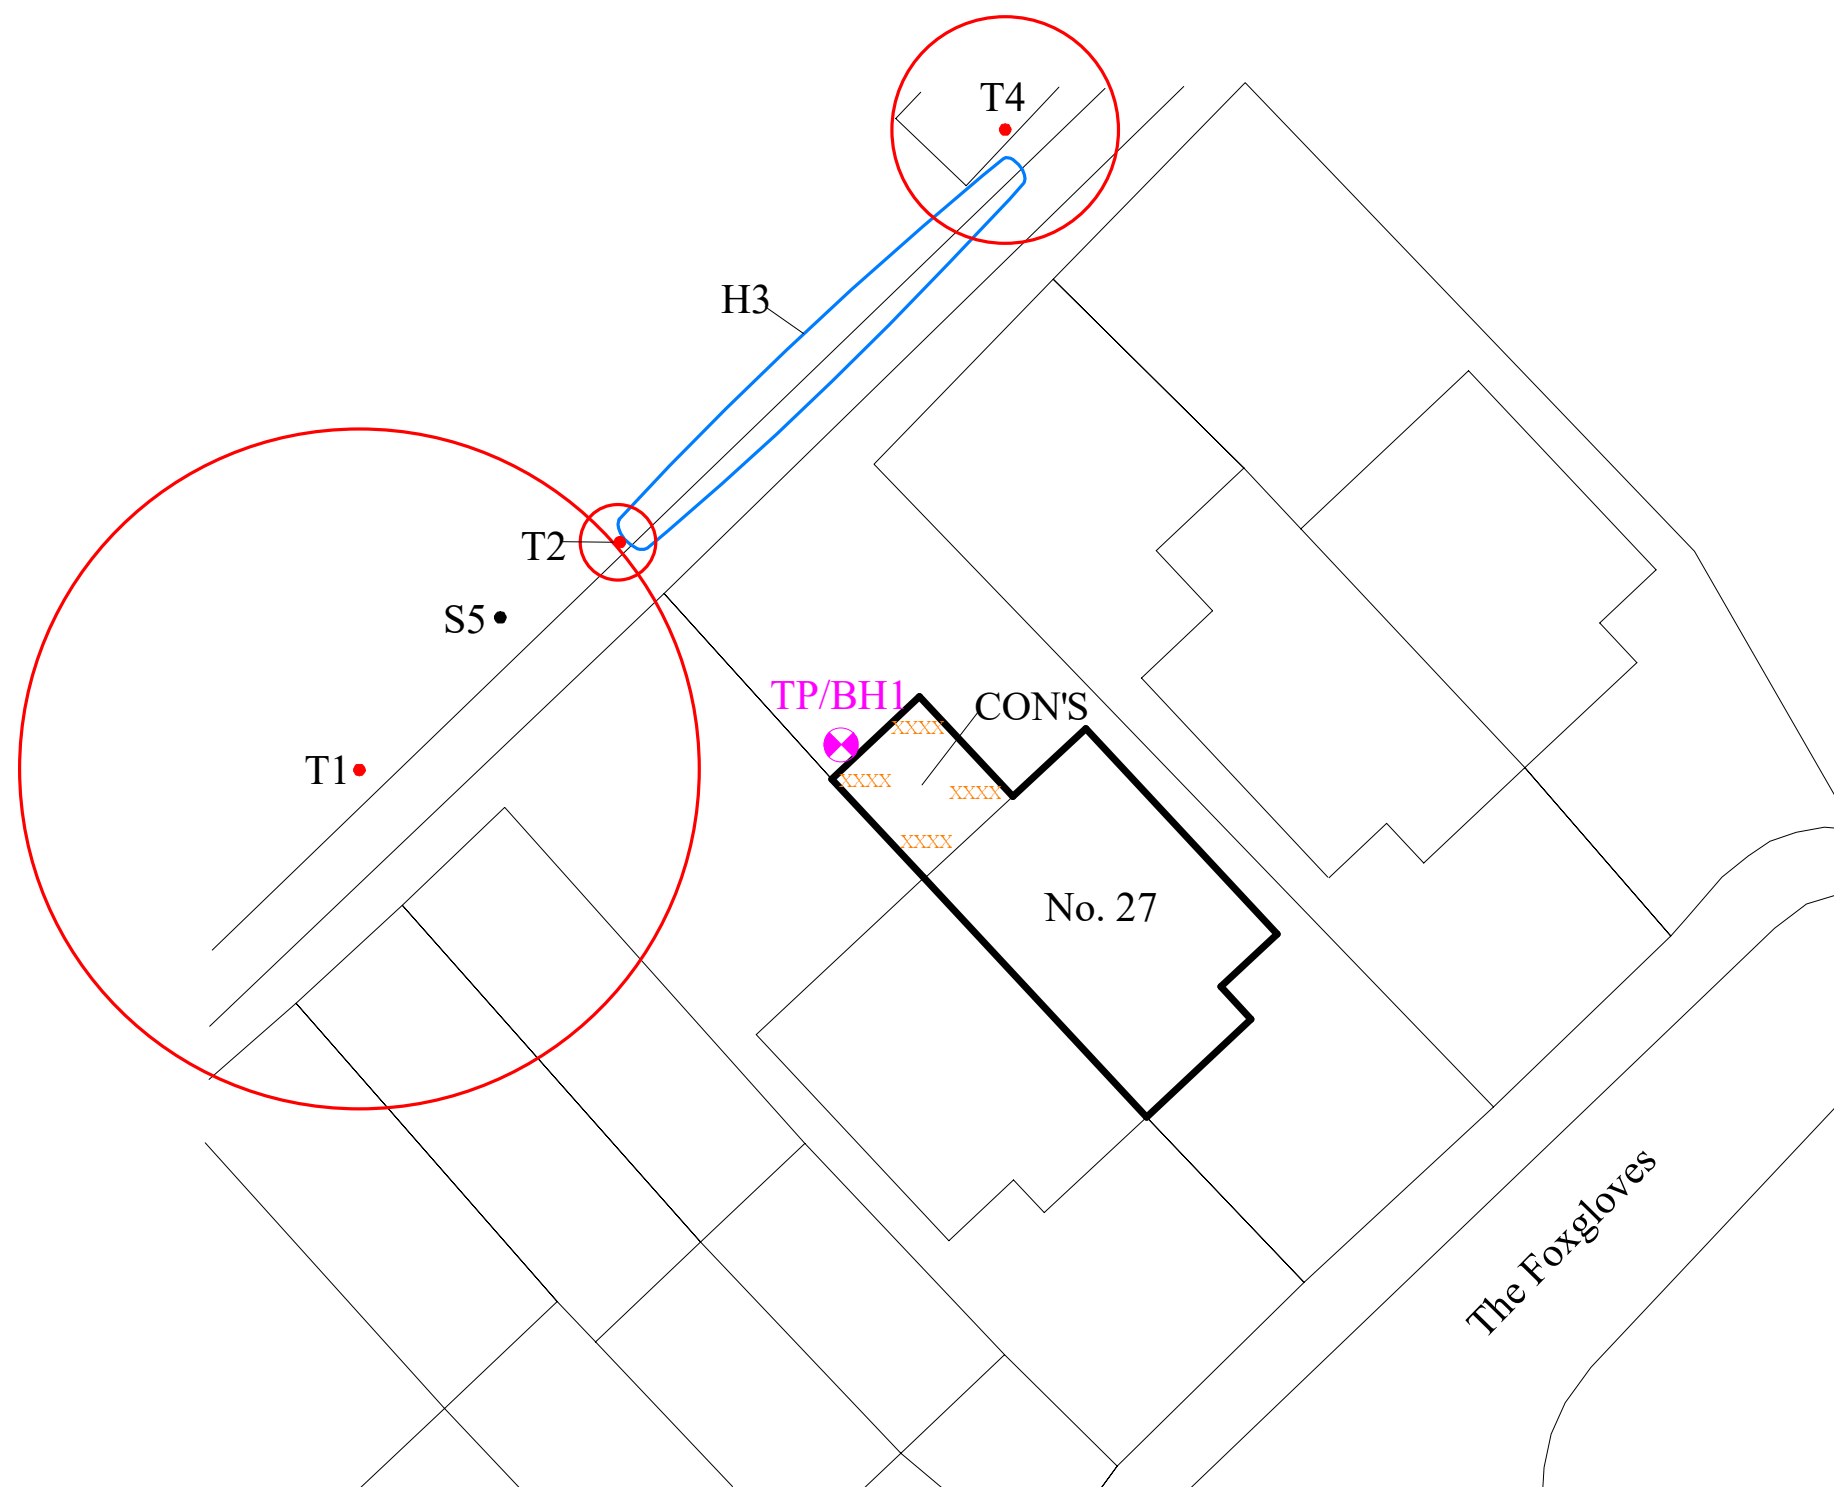
## Appendix 2: Site Plan

- 6.1 Having made a detailed survey of the site and given due consideration to the other information available, it is likely that subsidence damage is still occurring as a result of drying shrinkage caused by vegetation within influencing distance of the property.

- 6.2 This follows the partial removal of **T1** and the complete removal of **T2**, as identified by these tree numbers in the JCA Arboricultural Report Ref: **20603/AJB**. It should be noted that **T1**, detailed as **T2** within this report, was not removed completely and it has regrowth, indicating that the tree was not treated to prevent regrowth.

- 6.3 We have therefore recommended that **T1**, **T2** and **T4** be removed to ground level and that the stumps be treated to prevent regrowth.
- 6.4 As these are Third Party owned trees, the owner will require sufficient proof that the trees are contributing to the damage. In this case we have evidence of:

- 6.5 We consider the vegetation identified as **H3** to be of possible future concern to the subject property, if left unmanaged. We have therefore recommended that **H3** be maintained at its current height and spread over the forthcoming years. This work is only recommended as a precaution and is not considered a priority to resolve the damage observed at the subject property.
