## TREE INSPECTION REPORT

**Site:** 2 Rufus Close, Chandlers Ford, Hampshire, SO53 1FL.

**Date:** 10<sup>th</sup> October 2025

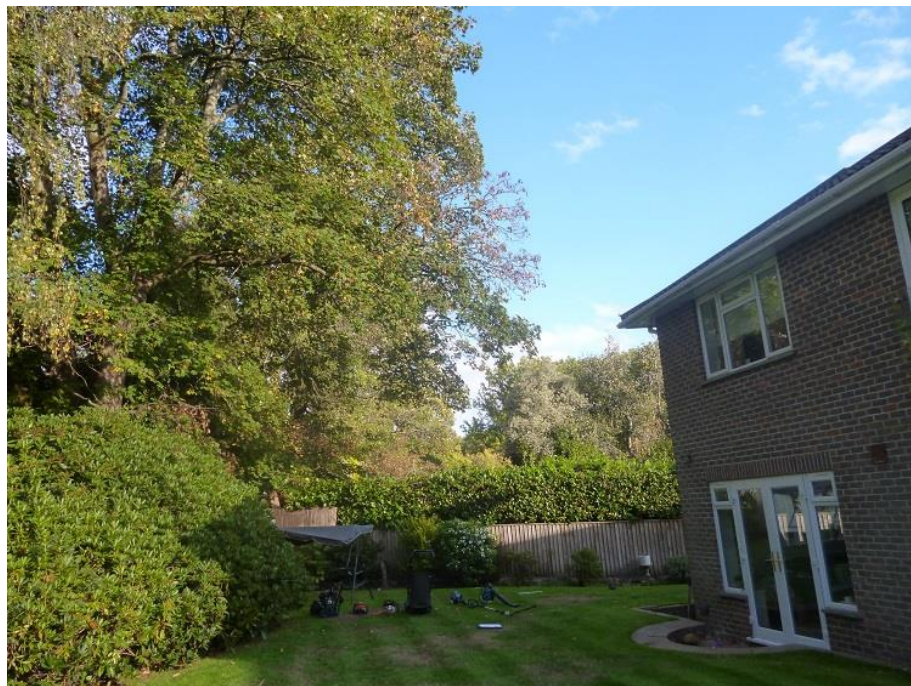
- 2.3 The tree was in good physical condition with good leaf cover and size.
- 2.4 Figure 1 Photo of Sycamore tree:

- 2.5 Structural condition was fair with the multi-stemmed union being sound and open. No cavities or decay was visibly present on the stems or within the crown considering the inspection was undertaken from ground level. For a fuller inspection of the crown, it is suggested that a full climbing inspection be undertaken by a qualified tree contractor.

- 3.2 Therefore, it is recommended that the tree be reduced in size only where appropriate. Details are as follows. Crown reduction of 2.5-3m on the north, south and west sides, with the height of the crown reduced by 3-4m. The crown on the east side is already smaller than the rest of the crown and is not necessary to carry out any work here. This will keep the crown balanced. Any dead wood within the crown can also be removed as part of good husbandry.

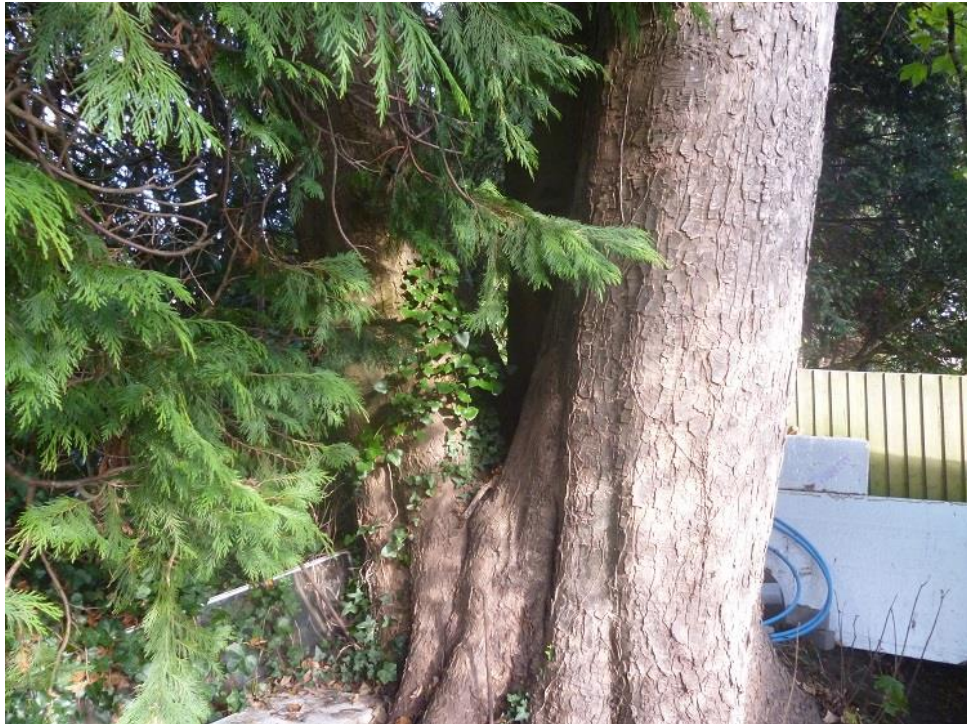
- 2.6 Exposed surface roots were noted on the south and east sides close to the stem. This is not a defect but just an observation. Minor dead wood and stubs were present on the stems and within the crown less than 10mm in diameter which is totally natural for a mature tree. Small old pruning wounds were noted on the stems occluding and occluded with no signs of decay.
- 2.7 Figure 2 Photo of multi-stemmed union.
