## Demolition / Refurbishment Asbestos Survey Report

Botley Parish Council

Workshop / Stores  
The Botley Centre  
High Street Recreation Ground  
Botley  
SO30 2ES

2<sup>nd</sup> September 2026

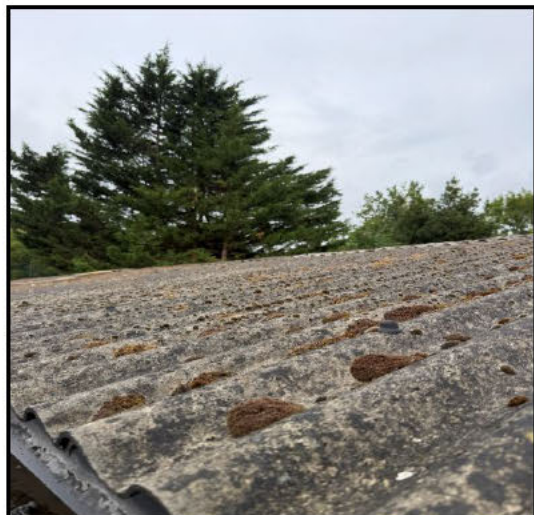
Sample Ref: B01 Location: External

Material Sampled: Cement (new-fibre) roof sheets

Analysis Result: **No Asbestos Detected**  
Approximate Quantity:  
Product Type:  
Condition:  
Surface Treatment:

Material Assessment Score: **0**

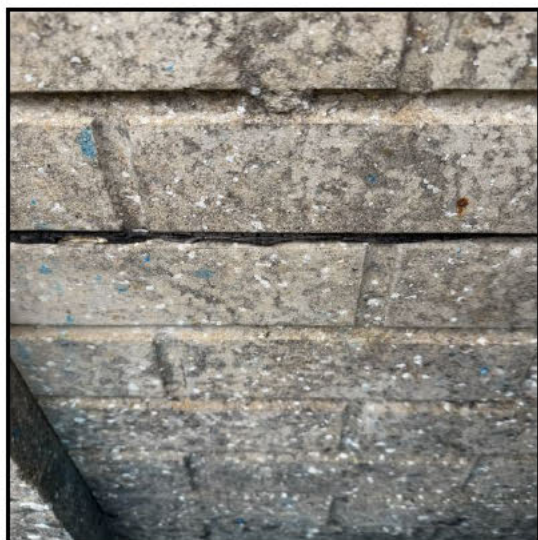
Sample Ref: B02 Location: External

Material Sampled: Mastic between wall panels

Analysis Result: **No Asbestos Detected**  
Approximate Quantity:  
Product Type:  
Condition:  
Surface Treatment:

Material Assessment Score: **0**

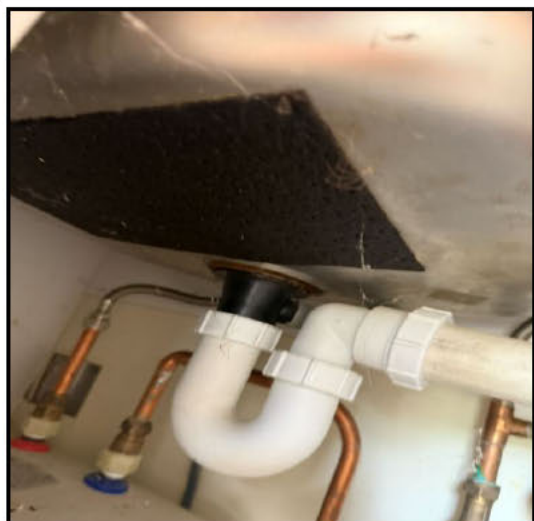
Sample Ref: B03 Location: Office/Kitchen

Material Sampled: Sink Pad

Analysis Result: **No Asbestos Detected**  
Approximate Quantity:  
Product Type:  
Condition:  
Surface Treatment:

Material Assessment Score: **0**
