# PHASE 1 DESK STUDY

**LAND AT BOORLEY GARDENS,  
FIELDFARE ROAD, BOORLEY GREEN,  
HEDGE END, HAMPSHIRE SO32 2BX**

**23/12718/GO**

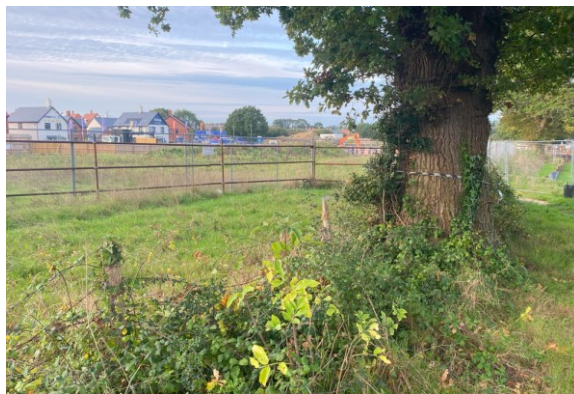
**Mature oak tree from public footpath**

The site is indicated as being within an area of moderate risk of shrink/swell hazards associated with the underlying Wittering Formation. The presence of two mature oak trees on the northern site boundary is likely to influence foundation design depending on the proximity of the proposed structure.

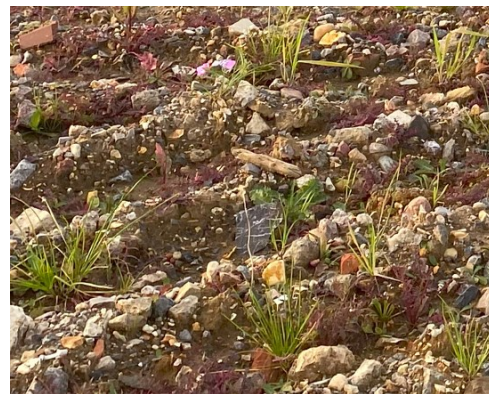
site has coarse and cobble-sized fragments of brick, concrete stone and other rubble evident at surface with storage of building bricks and blocks noted along the western edge of the site.

**Rubble at surface in west of site**

The presence of rubble at surface in the west of the site is presumably a temporary solution to assist in the storage of materials for the adjacent development. It should be appreciated however, that coarse or cobble-sized fragments of rubble, brick or concrete are unsuitable in areas of soft landscaping or gardens. This can be addressed as part of the normal ongoing development of the site.

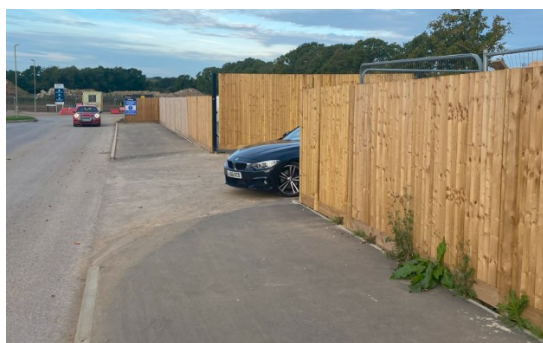
**View west along Fieldfare Road with secure access to wheelwash beyond gate**

The site has evidently had some itinerant use for storage of building materials and a wheelwash system however, these are both considered to be low risk activities. The wheelwash is a closed loop system with integral settlement tanks for separate off-site disposal of silt.

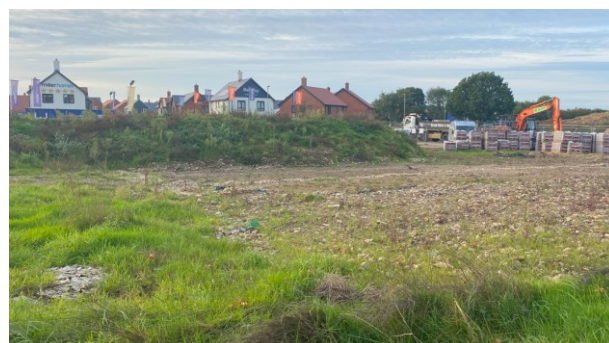
The mounds of earth noted on earlier street view imagery are still present, now being vegetated and are presumably comprised of site won materials which were excavated as part of the adjacent construction of Fieldfare Road. During the visit several photographs were taken which provide a general impression of the site at the time of the visit and these are included as Figure 2 and a selection below.

**View of site looking south west with earth mound evident and wheelwash obscured behind**

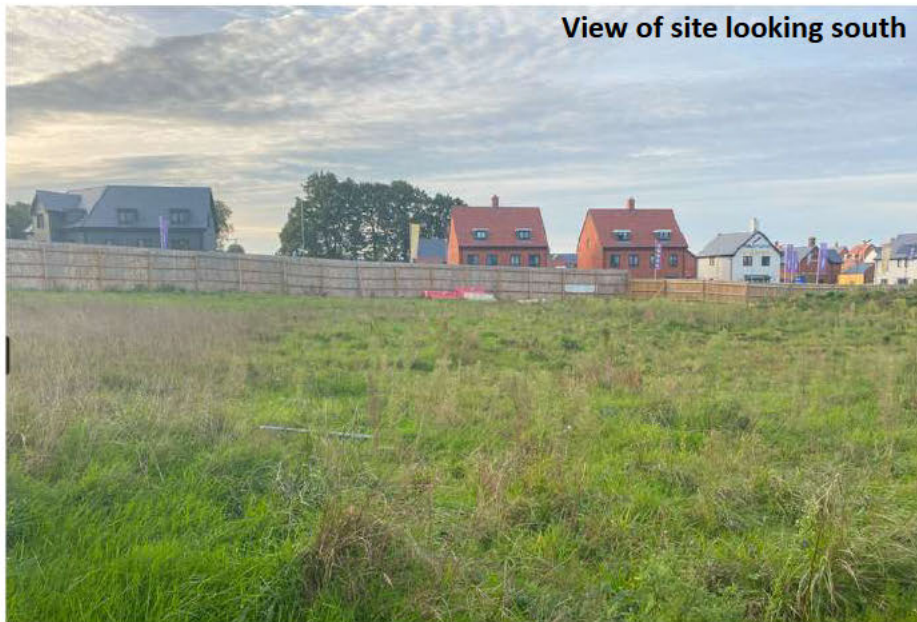
**View of site looking south**

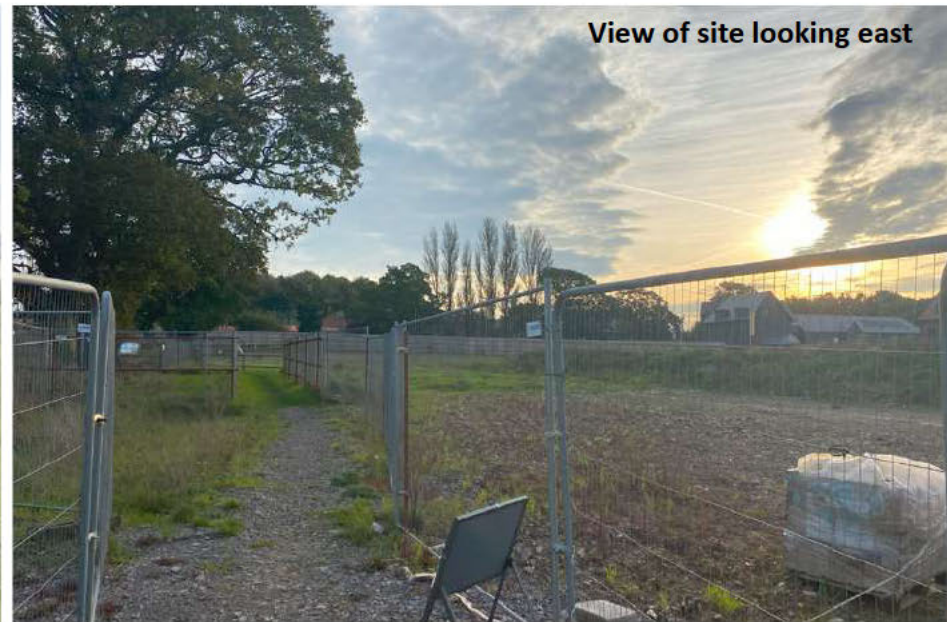
**View of site looking east**

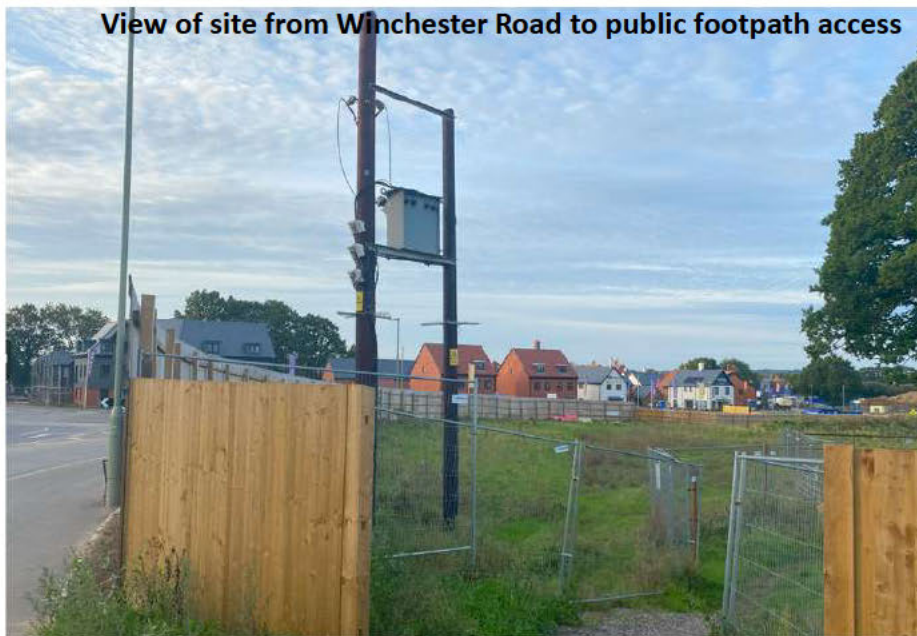
**View of site from Winchester Road to public footpath access**

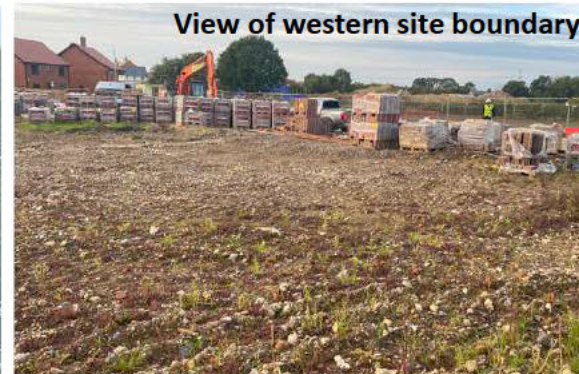
**View of western site boundary**

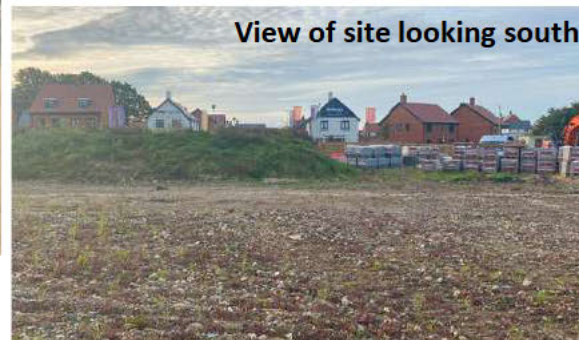
**View of site looking south**
