**Tree condition and hazard survey of two oak trees**  
**at**  
**Broomhill Allotment site, Boyatt Lane, Eastleigh**

8<sup>th</sup> September 2026

Allbrook Parish Council

J1720

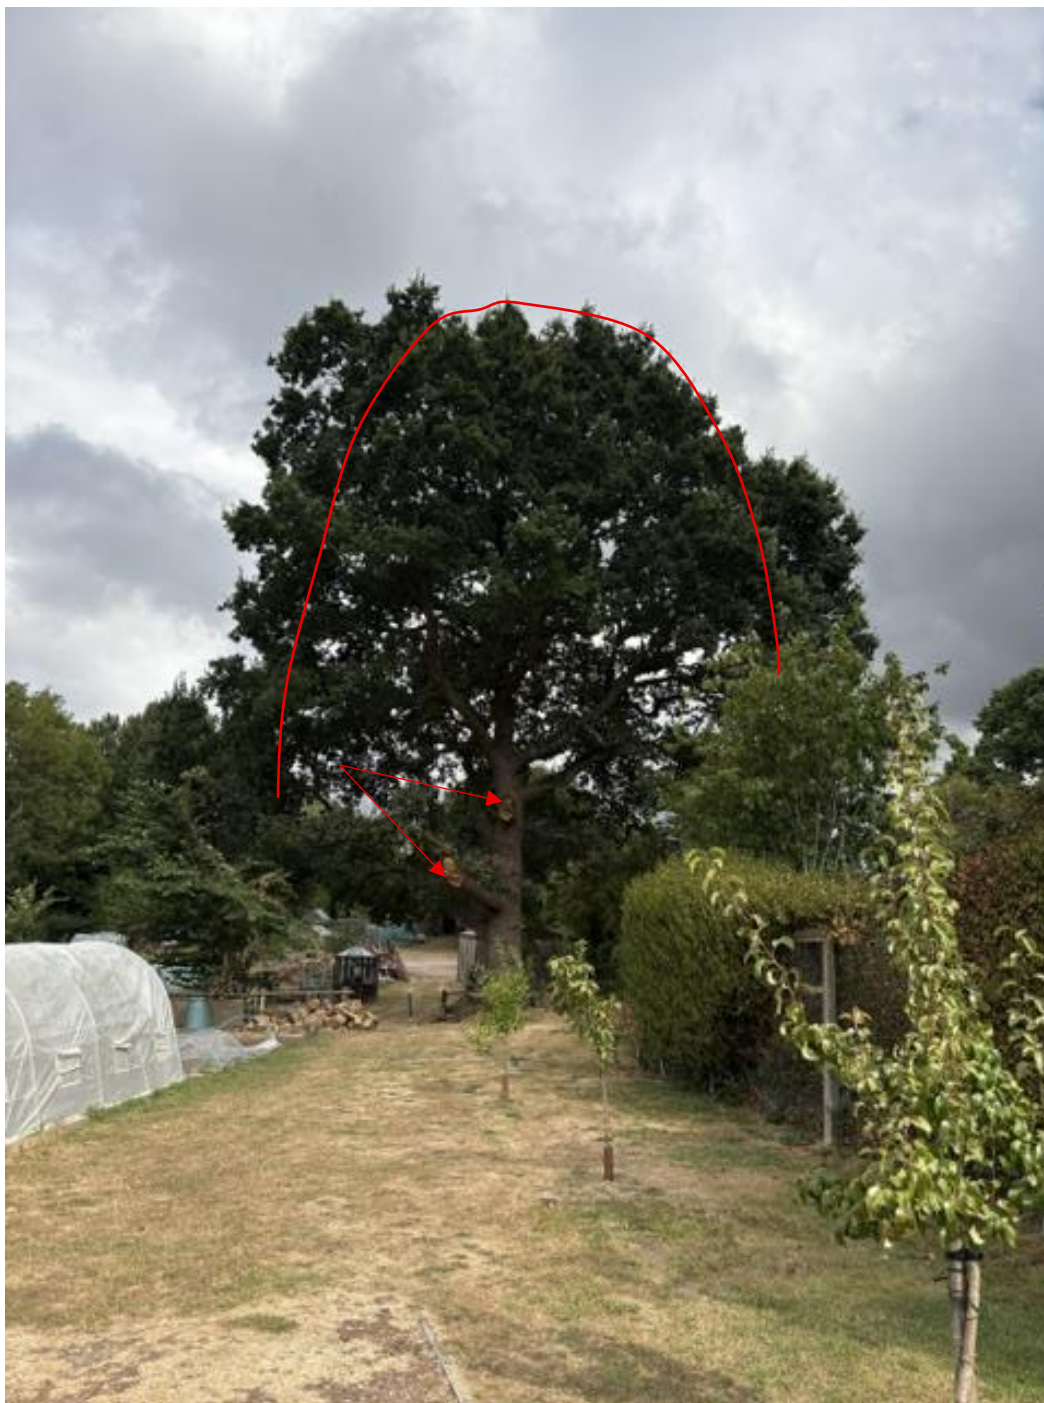
- 6.3 Decay from fungi can reduce the structure of the tree increasing the potential for branch, stem, or root-plate failure. Remedial works to reduce the weight and leverage may be appropriate to reduce the risk if the physiology of the tree is good. However, if there are numerous trees in the local area, or the tree is of poor vitality and unlikely to recover, it may be more appropriate to remove the tree to allow adjacent trees to develop or new trees to be planted. In this instance, T1 is subject to decay from *Fistulina hepatica*. In the particular circumstance of T1, I believe that the risk of branch failure from this tree is likely unless remedial works are implemented.

| Designation | Reference number | Species | Height (m) | Age class | Physiological condition | Structural condition | Condition notes | Condition related tree works | Priority |
|---|---|---|---|---|---|---|---|---|---|
| T | 1 | Oak <i>Quercus robur</i> | 22 | Mature | Good | Poor | Typical occasional moderate (25 to 100mm diameter) deadwood throughout. Two recent branch failures on the south side at c7m and c4m with potential brown rot. Three branches on the north side at c12m, c7m, and c3m with cavities close to the stem and subsequent decay (dry space habitat) from historic pruning or prior branch loss. Brown rot cavity on north side at to c1m height. Good prop root development into the ditch to the south. <i>Fistulina hepatica</i> (brown rot) at the base to the north west. | Tip reduction of branches to an even 8.5m horizontal radial canopy spread tapering with height to create a 'natural' dome shaped canopy whilst reducing the risk of branch failures. Remove deadwood more than 20mm diameter. Crown lift to 4m with a maximum wound diameter of 60mm. | Moderate |

SAL2 T1 with two branch failures identified by red arrows. Red line annotates the approximate remedial works for tip reduction for T1.

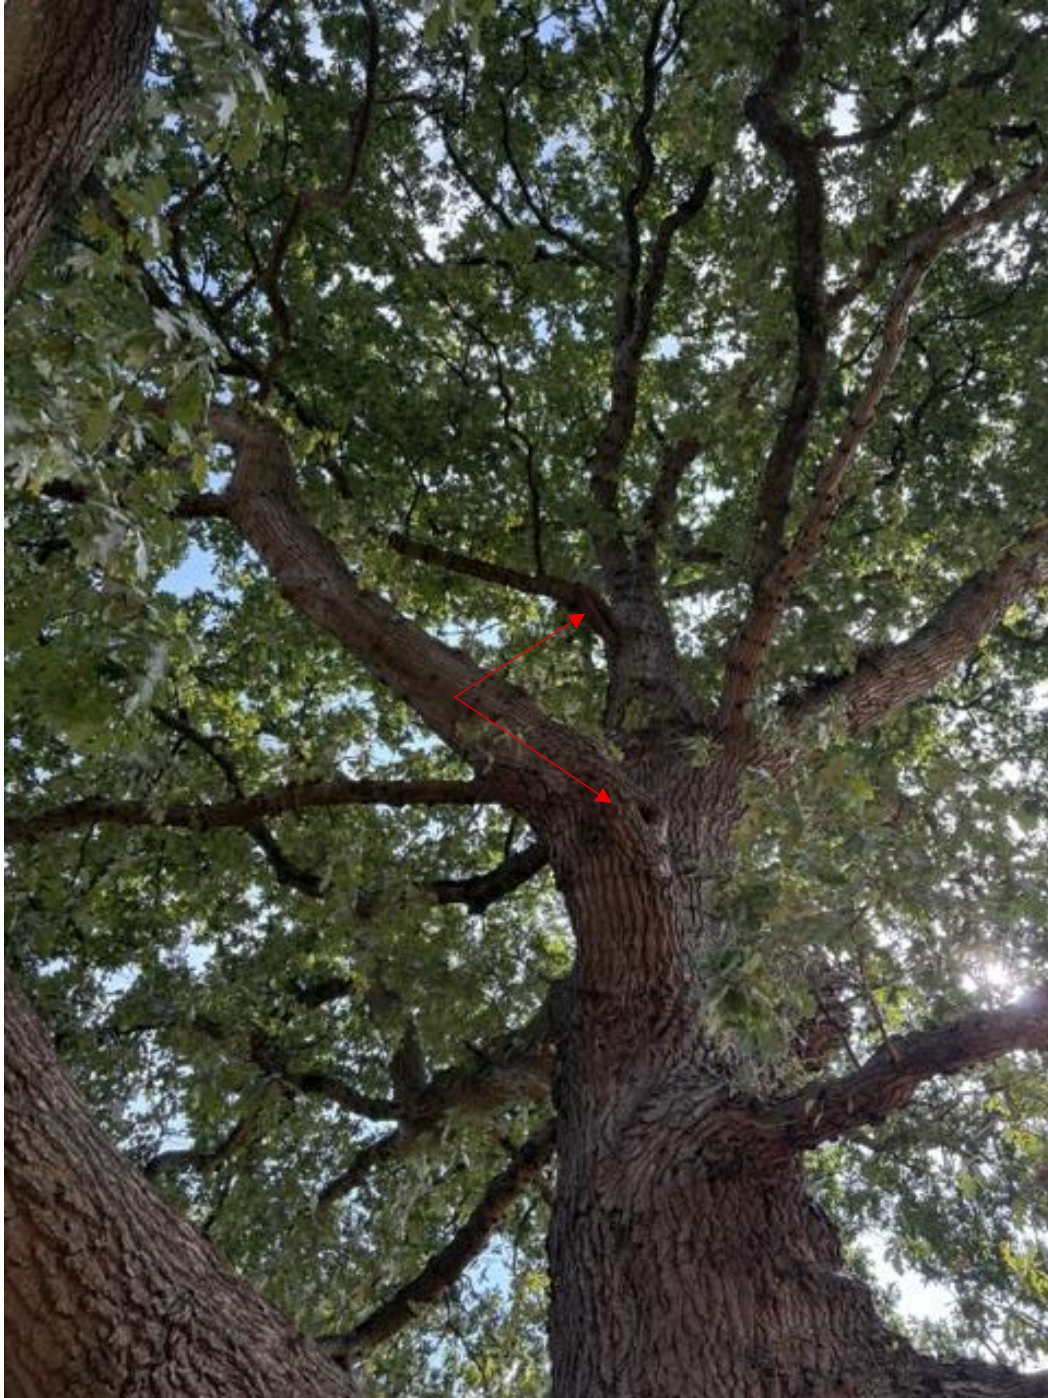
- 6.4 Cavities indicate that decay of the wood has occurred (see point above). This is a normal process and may not be of particular concern depending upon the extent of decayed stem. However, if the cavity / extent of decay is advanced or significant, then failure may occur and remedial pruning or removal may be appropriate prior to such failure(s).

SAL3 T1 and the upper and mid level additional cavities on the north side identified by red arrows.

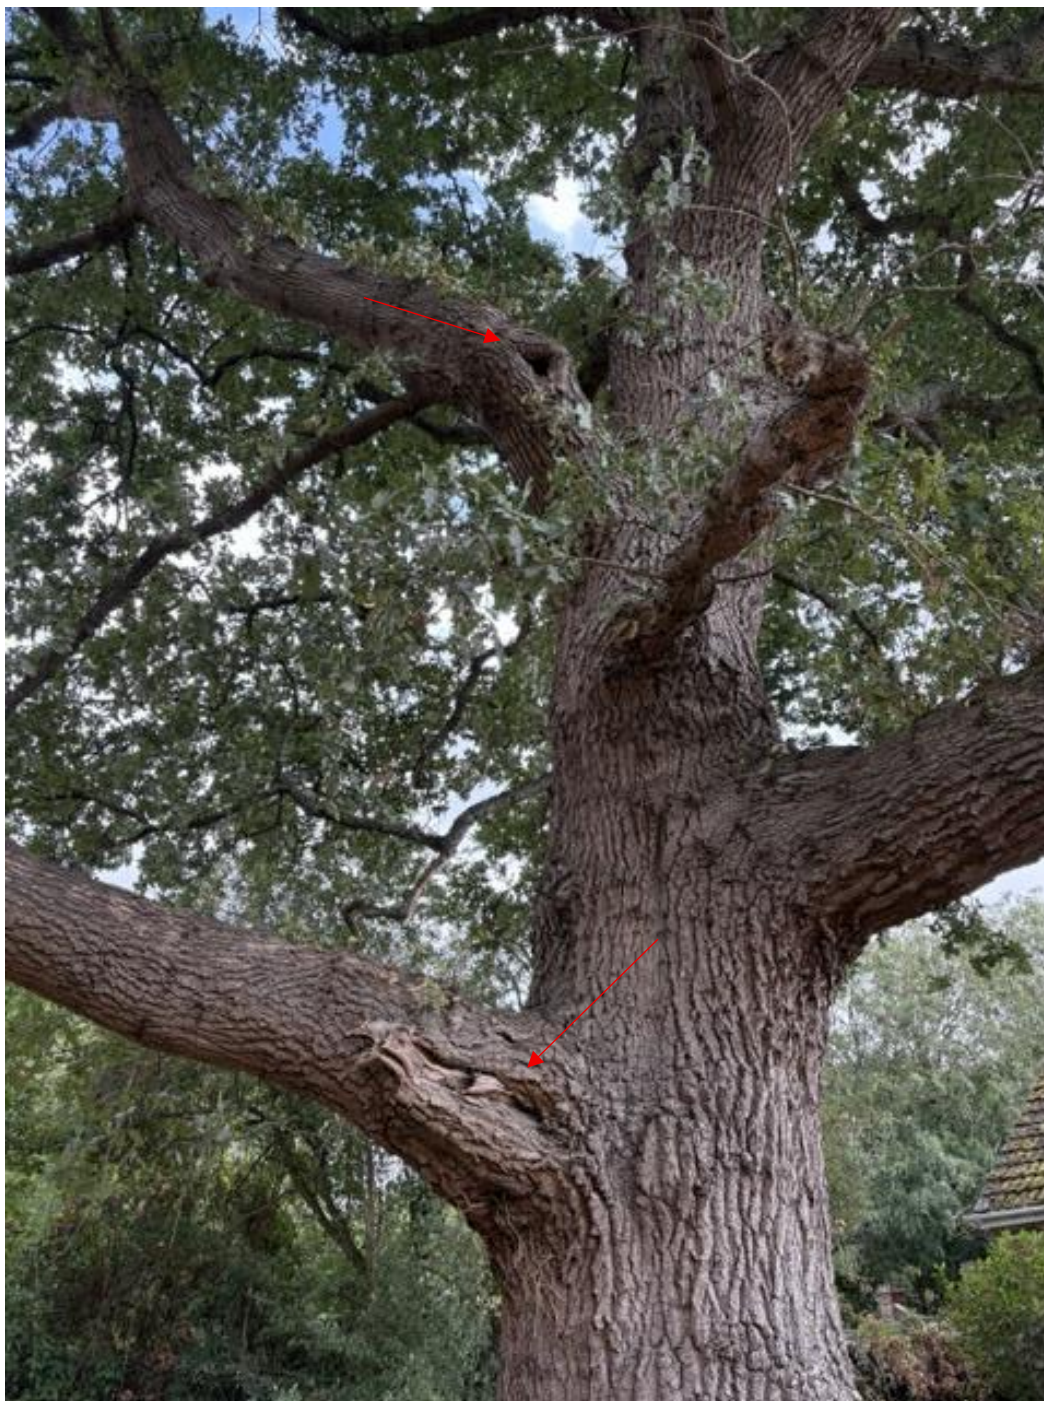
SAL4 T1 and the mid and lower level additional cavities on the north side identified by red arrows.

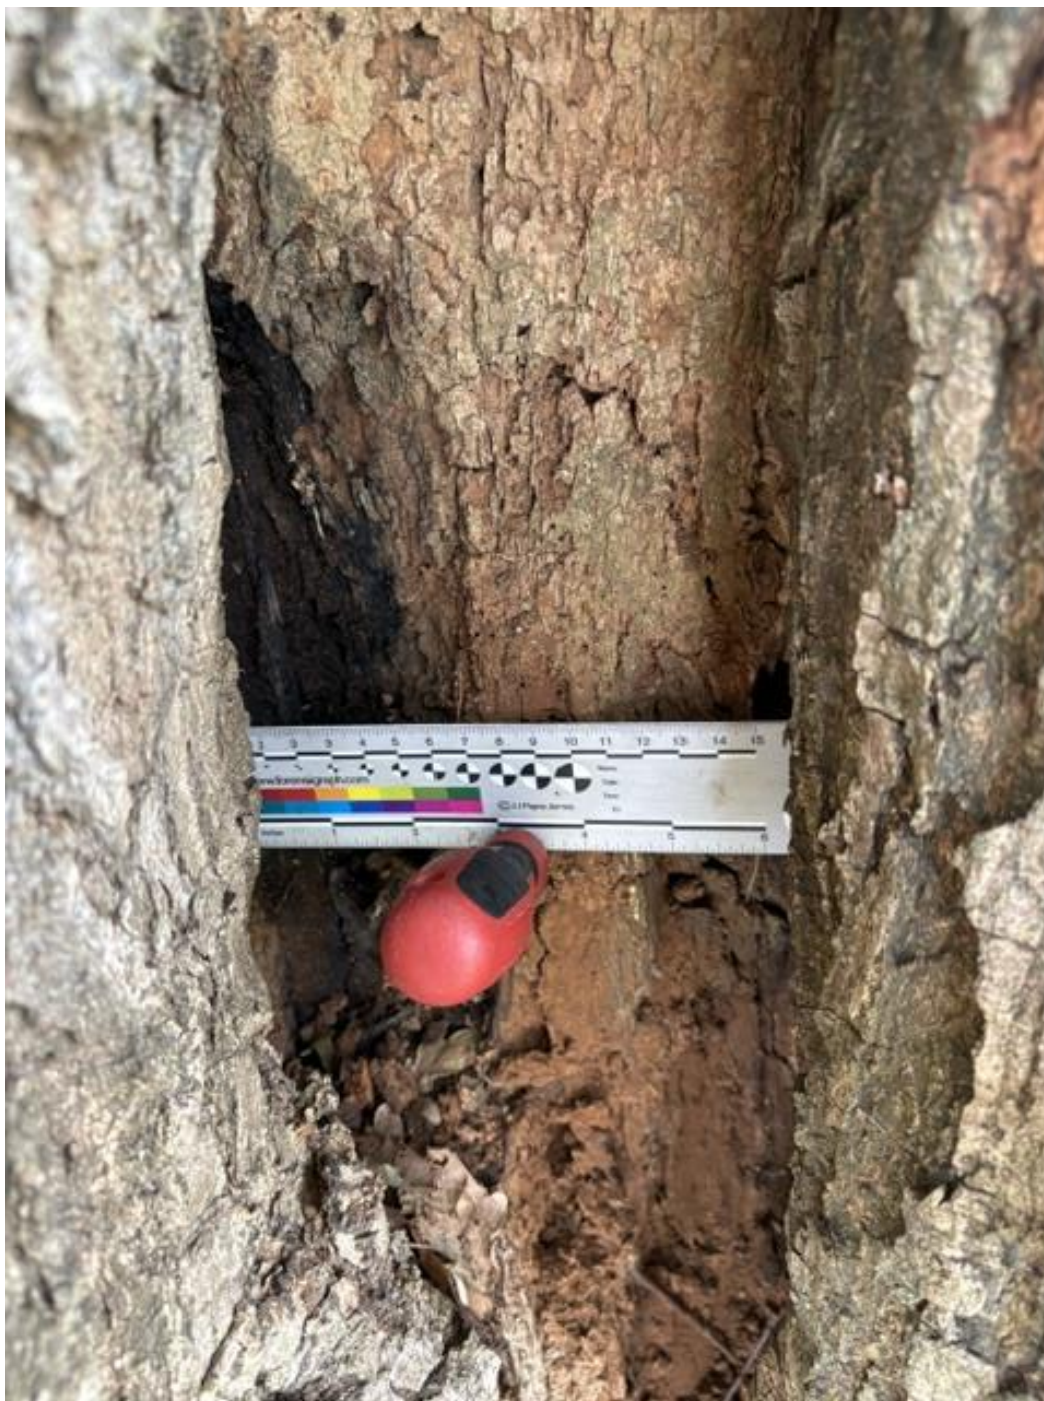
SAL5 Cavity at base of T1.

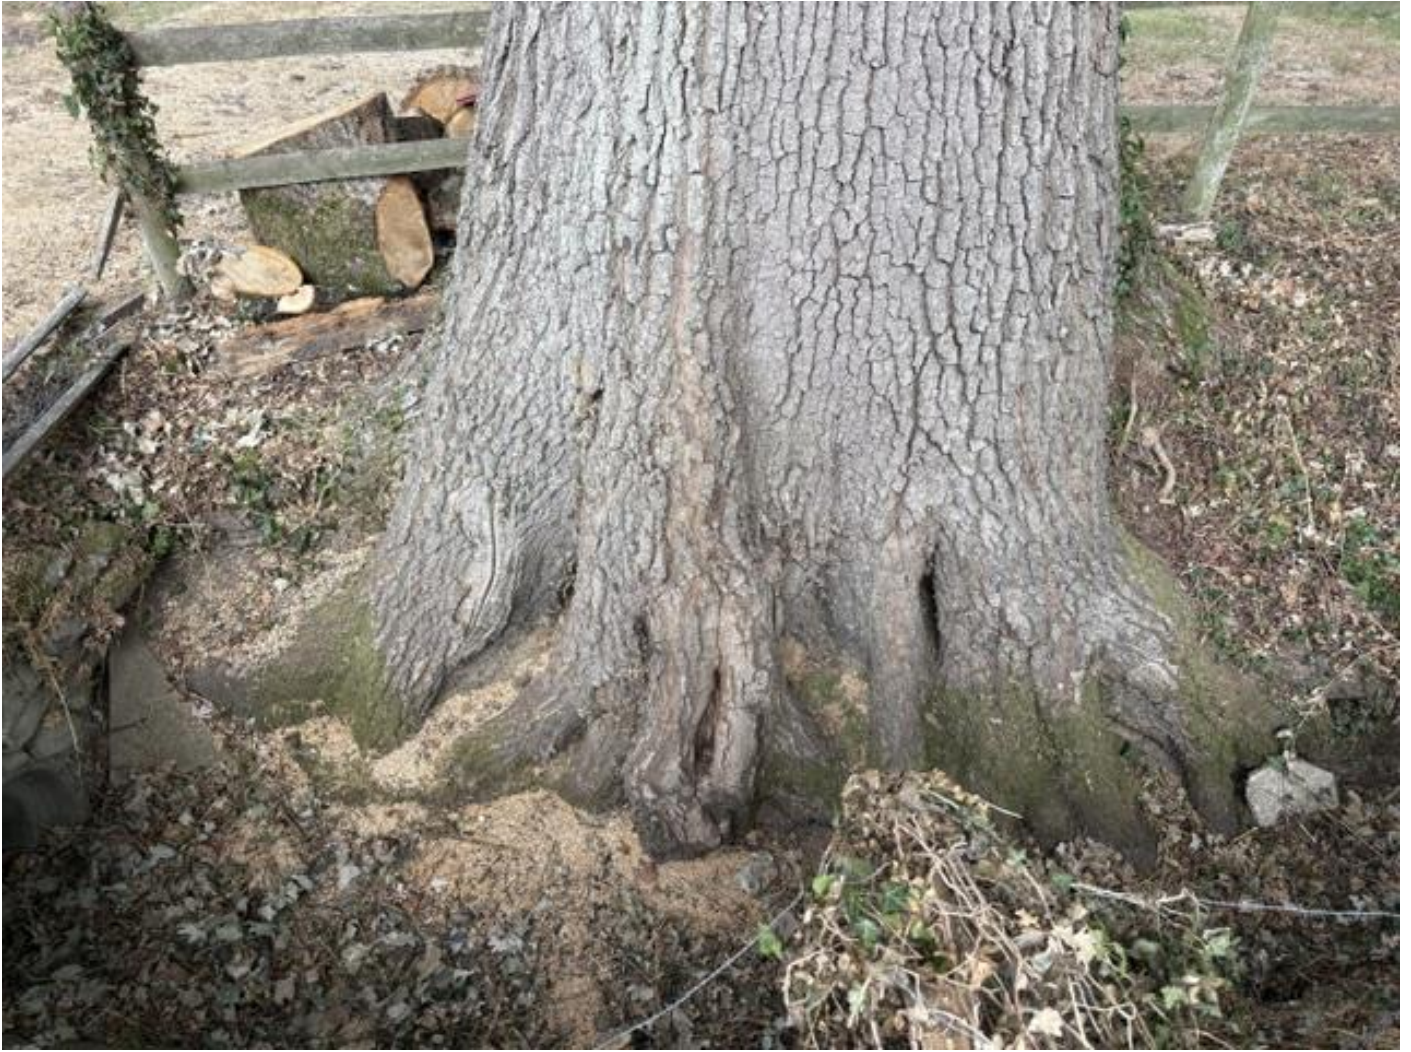
SAL6 T1 and prop root development to the south into the ditch.

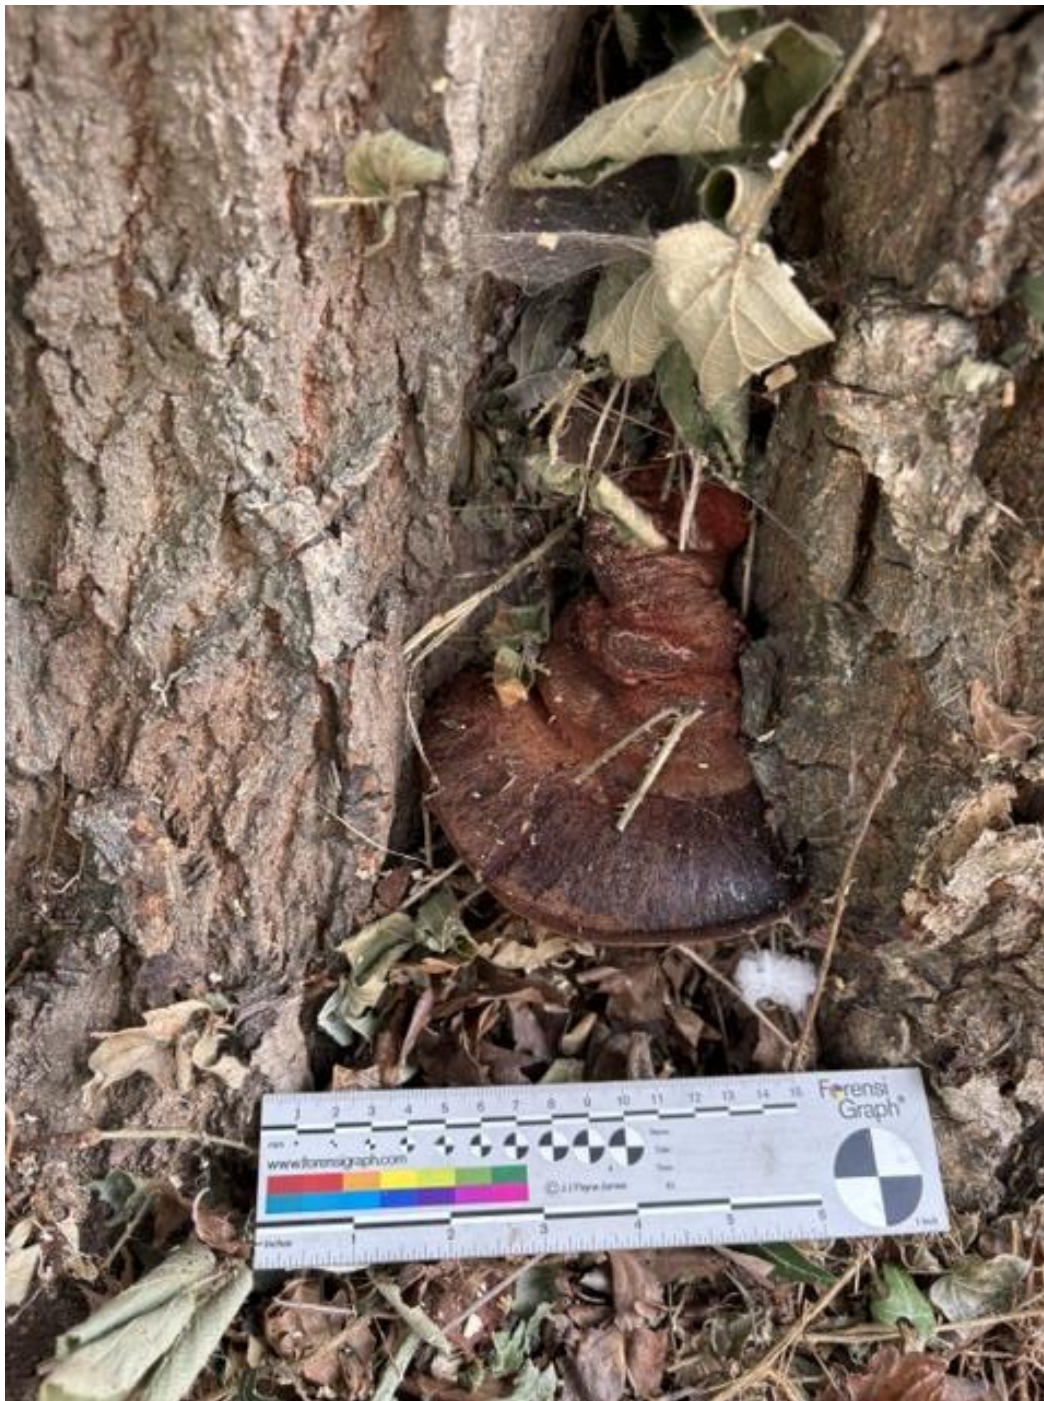
SAL7 T1 and *Fistulina hepatica* at base to northwest.
