ARBORICULTURAL ASSESSMENT OF KINGS  
COURT MASONIC CENTRE, 81  
WINCHESTER ROAD, CHANDLER'S FORD,  
SO53 2GG

Carried out by Matthew Rowden for Richard  
Piatkiewicz, applicant.

## TREE CONDITION ASSESSMENT - PHOTOGRAPHIC APPENDIX

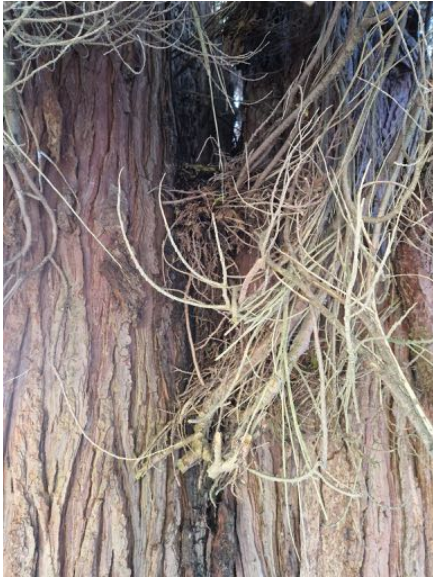
3. **Principal basal/lower-stem union.** Between approximately 2-4 m the tree divides into three substantial co-dominant stems around a pronounced included union. This is considered a defect of high significance. Smiley (2003) demonstrated a statistically significant reduction in the strength of co-dominant unions containing included bark. The consequence of failure at this position would be particularly significant because it could involve the loss of a very substantial proportion of the tree.

Photograph 1 - Included union and congested multi-stemmed structure within the lower crown.

Felling and replacement therefore represents the most proportionate long-term management option. Replacement should comprise a smaller-growing, high-quality specimen appropriate to the wooded setting, such as yew (*Taxus baccata*), Japanese Stewartia (*Stewartia pseudocamellia*) or Tibetan cherry (*Prunus serrula*). This would maintain long-term canopy and landscape continuity without recreating the present conflict between tree size, building proximity and occupation of the site.

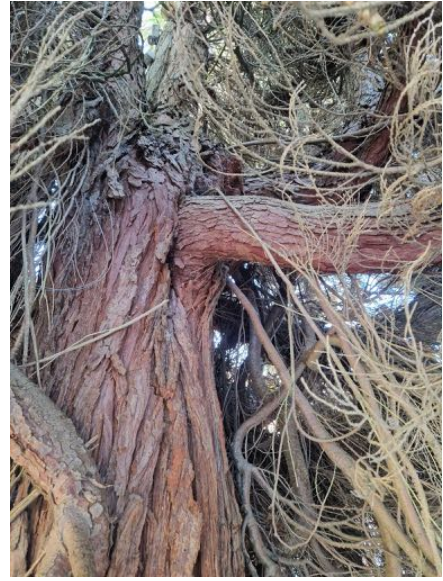
5. **Lateral limb attachments.** Lateral limbs at approximately 4 m on the southern aspect exhibit pronounced "ball-and-socket" style attachment morphology, assessed as being of moderate structural significance. These occur in addition to, rather than instead of, the more significant co-dominant unions and contribute to an overall pattern of structurally compromised architecture.

Photograph 2 - Major lateral attachment showing acute union morphology and locally disrupted adaptive growth.

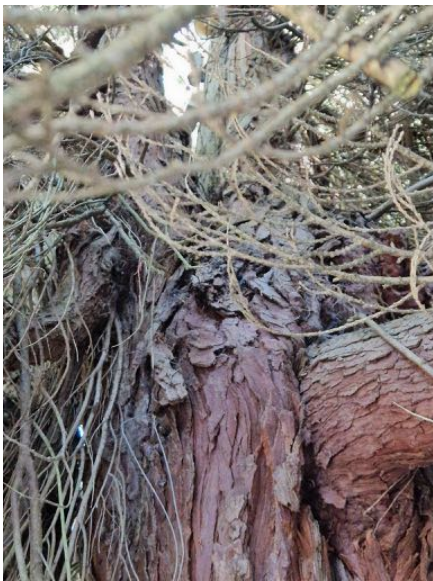
Photograph 3 - Detail of the principal union and associated bark morphology.

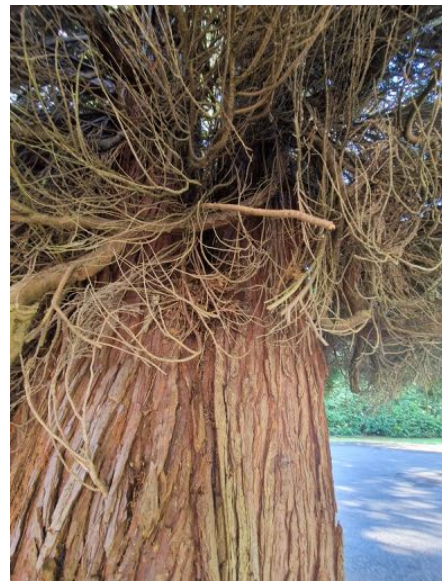
Photograph 4 - Dense internal crown structure and dead/shaded secondary branchwood.

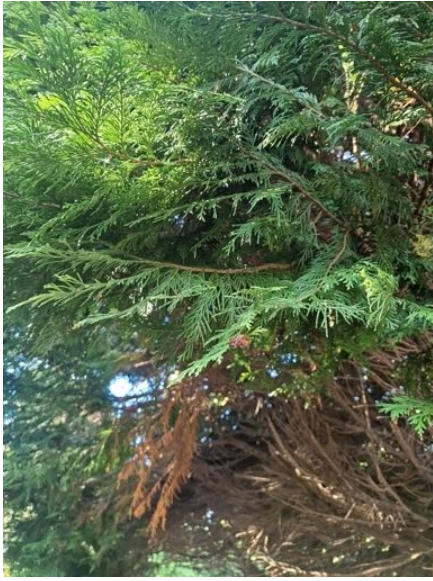
7. **Physiological condition.** Current canopy vitality remains good. This provides some physiological value but does not negate the structural defects described above. A vigorous crown may, conversely, continue to increase the dimensions, mass and lever arms associated with the already defective structural framework.

Photograph 5 - Foliage detail confirming good current canopy vitality.

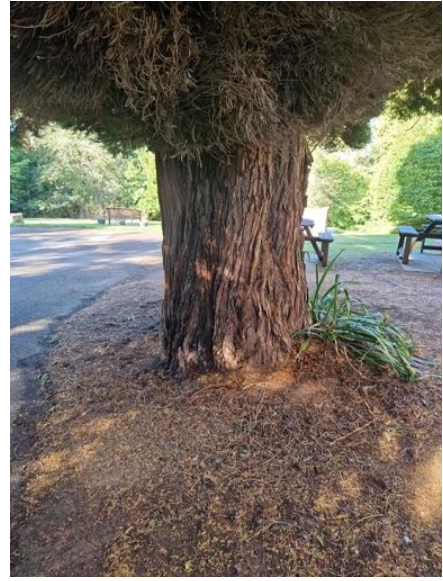
1. **Rooting environment and proximity to the building.** Exposed lateral roots are evident on the northern aspect extending towards the near face of the structure. The building lies within approximately 9 m of the stem. The 16 m tree therefore stands substantially closer to the building than its theoretical 20 m zone of influence when applying the  $1.25 \times$  height criterion used for high-water-demand trees. NHBC guidance applies a lateral zone of influence of  $1.25 \times$  mature height to high-water-demand species.

Photograph 6 - Basal stem and rooting environment adjacent to hard surfacing.

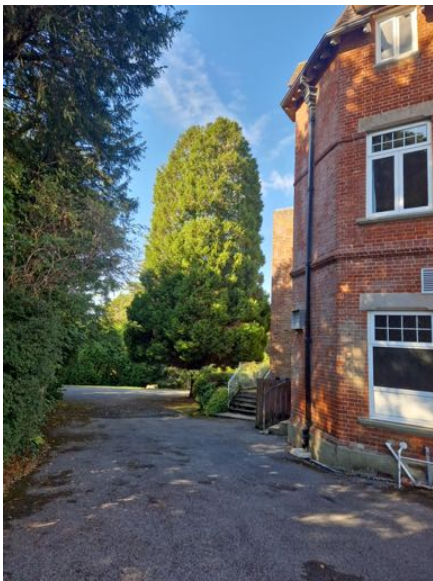
9. **Amenity value.** The amenity cost of removal is comparatively limited. The tree is set internally within densely wooded grounds and does not appear to make a significant contribution to the public street scene. The location plan confirms its enclosed position adjacent to the building rather than prominently on the Winchester Road frontage. Its loss would consequently be substantially absorbed by the surrounding mature vegetation.

Photograph 7 - Context view showing the tree within the densely wooded grounds and its relationship with the building.
