## SITE MONITORING REPORT SHEET

| <b>Site address:</b><br>Fieldfare Avenue, Boorley Gardens, Hedge End |
| <b>ACD Project Ref:</b> PRI24389 |

ACD Environmental Ltd. (ACD) conducted a site monitoring visit on 31/07/2026 for the development at Fieldfare Avenue, Boorley Gardens, Hedge End to address Condition 9 of the Planning Approval (ref: F/23/96629).

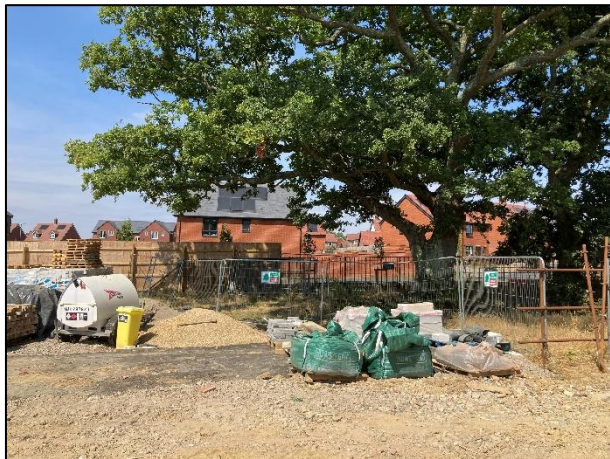
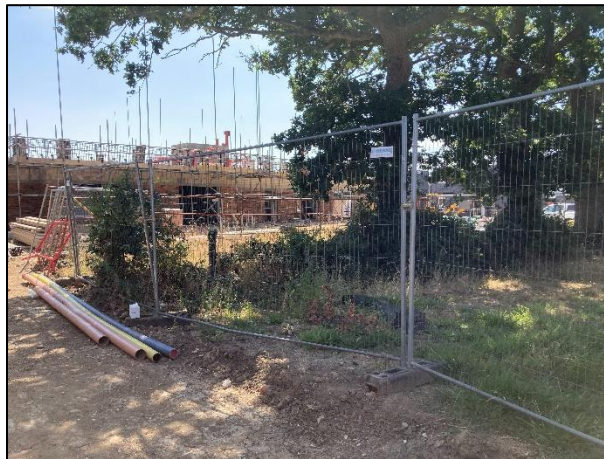
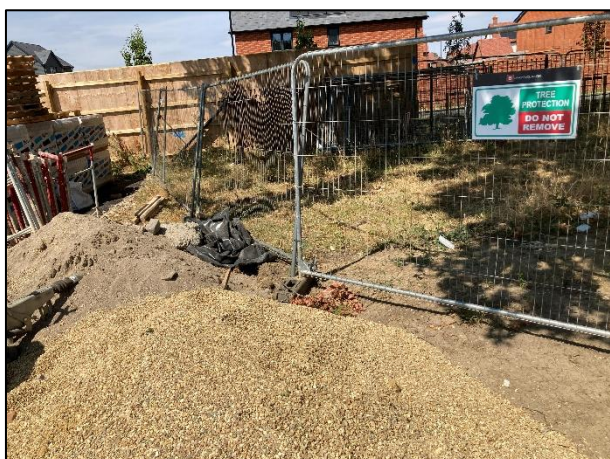
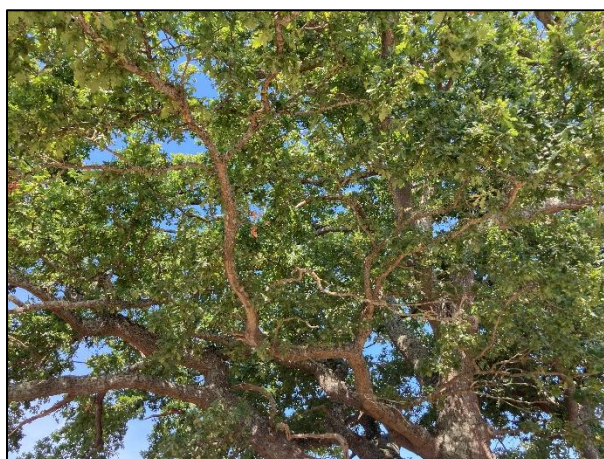
G14.1 – G14.3

#### **G14.1 – G14.3:**

- Trees seen to be in good outward health with vigorous leaf flush and no indicators of stress of dieback.
- x1 large deadwood piece over 50mm<sup>Ø</sup> visible from site office in mid-eastern crown aspect.

- Southern fencing is present and braced.
- Previous additional fencing to south has been removed for site logistics. Original braced fencing alignment remains.

- Eastern fencing is unbraced.
- Western fencing has been realigned 0.5m from Cellular Confinement Surfacing (CCS) surfacing within RPA in accordance with Tree Protection Plan. Fencing also partially covers area of future bin-store, but some soft ground exposed still. Re-aligned fencing has attached signage but currently un-braced. Fencing alignment showing signs of distortion as development traffic uses the area over CCS for material storage.

- Area of CCS surfacing previously installed has been covered with temporary sacrificial tarmac until installation of final wearing surface which has been confirmed will be of a porous design. Sacrificial tarmac to act as adequate ground protection.

- Development materials sited on sacrificial tarmac and within soft ground of RPA.
- Northern boundary treatment is in place and to act as suitable protective fencing alignment.

- **ACTION:**
    - Braced all tree protection fencing in correct position as shown on Tree Protection Plan.
    - Install adequate ground protection in areas as shown on Tree Protection Plan or fence area of soft ground within RPA off.

- Remove development material from soft ground within RPA.

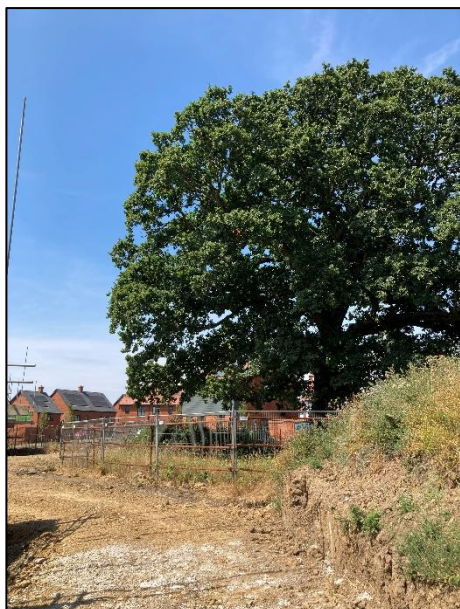
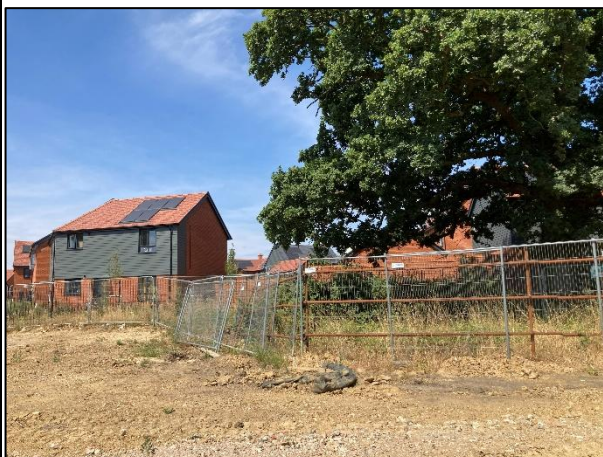
T19

#### **T19:**

- Tree seen to be in good outward health with vigorous leaf flush and no indicators of stress of dieback.
- Northern boundary treatment is in place and to act as suitable protective fencing alignment.
- Fencing alignment considered adequate with the exception of section to west which is unbraced.
  - **ACTION:**
    - Install bracing for western protective fencing alignment.
    - Ensure 'Tree Protection Fencing' is aligned as per Tree Protection Plan and signage is attached to correctly aligned/braced fencing.
