## SITE MONITORING REPORT SHEET

| <b>Site address:</b><br>Fieldfare Avenue, Boorley Gardens, Hedge End |
| <b>ACD Project Ref:</b> PRI24389 |

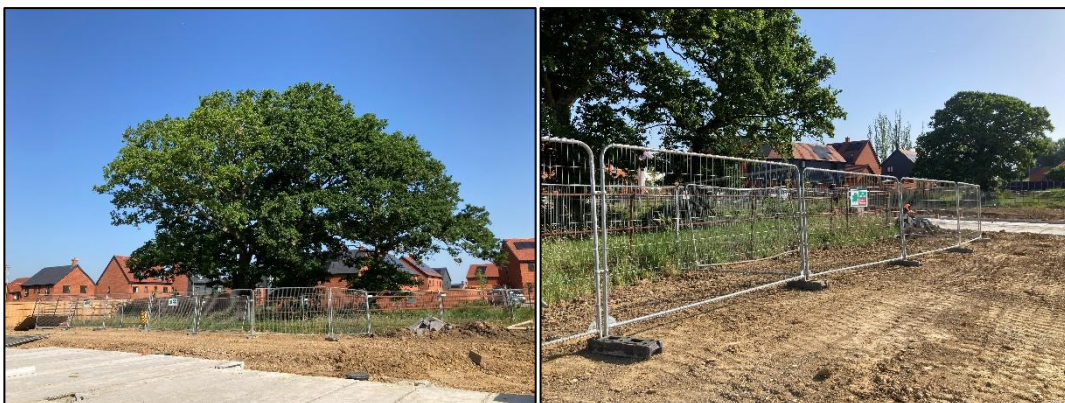
G14.1 – G14.3

- Trees seen to be in good outward health with vigorous leaf flush and no indicators of stress or dieback.
- Northern boundary treatment is in place and to act as suitable protective fencing alignment.

- Existing remaining protective Heras fencing alignment in-situ around trees G14.1, G14.2 and G14.3. Fencing mostly fully braced with scaffold framework, though areas to the east and west unbraced.

- Earthworks over existing ground levels observed to south of fencing alignment to allow for development logistics.
- Additional unbraced fencing alignment erected to the south of existing fencing with 'Tree Protection Fencing' signage attached.

- Fencing alignment seen to be in the wrong place, and beneath the crown of G14.1. confirmed that G14.1 has an RPA radius of 15m where protection measures will be required in the form of either fencing or ground protection as per the Tree Protection Plan. Advised that a CAD copy of the plan can be supplied so onsite engineer can identify fencing nodes accurately.

- o **ACTION:**
    - Re-align fencing to positions as shown on Tree Protection Plan and braced.
    - Install adequate ground protection in areas as shown on Tree Protection Plan and area of No-dig surfacing/construction prior to installation. (or alternatively these areas to be fenced off with a temporary fencing alignment until immediately prior to start of relative development works)

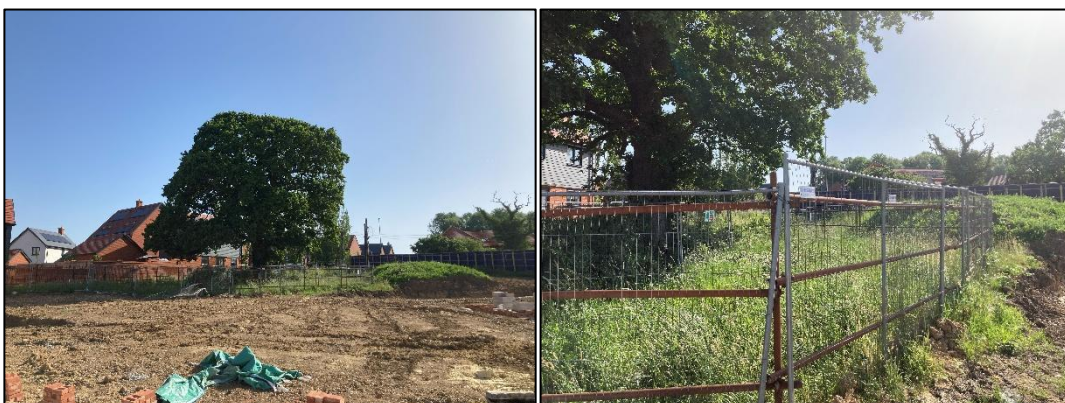
- Tree seen to be in good outward health with vigorous leaf flush and no indicators of stress or dieback.
- Northern boundary treatment is in place and to act as suitable protective fencing alignment.

- Existing remaining protective Heras fencing alignment in-situ around tree, fully encompassing crown, though not as shown on Tree Protection Plan. Confirmed that T19 has an RPA radius of 14m (13.6m). It was acknowledged however, that whilst there is likely some limited amounts of projected Root Protection Area (RPA) exposed outside of the current fencing alignment, there was ample additional areas of soft ground within the fencing alignment to the west of the tree which would fully compensate for this as per recommendations of BS5837:2012. Fencing alignment considered adequate.

- Section of western fencing unbraced.
- Secondary unbraced Heras fencing alignment observed within braced fencing alignment with attached signage identifying as 'Tree Protection Fencing'.

- **ACTION:**
    - Install bracing for western protective fencing alignment.
    - Ensure 'Tree Protection Fencing' signage is attached to correctly aligned/braced fencing.
