## SITE MONITORING REPORT SHEET

| <b>Site address:</b><br>Land off White Stork Road, Boorley Gardens, Hedge End, SO32 2BX |
| <b>Date of visit:</b> 28/08/2026 |
| <b>ACD Project Ref:</b> PRI24389 |

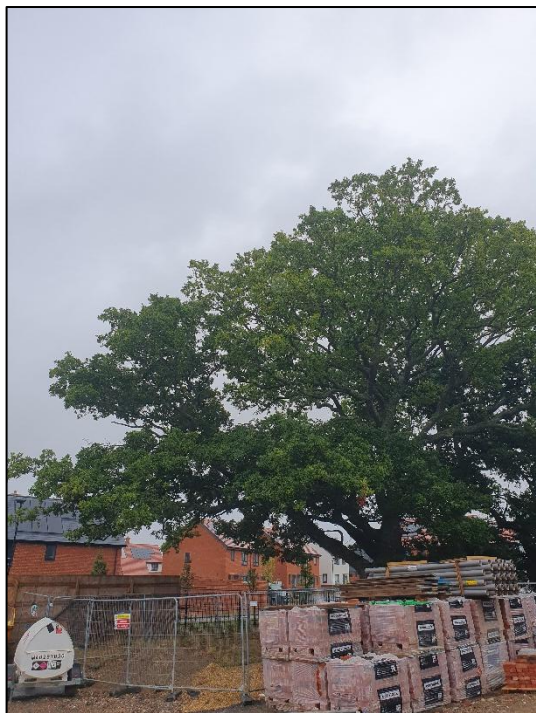
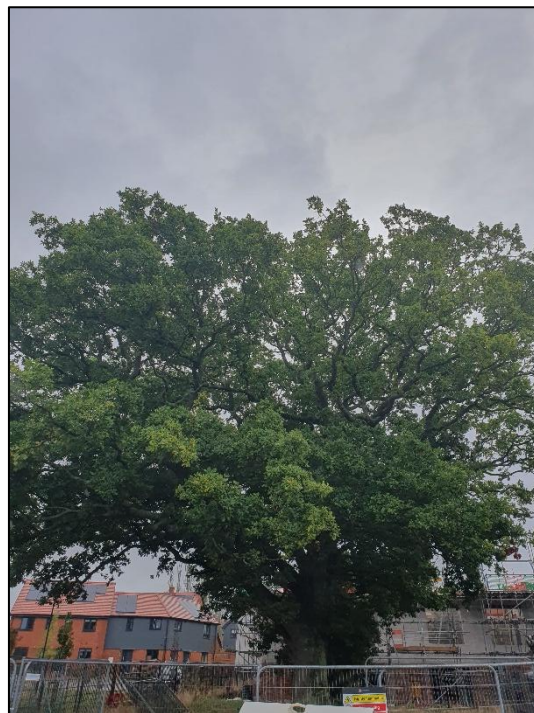
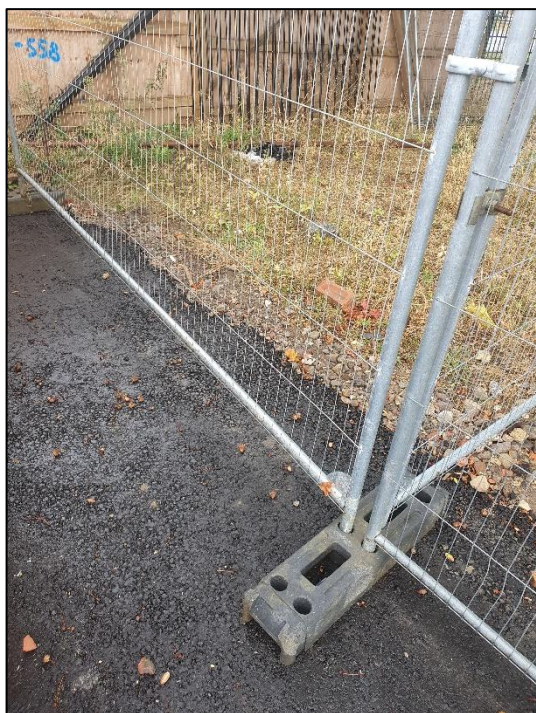
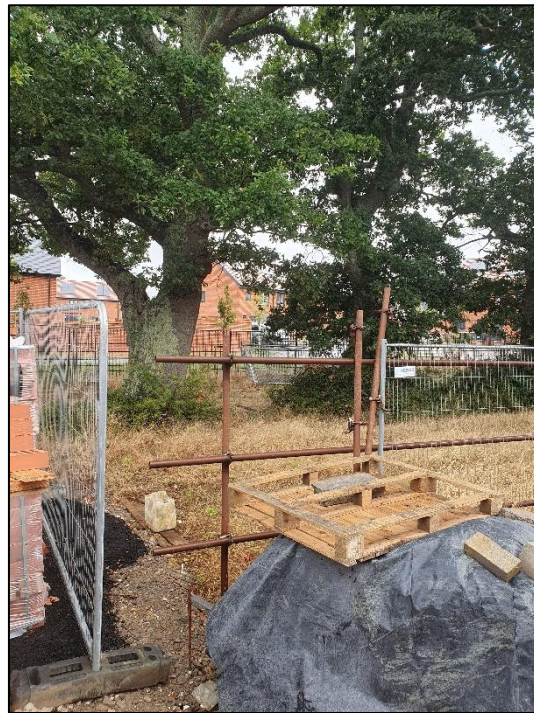
G14.1 – G14.3

- Trees seen to be in good outward health with vigorous leaf flush and no indicators of stress of dieback.
- x1 large deadwood piece over 50mm<sup>Ø</sup> visible from site office in mid-eastern crown aspect.

- Other deadwood >25mm in diameter noticeable throughout all components of group.
- Southern fencing is present and braced.
- Previous additional fencing to south has been removed for site logistics. Original braced fencing alignment remains.

- Eastern fencing is unbraced.
- Western fencing has been realigned 0.5m from Cellular Confinement Surfacing (CCS) surfacing within RPA in accordance with Tree Protection Plan.

- Area of CCS surfacing previously installed has been covered with temporary sacrificial tarmac until installation of final wearing surface which has been confirmed will be of a porous design. Sacrificial tarmac to act as adequate ground protection.

- Northern boundary treatment is in place and to act as suitable protective fencing alignment.
  - **ACTION:**
    - Braced all tree protection fencing in correct position as shown on Tree Protection Plan.

- Removal of deadwood post development completion.

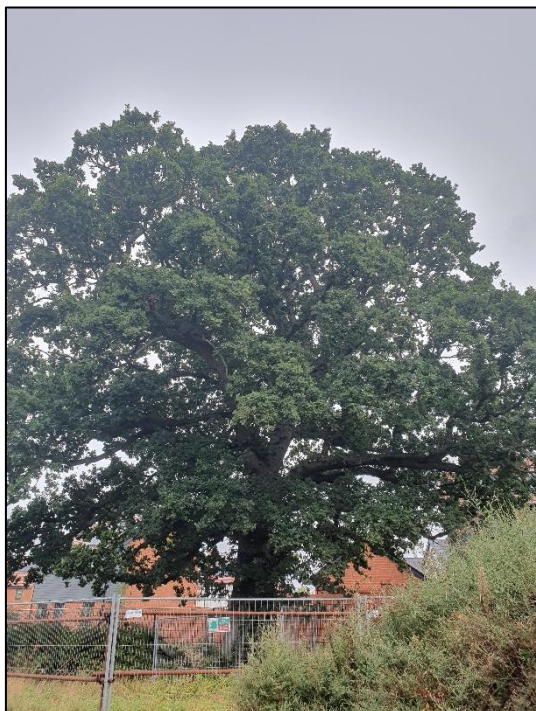
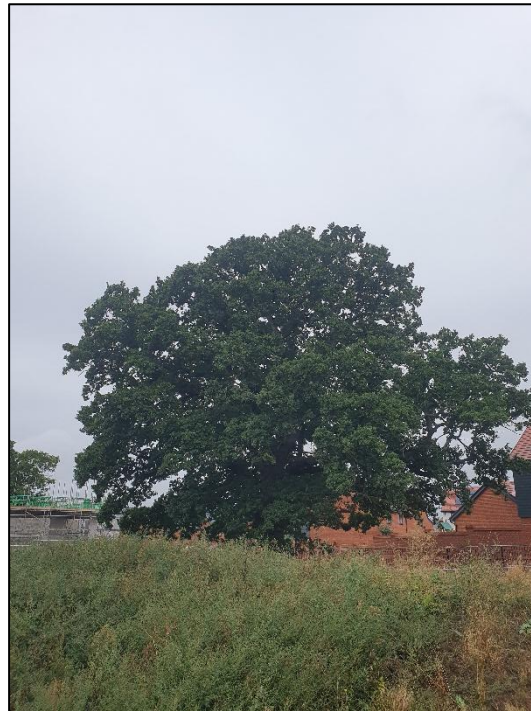
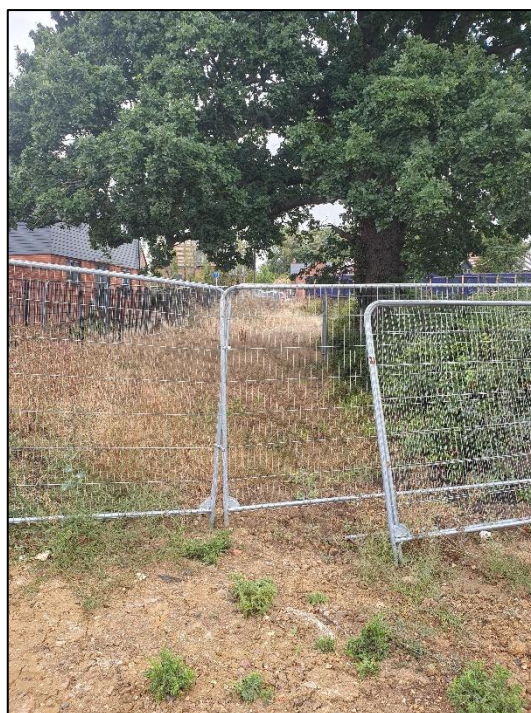
T19

- Tree seen to be in good outward health with vigorous leaf flush and no indicators of stress of dieback.
- Northern boundary treatment is in place and to act as suitable protective fencing alignment.
- Fencing alignment considered adequate with the exception of section to west which is unbraced.
- Deadwood >25mm in diameter noticeable in few sections of the crown.
  - **ACTION:**
    - Install bracing for western protective fencing alignment.
    - Ensure 'Tree Protection Fencing' is aligned as per Tree Protection Plan and signage is attached to correctly aligned/braced fencing.
    - Removal of deadwood post development completion
