Date: 2<sup>nd</sup> February 2024  
Our Ref: LIV-SN-22-004886

**Re: Damage to 62 Thistle Road, Hedge End, Southampton, SO30 0TT**  
**Insurer Claim Ref: 100-50-192954**

**ARBORICULTURAL REPORT**  
at  
**62 Thistle Road**  
**Hedge End**  
**Southampton**  
**Hampshire**  
**SO30 0TT**

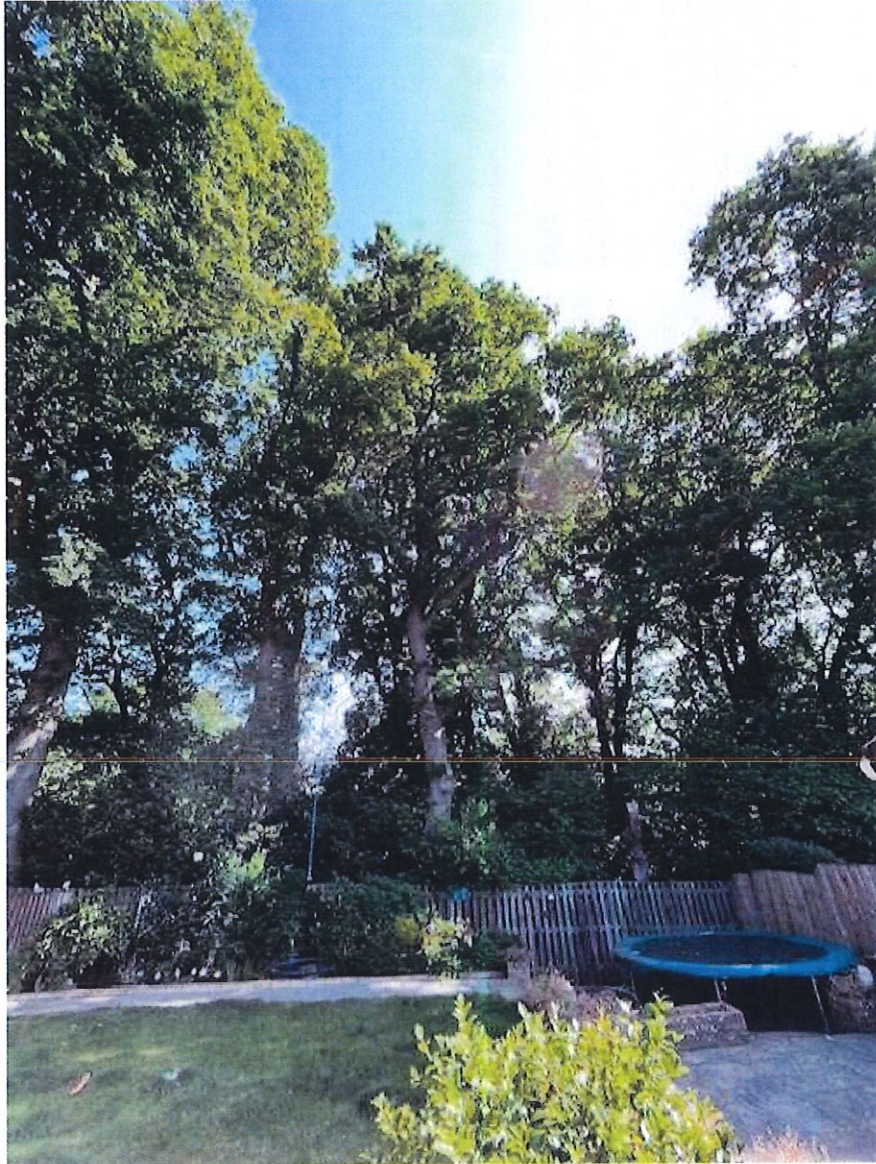
*Photograph 1: a view of the Oak trees at the rear of the property.*

*Please note that T1, T2, T3, T4 and T5 are protected by TPO No. 851-E.*

- 6.1 We have been informed by our client that the damage observed at the property is due to clay shrinkage caused by vegetation.
- 6.2 Based on this information, having made a detailed survey of the site and having given due consideration to the other information supplied, we consider the vegetation identified as **T1, T2, T3** and **T4** to be collectively contributing to the damage observed at the subject property. In order to negate their influence, the only vegetation management option available is to remove **T1, T2, T3** and **T4** and treat the stumps with Ecoplugs to prevent regrowth.
