**TREES AT LAND ADJACENT TO IVY COTTAGE, BOTLEY ROAD, HORTON HEATH,  
EASTLEIGH, SO50 7DT**

**Brief:** Inspect the trees at Land Adjacent to Ivy Cottage, Botley Road, Horton Heath, Eastleigh, SO50 7DT. Comment upon their condition and suitability for retention. Indicate the constraints which retained trees would place upon any new development on this site.

**Date of Inspection:** 12.12.23.

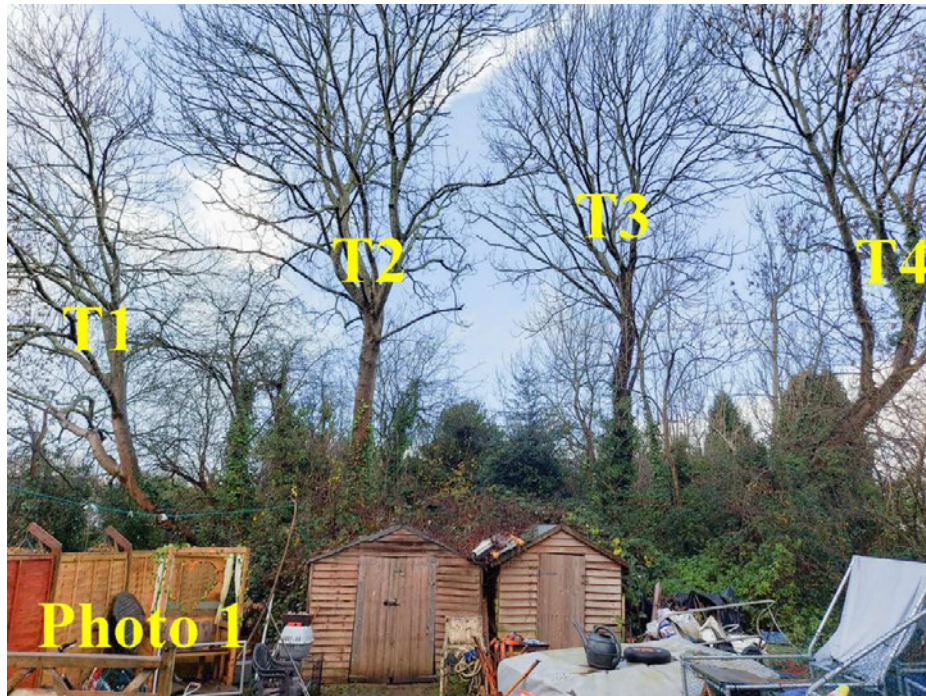
**General comments:** Trees 1 – 4 are a mature group of Ash along the northern boundary of the site (Photo 1). Trees 1 & 4 lean heavily to the west and east respectively. The Root Protection area (RPA) radii are shown shaded orange on the attached Tree Survey and Constraints Plan. In our view the RPA need not be considered a total ‘no-go’ area for new development on this site. Part of the RPA is already occupied by a number of outbuildings and other fowl rearing paraphernalia.

The high canopies, low shade giving, and northern orientation of the ash trees mean that a dwelling placed under their canopies, provided that it is on a minimum dig foundation regime such as piles and lintels, should not pose any unreasonable threat to their continued existence. Unfortunately, Ash-dieback remains as the most likely cause of the loss of these trees within the next 20 years.

Applying a similar approach to any new dwelling would allow for the use of piles and lintels to achieve an above ground construction which could be installed within the RPAs of Trees 1 – 4 without significant detriment.

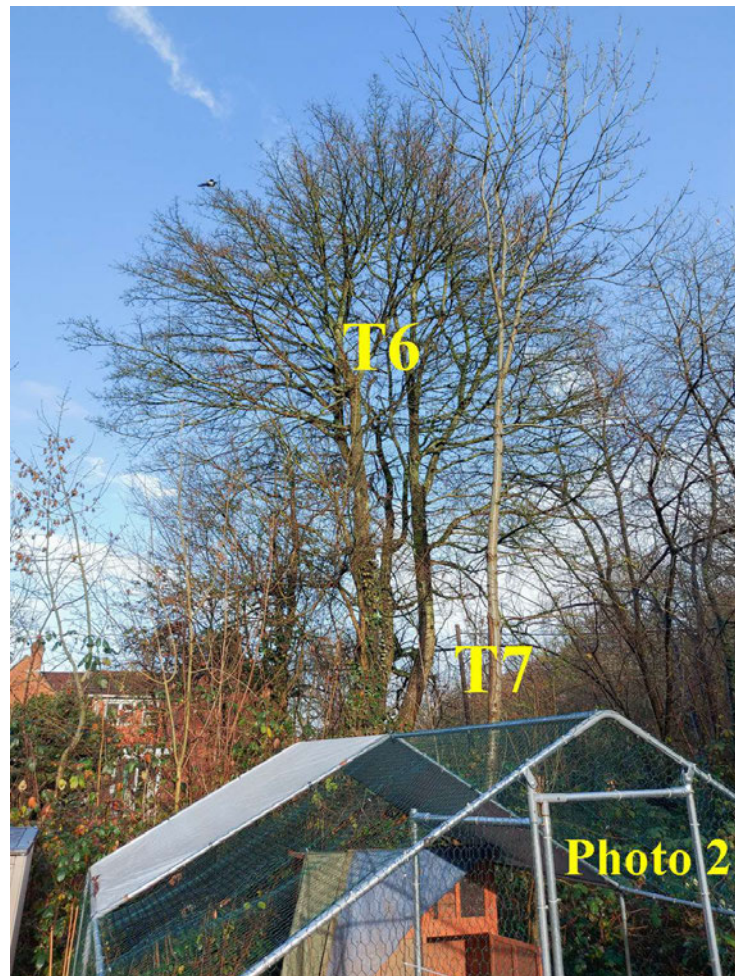
The Field Maple on the eastern boundary is an important native tree in an important location (Photos 2 & 4). No significant excavations can be undertaken within the RPA of this tree. The same is true of T8, the Native Yew (Photo 3).

**Constraints and opportunities:** The four Ash at the rear boundary, the Field Maple and the Yew are all significant constraints upon developing this site if excavations are required. Foundation trenches, service trenches and any reduction in soil level cannot be achieved within their RPAs. However, the land on site lies low and wet. Any new driveway or access construction will have to be installed above existing ground level to reconcile with the existing carriageway height. Maintaining it as an above ground no-dig specification will aid with keeping the finished surface free from standing water.

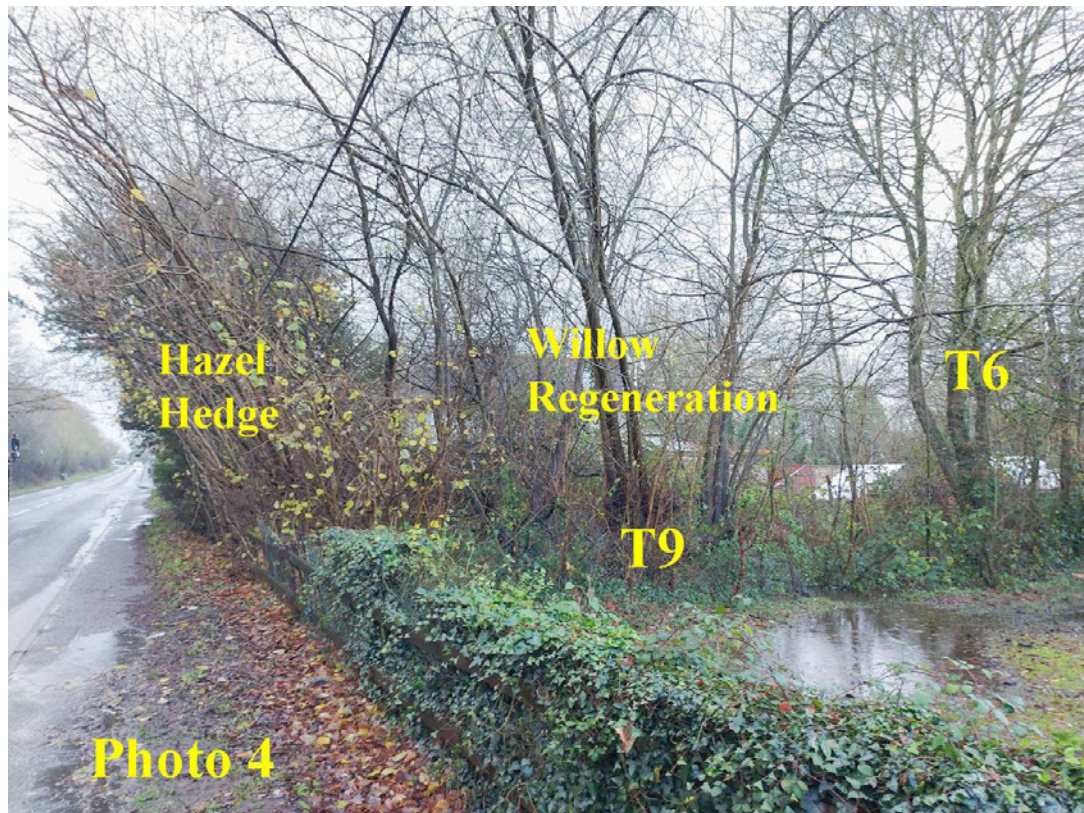
T9 is a fallen willow (Photo 4 & 5). The fallen trunk has resulted in some natural regeneration, however such growth cannot reasonably be retained or protected adjacent to the existing dwelling on this site.

The fallen willow stump will produce coppice re-growth if left after the fallen remains have been removed.

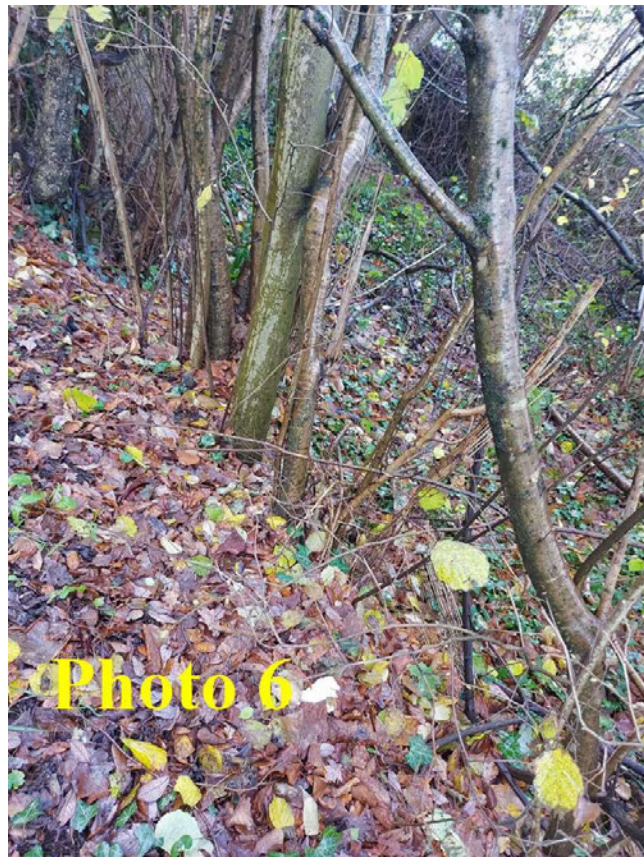
Photo 6 shows the abandoned hazel front boundary hedge. It also shows the considerable height difference between the carriageway of the B3354 and the significantly lower ground of the survey site. There is a similar height differential on the other side of the road, leading us to conclude that the B3354 was originally constructed as a causeway over an area of ground prone to lie wet.

The front boundary hedge hazels could be re-coppiced and shunted back from the boundary to allow for the drive entrance and visibility splays without them being lost.
