**Tree Survey and Arboricultural Impact Assessment  
In Accordance with BS5837:2012**

| Project No.<br><b>10750</b> | <b>Rosewood, Brook Lane, Botley, SO30 2ER</b> | | |
| Date of Report: | 22/02/2024 | Revision: | Original |

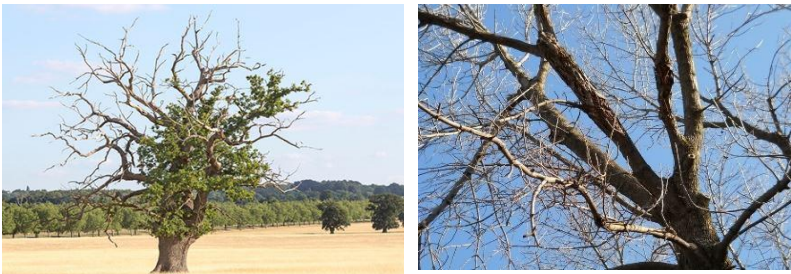
| <b>Name: Deadwood</b> | |
| <b>Symptoms/damage type and cause:</b> | This relates to dead branches in the crown of the tree. In the majority of cases, this is caused by the natural ageing process of the tree or shading due to its close proximity to neighbouring trees. However, in some situations, it may be related to fungal, bacterial or viral infection. |
| <b>Consequence:</b> | Depending upon the location and mass of dead wood removal of the affected tissue may be necessary to prevent harm to persons or property as the wood will become unstable as it decays and in some circumstances is likely to fall from the tree with little or no warning. |

| <b>Name: Deadwood</b> | |
|---|---|
| <b>Control:</b> | Detailed monitoring should be undertaken on those trees showing signs of excessive deadwood production to identify the underlying cause. |

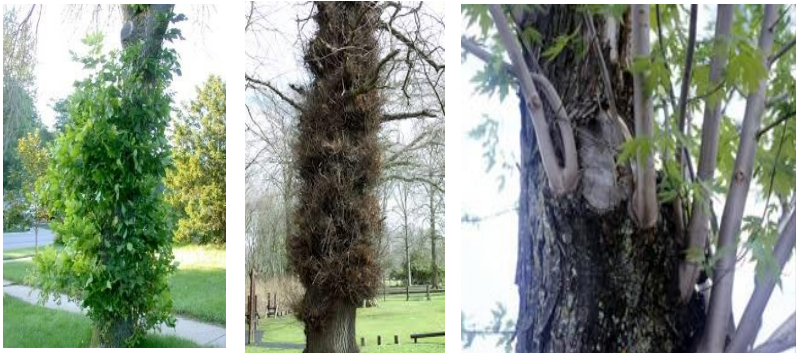
| <b>Name: Epicormic growth</b> | |
| <b>Symptoms/damage type and cause:</b> | This is the production of numerous shoots on the main stem and branches of the tree. They are produced by the bursting into life of otherwise dormant buds. It is commonly associated with elevated levels of stress on the tree. |
| <b>Consequence:</b> | Whilst epicormic growth is usually symptomatic of an issue elsewhere within the tree, heavy proliferation can cause the trees resources to become depleted or may mask significant structural weaknesses within the framework of the tree. |

| <b>Name: Epicormic growth</b> | |
|---|---|
| <b>Control:</b> | Pruning off epicormic growth may be necessary to improve the visual amenity of the tree or prevent the development of a hazard or obstruction. No direct means of prevention are available other than therapeutic measures to alleviate stresses on the tree. |
