### **VISUAL TREE ASSESSMENT REPORT (VTA)**

**STRAWBERRY HILL,  
BURSLEDON,  
HAMPSHIRE**

**Report Number: MB240212**

**February 2024**

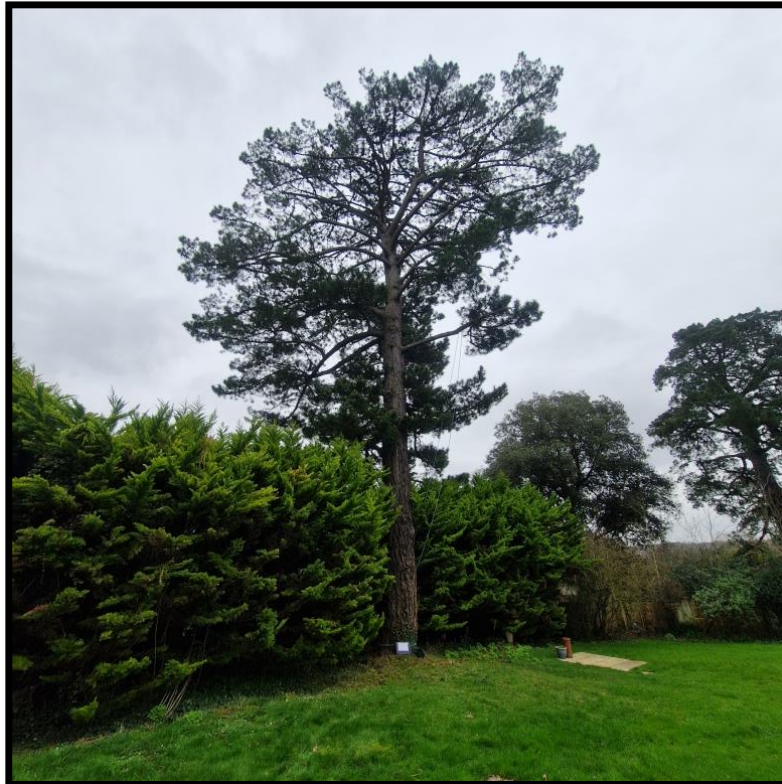
**4.1.2** The Monterey Pine tree was inspected at ground level where strong evidence of internal decay and root rot was evident. There were outwardly signs to suggest the tree was in stress or had a debilitating pathogen.

**Plate 1- Monterey Pine tree surveyed.**

This tree should be felled due to the significance of the fungal infection and position in the landscape.

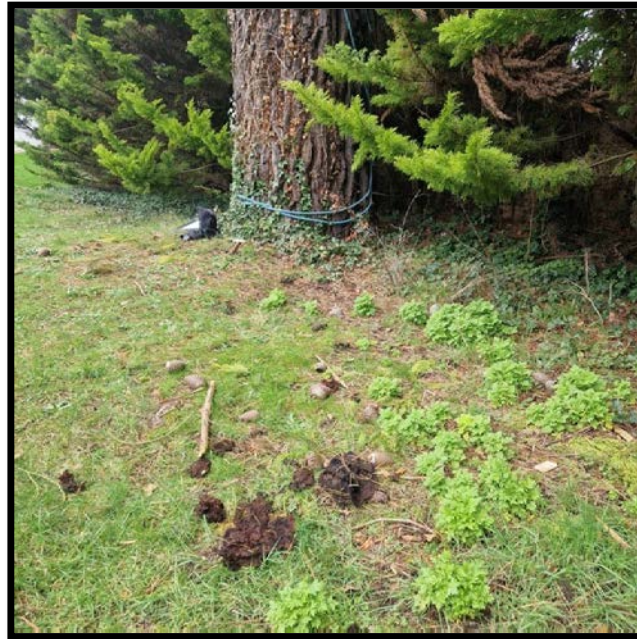
**Plate 2 –Clusters of fungi.**

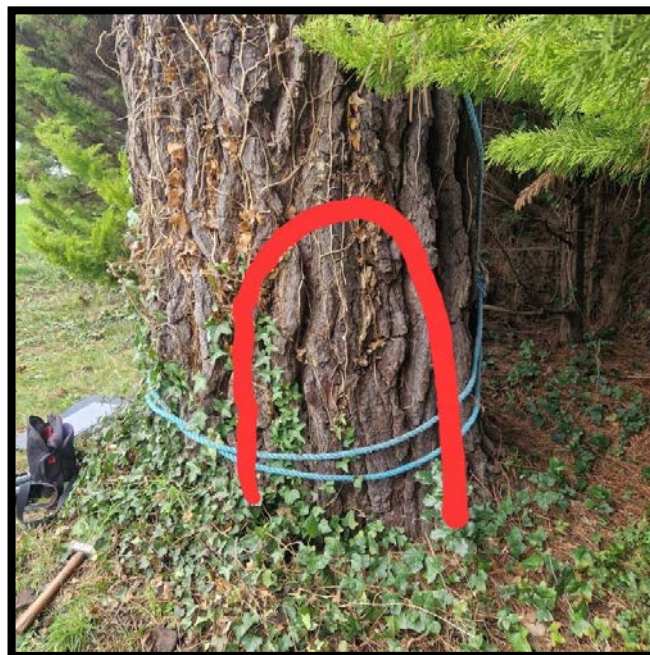
**4.1.5** A section of the stem was sounded and resulted in a large portion of stem being hollow.

**Plate 3: Area of hollow stem.**
