# East Horton Business Park – Condition 5 – F/23/94668

Please find below the further information requested following the request for further information received.

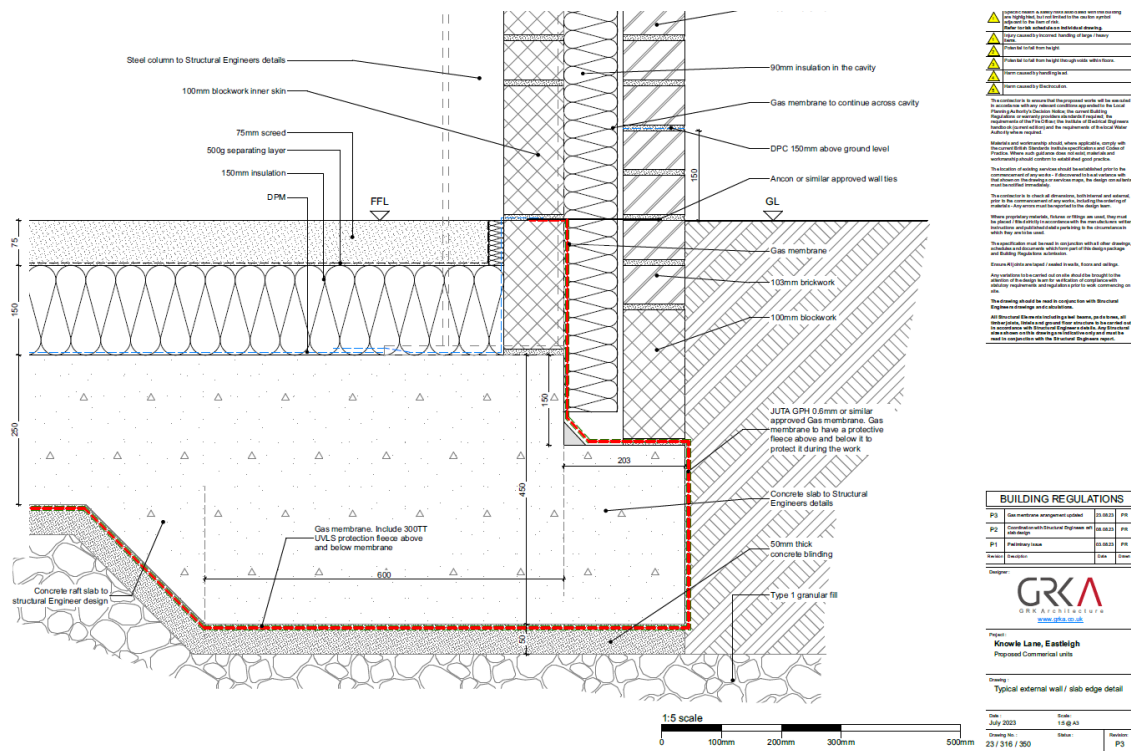
All rafts have been constructed in accordance with the below detail which was within the verification report.

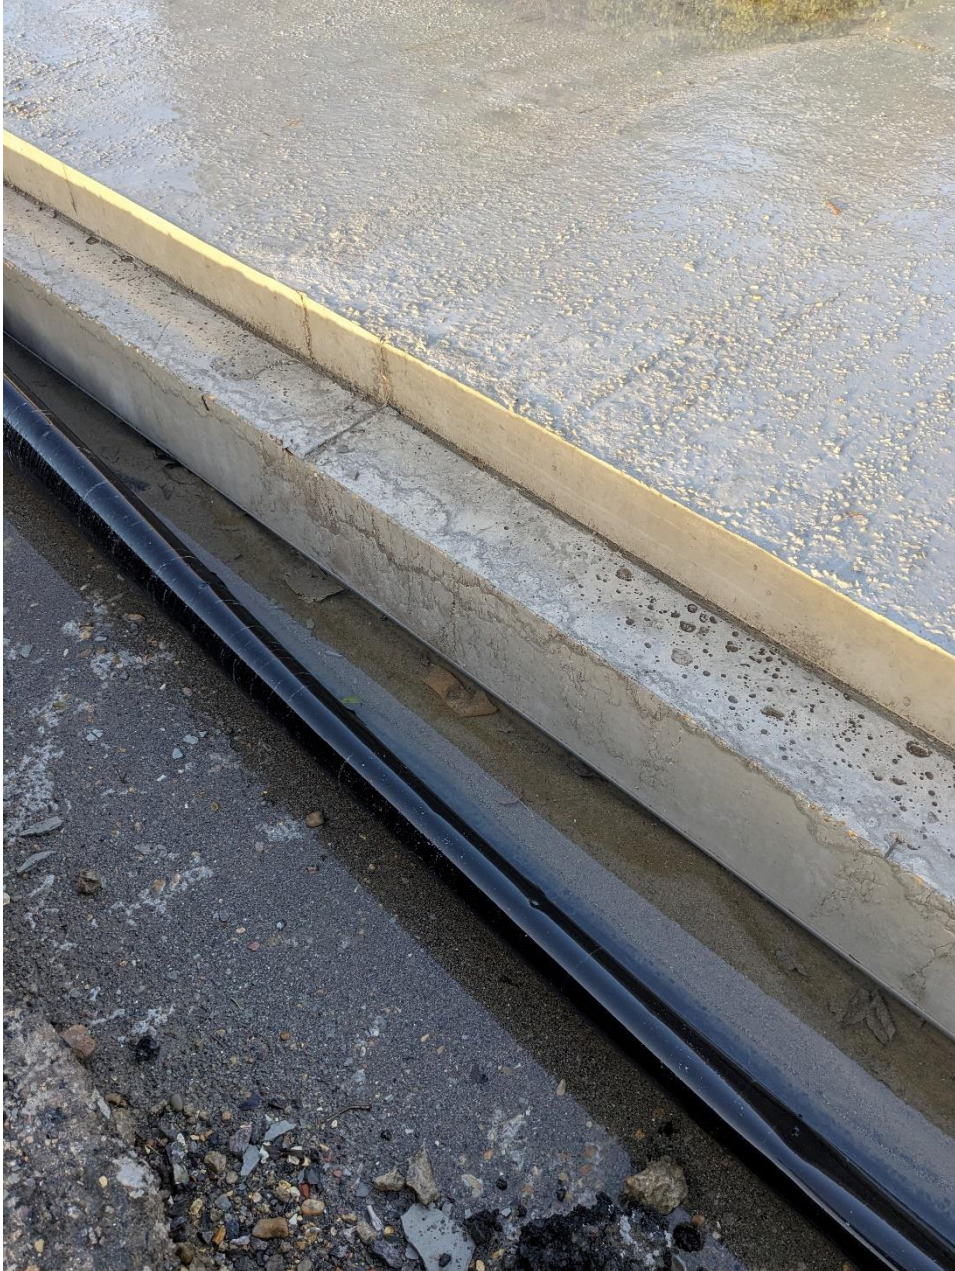
- Photo 1 – Block A edge of slab, showing the full depth of concrete and gas membrane below ready to be lapped up the edge of the toe.
- Photo 2 - Block E edge of slab again showing the full depth of 450mm thick concrete raft foundation, and the gas membrane beneath ready to be lapped around the toe.
- Photo 3 - Block B edge of slab the same as photo 1 & 2.
- Photo 4 & 5 - Service penetrations fully concreted around

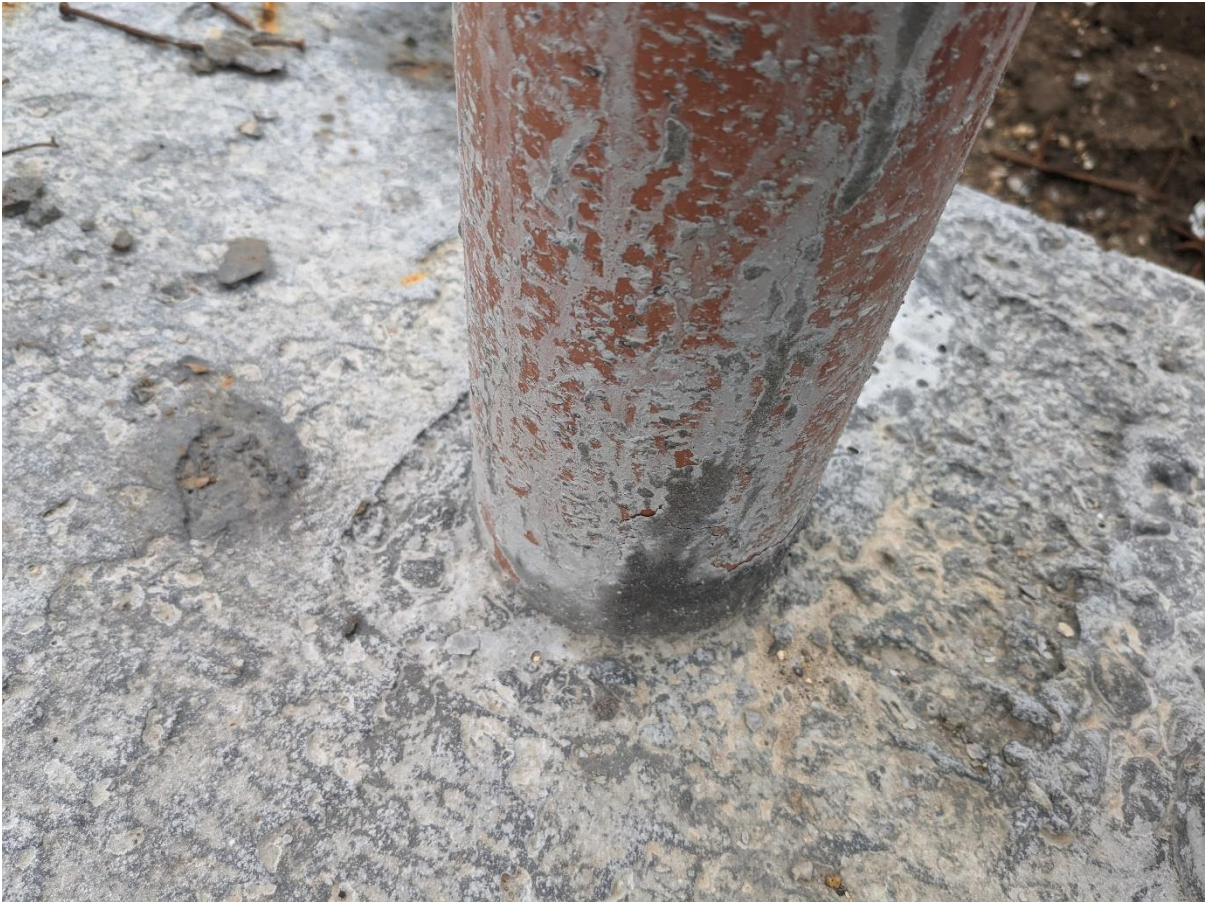
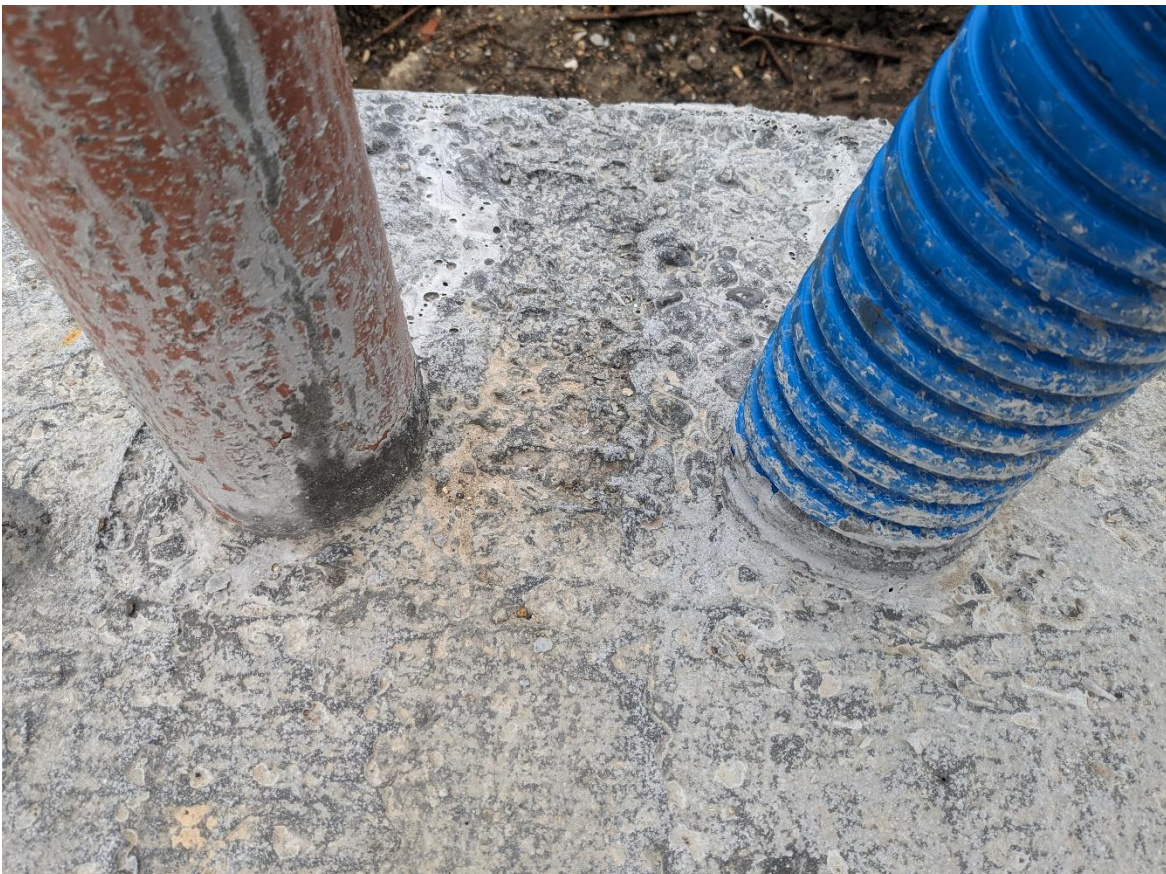
All Rafts have been installed as per the plans for a ground bearing raft. There are minimal service penetrations for each building, all of which have been surrounded by concrete as well as seal around with the gas membrane.
