## Memorial Hall – Bishopstoke Pre-Demolition Survey

**Memorial Hall  
17 Riverside  
Bishopstoke  
Eastleigh  
SO50 6LQ**

## **Memorial Hall, Bishopstoke**

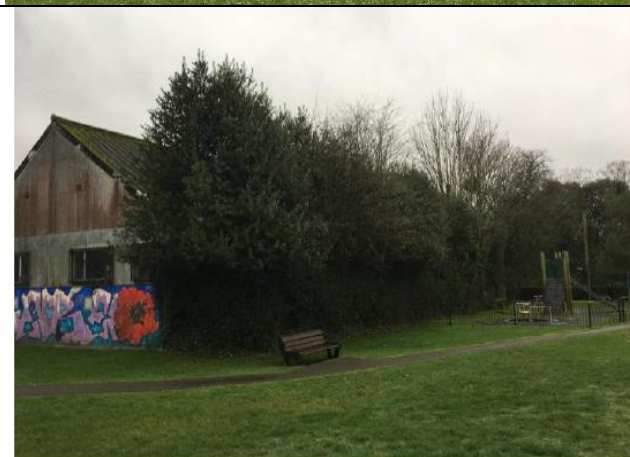
Trees close to  
western side of  
building

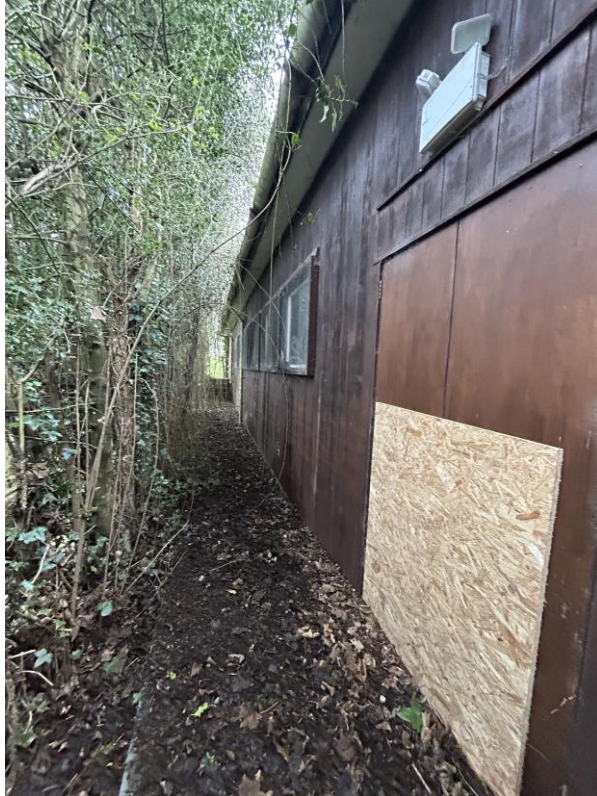
External fire  
escape route  
inaccessible with  
no real means of  
escape.

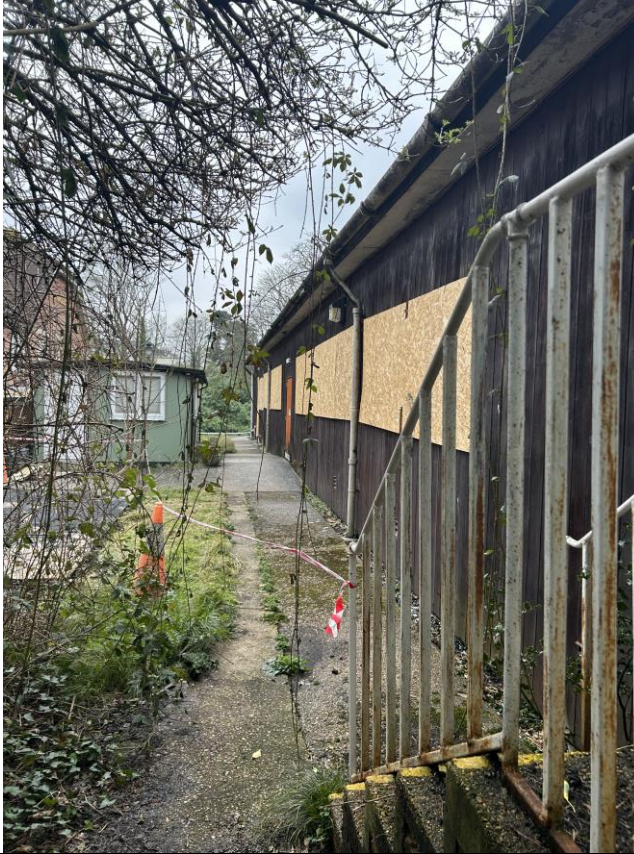
Current route for wheelchair access. Photo taken from park entrance.

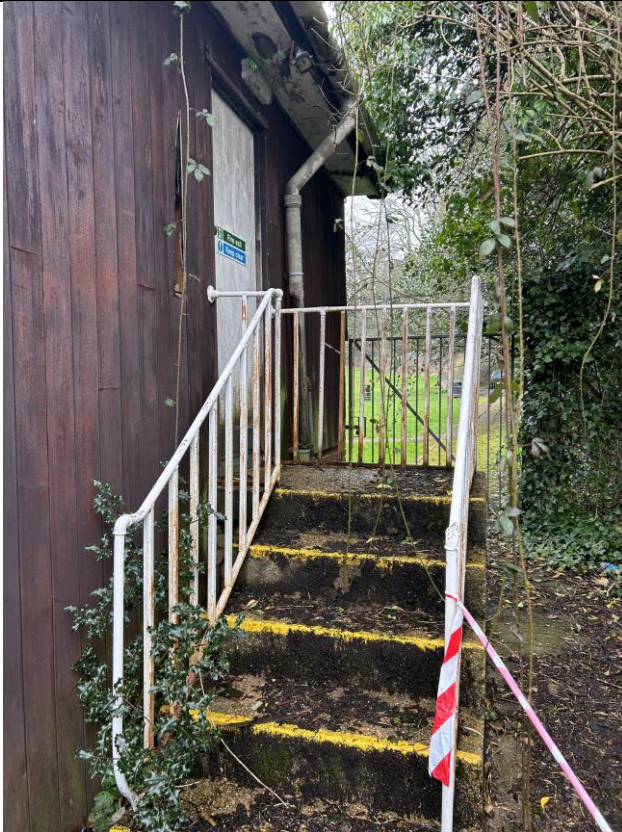
Access steps to Green room, non-compliant by modern standards with risers and goings incorrectly sized.

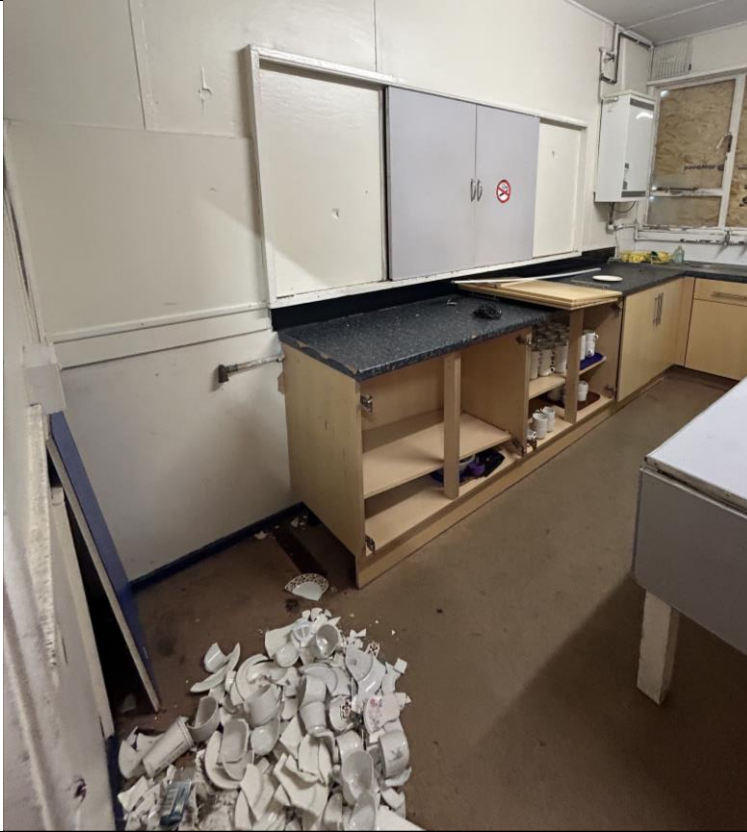
Service hatch  
between kitchen  
and hall non-fire  
rated.

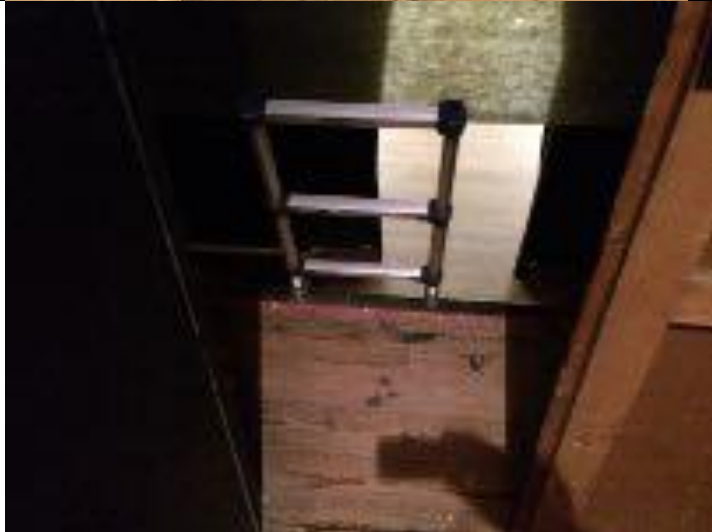
The storage area over the Green room is not afforded permanent access and relies on the use of step ladders.

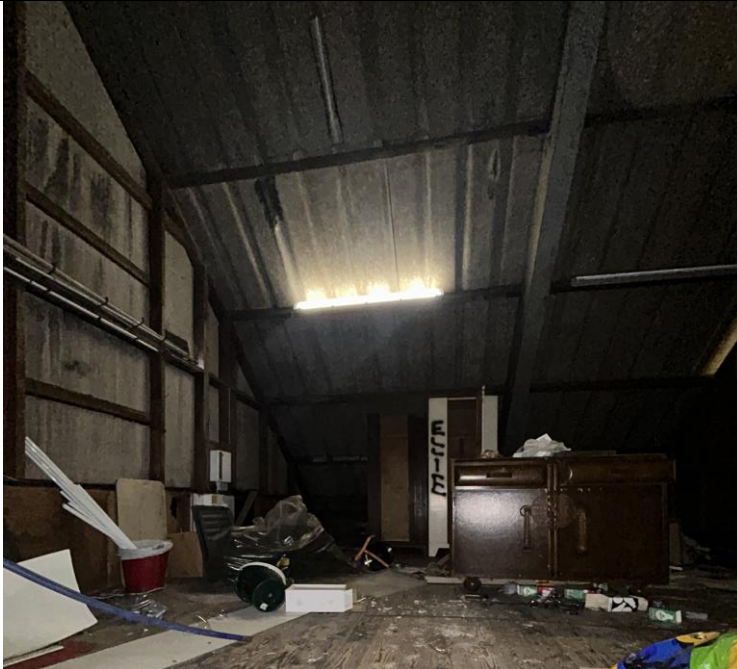
Mezzanine areas  
water staining to  
back of AC roof  
sheets.

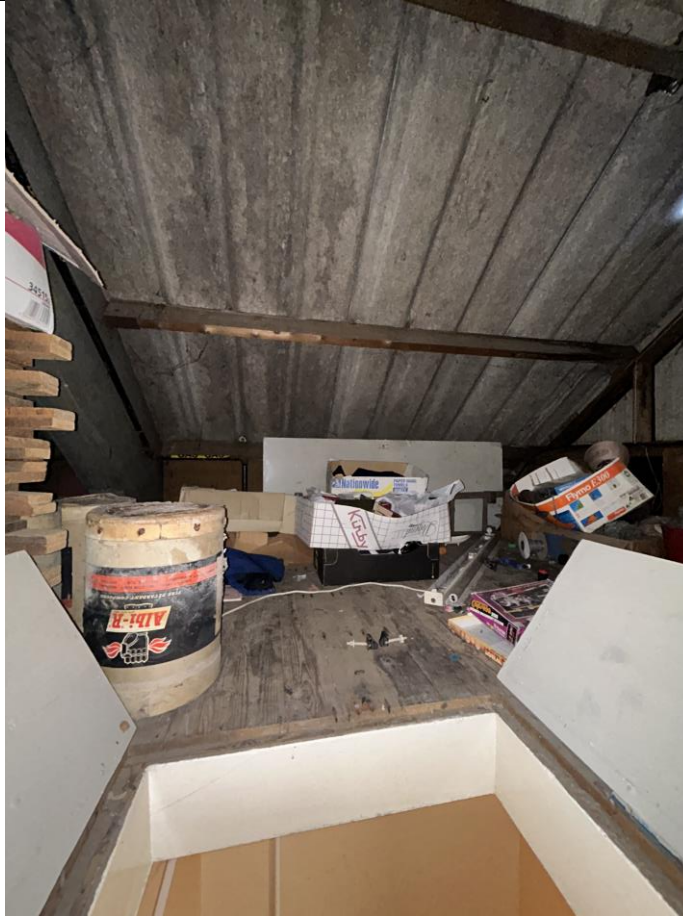
Basic roof structure without internal linings.

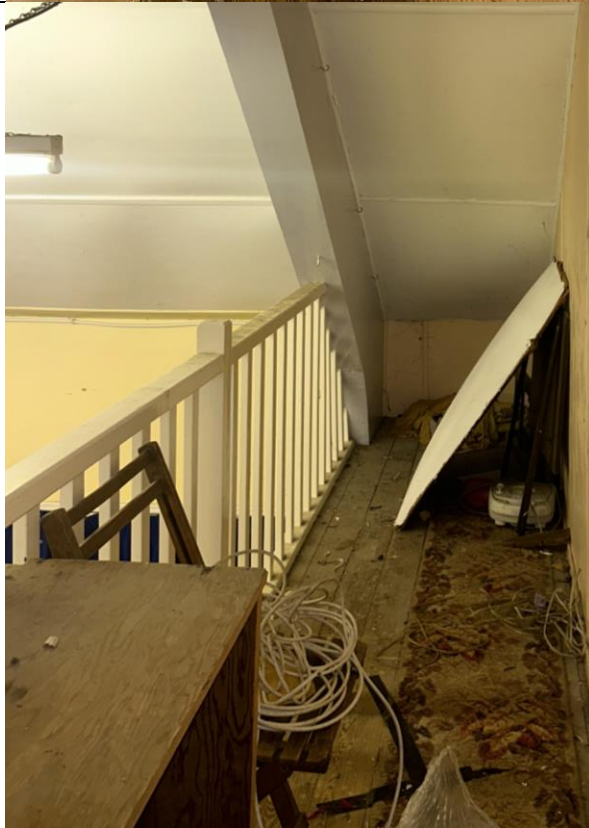
Mezzanine  
balcony handrail  
below current  
standards.

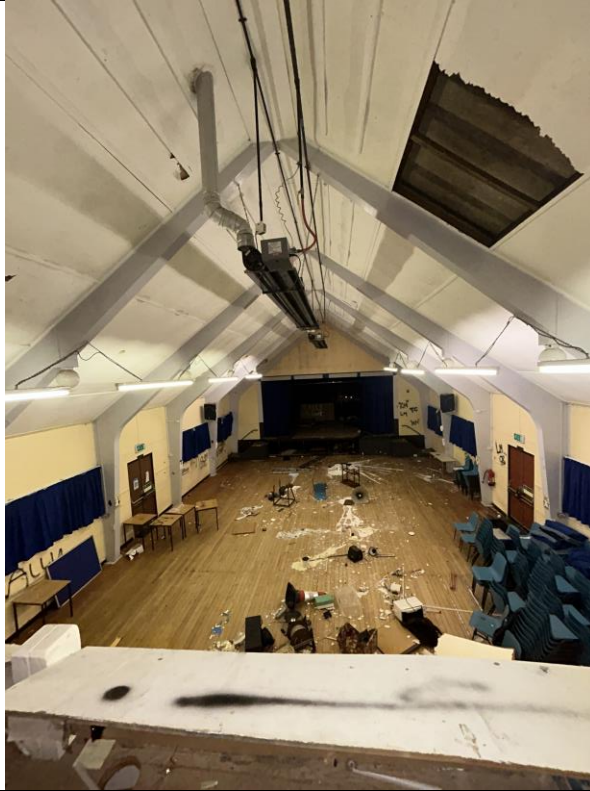
Main hall  
overview showing  
box section portal  
frame, note roof  
sheet broken.
