# East Horton Business Park – Condition 5 – F/23/94668

Please find below the further information requested following the request for further information received for Blocks C & D

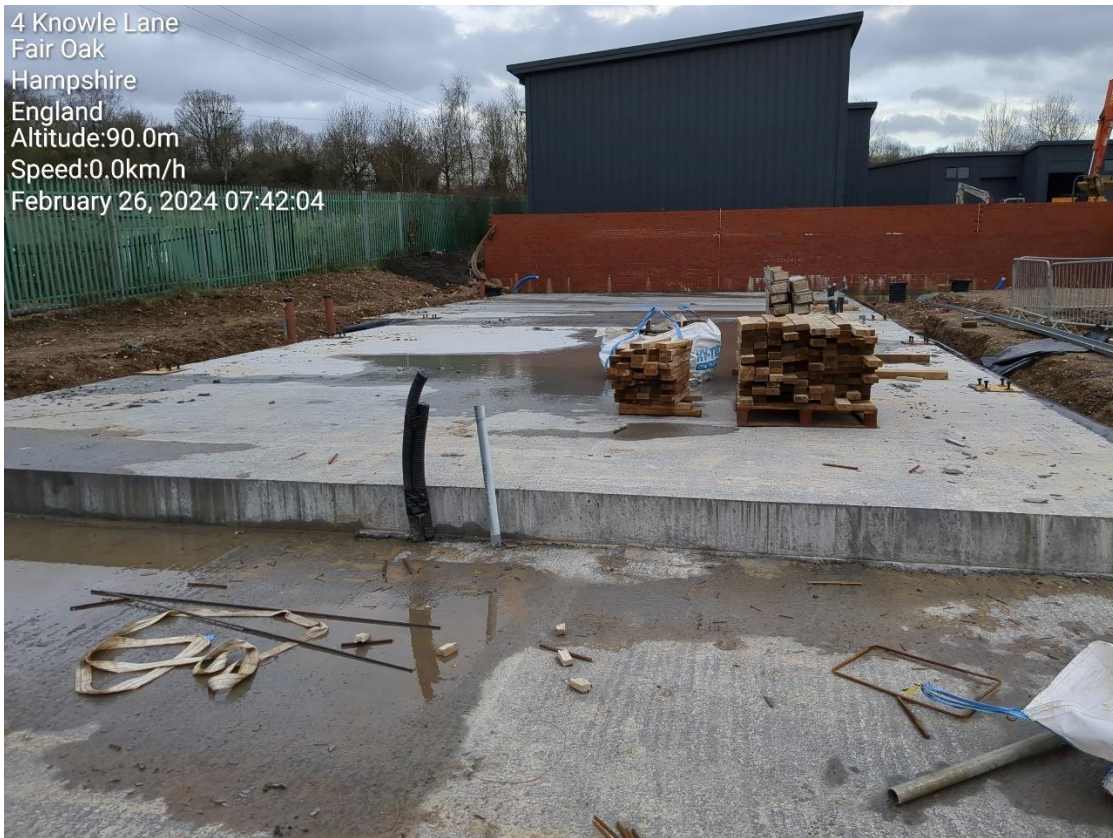
- Photo 1 – Block D Slab, showing the full thickness of the slab and 2 service penetrations, fully surrounded by concrete.
- Photo 2 - Block D edge of slab again showing the full depth of 450mm thick concrete raft foundation, and the gas membrane beneath ready to be lapped around the toe.
- Photo 3 - Block C Edge of Slab showing the full depth of the concrete and the gas membrane beneath ready to be lapped around the toe.
