**Project Name:** 1 - 3 Market Street\_ SO50 5RL  
**Project Description:** Building Works  
**Project Number:** JSD7105  
**Project Status:** Complete  
**Project Date:** 19/03/2024  
**Inspection Standard:** MSCC4 Sewers & Drainage GB (SRM4 Scoring)

1 - 3 Market Street, SO50 5RL

## Section Inspection - 13/03/2024 - Red.Gully1X

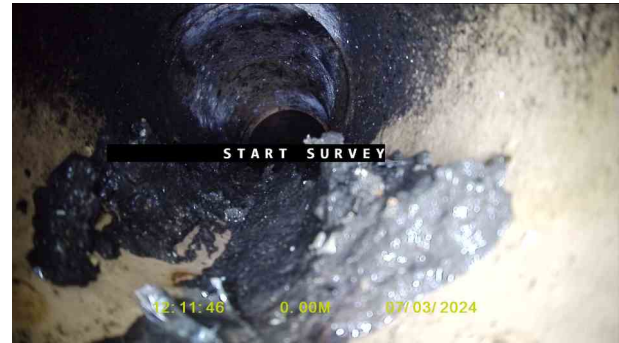
Red.Gully1X\_79d8ca3a-42d2-422f-b9a8-e0b8981584cb\_20240319\_153744\_784.jpg, 00:00:10, 0.00 m  
Water level, 0% of the vertical dimension

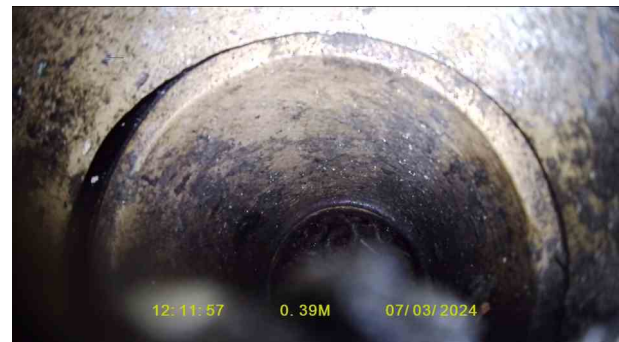
Red.Gully1X\_284b2ead-1883-4418-9efe-a9f249573e7c\_20240319\_154140\_751.jpg, 00:00:20, 0.39 m  
Open joint, medium

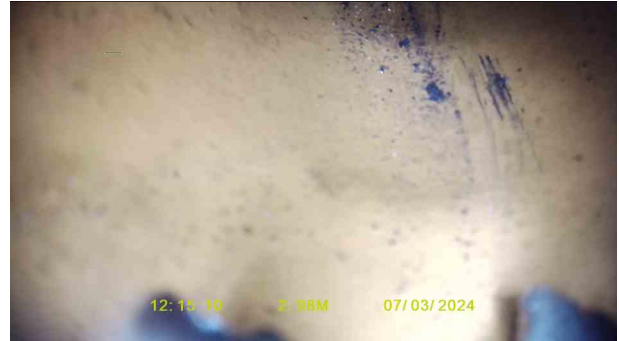
1X\_c88ebd88-327b-4f93-a59c-5d9d1b7d3717\_20240319\_154  
459\_289.jpg, 00:00:48, 2.68 m  
Joint displaced, medium

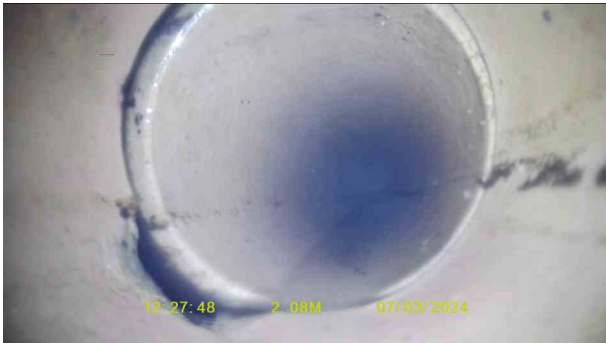
1X\_4b6c1206-5c7a-4fb7-894c-dc050f9f0fc0\_20240319\_1554  
14\_089.jpg, 00:00:34, 2.08 m  
Broken pipe at joint from 5 o'clock to 11 o'clock ,

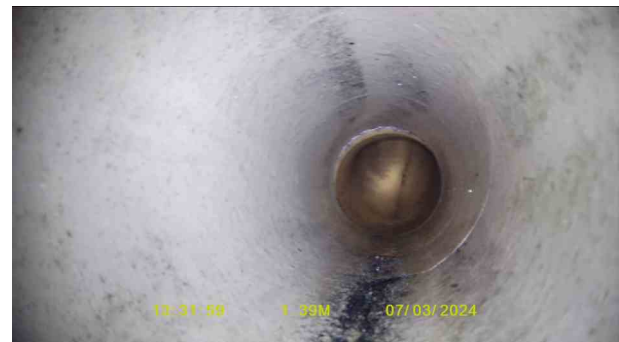
| Scale: | 1:50 | Position [m] | Code | Observation | MPEG | Photo | Grade |
|---|---|---|---|---|---|---|---|
| | 1.39 | CC | Crack, circumferential from 2 o'clock to 6 o'clock | 00:00:59 | RWDP<br>6X_1651b<br>db6-0acb- | | 2 |

RWDP  
6X\_1651bdb6-0acb-4e87-a5f2-7ff06c594d64\_20240320\_0943  
22\_436.jpg, 00:00:59, 1.39 m  
Crack, circumferential from 2 o'clock to 6 o'clock

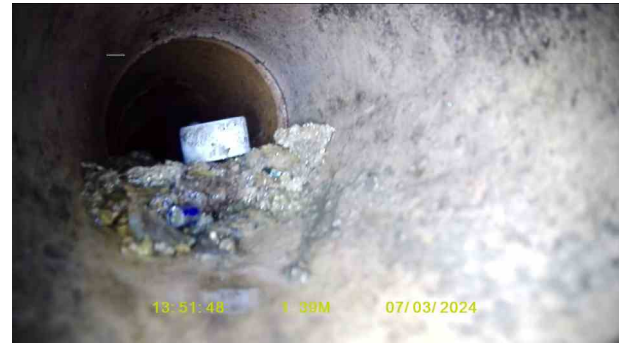
Gully  
1X\_ce571131-df52-4d57-822c-c7a8c5ad5515\_20240320\_102  
503\_528.jpg, 00:00:38, 1.49 m  
Open joint, large

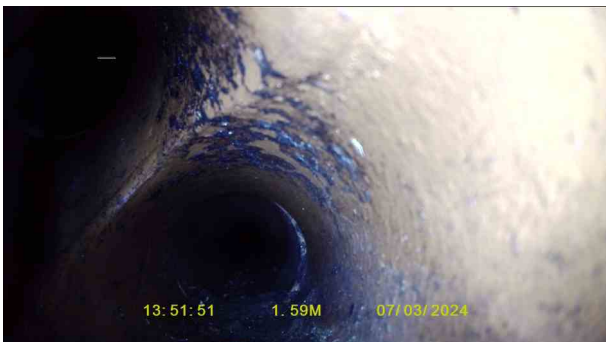
Gully  
1X\_56dbc946-710d-462b-b4e0-fb8535b12485\_20240320\_102  
558\_250.jpg, 00:00:41, 1.50 m  
Settled deposits, coarse, 15% cross-sectional area loss

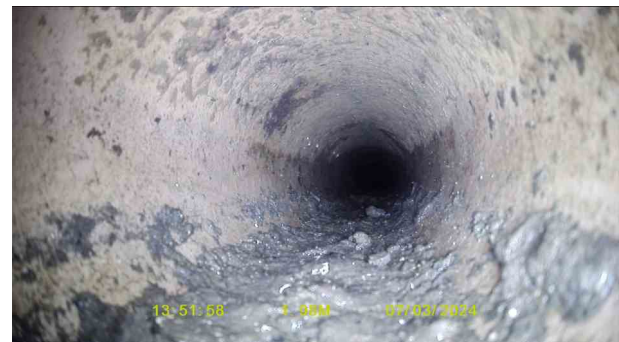
| Scale: | 1:50 | Position [m] | Code | Observation | MPEG | Photo | Grade |
|---|---|---|---|---|---|---|---|
| | 1.59 | JXD | Defective junction, damaged at 10 o'clock, diameter: 100mm | 00:00:44 | Gully 1X_699bef 15-4056-4f | | |

Gully  
1X\_699bef15-4056-4fa3-b40e-d84956fbfb8c\_20240320\_1026  
27\_547.jpg, 00:00:44, 1.59 m  
Defective junction, damaged at 10 o'clock, diameter: 100mm

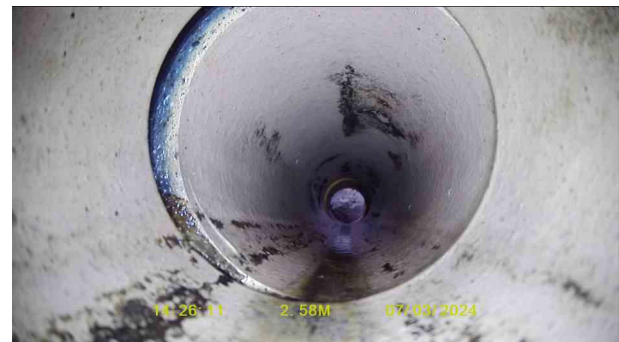
Manhole  
4X\_33011e05-1a2d-476f-8880-bcb86fc60f80\_20240320\_104427\_334.jpg, 00:00:43, 2.58 m  
Open joint, medium

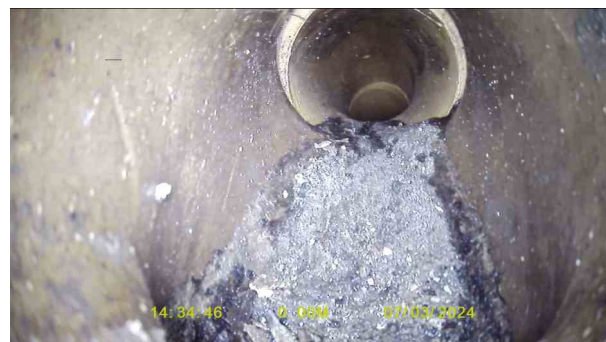
| Scale: | 1:50 | Position [m] | Code | Observation | MPEG | Photo | Grade |
|---|---|---|---|---|---|---|---|
| | | 0.25 | REM | General remark: Back of interceptor is cracked | 00:00:10 | Manhole 5X_119f0b8f-6544-4a | |

Manhole  
5X\_119f0b8f-6544-4a8a-a0b1-066a48cf28c2\_20240320\_1114  
55\_101.jpg, 00:00:10, 0.25 m  
General remark, Back of interceptor is cracked

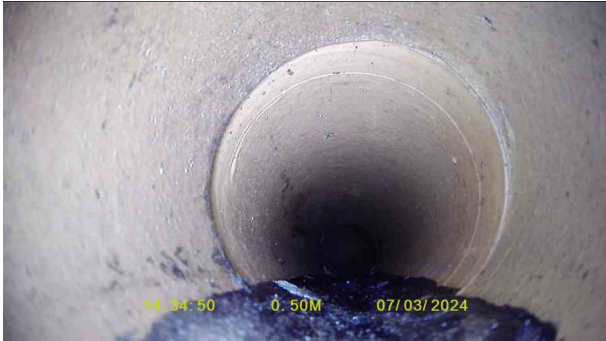
| Scale: | 1:50 | Position [m] | Code | Observation | MPEG | Photo | Grade |
|---|---|---|---|---|---|---|---|
| | | 0.50 | CC | Crack, circumferential from 8 o'clock to 4 o'clock | 00:00:14 | Manhole 5X_b64fad70-cb31-4 | 2 |

Manhole  
5X\_b64fad70-cb31-407c-a04b-6266f652e273\_20240320\_111  
413\_547.jpg, 00:00:14, 0.50 m  
Crack, circumferential from 8 o'clock to 4 o'clock

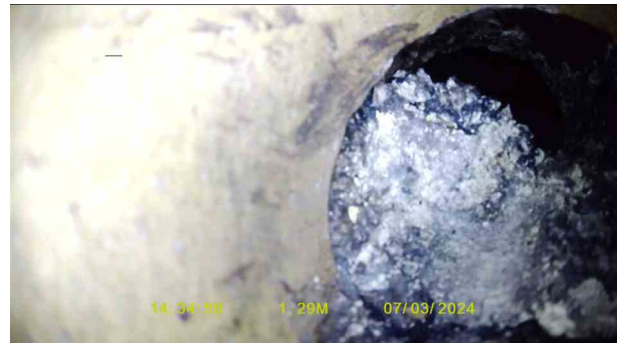
Manhole  
5X\_04b28b9d-c3d2-443d-8588-5e3fe19a8ddf\_20240320\_111  
612\_778.jpg, 00:00:23, 1.29 m  
Attached deposits, encrustation at joint from 4 o'clock to 10 o'clock, 35% cross-sectional area loss

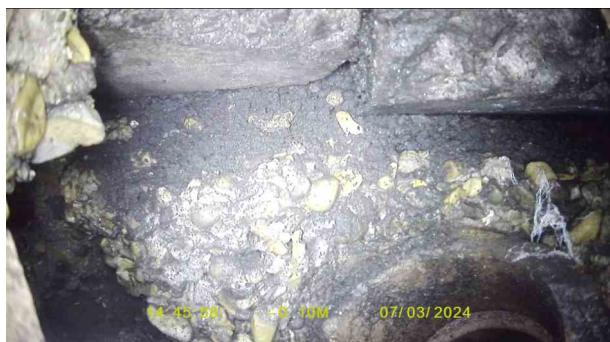
| Scale: | 1:50 | Position [m] | Code | Observation | MPEG | Photo | Grade |
|---|---|---|---|---|---|---|---|
| | | 0.10 | VV | Void visible beyond defect | 00:00:08 | Manhole 6X_fb349593-b3ee-4 | |

Manhole  
6X\_fb349593-b3ee-4de9-bb3f-f9efa26295b7\_20240320\_1236  
05\_857.jpg, 00:00:08, 0.10 m  
Void visible beyond defect

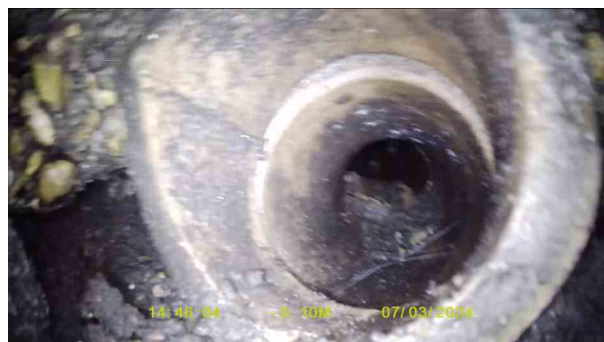
Manhole  
6X\_a757fd52-7cfa-4a75-8ecd-5504444e4bf1\_20240320\_1237  
19\_371.jpg, 00:00:14, 0.10 m  
Collapsed drain or sewer

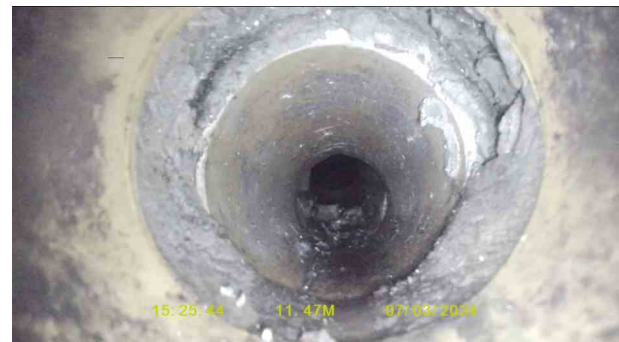
Manhole  
8X\_72bfa4cb-2bd6-42bc-870b-6ab8eb562af6\_20240320\_130  
852\_380.jpg, 00:02:20, 11.47 m  
Open joint, large

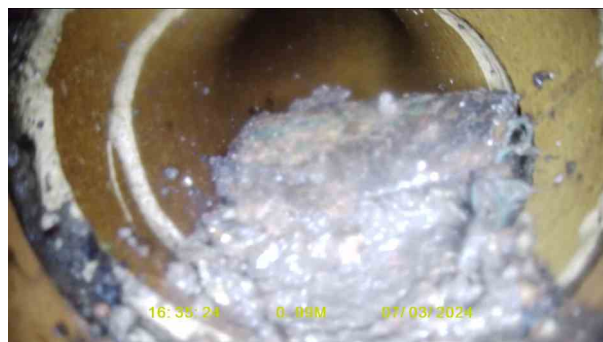
| Scale: | 1:50 | Position [m] | Code | Observation | MPEG | Photo | Grade |
|---|---|---|---|---|---|---|---|
| | 0.99 | FMJ | Fracture, multiple at joint from 12 o'clock to 12 o'clock | 00:00:26 | RWDP<br>7X_4de7d<br>4eb-8b0c- | | 4 |

RWDP  
7X\_4de7d4eb-8b0c-4540-b134-49188c4c8bde\_20240320\_13  
2813\_237.jpg, 00:00:26, 0.99 m  
Fracture, multiple at joint from 12 o'clock to 12 o'clock
