Project name :  
**143and145PASSFIELD AVENUE**

Date :  
**30/01/2023**

Site: **143 - 145 PASSFIELD AVENUE**

## Inspection pictures

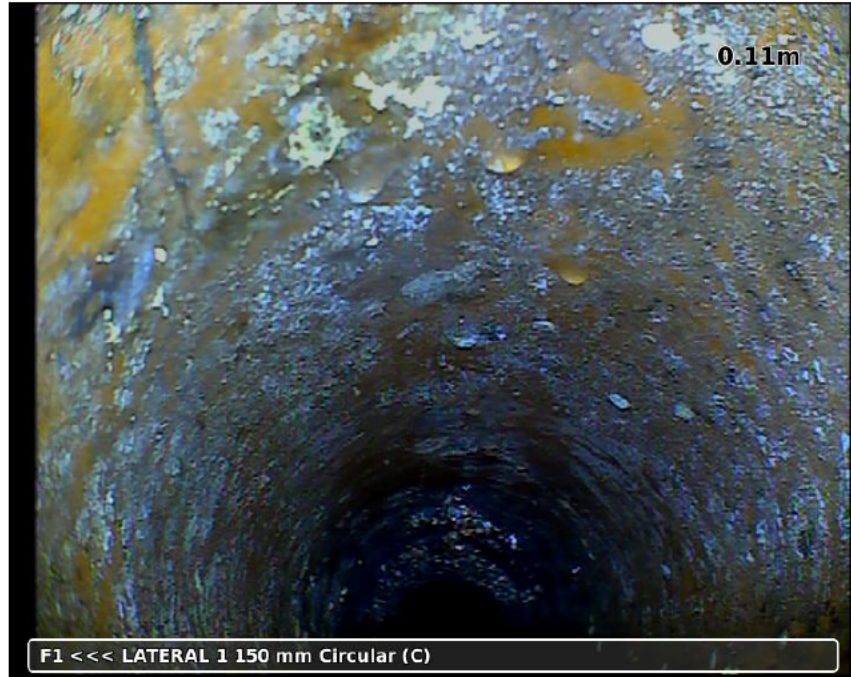
Photo: 20230130-082242-snap0000.jpg, 00:00:07  
0.11m, Start node type manhole reference number: F1

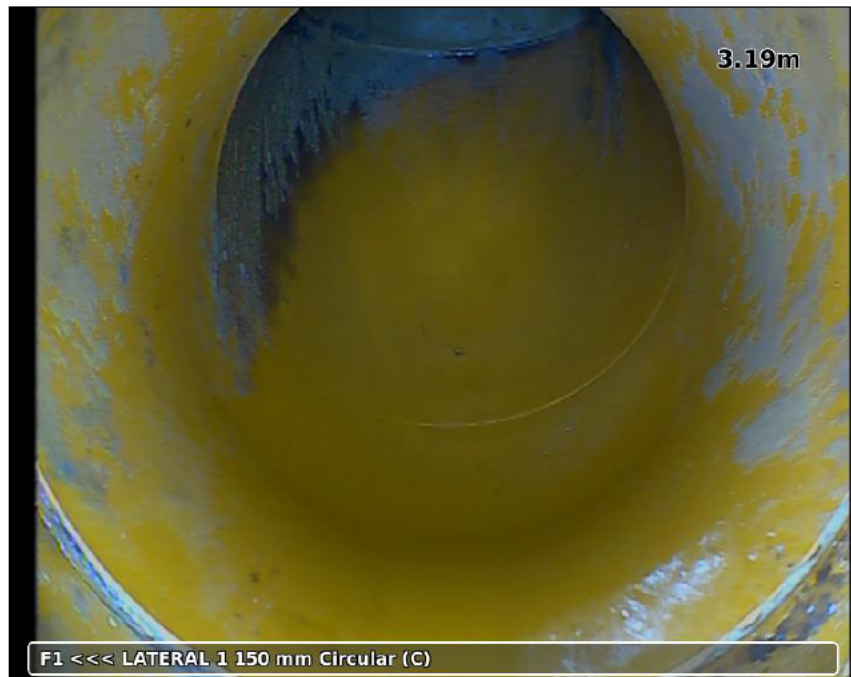
Photo: 20230130-082242-snap0001.jpg, 00:00:58  
3.19m, Finish node type outfall reference number: LATERAL 1 INTERNAL WASTE  
STACK

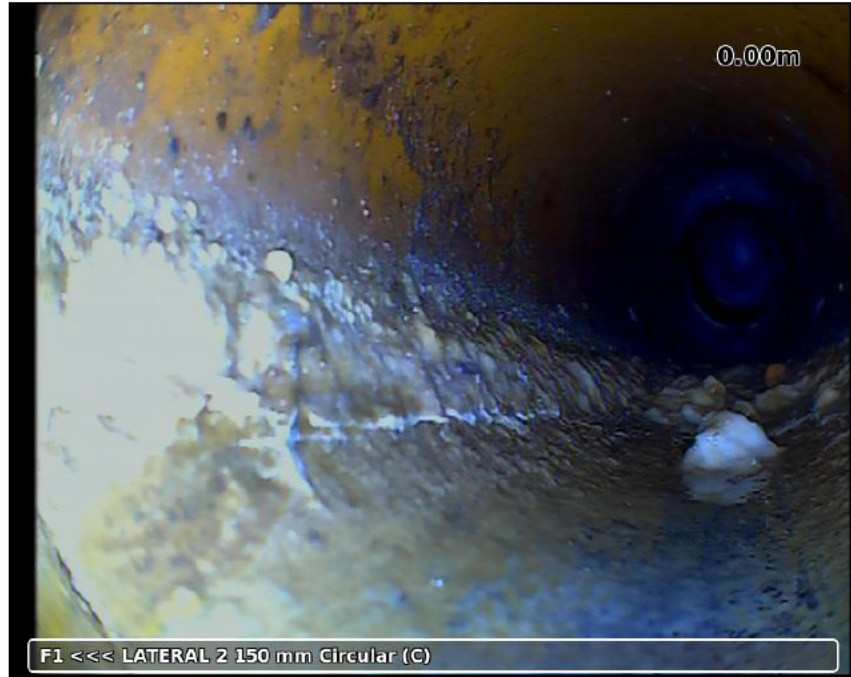
Photo: 20230130-082500-snap0000.jpg, 00:00:01  
0m, Start node type manhole reference number: F1

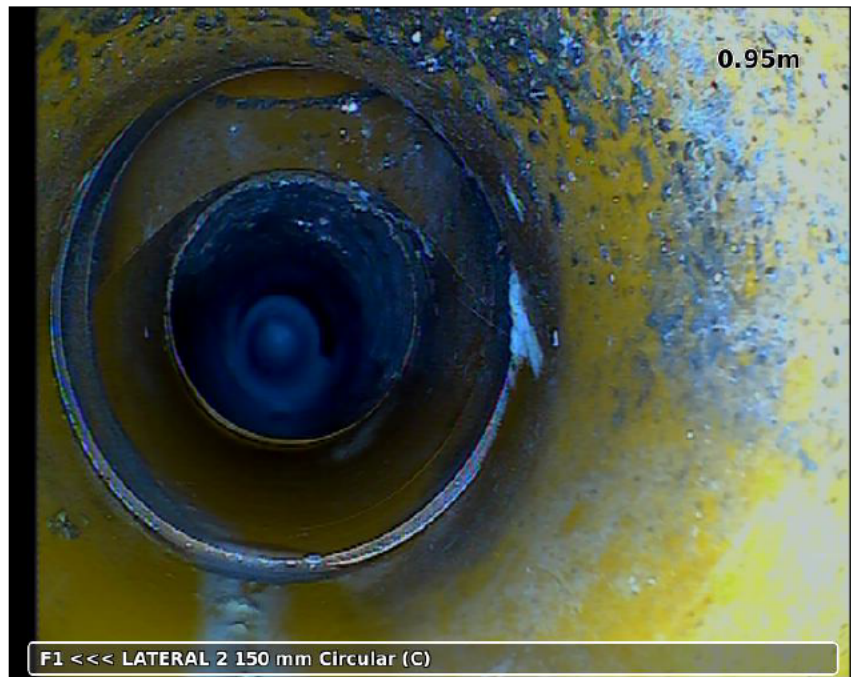
Photo: 20230130-082500-snap0001.jpg, 00:00:29  
0.95m, Junction from/at 12 o'clock diameter: 100 mm

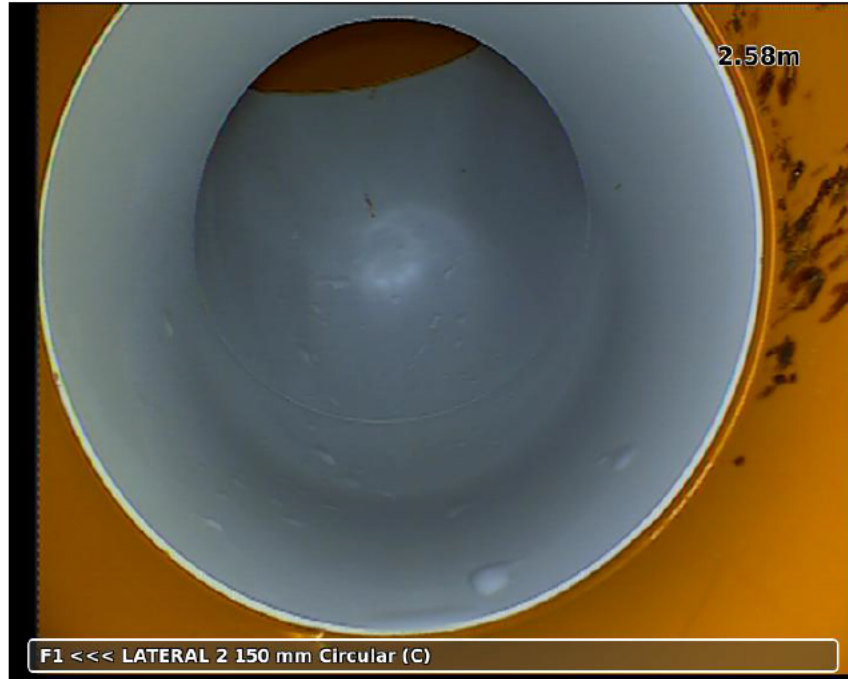
Photo: 20230130-082500-snap0002.jpg, 00:01:58  
2.58m, Finish node type outfall reference number: LATERAL 2 INTERNAL WASTE  
STACK

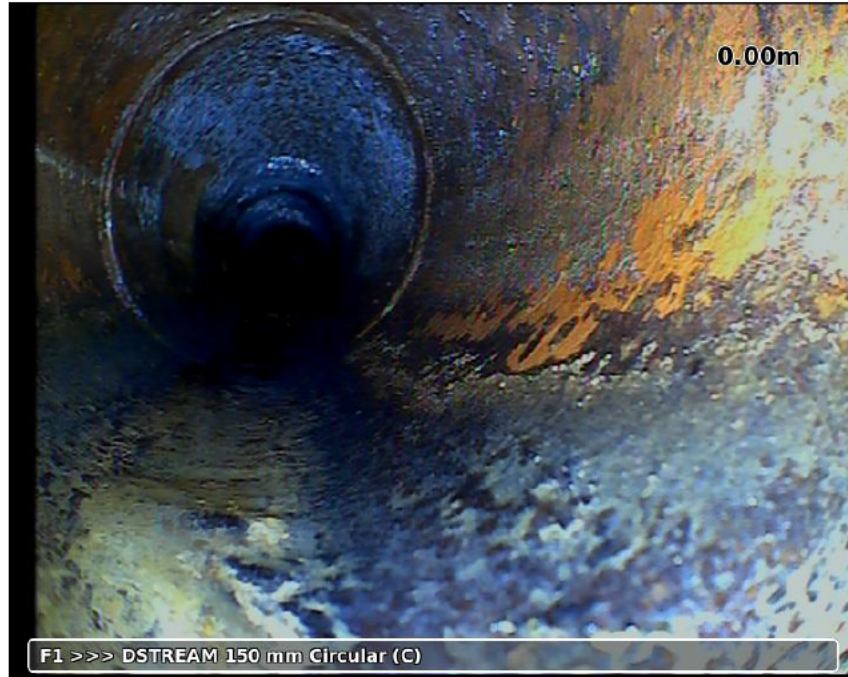
Photo: 20230130-082748-snap0000.jpg, 00:00:02  
0m, Start node type manhole reference number: F1

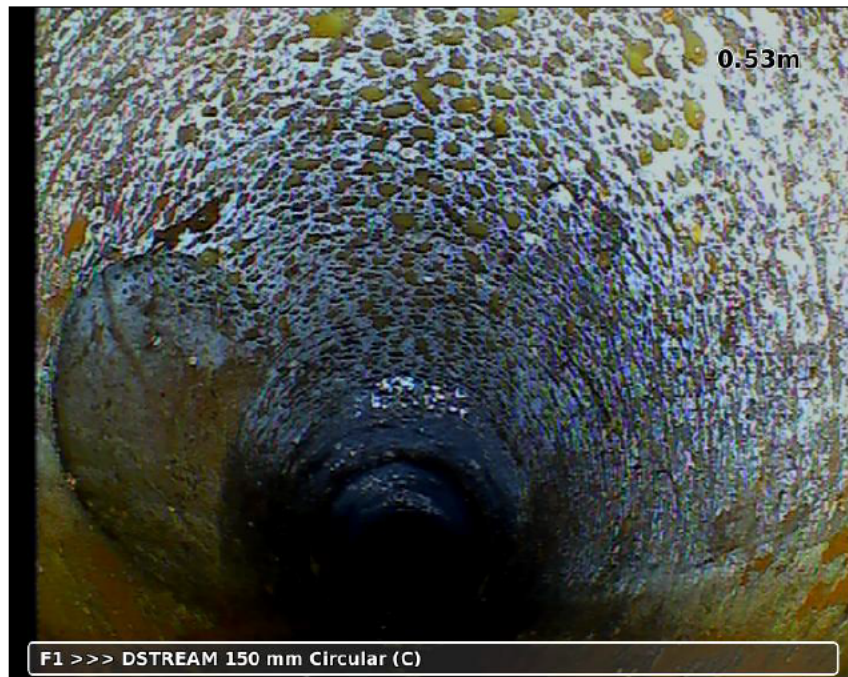
| 1:50 | Position | Observation | Photo | | | | | | |
|---|---|---|---|---|---|---|---|---|---|
| | 0.53 | Junction from/at 10 o'clock diameter: 100 mm | 20230130-082748-snap0001.jpg | | | | | | |

Photo: 20230130-082748-snap0001.jpg, 00:00:25  
0.53m, Junction from/at 10 o'clock diameter: 100 mm

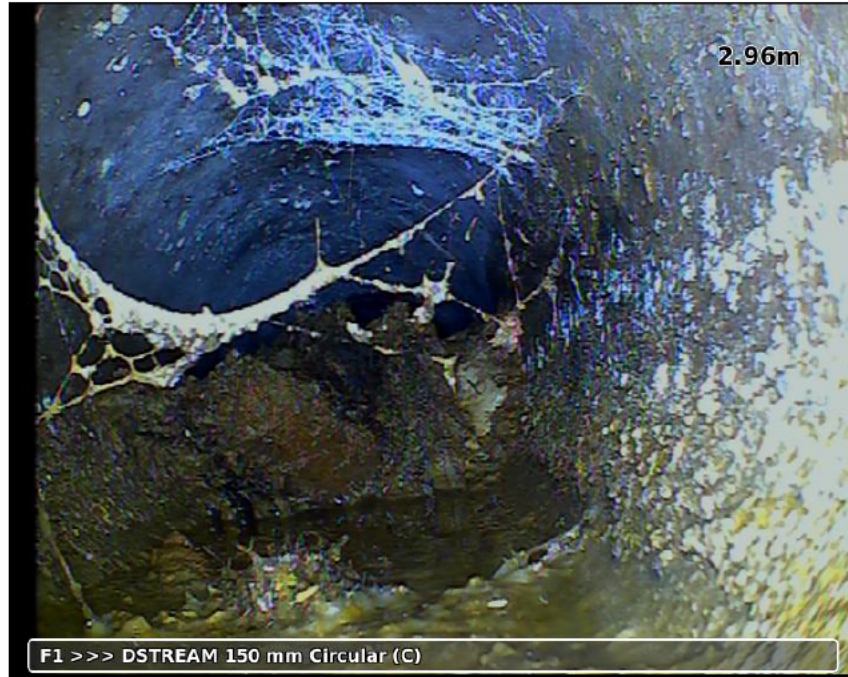
| 1:50 | Position | Observation | Photo | | | | | | |
|---|---|---|---|---|---|---|---|---|---|
| | 2.96 | Survey abandoned Remarks: ROOT BLOCKAGE IN PIPE | 20230130-082748-snap0002.jpg | | | | | | |

Photo: 20230130-082748-snap0002.jpg, 00:00:56  
2.96m, Survey abandoned Remarks: ROOT BLOCKAGE IN PIPE

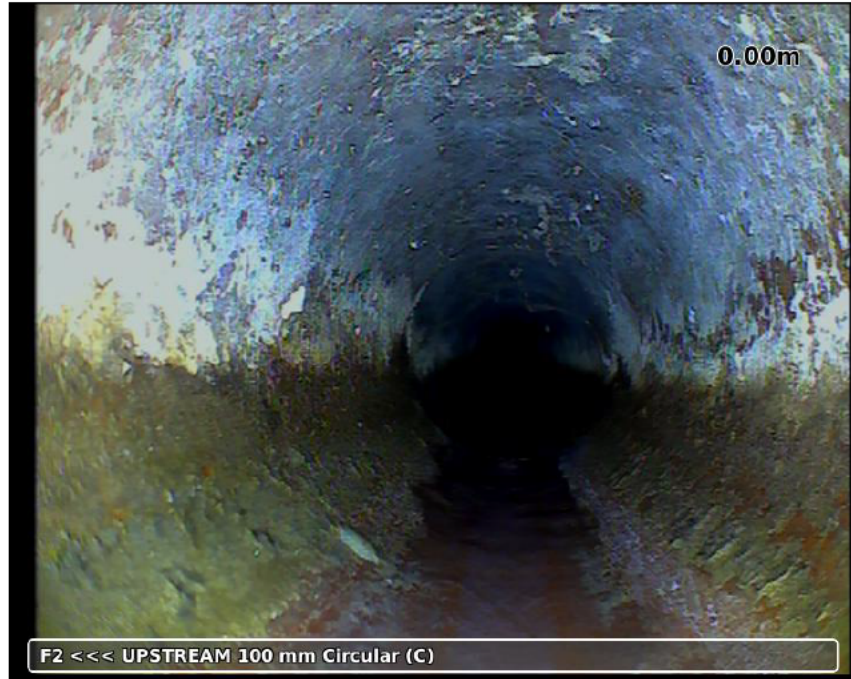
Photo: 20230130-083212-snap0000.jpg, 00:00:04  
0m, Start node type manhole reference number: F2

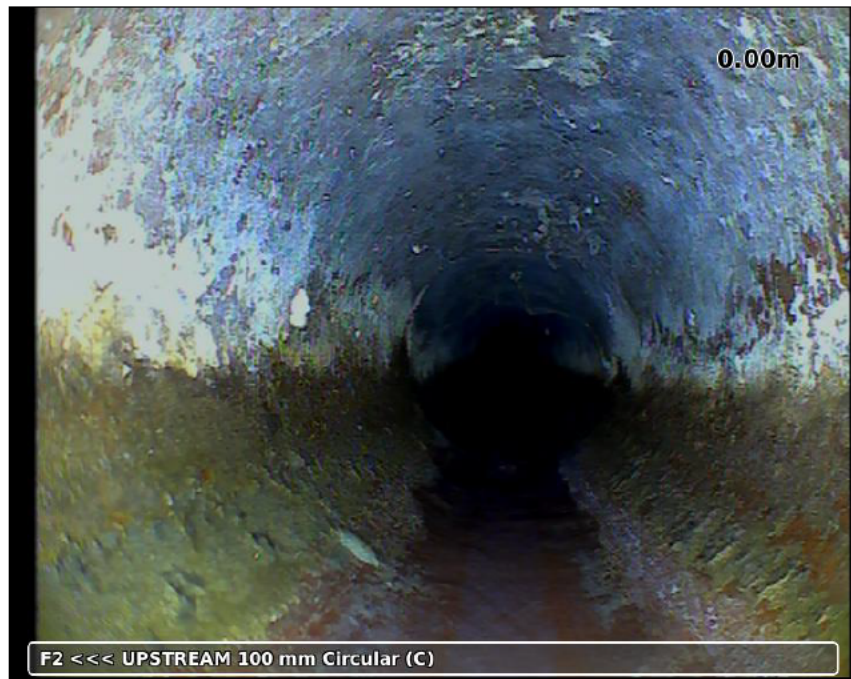
Photo: 20230130-083212-snap0001.jpg, 00:00:07  
0m, Water level 05 % of the vertical dimension

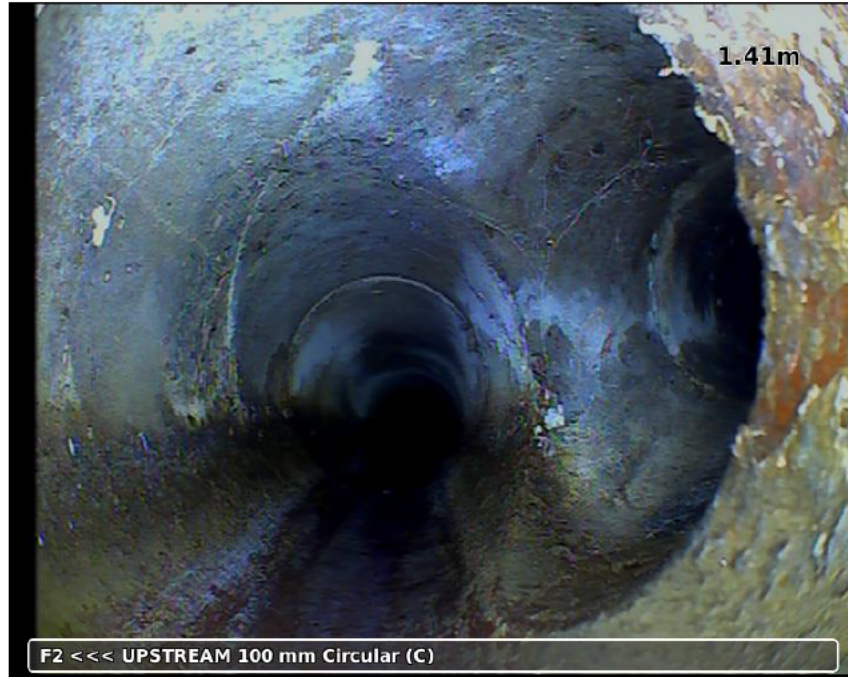
Photo: 20230130-083212-snap0002.jpg, 00:00:26  
1.41m, Junction from/at 02 o'clock diameter: 100 mm

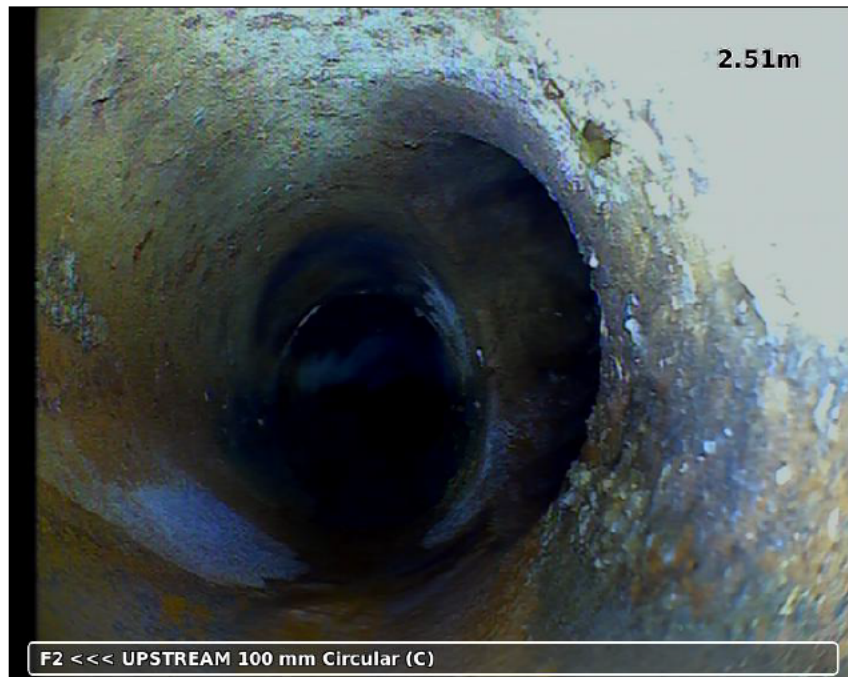
Photo: 20230130-083212-snap0003.jpg, 00:01:01  
2.51m, Junction from/at 02 o'clock diameter: 100 mm

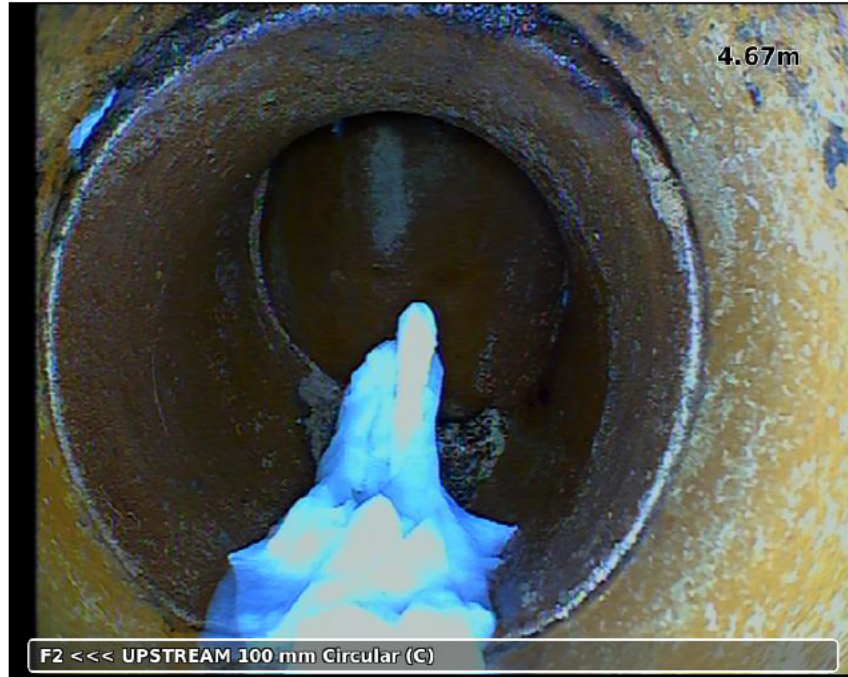
Photo: 20230130-083212-snap0004.jpg, 00:01:41

4.67m, Finish node type outfall reference number: UPSTREAM INTERNAL WASTE  
STACK

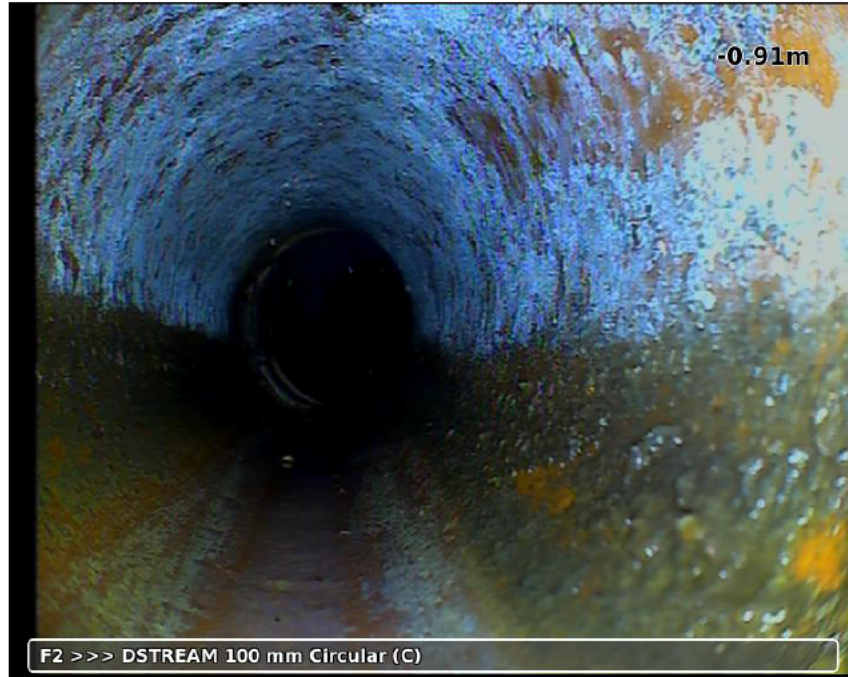
Photo: 20230130-083451-snap0000.jpg, 00:00:00  
-0.91m, Start node type manhole reference number: F2

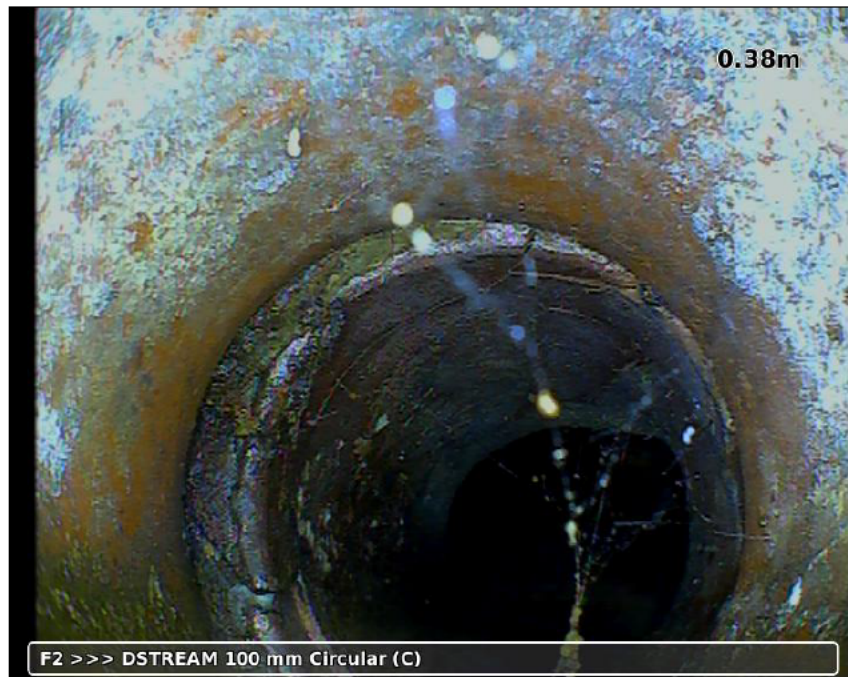
| 1:50 | Position | Observation | Photo |
|---|---|---|---|
| | 0.38 | Joint displaced medium | 20230130-083451-snap0001.jpg |

Photo: 20230130-083451-snap0001.jpg, 00:00:35  
0.38m, Joint displaced medium

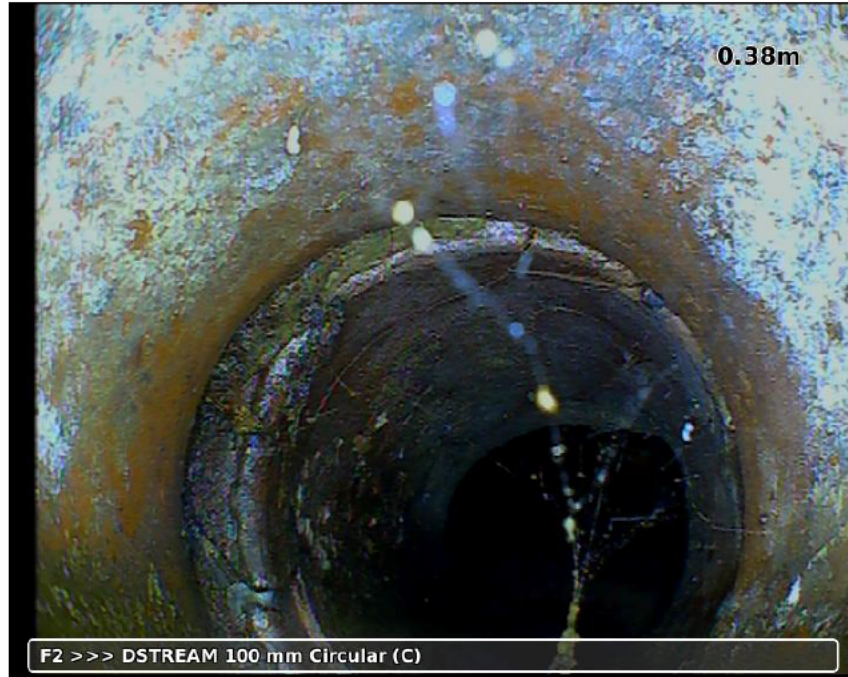
| 1:50 | Position | Observation | Photo |
|---|---|---|---|
| | 0.38 | Cracks multiple at joint from/at 07 o'clock to 02 o'clock | 20230130-083451-snap0002.jpg |

Photo: 20230130-083451-snap0002.jpg, 00:00:47  
0.38m, Cracks multiple at joint from/at 07 o'clock to 02 o'clock

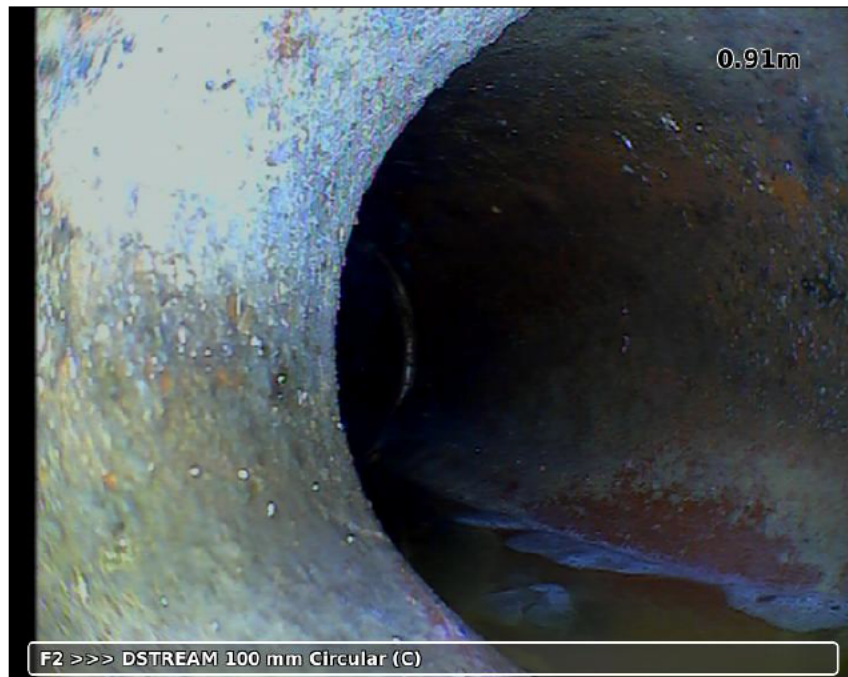
| 1:50 | Position | Observation | Photo |
|---|---|---|---|
| | 0.91 | Line deviates left Remarks: DROPPING INTO PIPE RUNNING FROM MANHOLE F1 | 20230130-083451-snap0003.jpg |

Photo: 20230130-083451-snap0003.jpg, 00:01:17  
0.91m, Line deviates left Remarks: DROPPING INTO PIPE RUNNING FROM  
MANHOLE F1

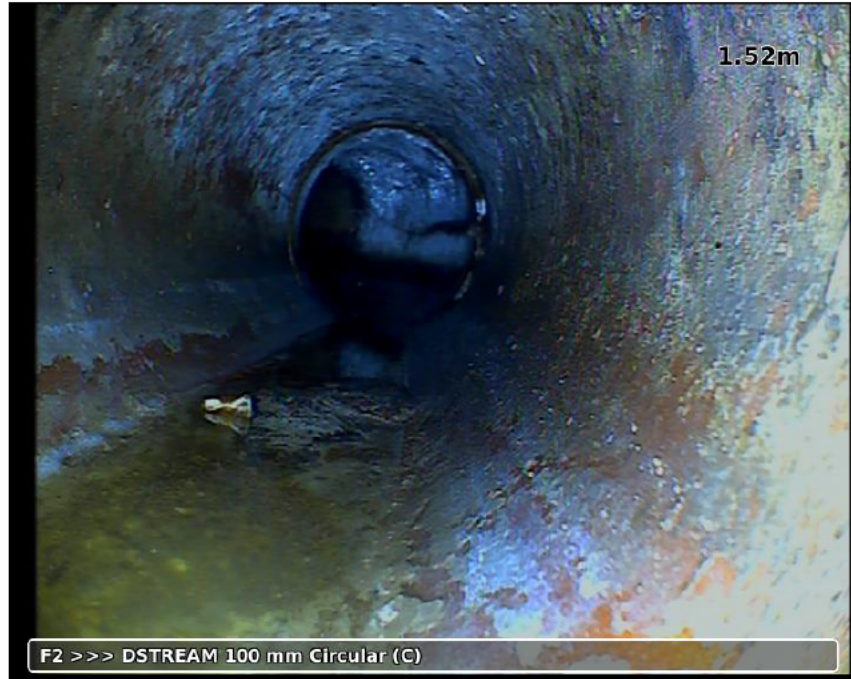
| 1:50 | Position | Observation | Photo |
|---|---|---|---|
| | 1.52 | Size changes new size(s) 150 mm high 150 mm wide | 20230130-083451-snap0004.jpg |

Photo: 20230130-083451-snap0004.jpg, 00:01:36  
1.52m, Size changes new size(s) 150 mm high 150 mm wide

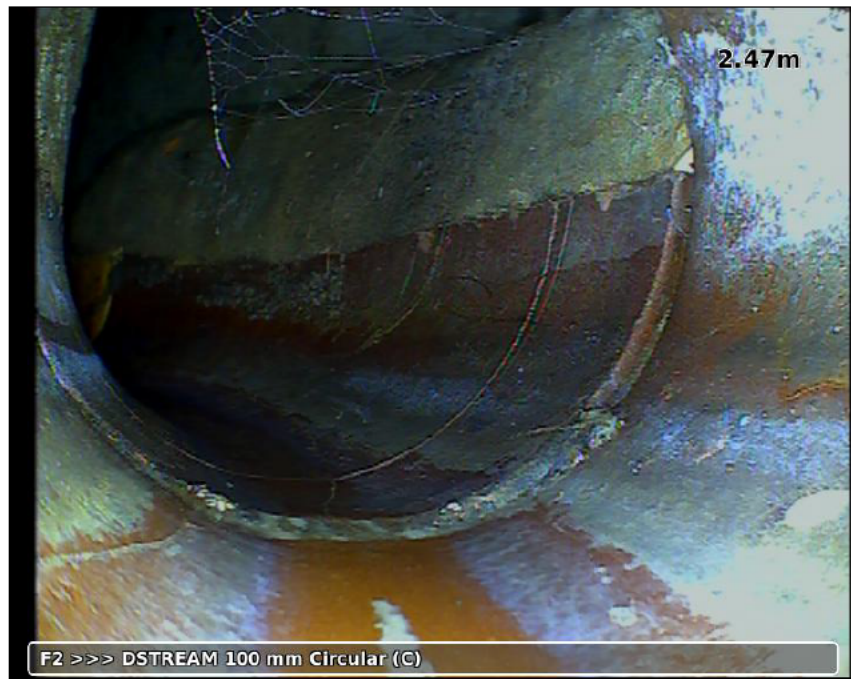
| 1:50 | Position | Observation | Photo |
|---|---|---|---|
| | 2.47 | Line deviates left | 20230130-083451-snap0005.jpg |

Photo: 20230130-083451-snap0005.jpg, 00:01:56  
2.47m, Line deviates left

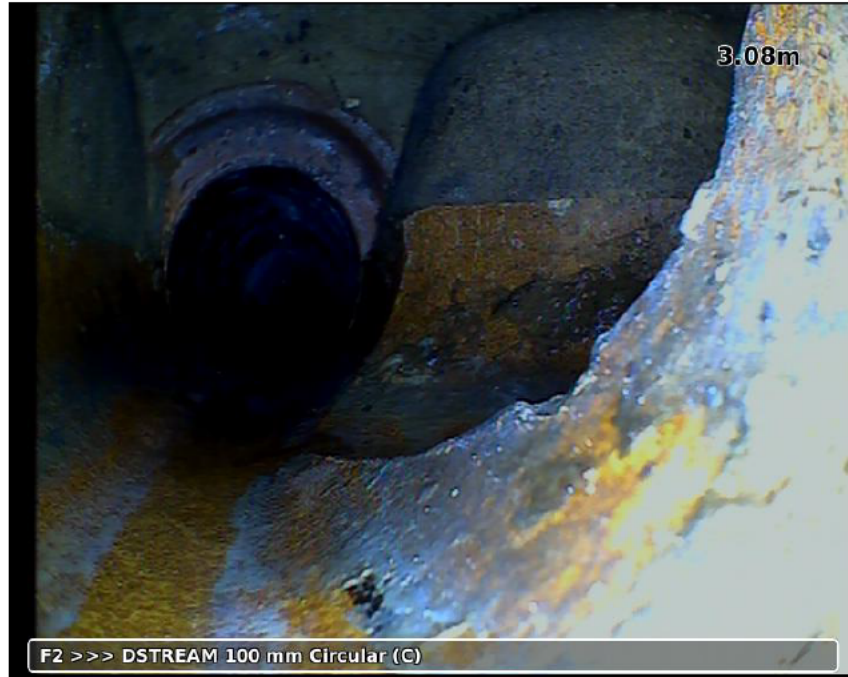
Photo: 20230130-083451-snap0006.jpg, 00:02:06

3.08m, Finish node type manhole reference number: DSTREAM INTO F3 MAIN

SEWER Remarks: LOCATED IN GARDEN OF NEIGHBOUR. UNABLE TO LOCATE
