**VERIFICATION REPORT**

**PLOTS 29-35 & 47-55**

**HAMBLEWOOD, HEATH HOUSE LANE,  
HEDGE END, HAMPSHIRE, SO30 0LE**

| Reference: | GE20045/VR/PLOTS 29-35 & 47-55/APR24 |

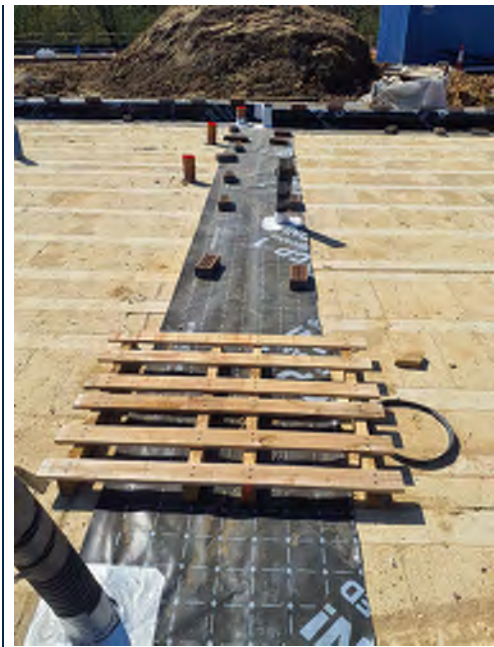
Plot 59-60 party wall

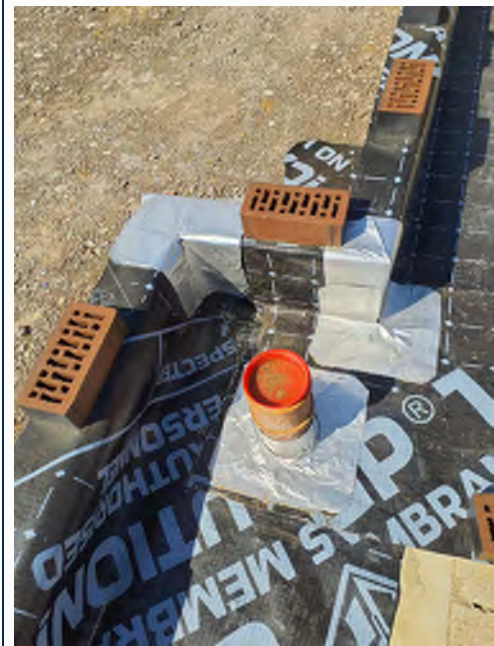
Plot 59

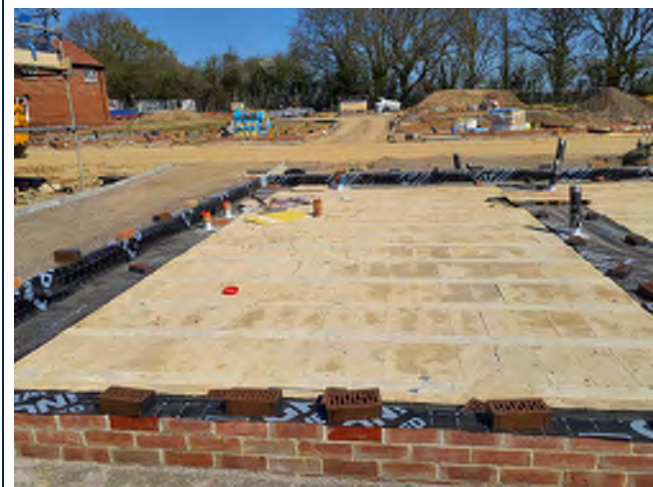
Plot 60 overview

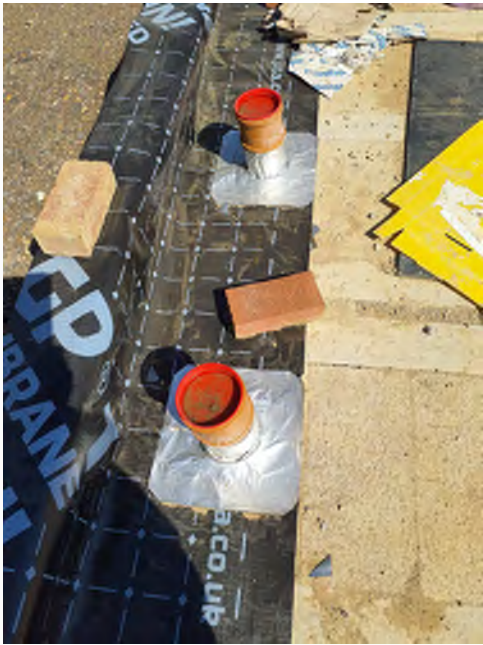
| | Plot 60 services |

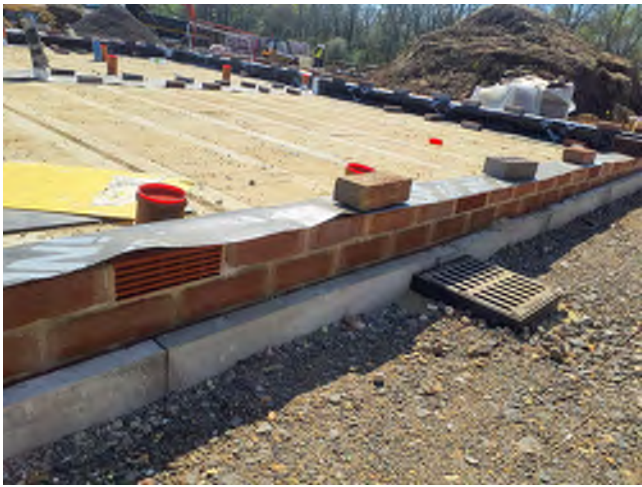
| | Plot 60 airbricks |

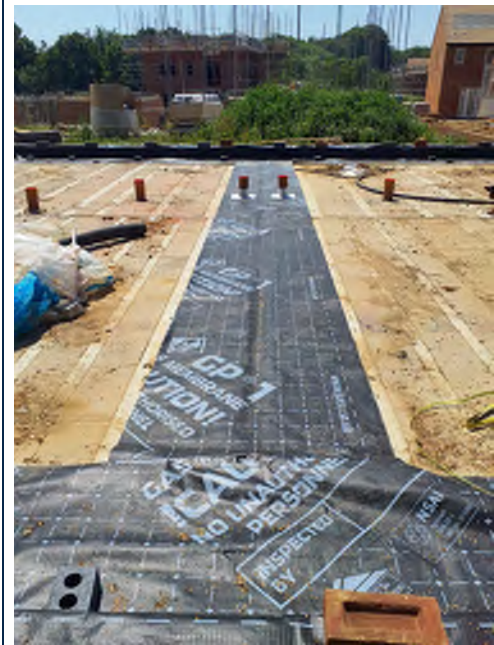
Plot 33 & 34 party wall

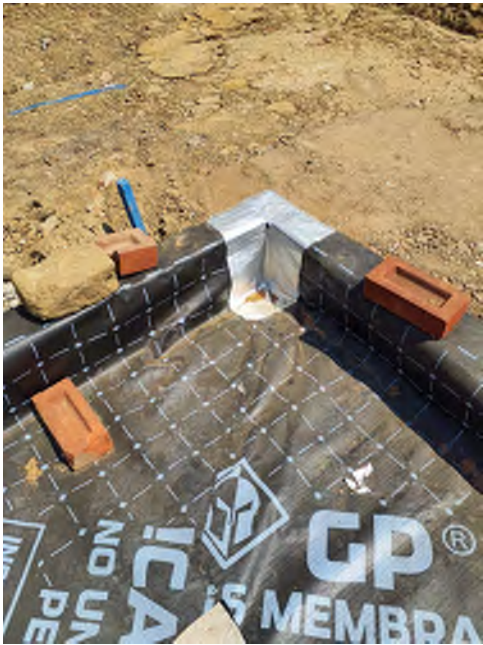
| | Plot 35 corner |

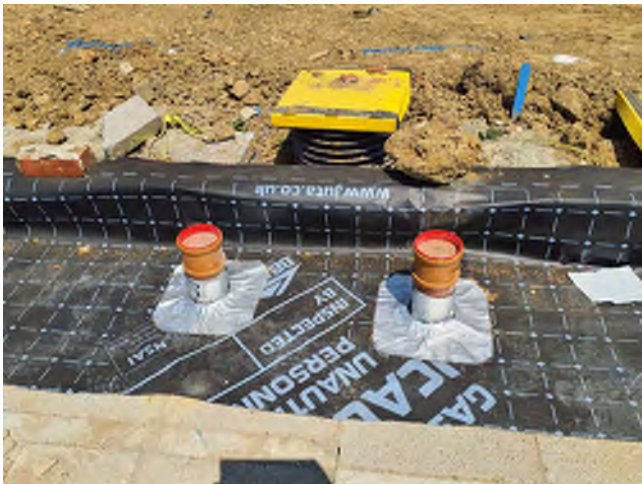
| | Plot 35 services |

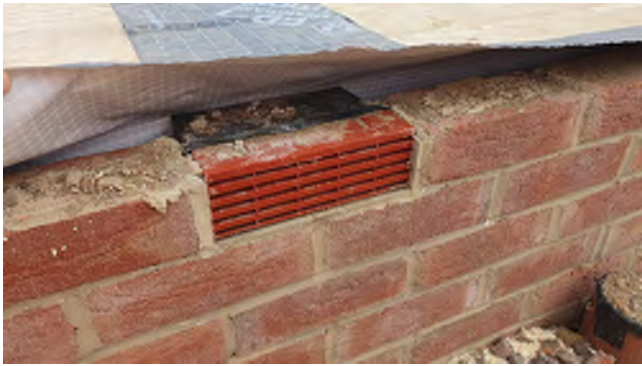
Air brick and telescopic duct

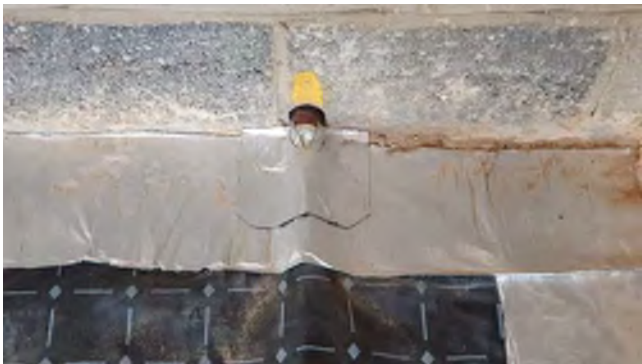
| | | Plot 55 gas entry sealed to membrane |

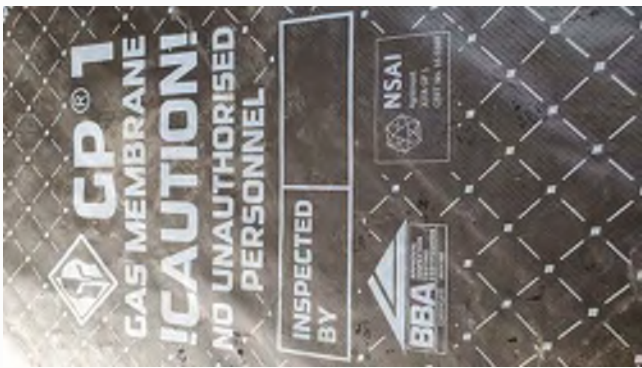
| | | Plot 55 membrane BBA stamp |

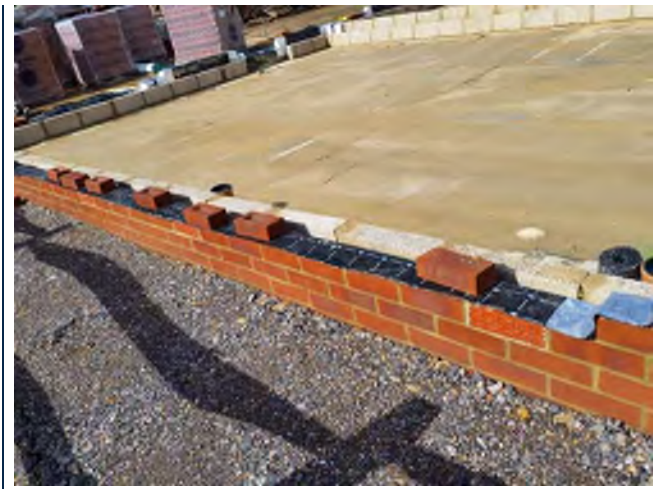
Plot 54 airbricks

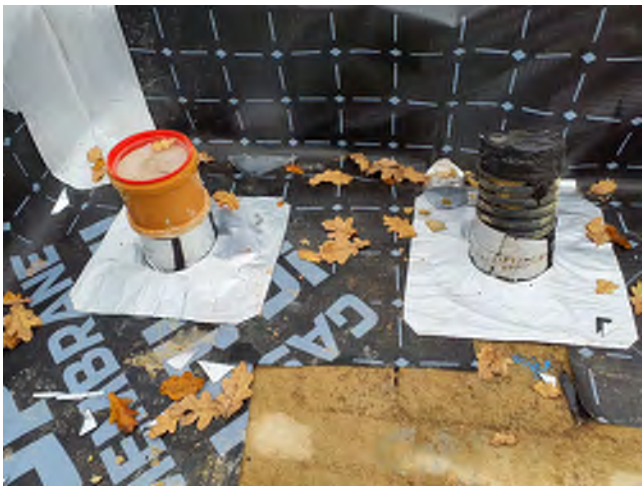
| | Plot 31 services |

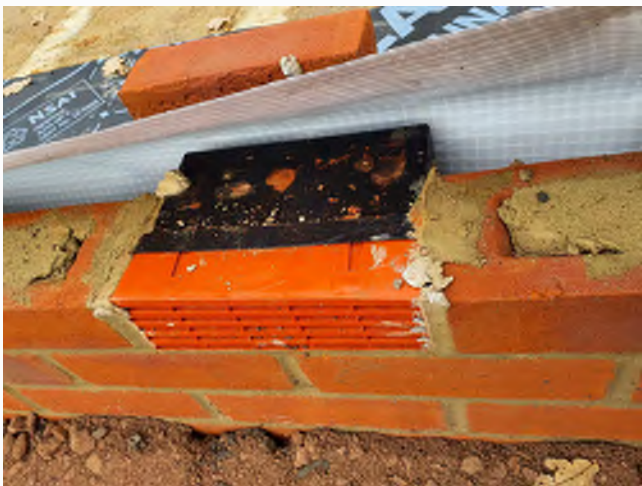
| | Plot 31 air vent |

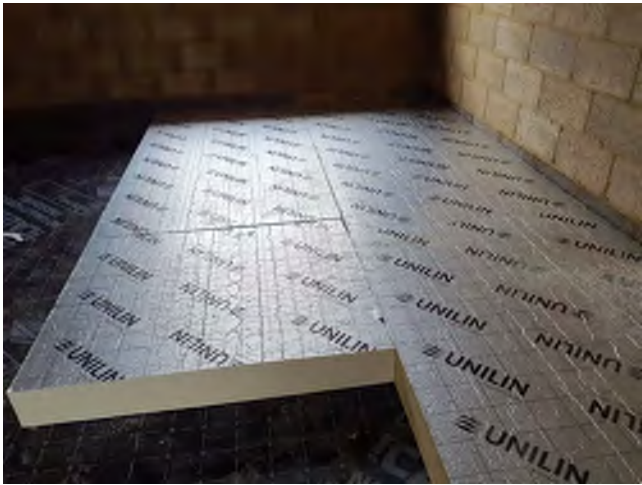
| | Plot 35 insulation on part of membrane |

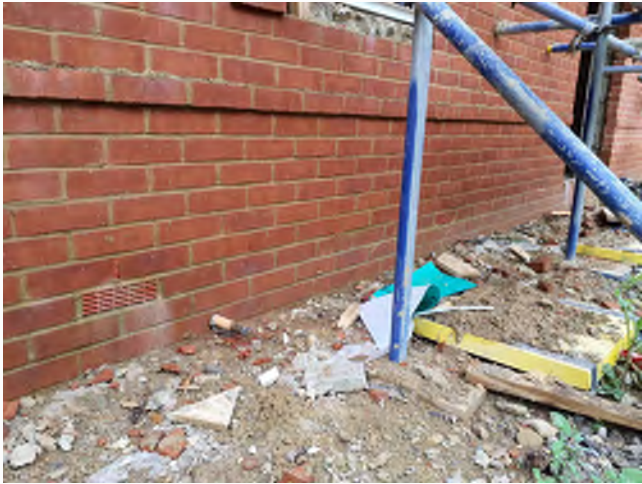
| | Plot 35 airbricks |

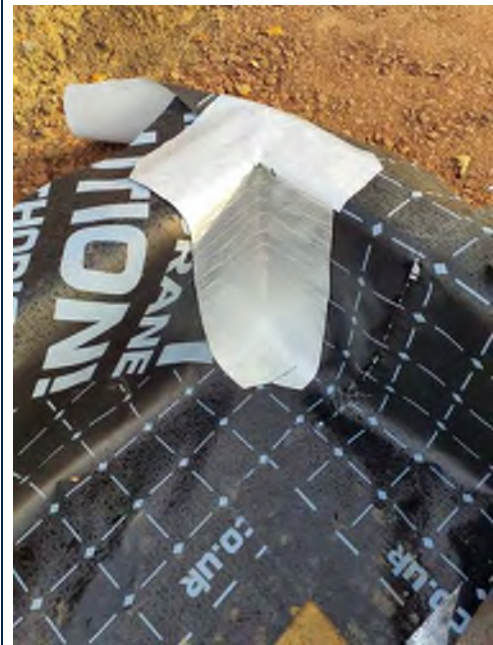
Plot 30 corner

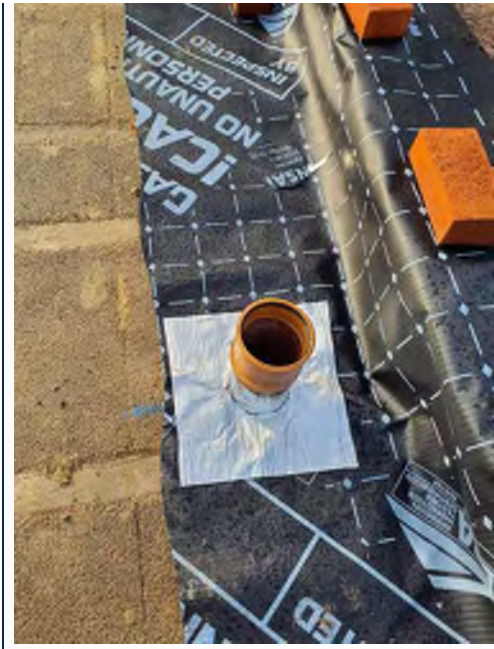
Plot 29 service

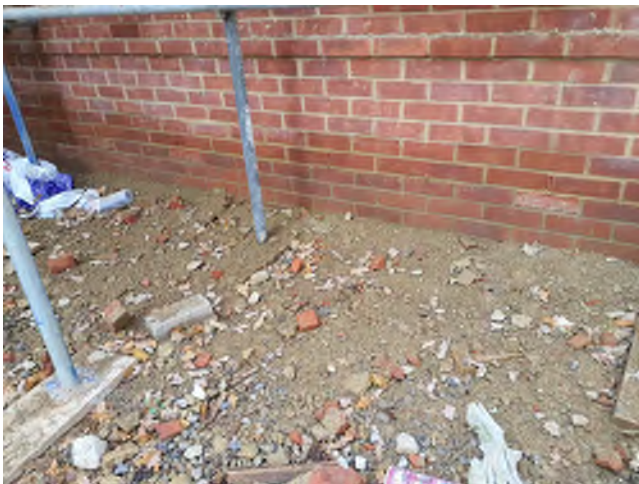
Plot 33 airbricks

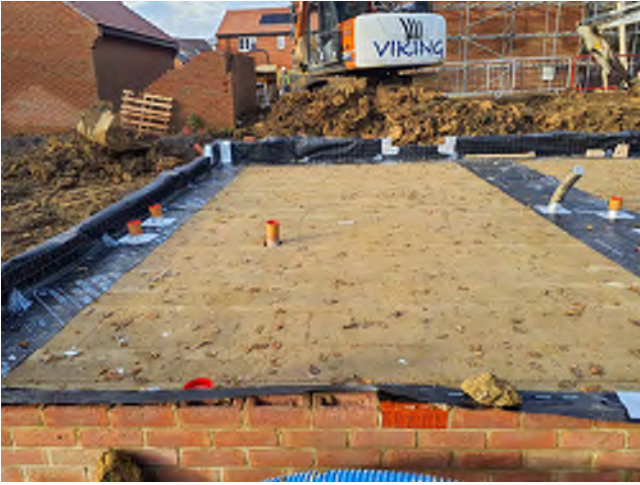
| Photograph | Photograph Title |
|---|---|
| A wide-angle photograph showing a construction site for a new building. In the foreground, there is a large, flat, light-colored area, possibly a foundation or a prepared ground surface. To the left, there is a brick wall. In the background, there are other buildings, some with scaffolding, and a large excavator with 'VIKING' written on its side. The ground is uneven and appears to be under construction. | Plot 47 overview |

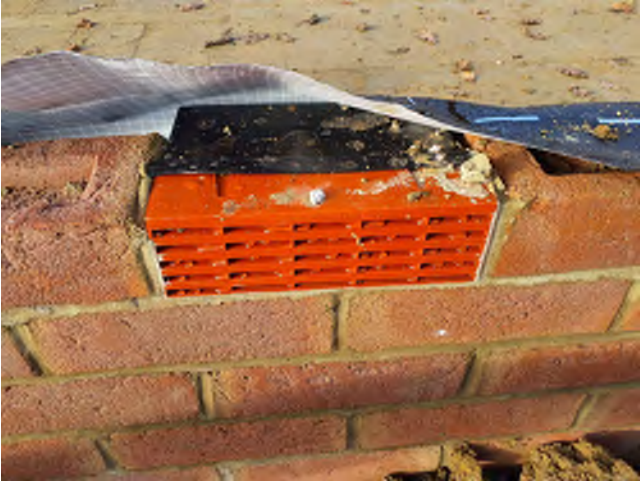
| Photograph | Photograph Title |
|---|---|
| A close-up photograph of a brick wall. A red brick is being laid into a cavity, and a black plastic air brick is being inserted into the gap. The brick is partially covered by a black plastic sheet. The surrounding area is sandy and appears to be under construction. | Plot 47 air brick |

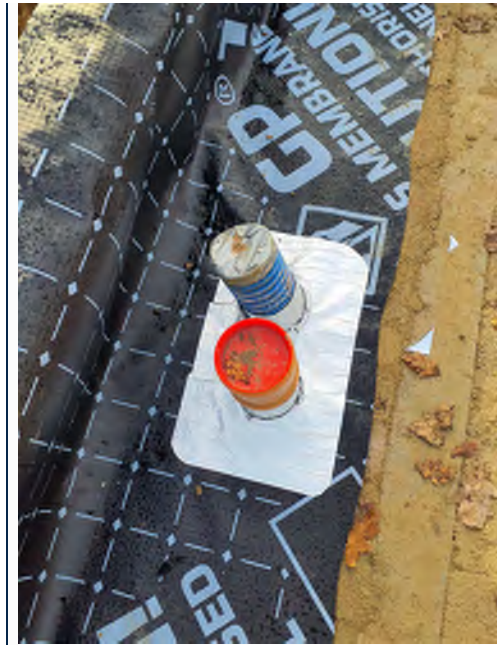
Plot 47 services

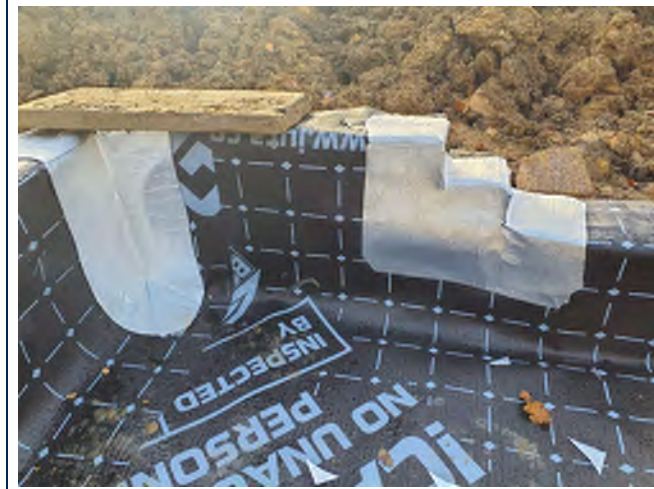
Plot 47 corner detail

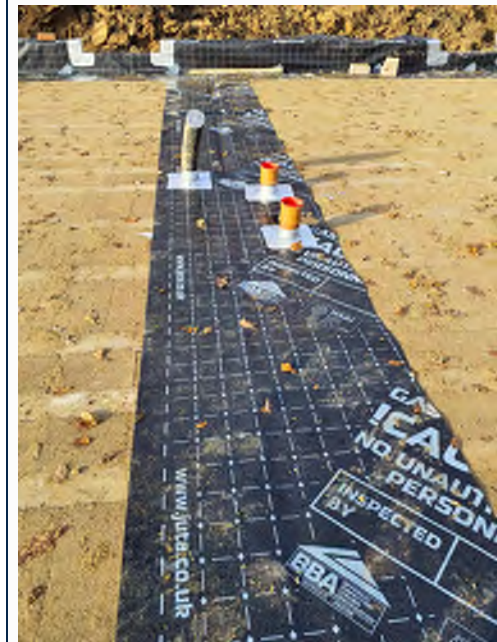
Plots 47-48 party wall

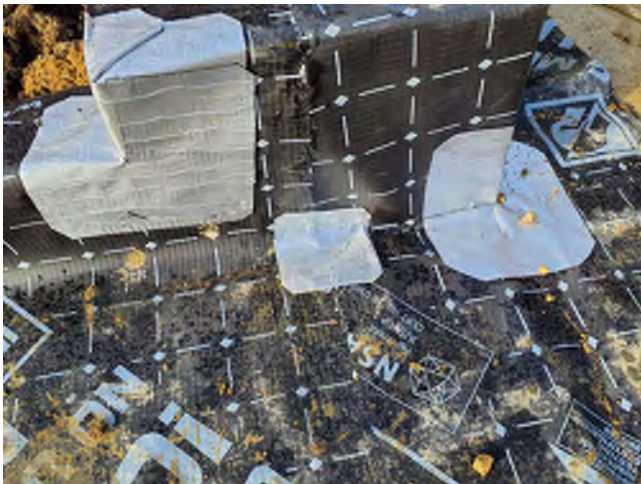
Plot 48 patch repair

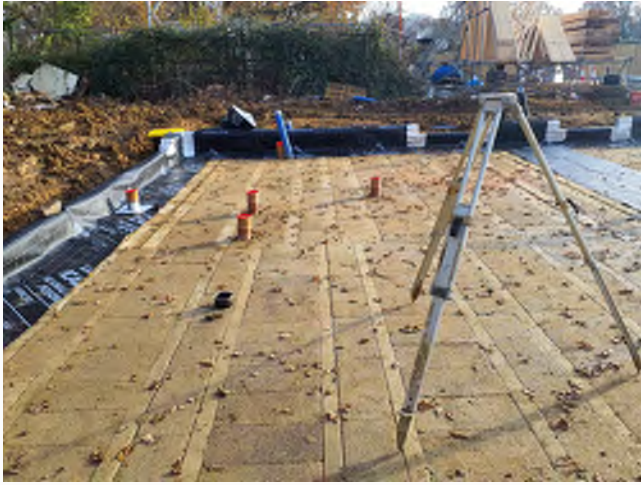
Plot 49 overview

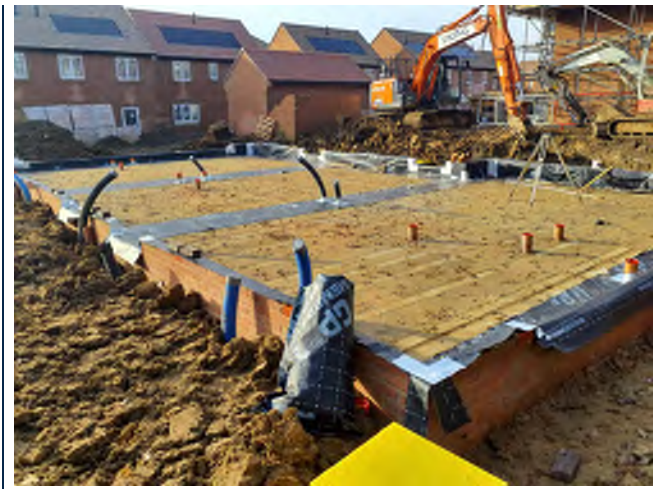
Plots 47-49 overview

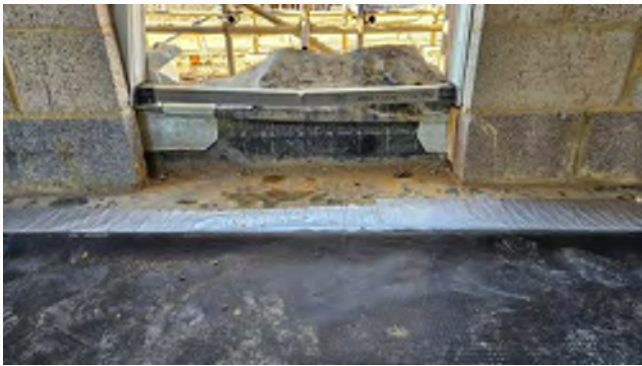
| | Front threshold |

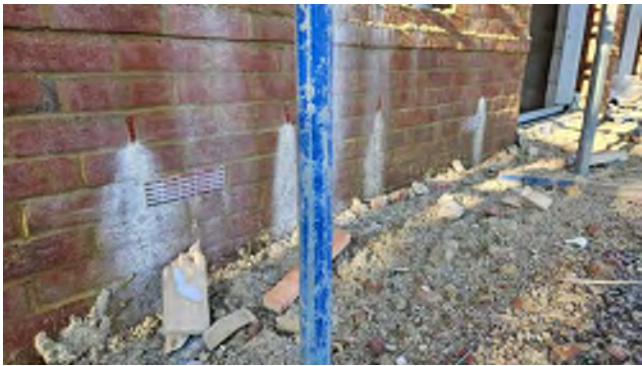
| | Air vent |

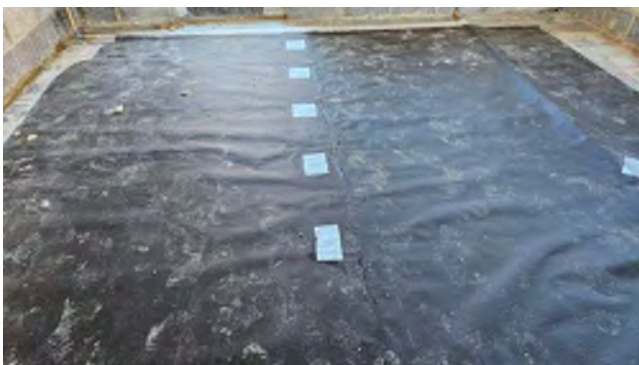
Patch repairs

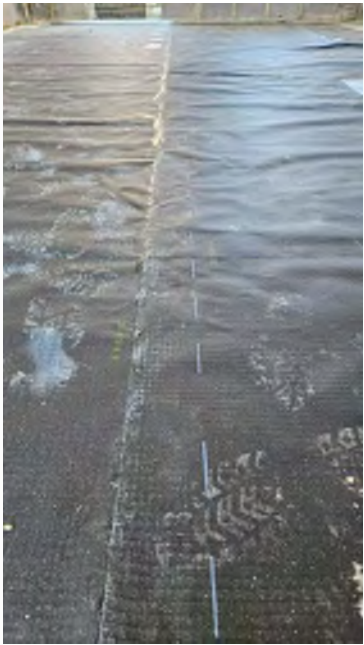
| | | Welded lap joint |

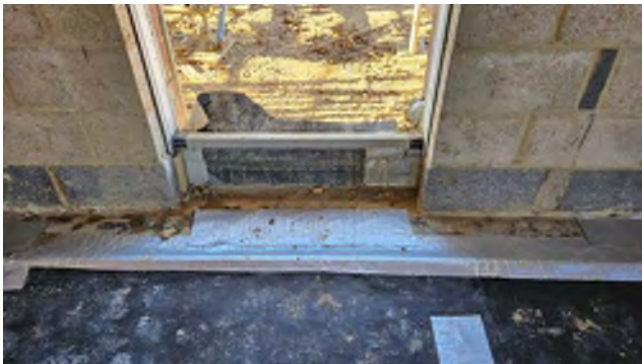
| | | Front threshold |

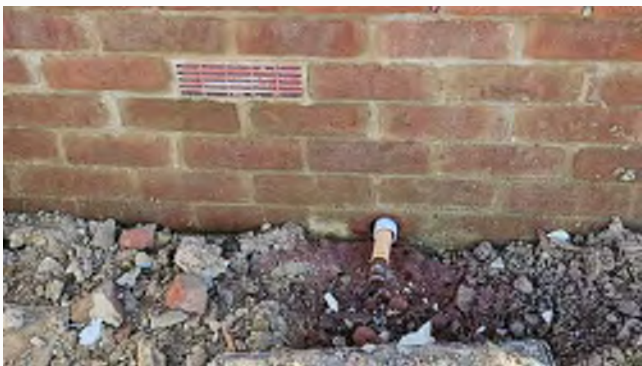
| | | Air vent |

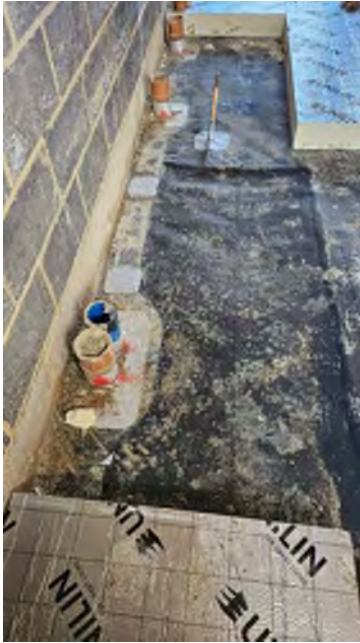
Services seals and patch repairs

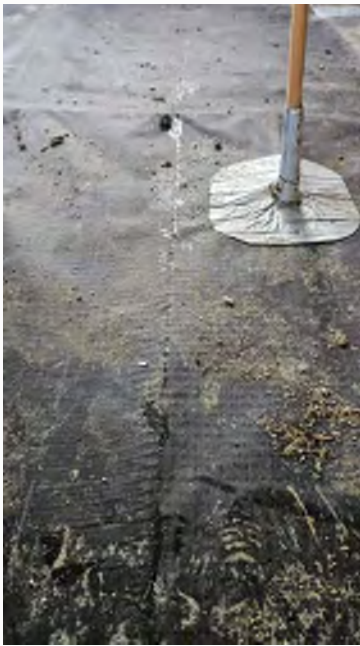
Welded joint and service seal

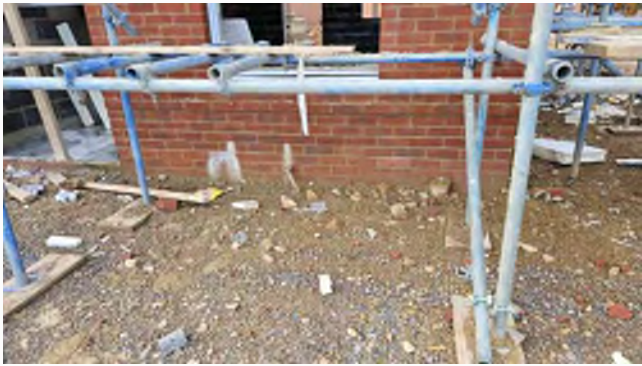
| | Air bricks at rea |

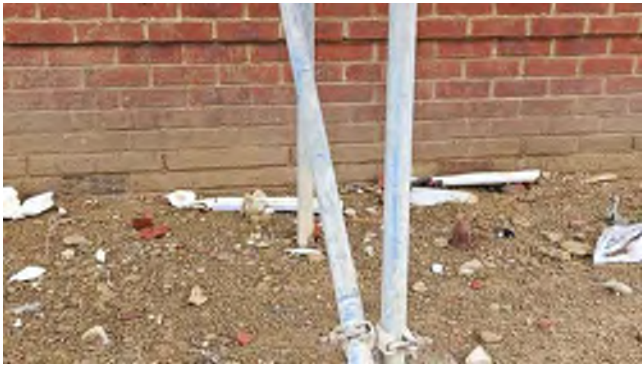
| | Side Air bricks |

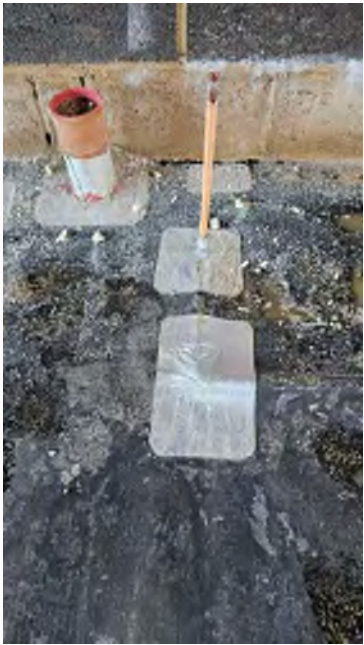
| | Bespoke service seals |

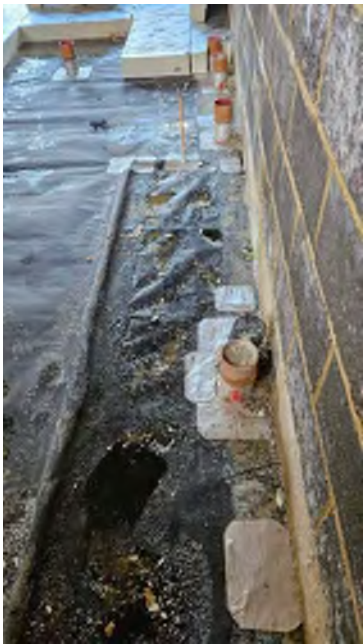
| | Service seals and patch repairs |

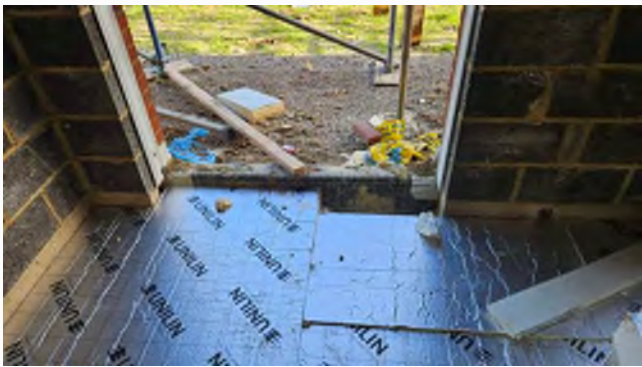
| | Rear threshold |

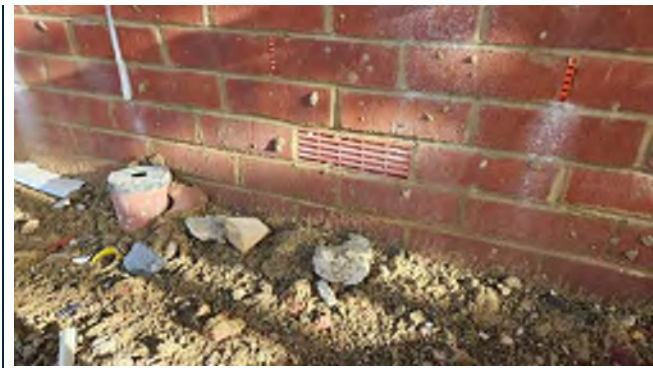
External air brick

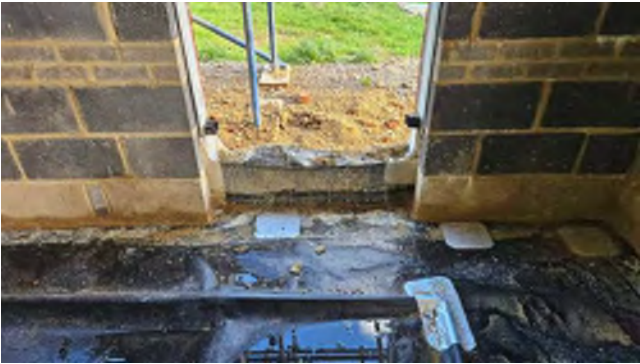
| | | Rear threshold |

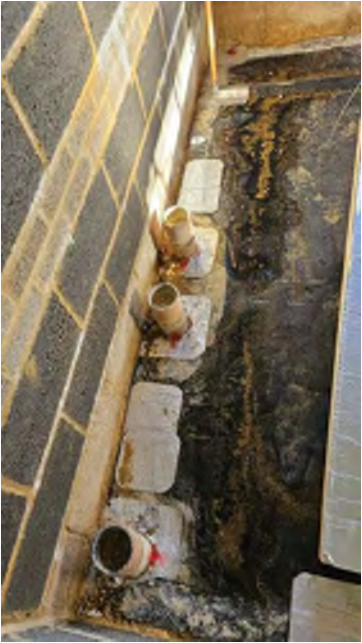
| | Services seals |

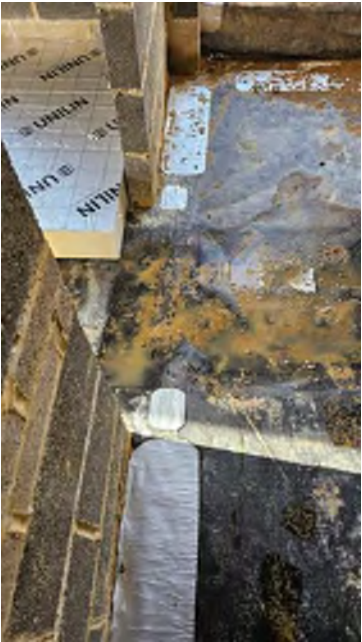
| | Patch repairs |

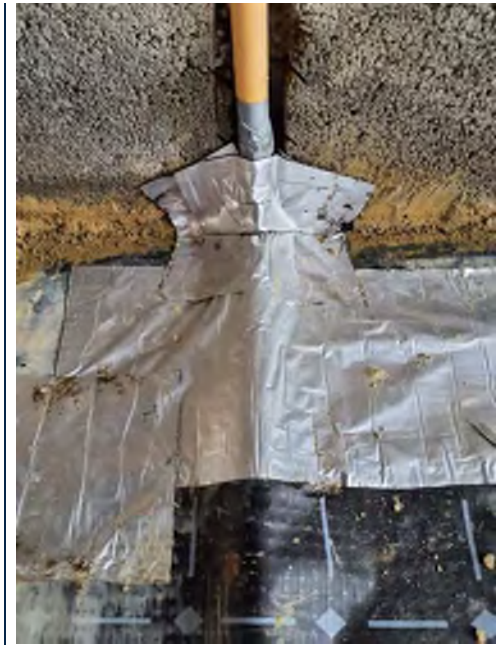
Plot 32 service

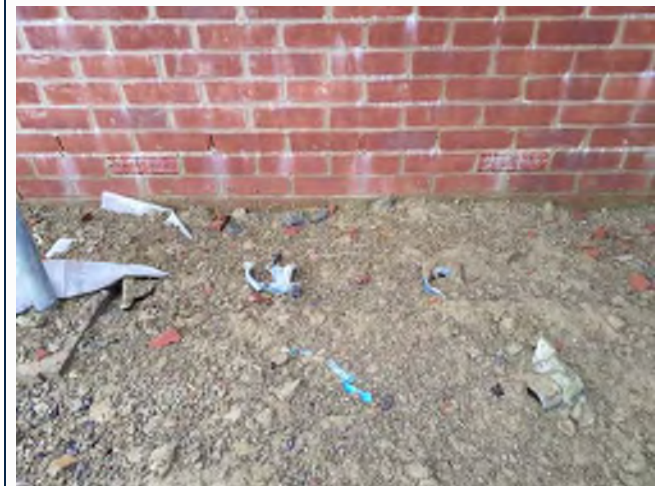
Plot 32 air bricks

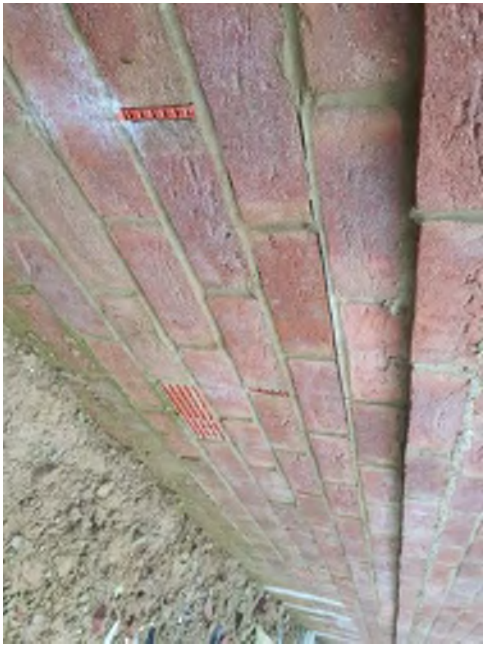
Plot 47 airbricks

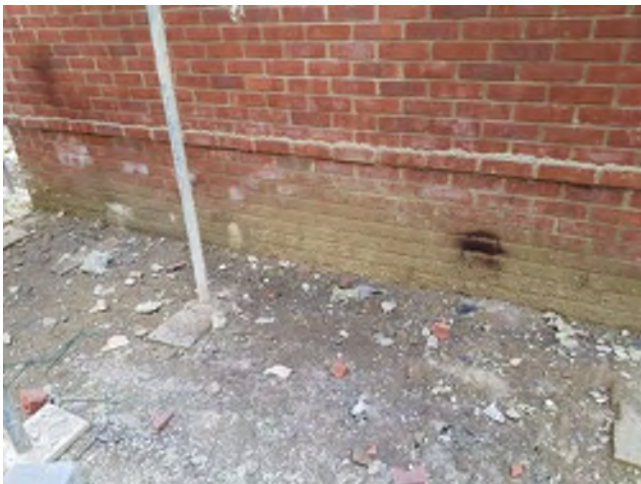
Plot 30 airbricks

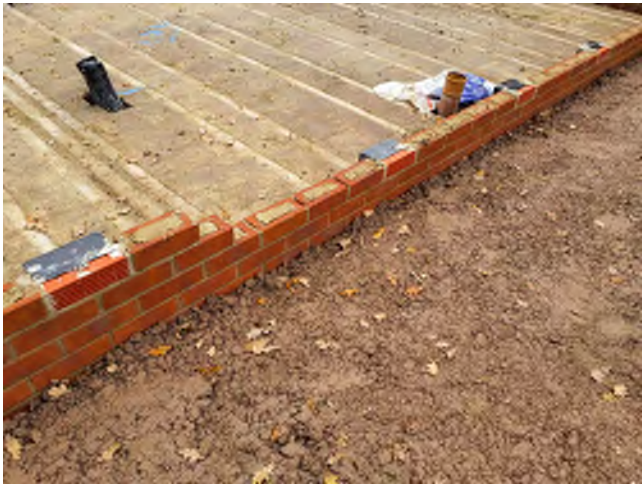
Plot 29 airbricks

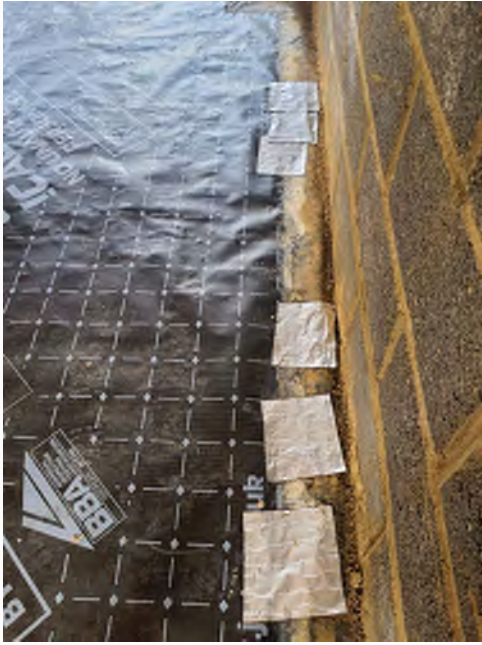
Plot 41 patch repairs

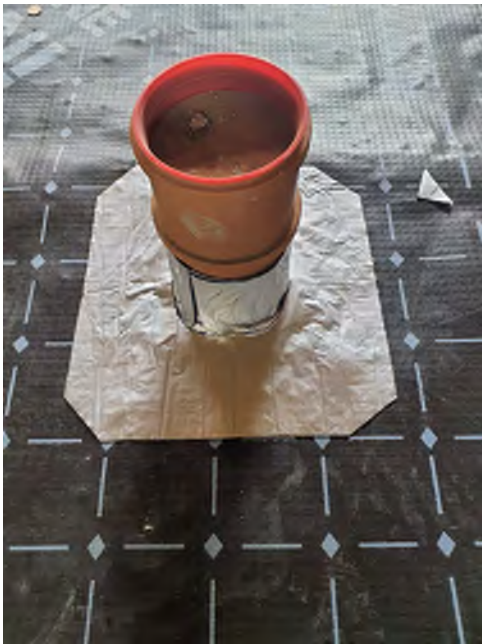
Plot 41 service

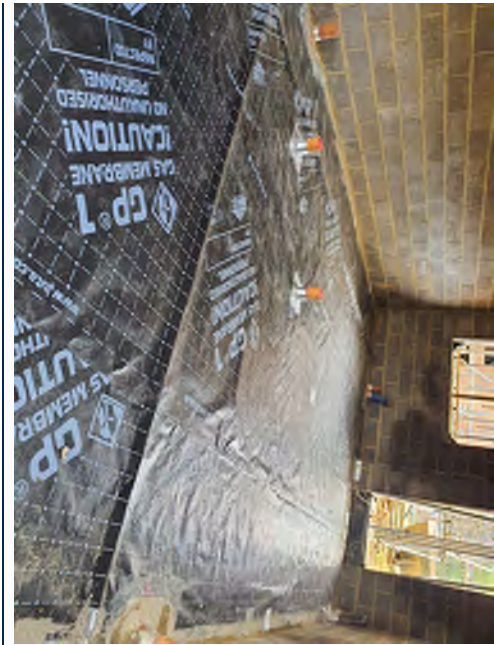
Plot 40 overview

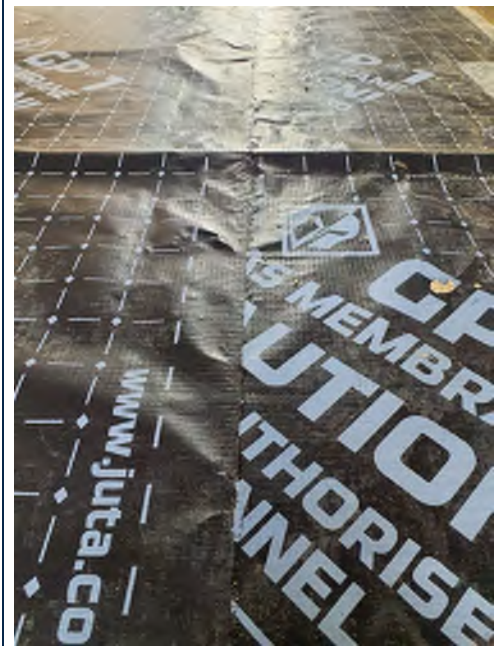
Plot 40 membrane join

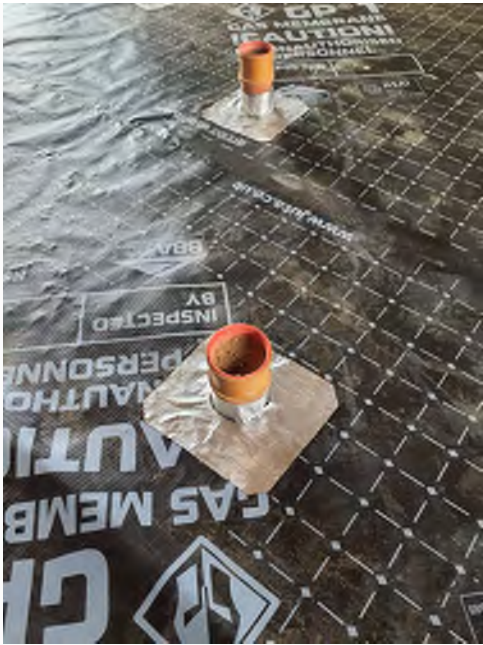
| | Plot 40 services |

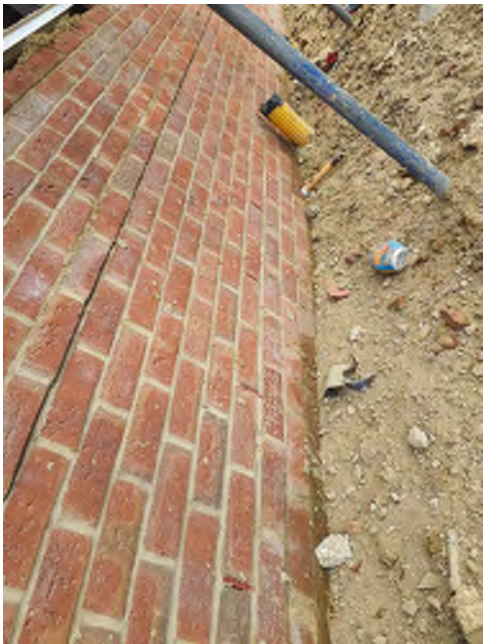
| | Plot 40 airbricks |
