## CAMPBELL ROAD, EASTLEIGH - VALIDATION REPORT

| Document Ref: | Issue Date | Description | Prepared By | Reviewed By | Approved By |
| ESL/DS/101 | February 2024 | R1 noting installation of gas membrane | David Slater | Simon Farr | Neil McLeod |

## Remediation Validation Report (R2)

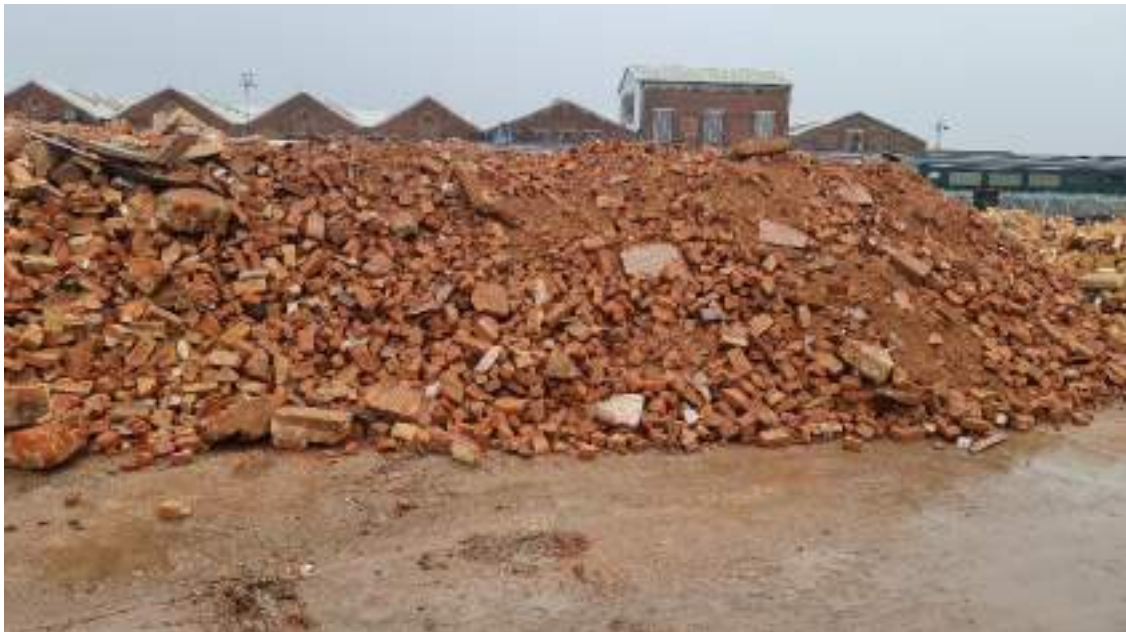
Figure 5 – Demolition Stockpile (prior to crushing).

Hardstanding areas (predominantly reinforced concrete) were broken out and stockpiled to await crushing. The underlying ashy made ground was removed and stockpiled as per the agreed stockpile management plan (see Appendices D of declared MMP), there were deviations from this in terms of actual stockpile locations, however the basic principles were adhered to. Equally, the underlying natural clay was removed to the required depth and stockpiled separately. All materials were visually inspected prior to stockpiling. During each watching brief visit, a check was carried out to ensure stockpiles were appropriately separated to avoid potential cross contamination.

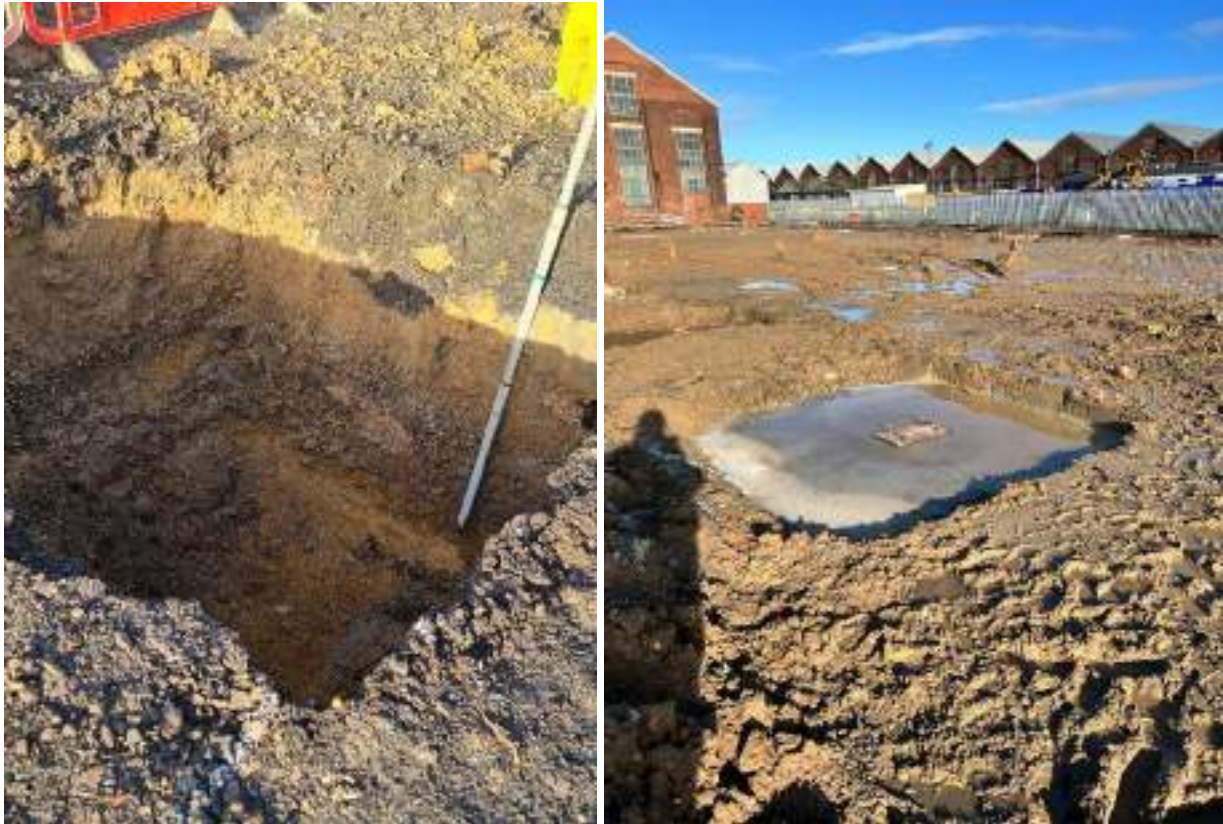
Figure 8 – Watching brief during groundworks.

On site geotechnical assessments undertaken by the groundworks company at formation level, indicated that the required ground bearing capacities had not been achieved. The client took the decision to further reduce the formation level to enable an increase in slab make up. This resulted in an additional off site disposal volume.

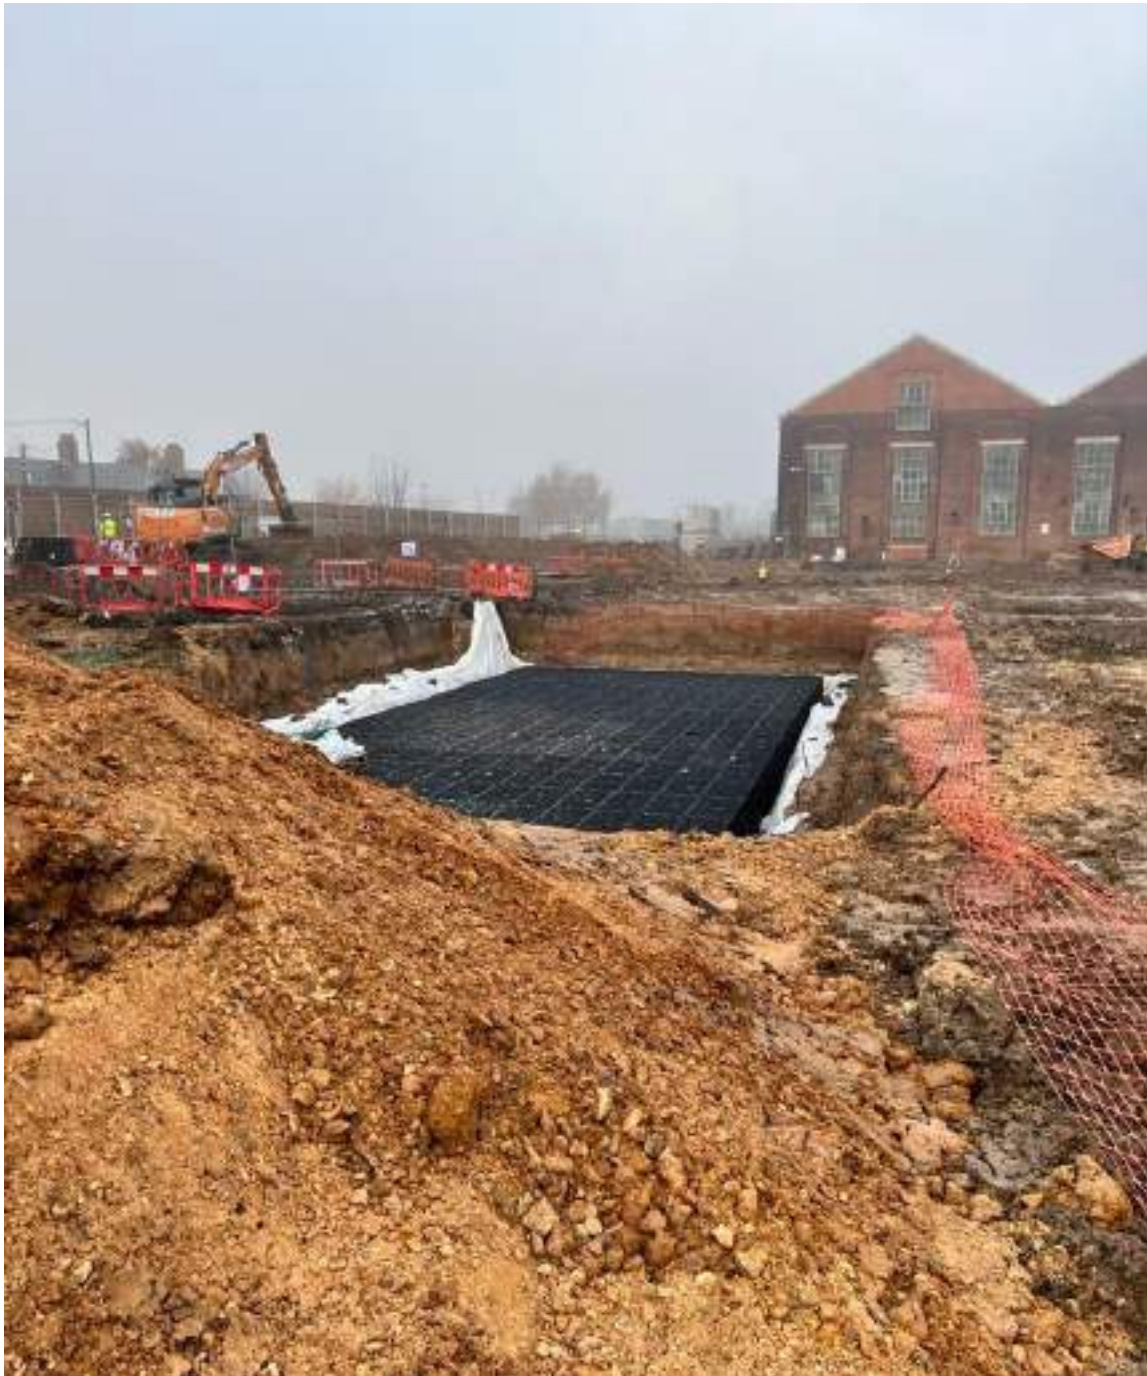
Figure 10 – Watching brief during drainage & service ducts.

Excavated soils from the installation of attenuation tanks, manhole installations, storm / foul drainage runs and required service ducts were visually inspected and stockpiled in accordance with the requirements of the stockpile management plan and agreed MMP. All materials that visually appeared to be ashy in appearance was stockpiled accordingly. All natural soils / clays were stockpiled accordingly.

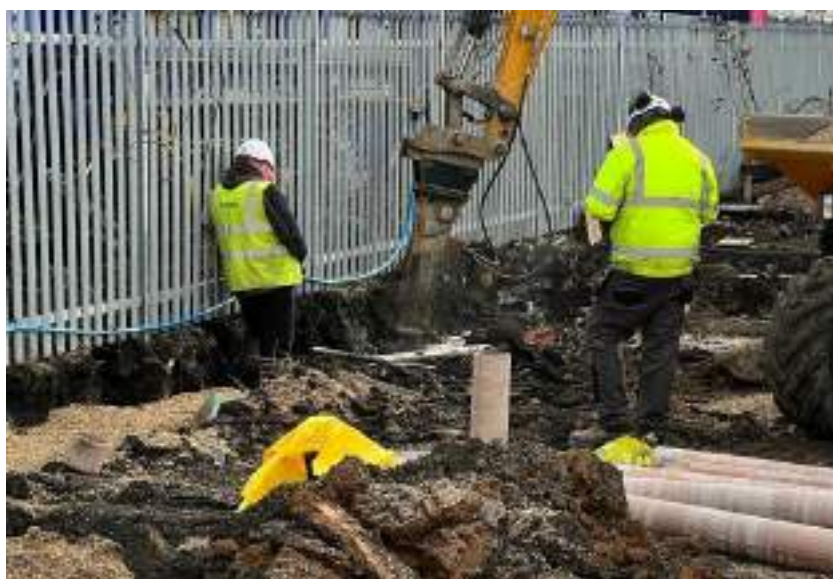
Figure 11 – Watching brief for redundant boreholes.

The following may have been lost during the erection of the acoustic fencing by others (and therefore not found)

Envirotreat was on site during enabling works in this part of the site and the boreholes were not found. All made ground was removed in this part of the site down to the underlying clay and therefore all potential contamination source removed.

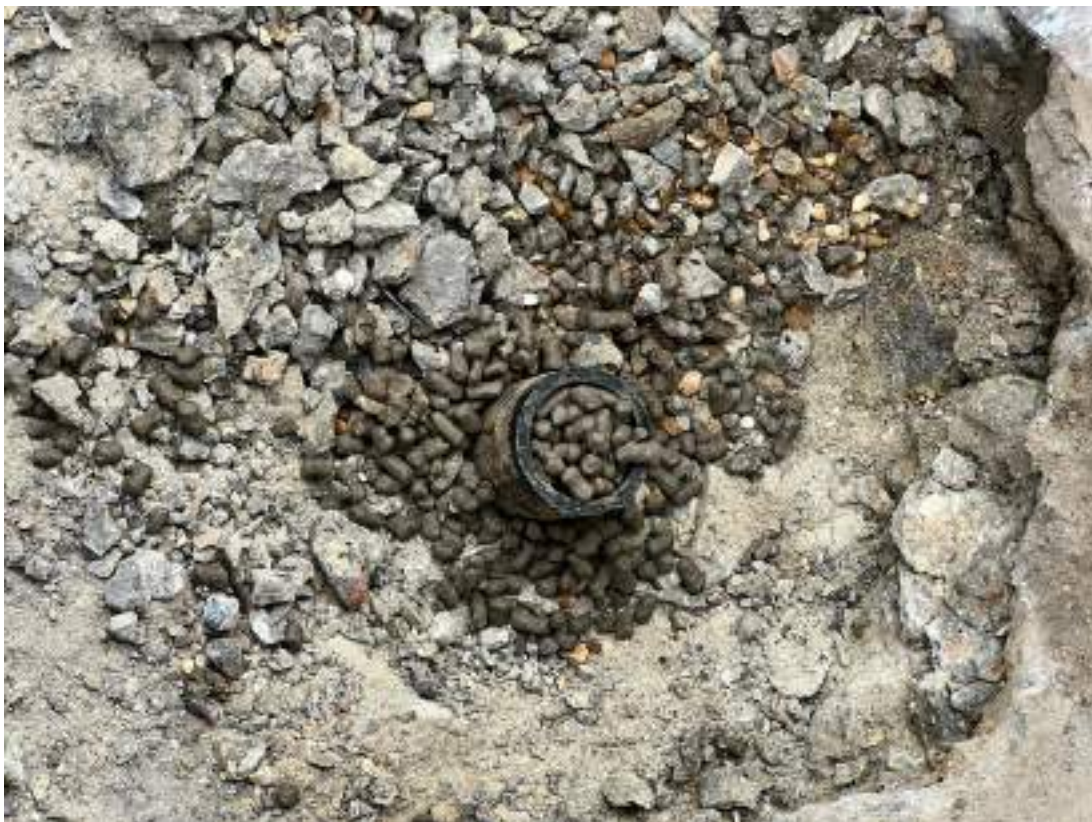
Figure 12 – Decommissioning boreholes.

Borehole DS108 and previously been concreted over (by others) and BH107 not found, however all made ground was removed in this part of the site down to the underlying clay and therefore all potential contamination source removed.

All the 2022 Envirotreat boreholes were decommissioned.

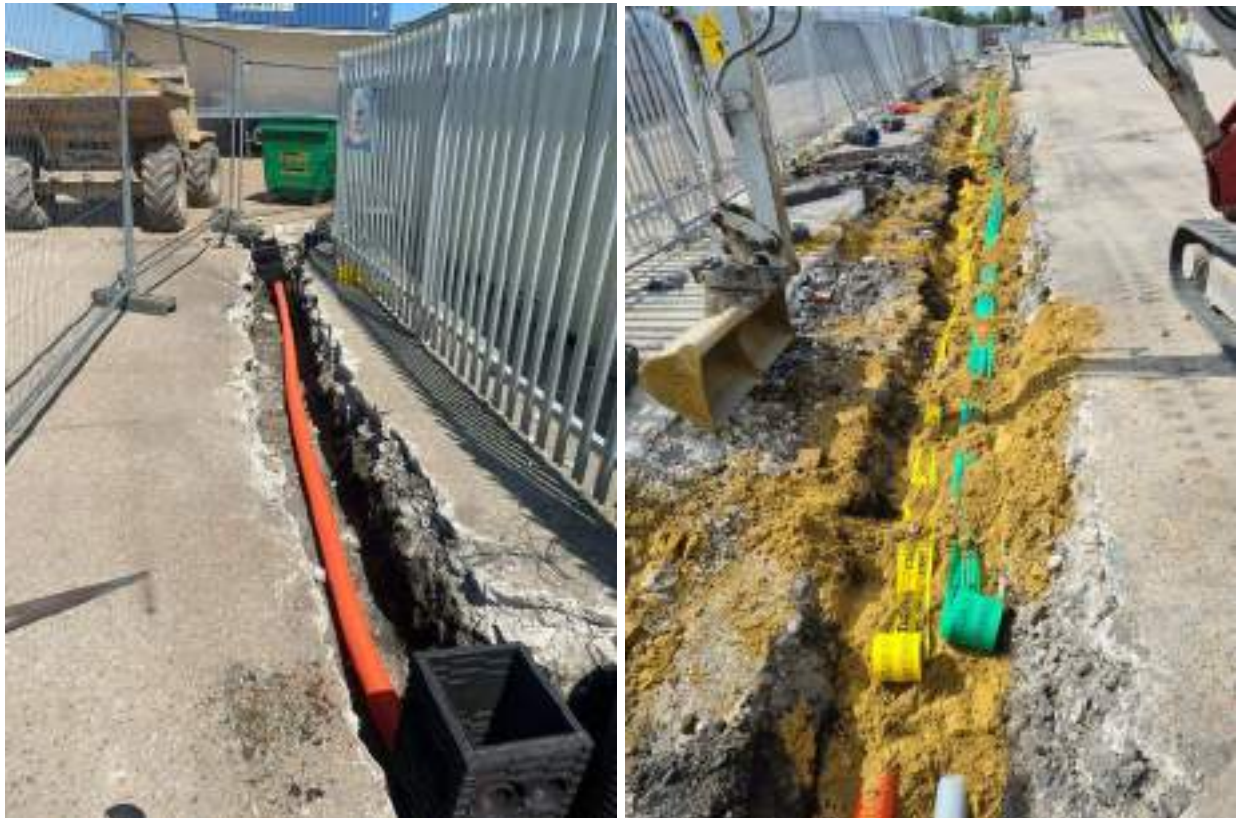
Figure 16 – Services Installation.

The excavation of service duct corridors was carried out as per the requirements / recommendations of the Delta Simons Site Investigation report.
