**ALPHA PARK, CHANDLER'S FORD, EASTLEIGH**

**THE BUILDING MANUAL**  
(incorporating the Health & Safety File)

**DRAINAGE SURVEY**

| Project name<br><b>C3414, Alpha Park, Chandlers Ford,</b> | Project number<br><b>PV041452</b> | Contact | Date<br><b>11/11/2016</b> |

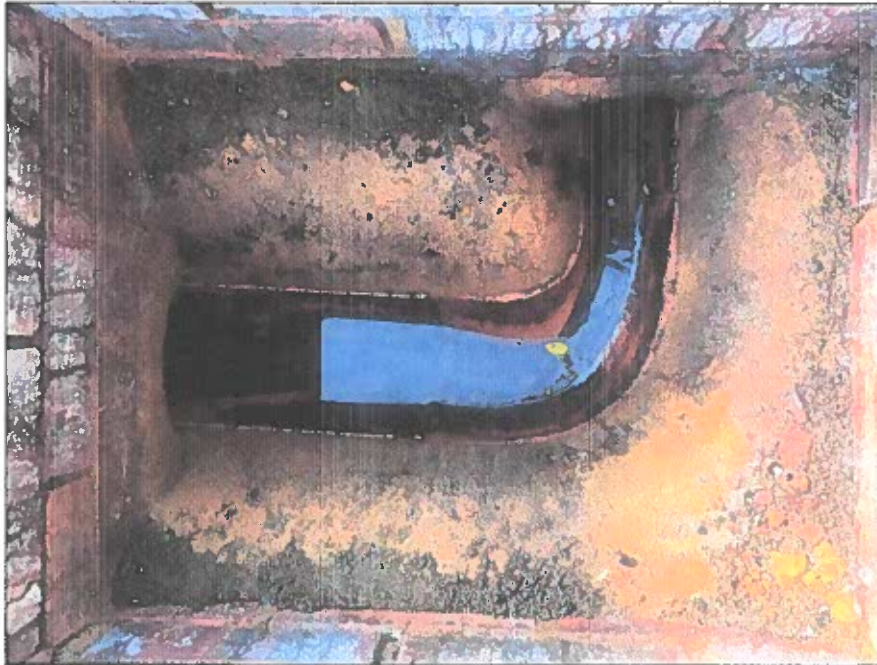
Photo: CABIN MH 2.JPG

0m, Start node type, inspection chamber, reference number : CABIN MH2

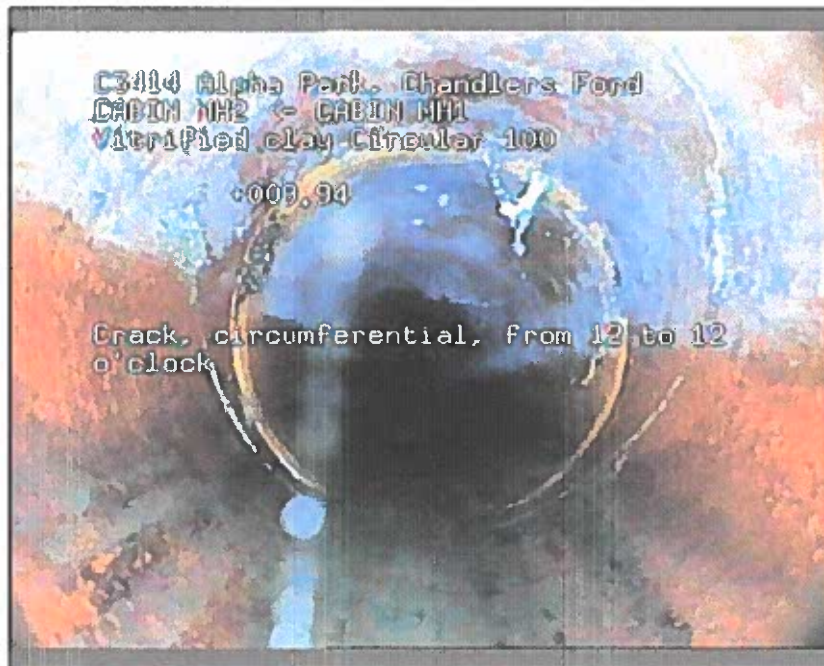
Photo: 1\_1\_5\_A.JPG

9.94m, Crack, circumferential, from 12 to 12 o'clock

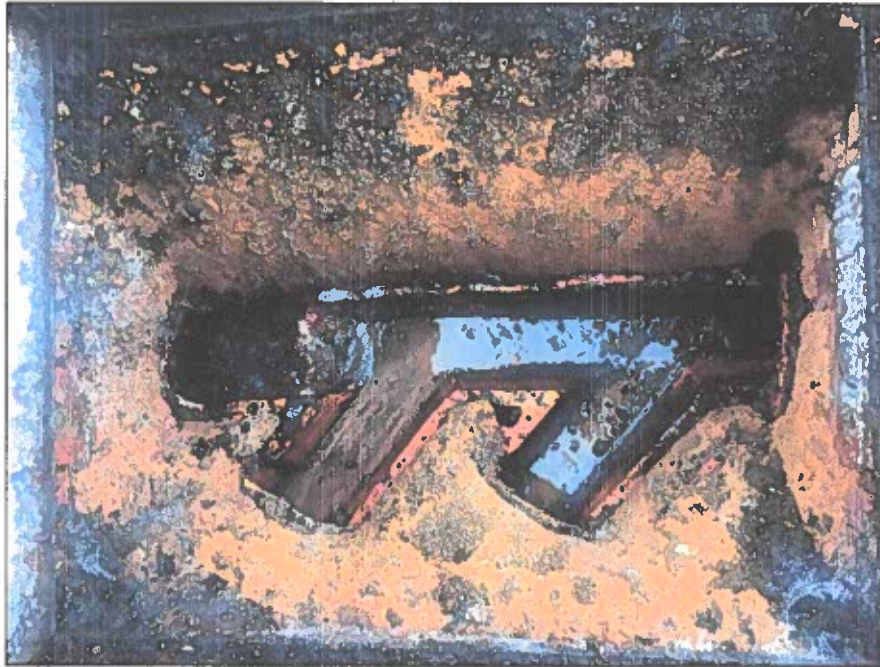
Photo: CABIN MH 1.JPG  
18.07m, Finish node type, inspection chamber reference number: CABIN MH1

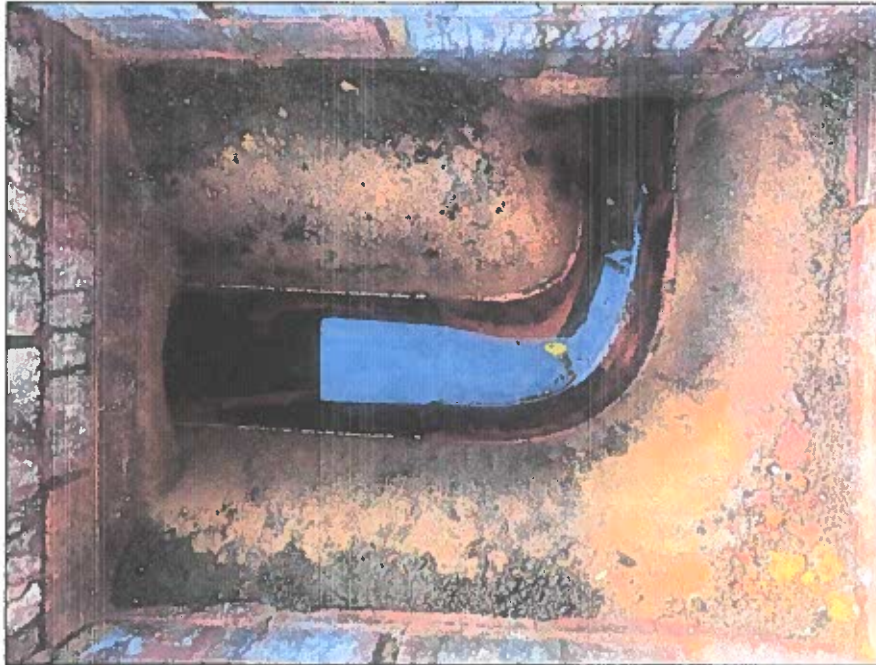
Photo: CABIN MH 2.JPG

0m, Start node type, inspection chamber, reference number : CABIN MH2

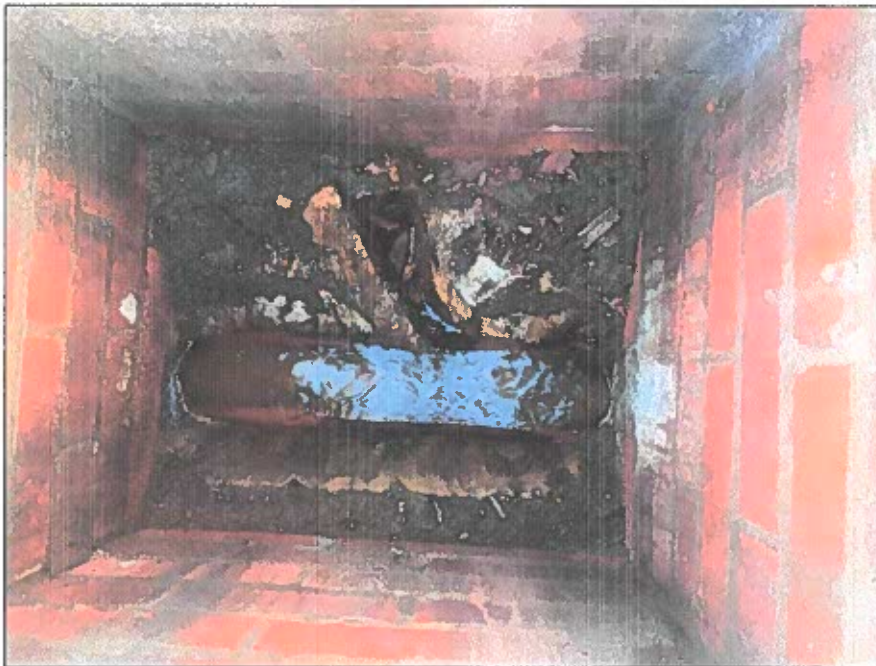
Photo: CABIN MH 3.JPG

16.56m, Finish node type, inspection chamber reference number: CABIN MH3

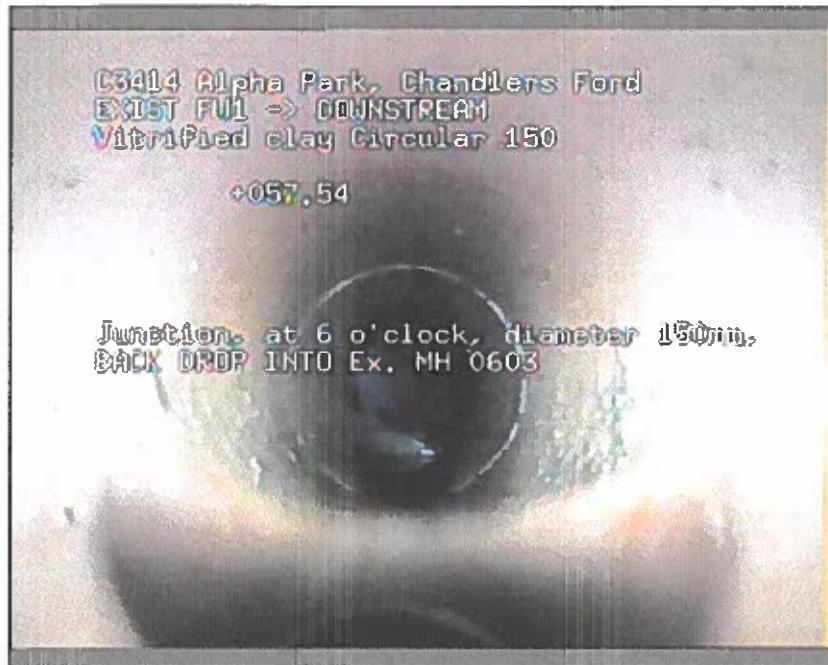
Photo: 4\_4\_25\_A.JPG  
57.54m, Junction, at 6 o'clock, diameter 150mm

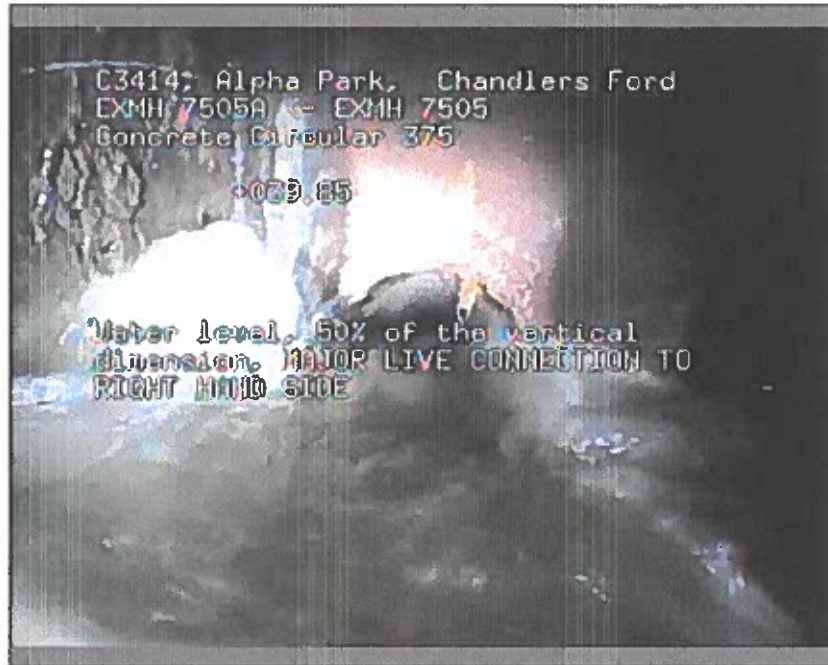
Water level, 50% of the vertical dimension  
Remarks: MAJOR LIVE CONNECTION TO  
RIGHT HAND SIDE

Photo: 1\_1\_5\_A.JPG  
39.85m, Water level, 50% of the vertical dimension

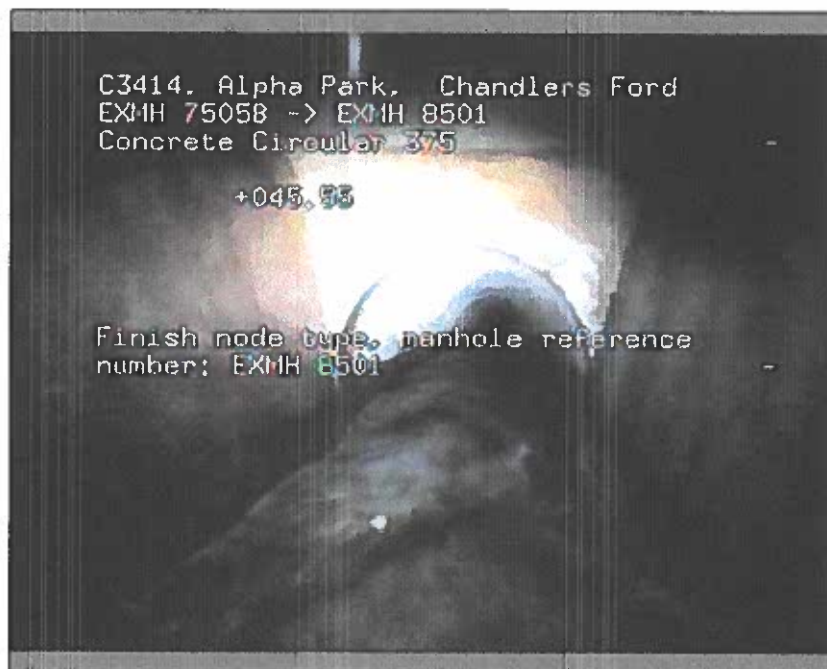
Photo: 4\_4\_16\_A.JPG  
45.55m, Finish node type, manhole reference number: EXMH 8501

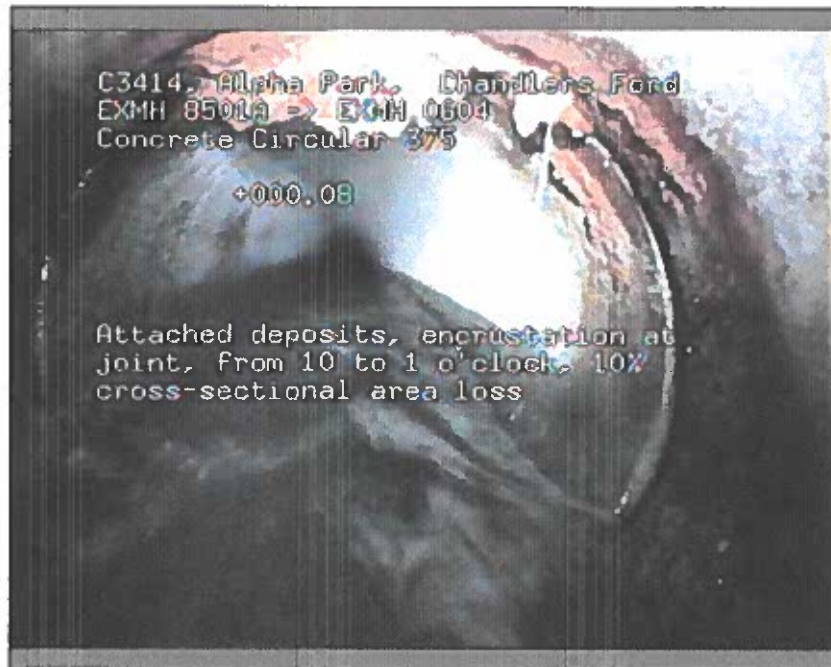
Photo: 6\_6\_23\_A.JPG

0.08m. Attached deposits, encrustation at joint, from 10 to 1 o'clock, 10% cross-sectional area loss

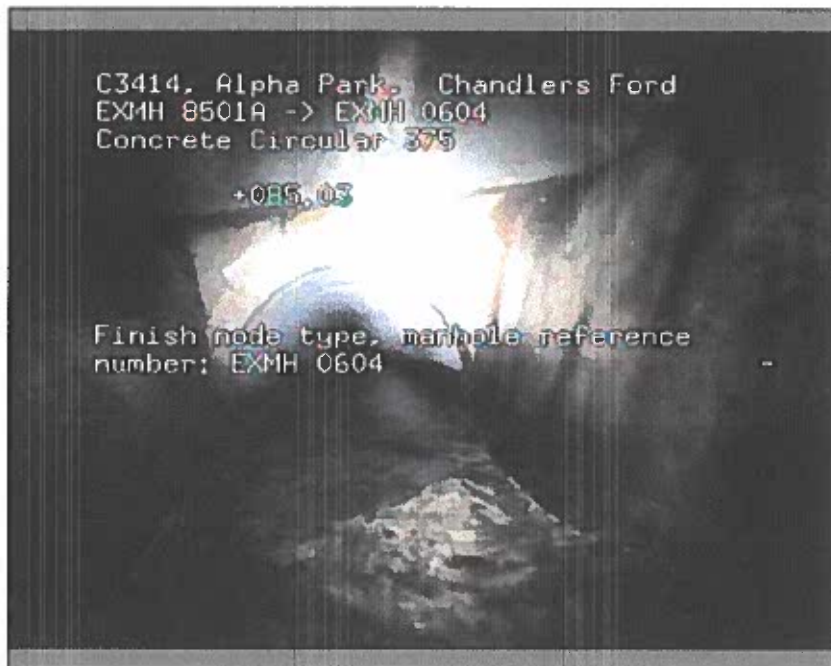
Photo: 6\_6\_25\_A.JPG

85.03m, Finish node type, manhole reference number: EXMH 0604

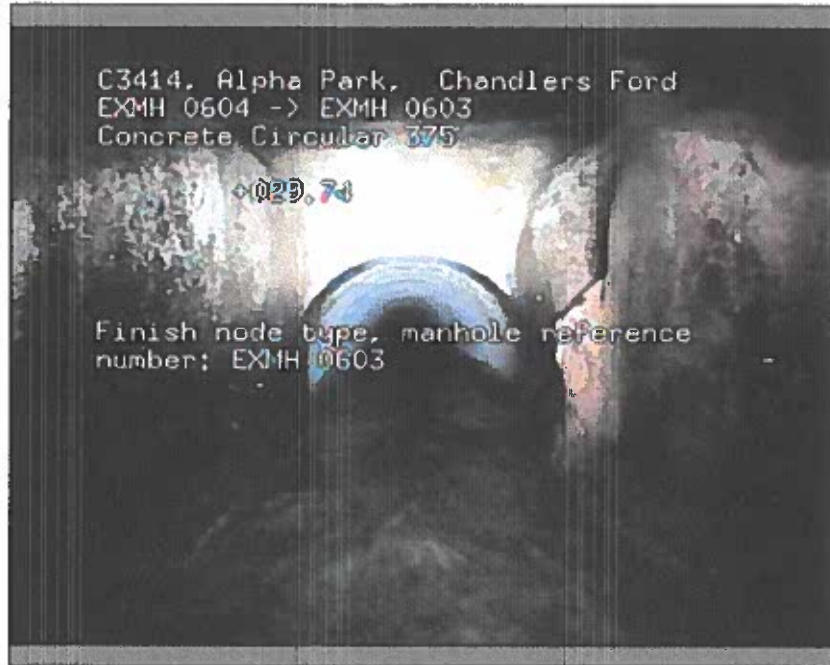
Photo: 7\_7\_29\_A.JPG

29.74m, Finish node type, manhole reference number: EXMH 0603
