Gas Membrane Installation  
Validation Report  
Elivia Homes  
2 Grange Road  
Abbey Fruit Farm  
Phase 2  
Netley  
SO31 5HZ  
V2 30/04/2024

## Appendix 1 – Site Survey Sheets

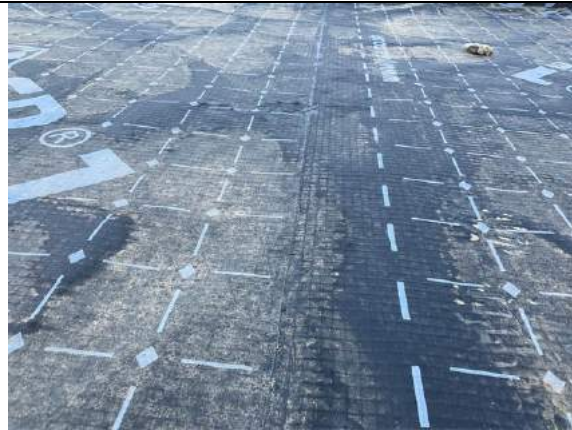
Plot 15. Overview of a hand welded membrane lap joint.

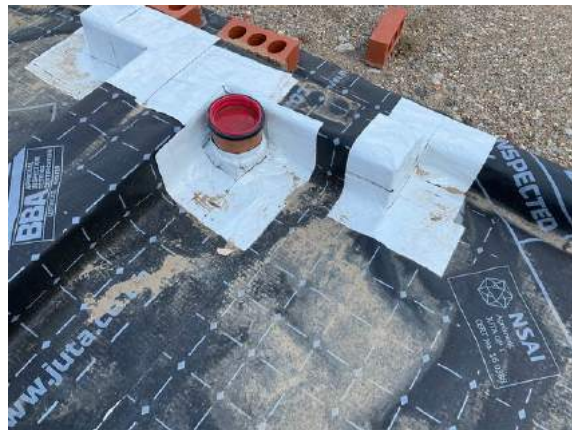
Plot 16. Corner, threshold & pipe entry sealed with SAGM.

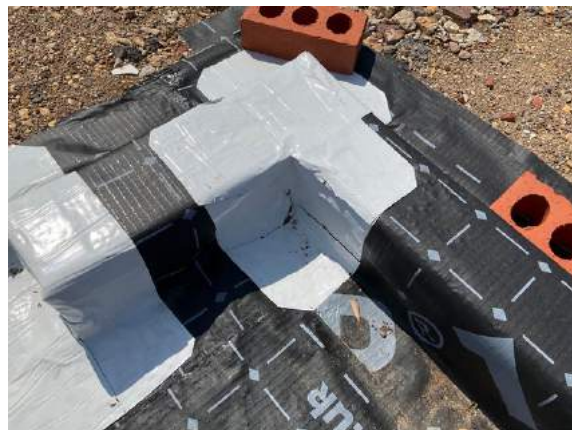
Plot 17. Typical corner detail sealed with SAGM.

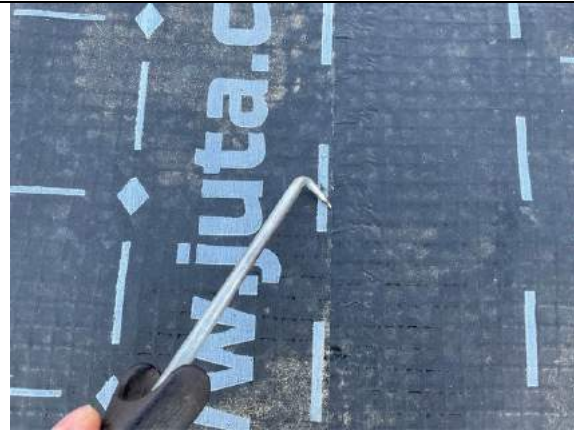
Plot 18. Pick testing along hand welded lap joint.

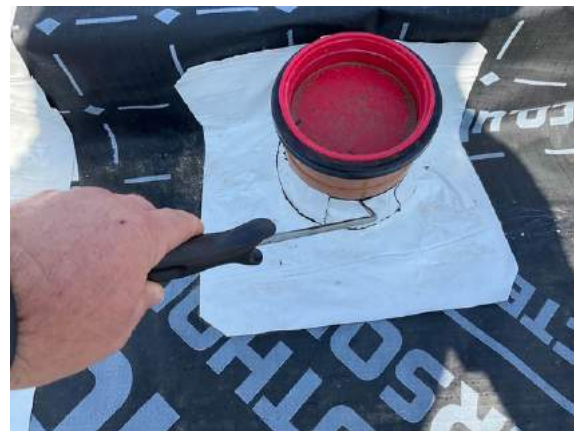
Plot 19. Pick test to sealed pipe entry.

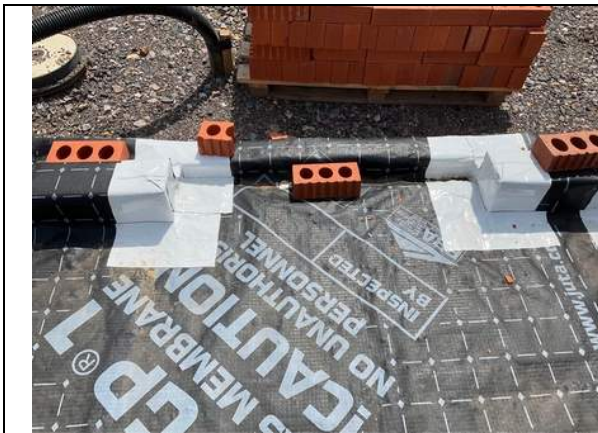
Plot 21. Threshold detail sealed using SAGM.

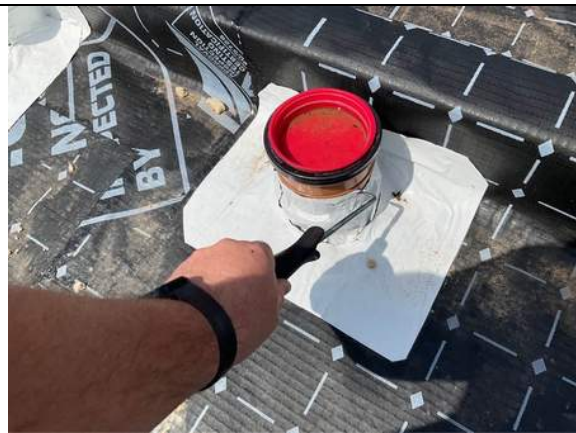
Plot 21. Pick testing to sealed pipe entry.

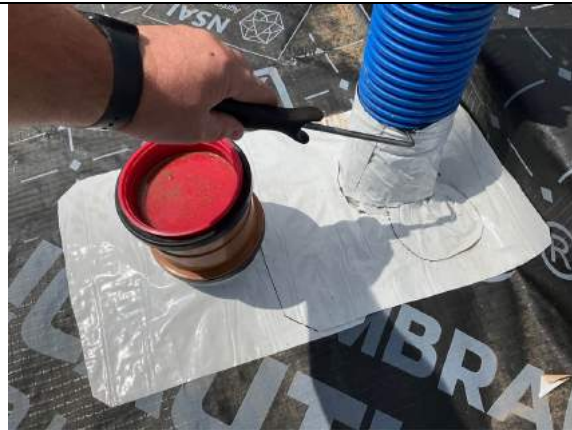
Plot 22. Pick testing upon sealed pipe penetration's.

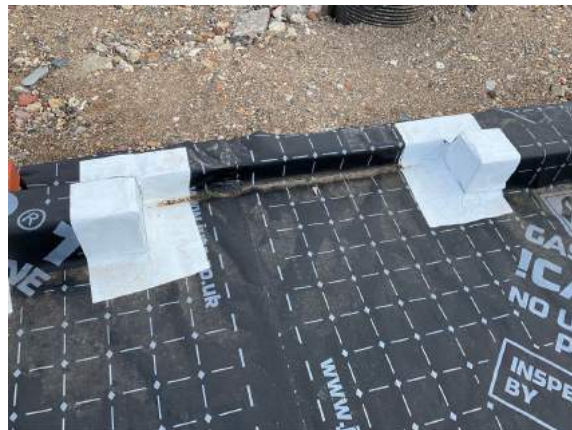
Plot 23. Threshold detail sealed with SAGM.

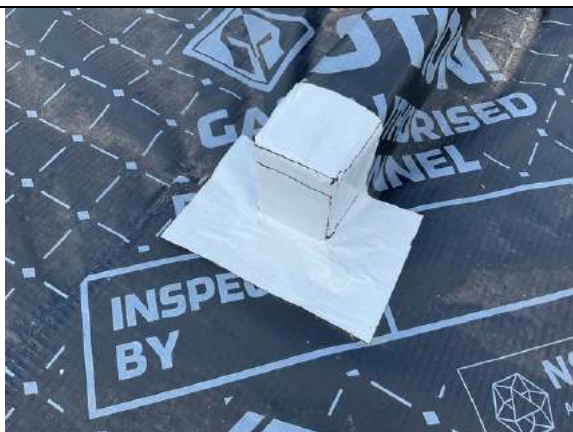
Plot 24. Internal wall corners sealed with SAGM.

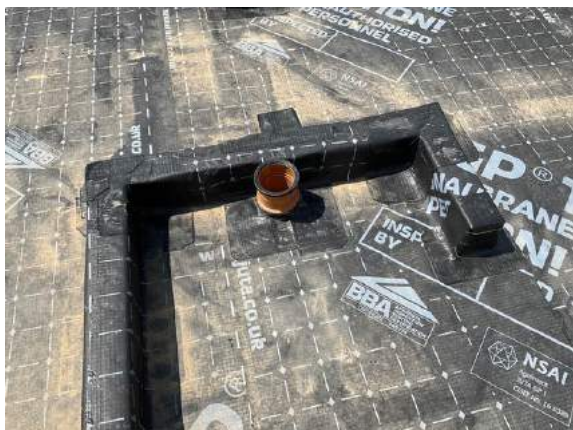
Plot 25. Multiple corner details and pipe entry sealed with SAGM.

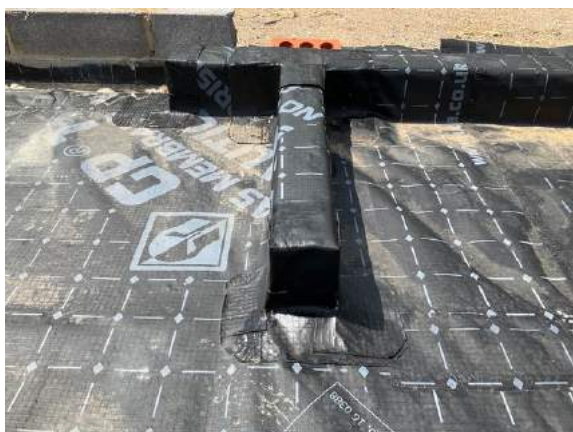
Plot 26. Corner details sealed with SAGM.

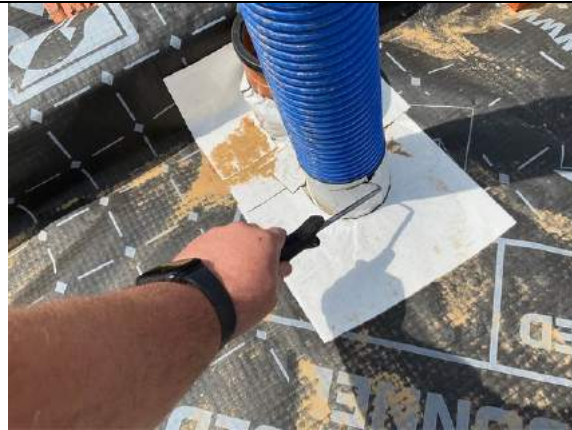
Plot 50. Pick test to sealed pipe entry's.

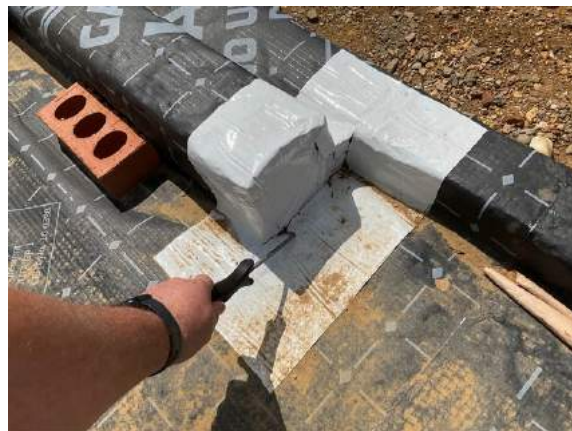
Plot 51. Pick test to sealed threshold detail.

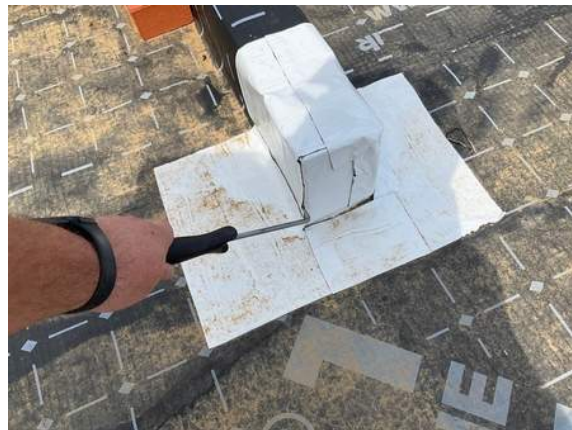
Plot 52. Pick test to internal wall corner details.

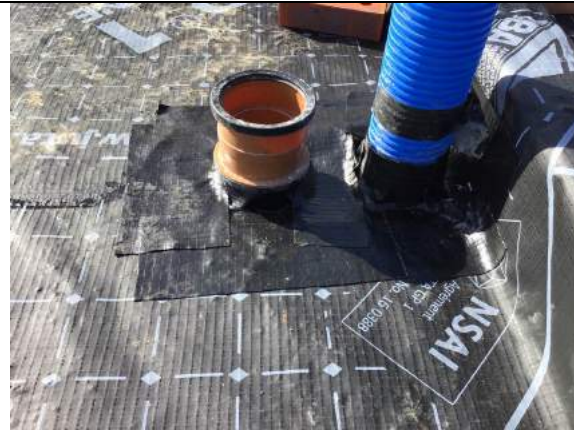
Typical double pipe penetration seal using SAGM in plot 28.

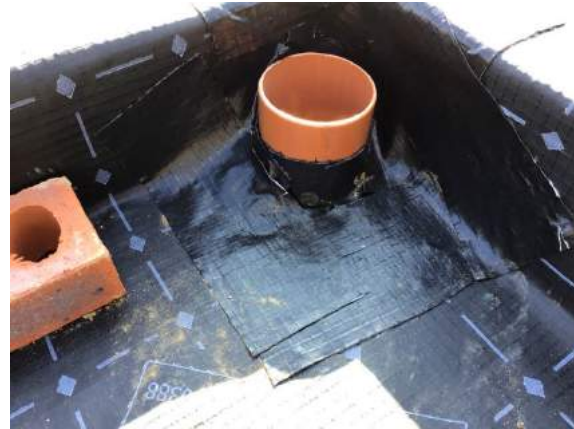
Typical pipe penetration seal using SAGM in plot 29.

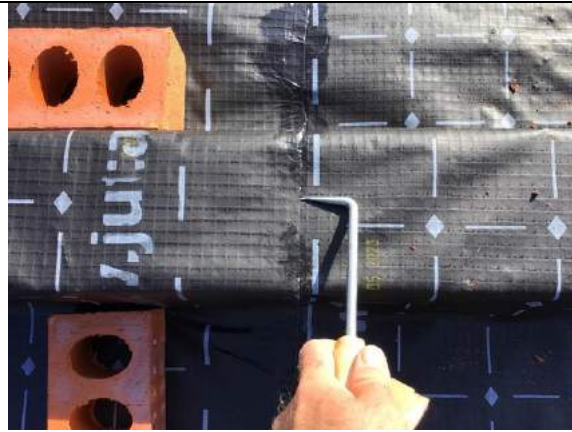
Pick testing all hand welded membrane laps in plot 30.

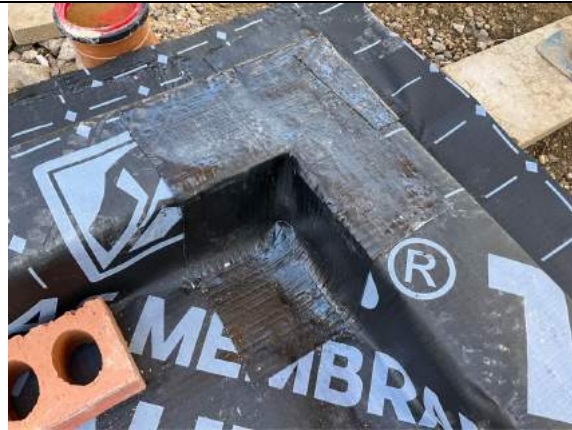
Plot 27. Typical corner detail sealed using SAGM.

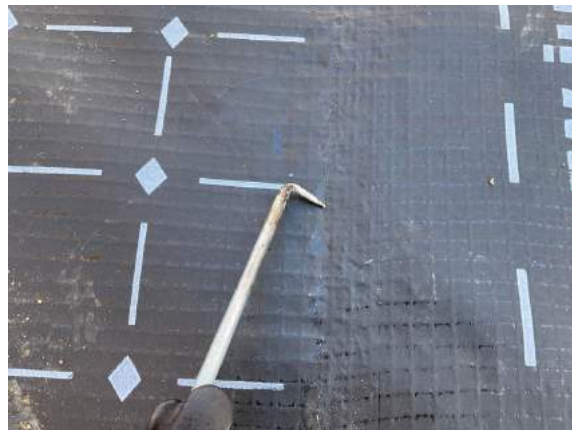
Plot 27. Pick testing along all hand welded membrane lap joints.

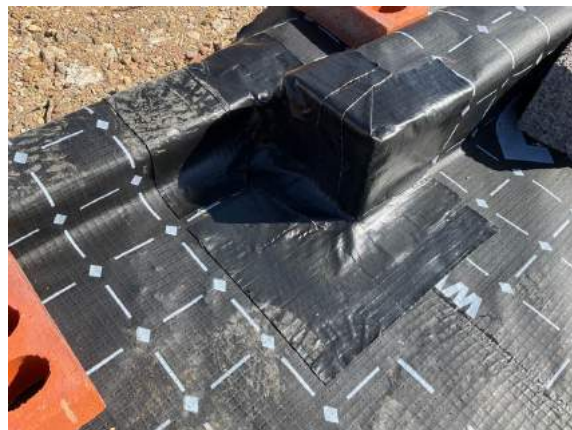
Plot 38. Typical door threshold detail sealed with SAGM.

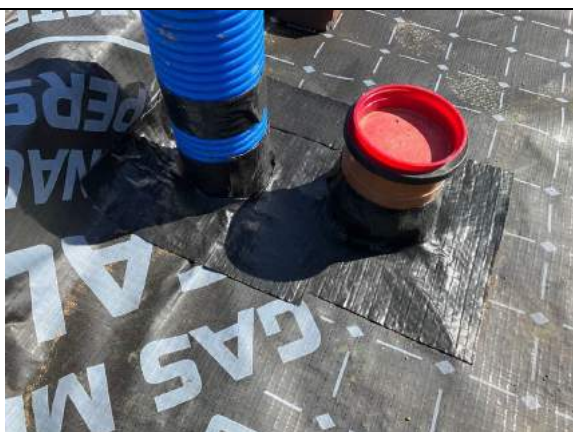
Plot 38. Typical pipe penetration's sealed using SAGM.

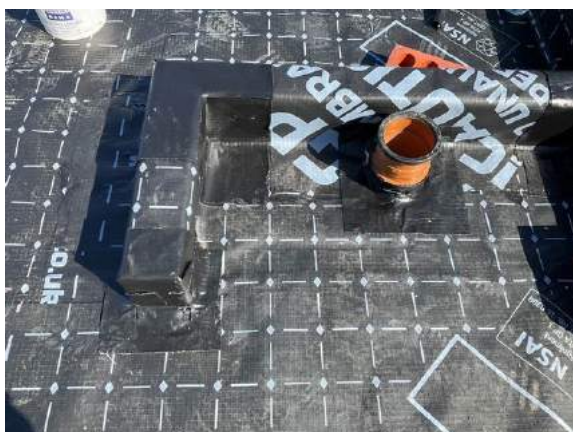
Plot 39. Multiple details sealed using SAGM.

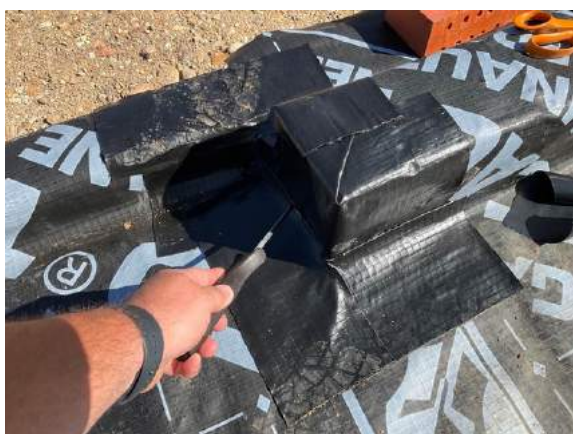
Plot 39. Pick testing to sealed threshold detail.

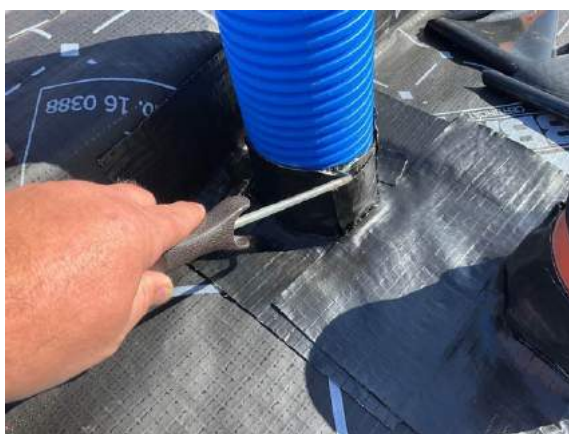
Plot 39. Pick testing to sealed pipe penetration's.

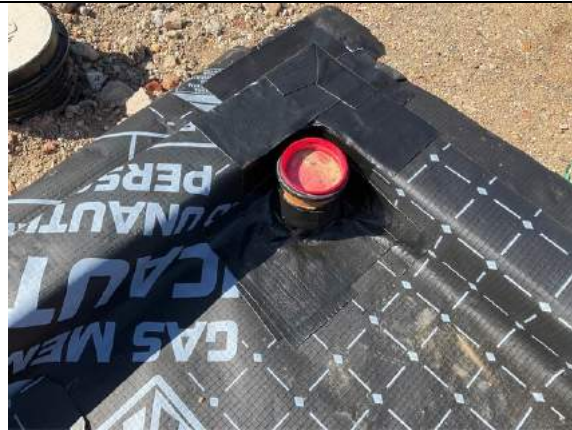
Plot 40. Multiple details corner and pipe entry sealed with SAGM.

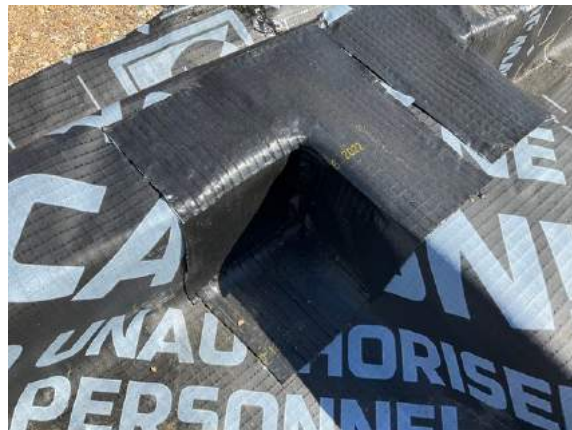
Plot 40. Typical corner detail sealed using SAGM.

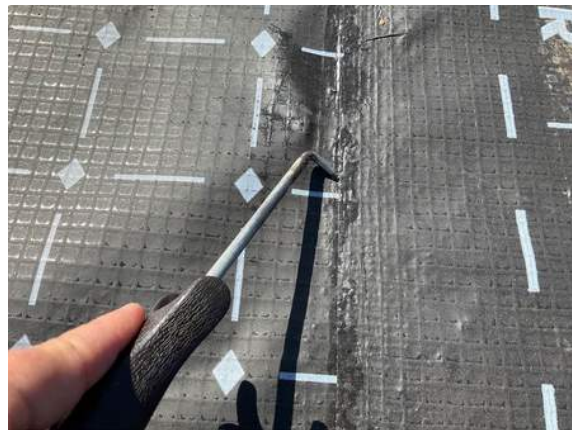
Plot 41. Pick testing along hand welded lap joints.

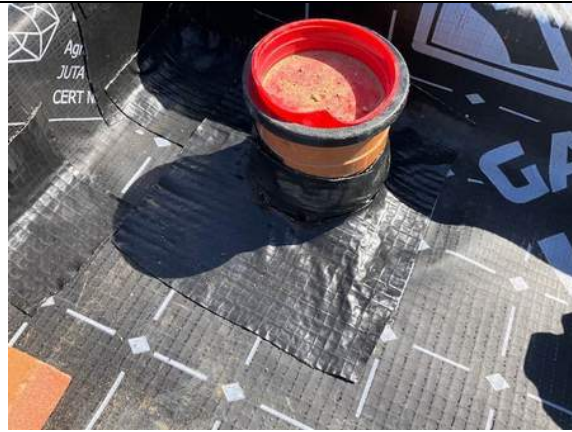
Plot 41. Typical pipe penetration sealed with SAGM.

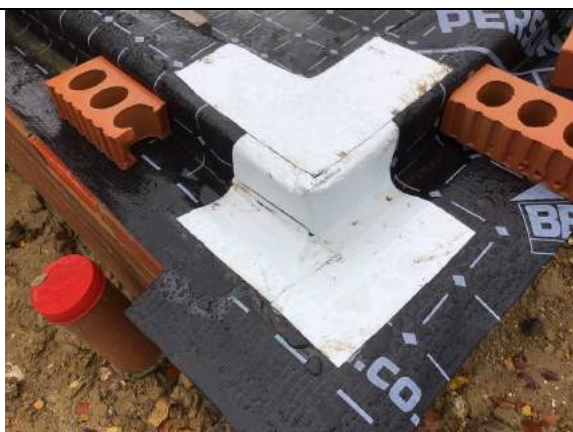
Typical corner seal using SAGM in plot 31.

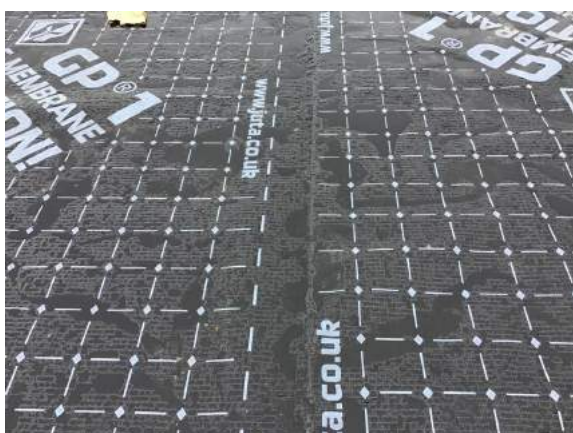
Hand welded membrane lap in plot 31.

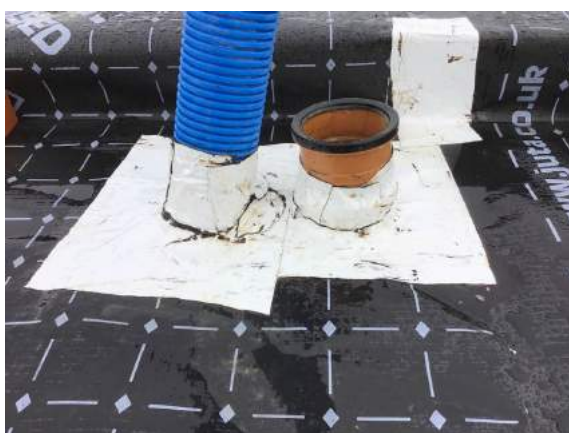
Typical double pipe penetration seal using SAGM in plot 36.

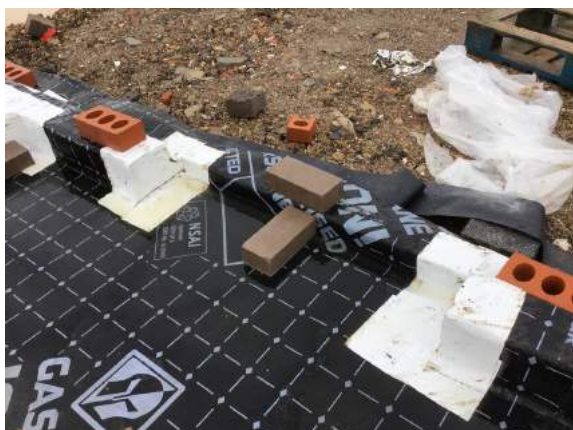
Typical door threshold seal using SAGM in plot 36.

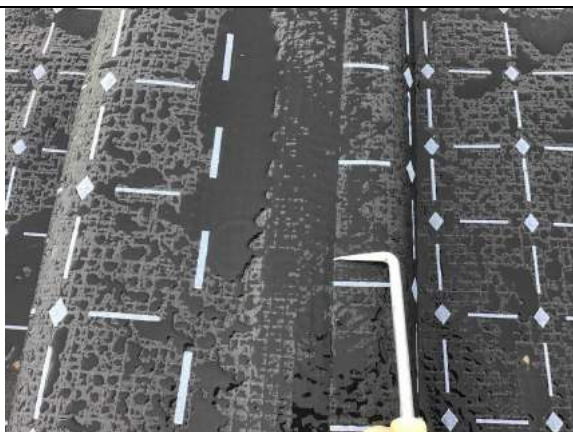
Pick testing all hand welded membrane laps in plot 77.

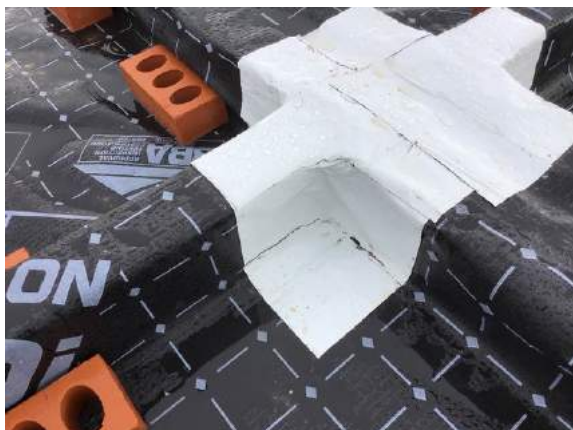
Typical corner seal using SAGM in plot 77.

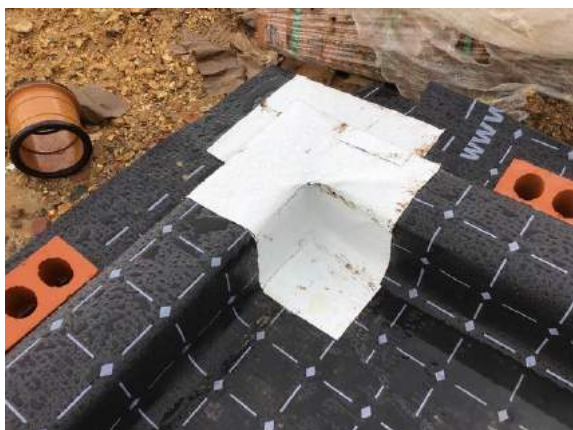
Typical corner seal using SAGM in plot 78.

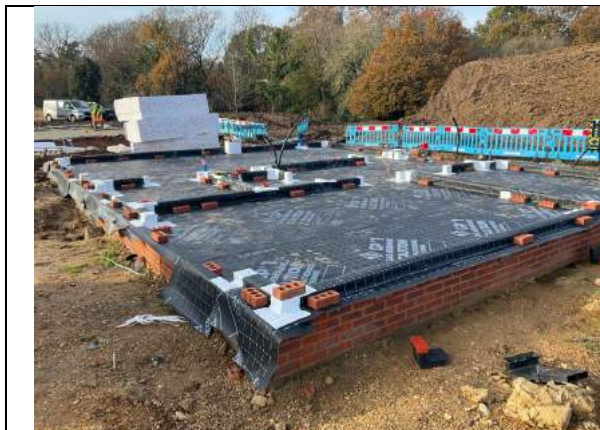
Overview of the installation of Juta GP1 Gas Barrier to Plot 34.

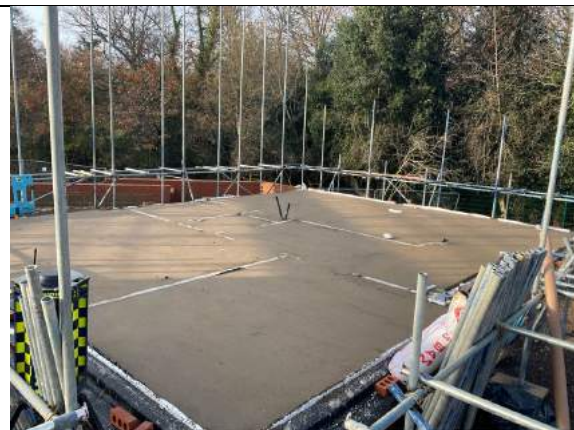
Overview of Plot 32 installed this week, but screeded prior to our visit.

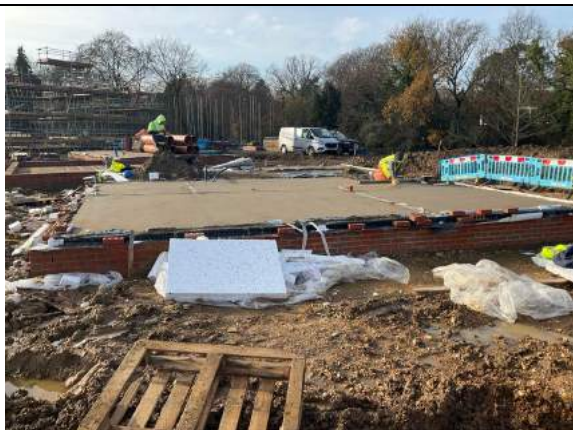
Overview of Plot 35 installed this week, but screeded prior to our visit.

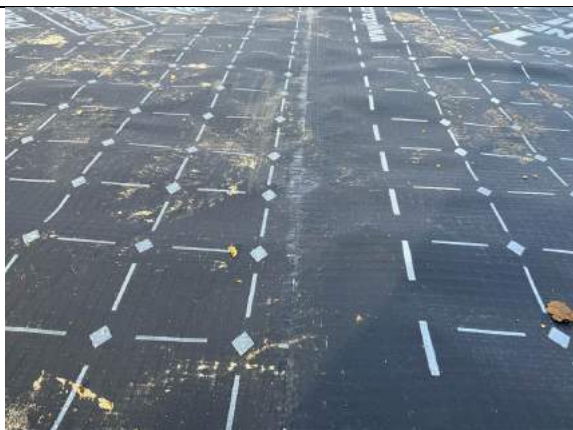
Plot 34. Overview along a hand welded membrane lap joint.

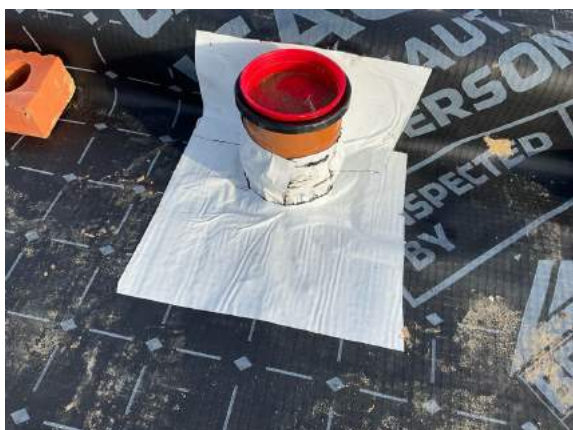
Plot 34. Typical pipe penetration's sealed with SAGM.

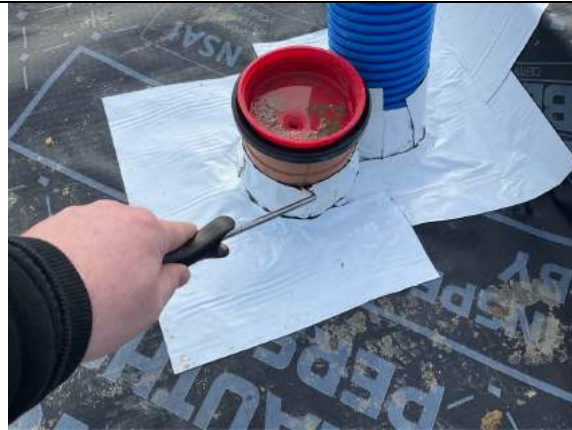
Plot 34. Pick testing upon sealed pipe penetration's.

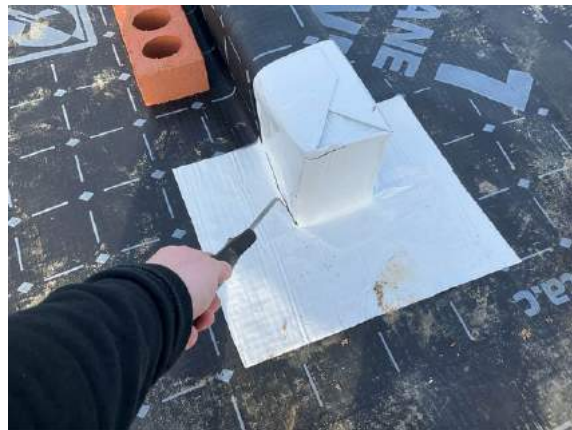
Plot 34. Pick & Probe testing upon sealed corner details.

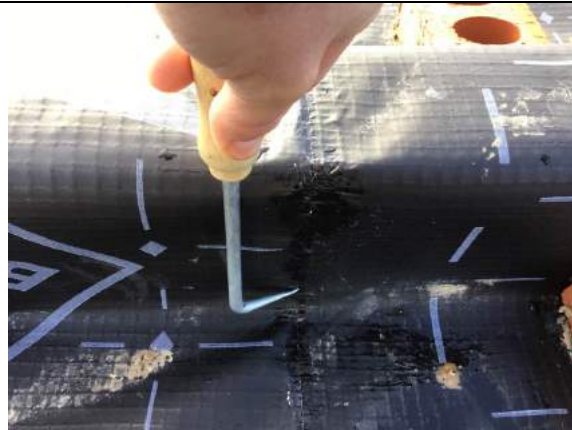
Pick testing hand welded membrane lap to the perimeter up stand.

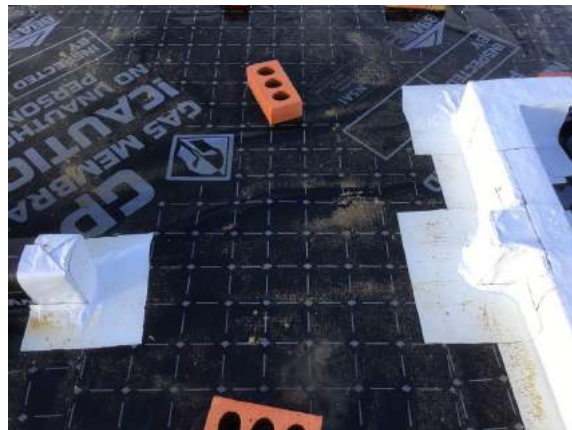
Sealed internal door threshold using SAGM.

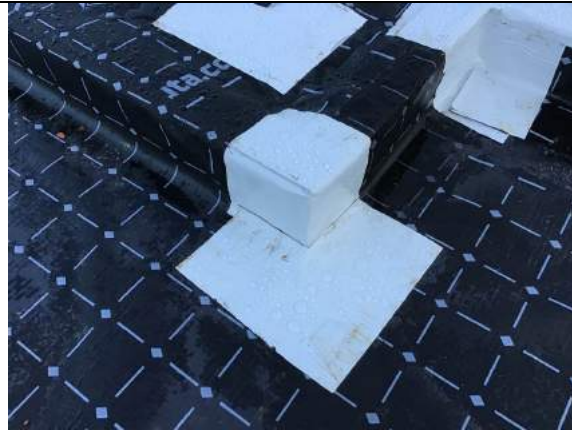
Typical corner seal using SAGM in apartment plots 62-66.

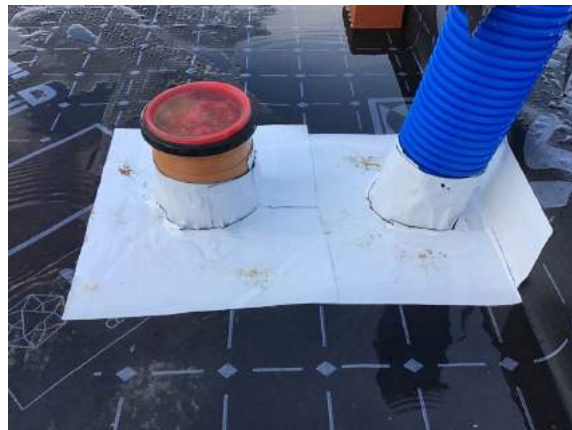
Typical double pipe penetration seal using SAGM in plot 59.

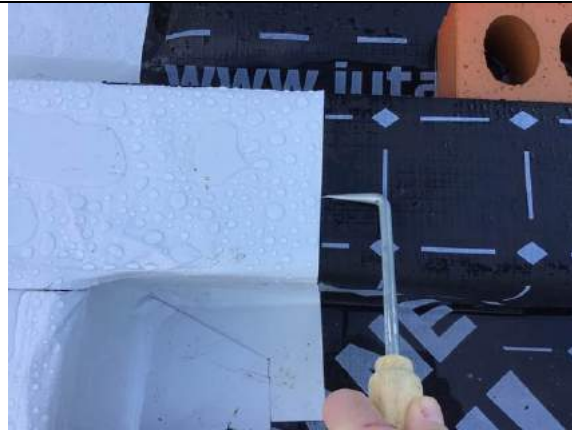
Pick testing all SAGM detailing in plot 59.

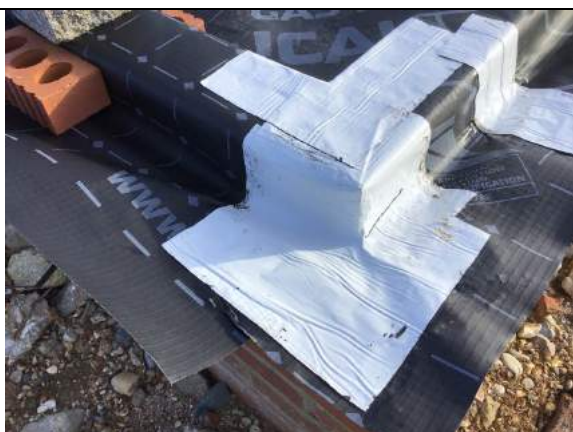
Typical corner seal using SAGM in plot 56.

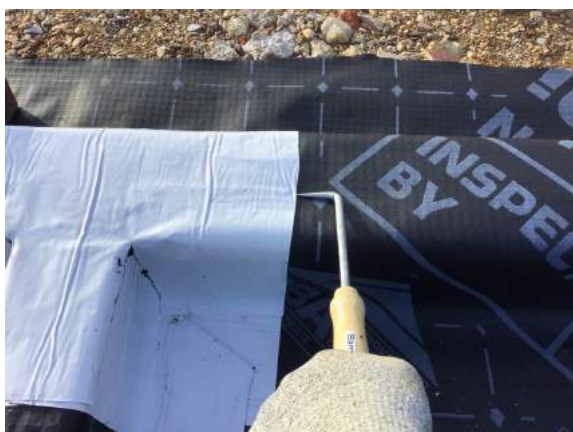
Pick testing all SAGM detailing in plot 57.

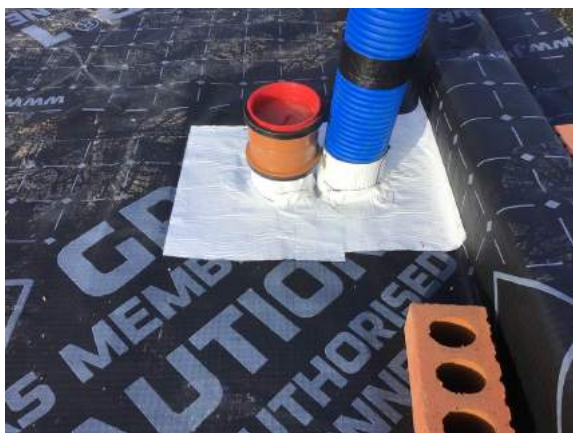
Typical double pipe penetration seal using SAGM in plot 58.

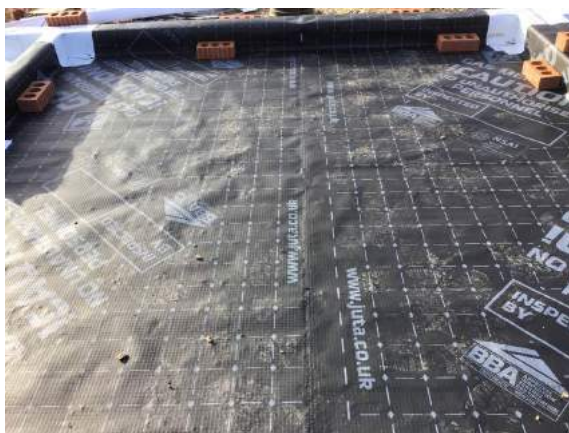
All membrane laps have been hand welded using a hot air gun and rolled using a neoprene roller in plot 58.

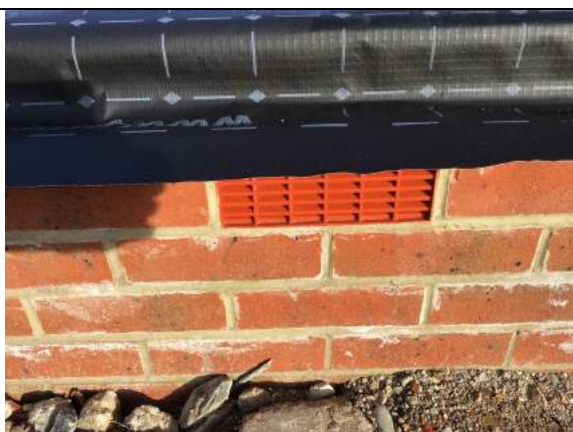
Air brick in place at the time of our inspection under the membrane to plot 60.

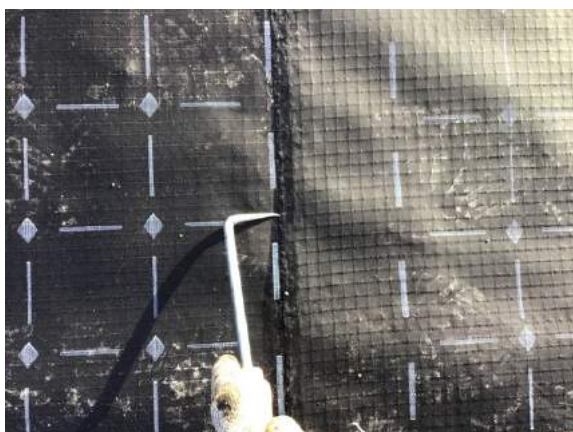
Pick testing all hand welded membrane laps in plot 61.

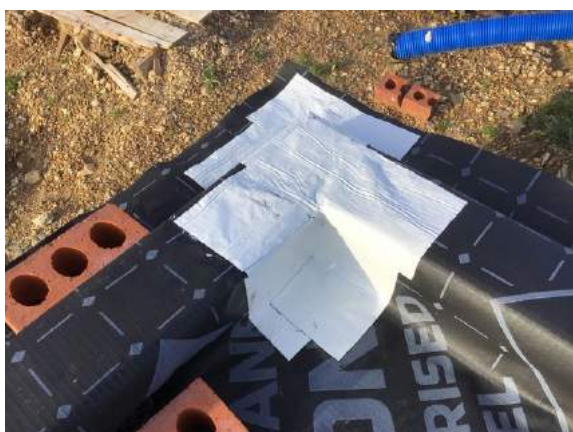
Typical corner seal using SAGM in plot 69.

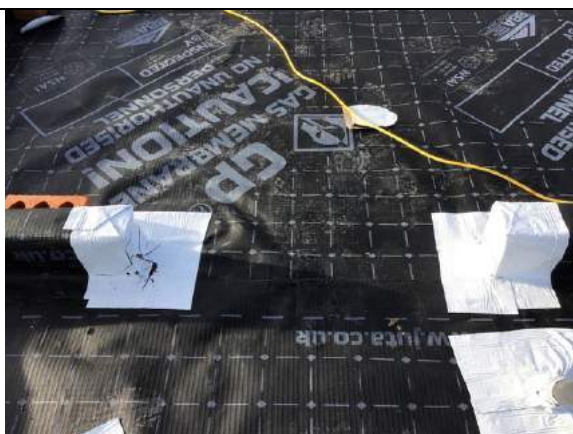
Sealed internal door threshold using SAGM in plot 69.

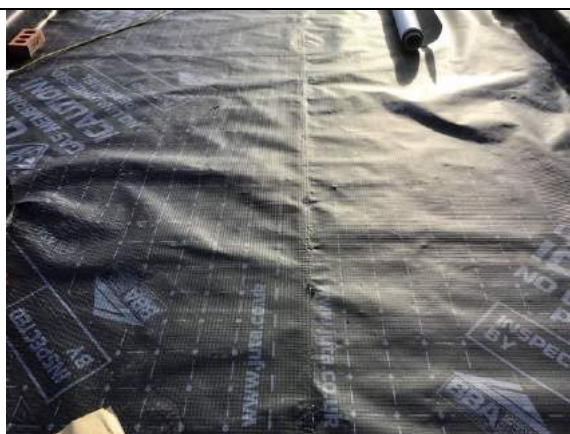
Hand welded membrane lap in plot 69.

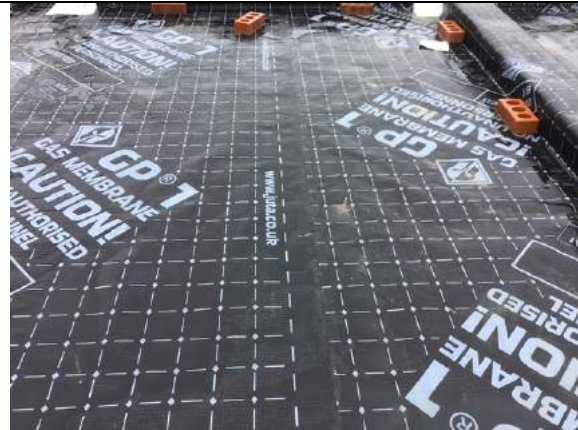
All membrane laps have been hand welded using a hot air gun and rolled using a neoprene roller in plot 68.

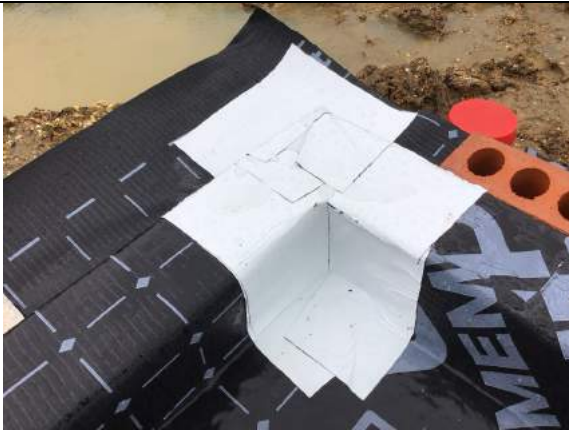
Typical corner seal using SAGM in plot 70.
