Gas Membrane Installation  
Validation Report  
Eliva Homes  
Royale Victoria Grange  
2 Grange Road  
Netley  
Southampton  
SO31 5HZ  
V2 09/05/24

## Appendix 1 – Site Survey Sheets

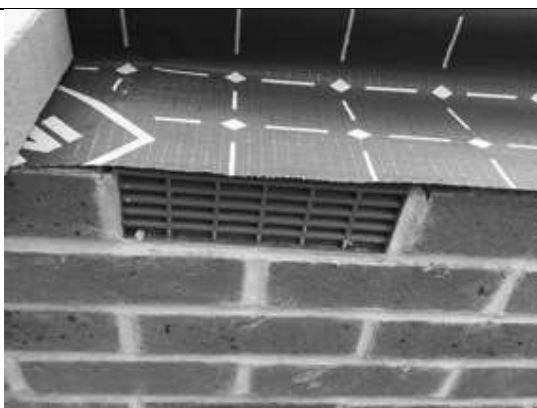
Air brick in place on plot 2.

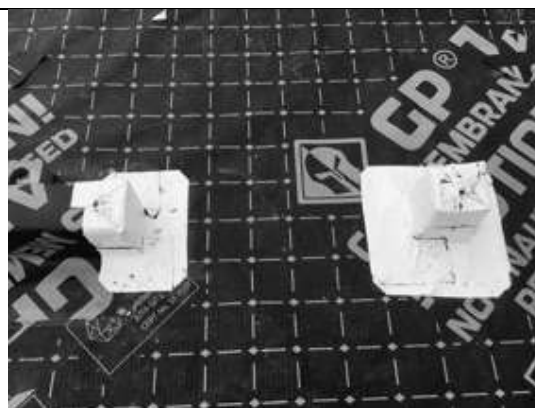
Typical internal door threshold seal using SAGM to plot 2.

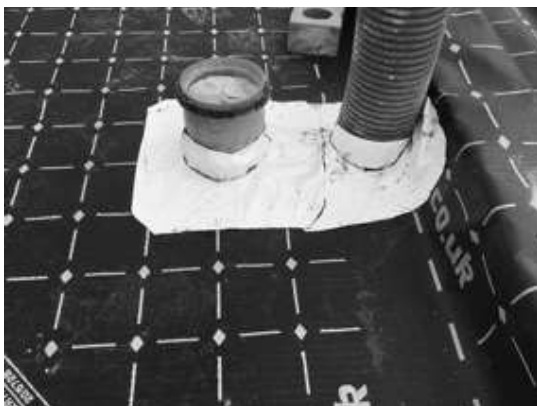
Typical double pipe penetration seal using SAGM to plot 3.

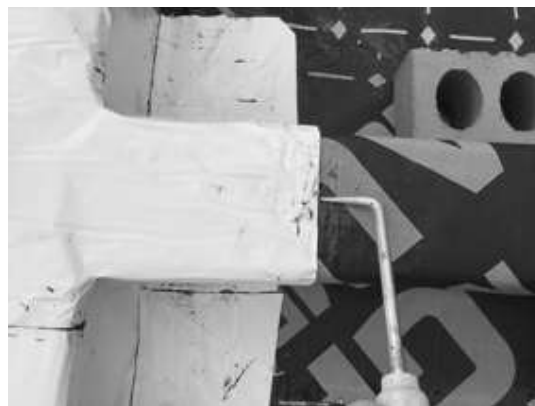
Pick testing all SAGM detailing to plot 3.

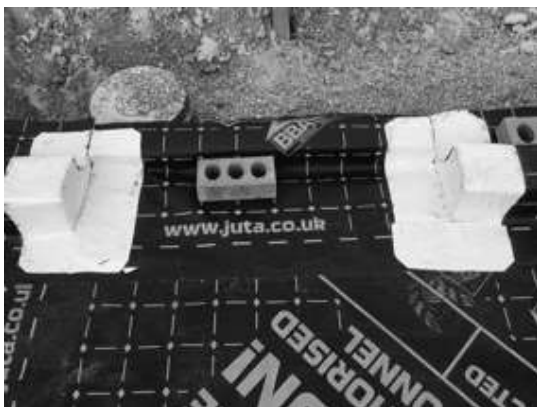
Typical door threshold seal using SAGM to plot 4.

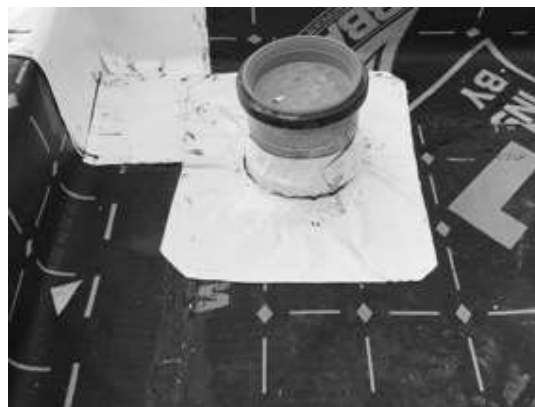
Typical pipe penetration seal using SAGM to plot 4.

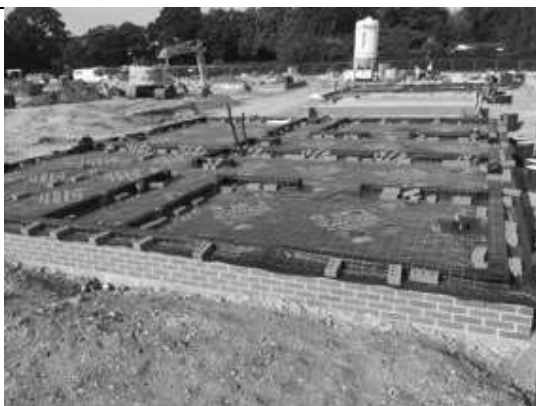
Overview of plot 5 & 6.

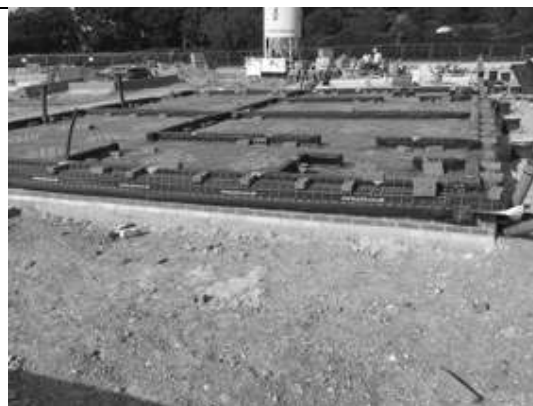
Overview of plots 8 & 9.

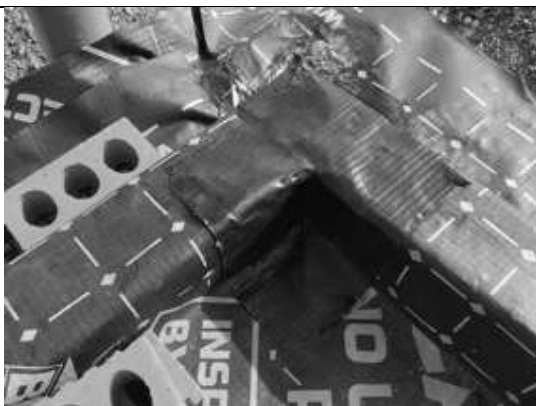
Typical corner seal using SAGM to plot 5.

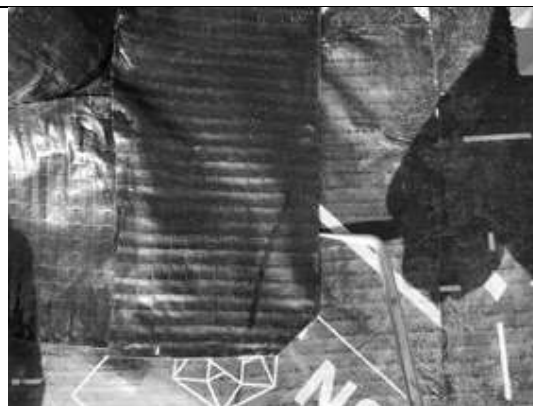
Pick testing all SAGM detailing to plot 5.

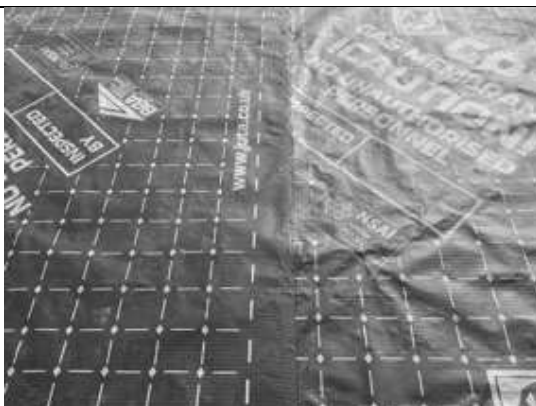
Hand welded membrane lap to plot 6.

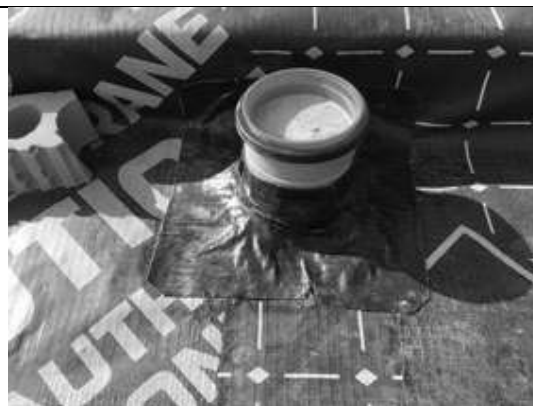
Typical pipe penetration seal using SAGM to plot 6.

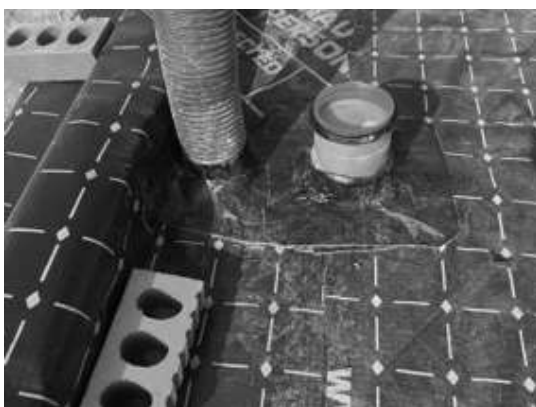
Typical double pipe penetration seal using SAGM to plot 8.

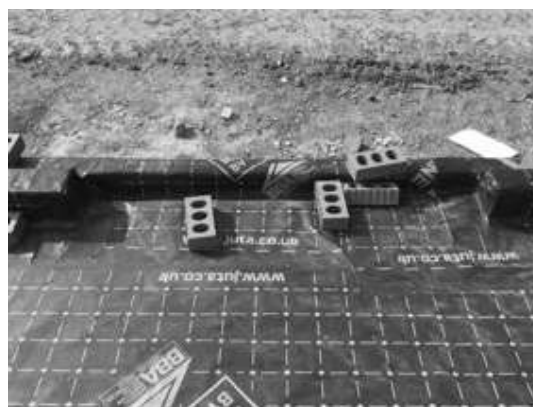
Sealed door threshold detail sealed using SAGM to plot 8.

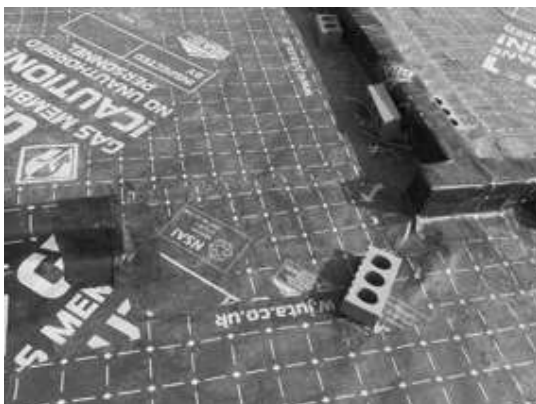
Sealed internal door threshold detail using SAGM to plot 9.

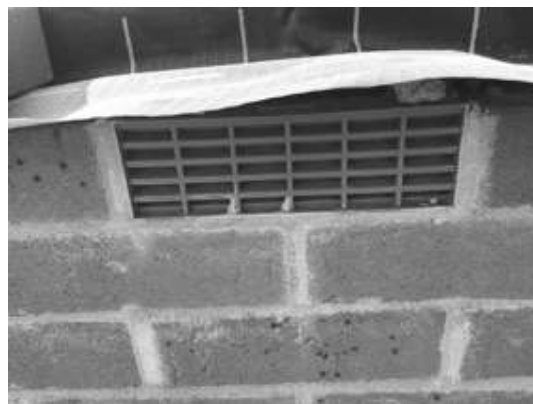
Air brick in place under the membrane at the time of our inspection to plot 9.

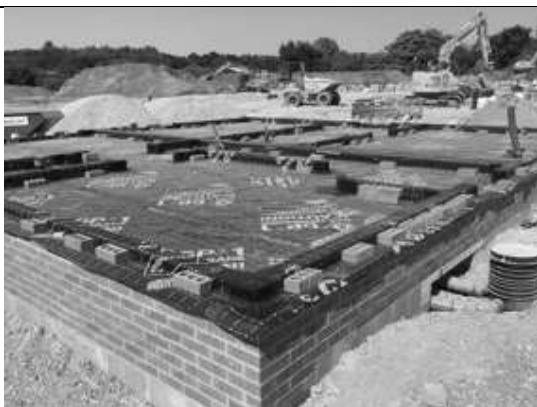
Overview of plots 48 & 49.

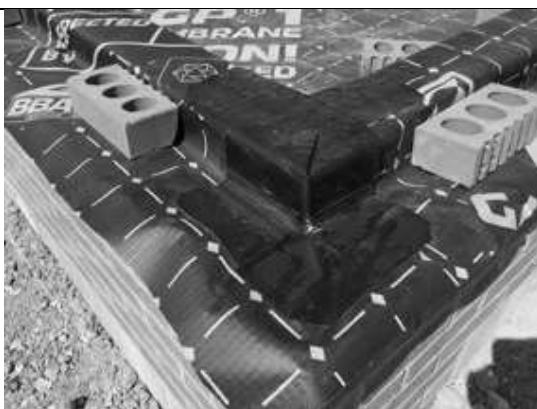
Typical corner seal using SAGM to plot 48.

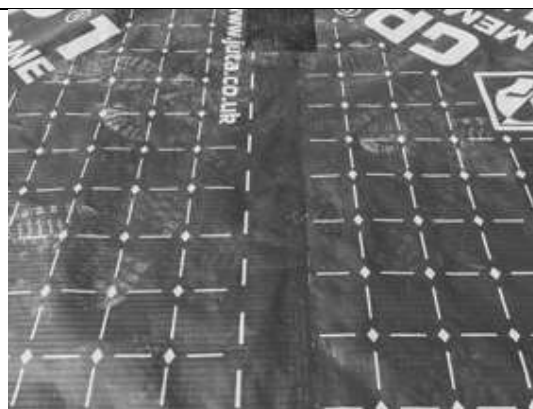
All lapped membrane has been hand welded in plot 48.

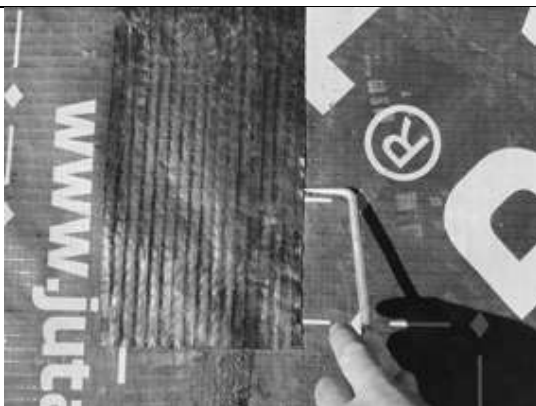
Pick testing all SAGM detailing to plot 48.

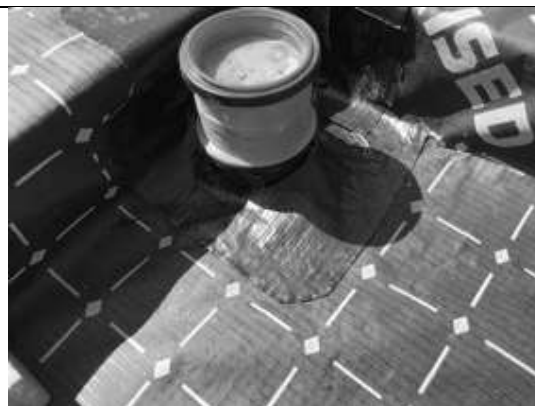
Typical corner seal using SAGM to plot 48.

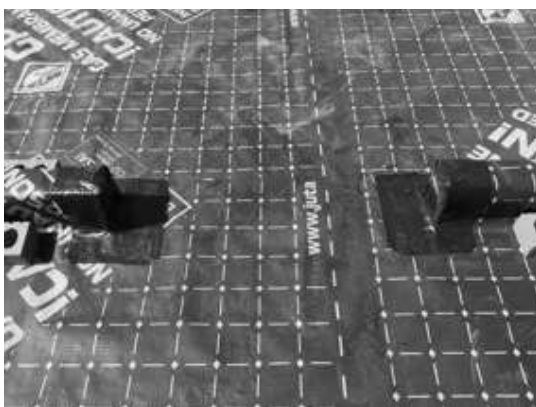
Typical internal door threshold seal using SAGM in plot 49.

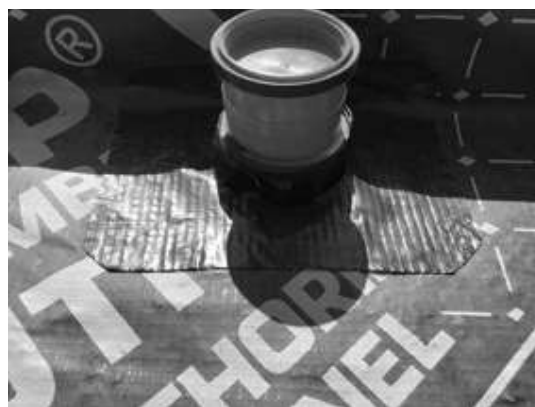
Typical pipe penetration seal using SAGM in plot 49.

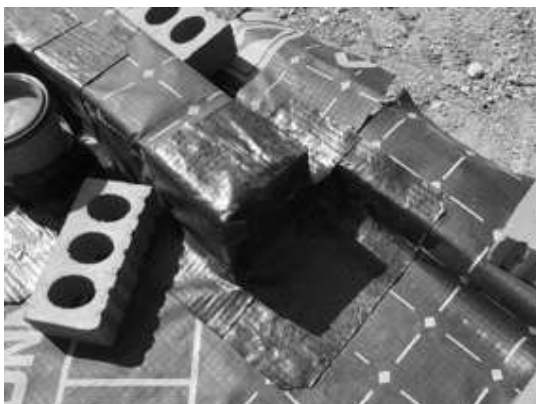
Typical door threshold seal using SAGM to plot 49.

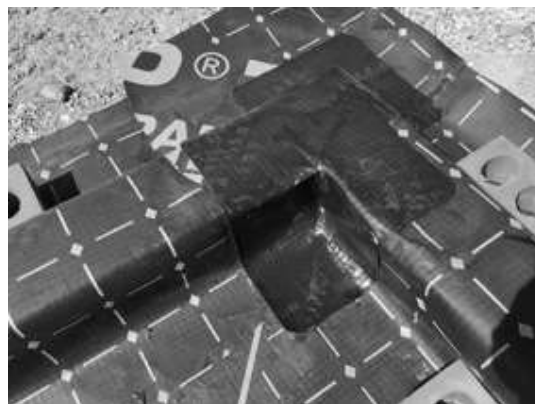
Typical corner seal using SAGM to plot 49.

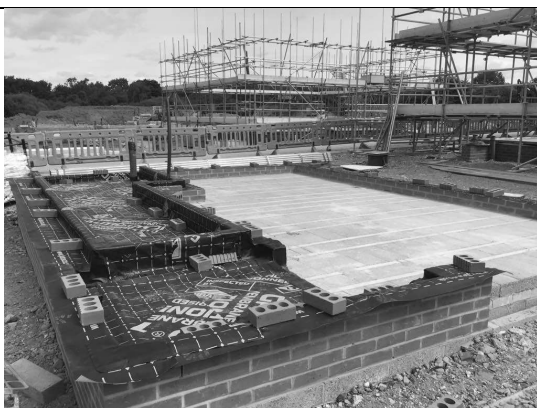
Overview of plot 7.

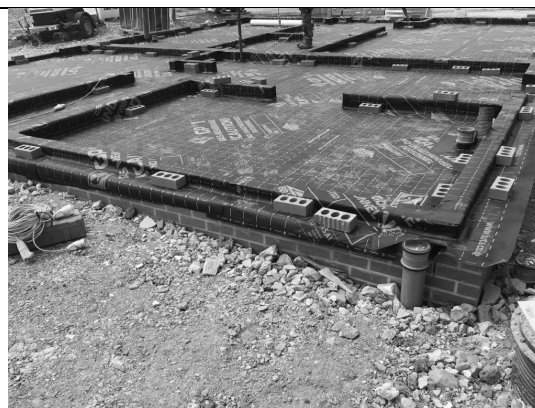
Overview of plots 10 & 11.

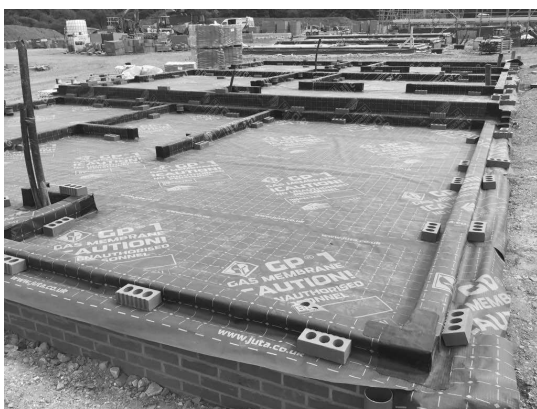
Overview of plots 42,43 & 44.

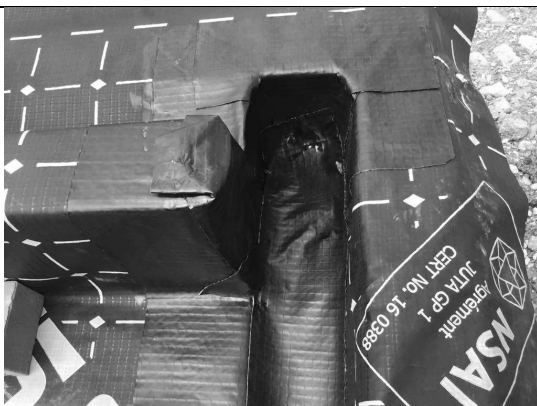
Sealed corner detail using SAGM to plot 7.

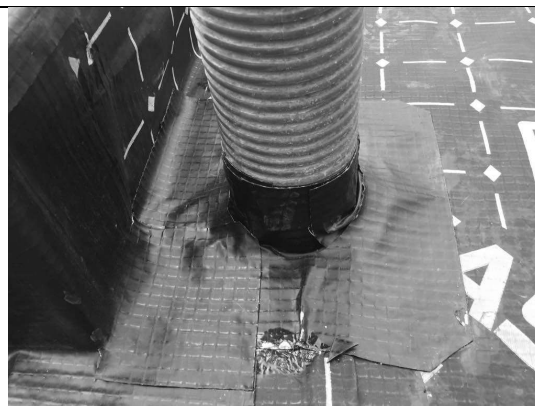
Typical pipe penetration seal using SAGM to plot 7.

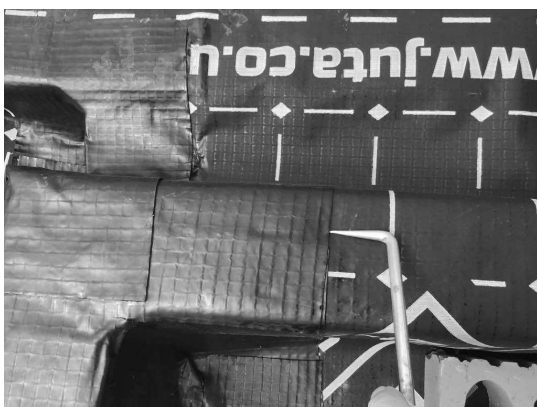
Pick testing all SAGM detailing to plot 7.

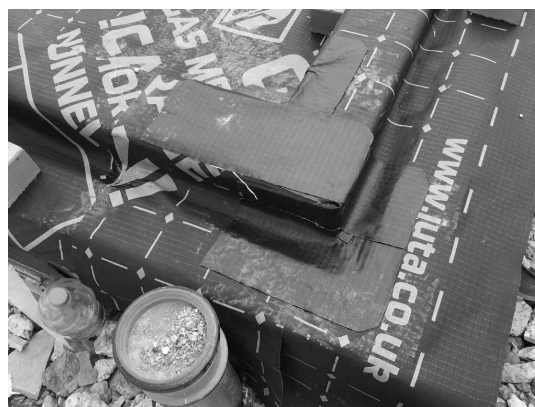
Typical corner seal using SAGM to plot 10.

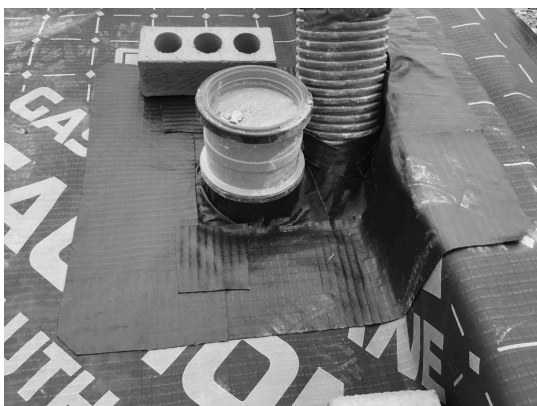
Typical double pipe penetration seal using SAGM to plot 10.

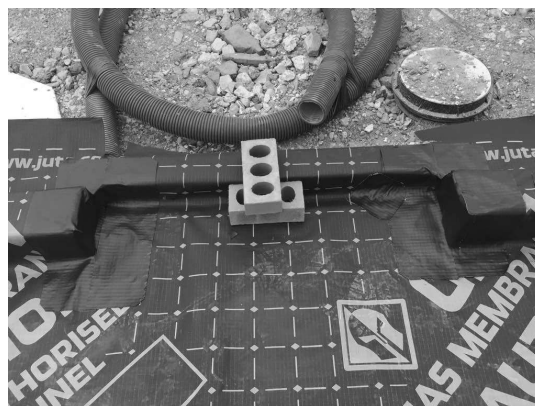
Typical door threshold seal using SAGM to plot 11.

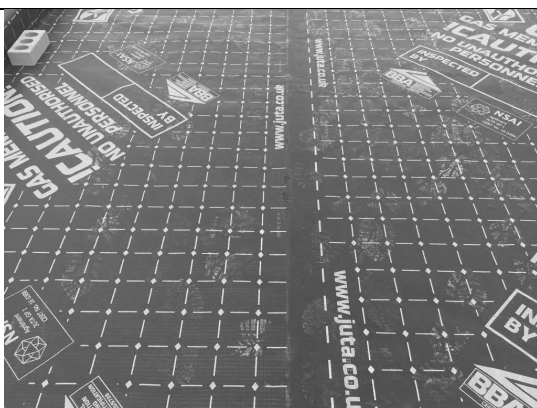
All membrane laps have been hand welded in plot 11.

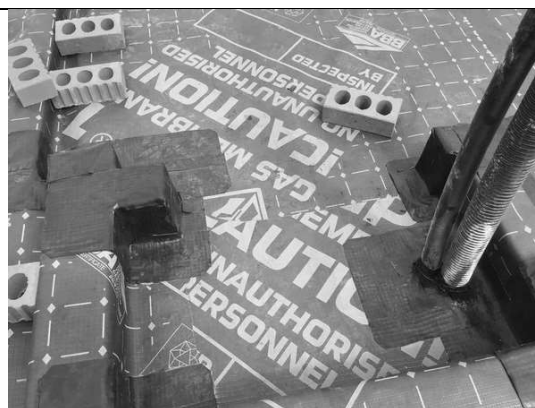
Sealed internal door thresholds using SAGM to plot 42.

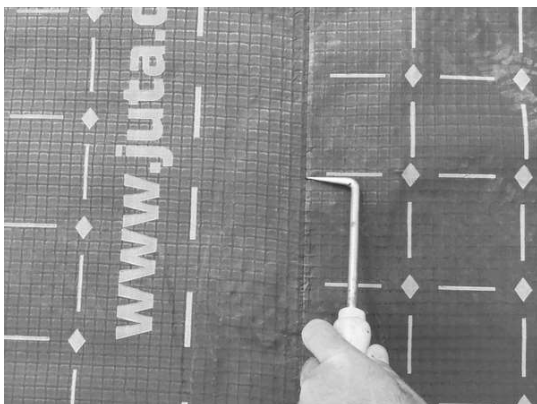
Pick testing all hand welded membrane laps in plot 42.

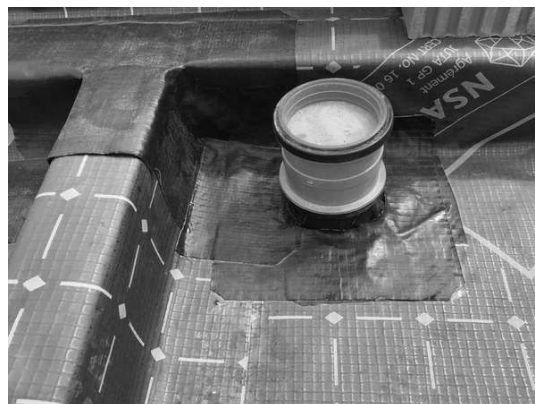
Typical pipe penetration seal using SAGM to plot 43.

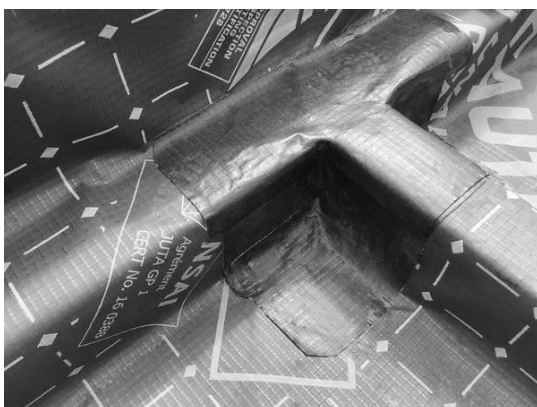
Typical corner seal using SAGM to plot 43.

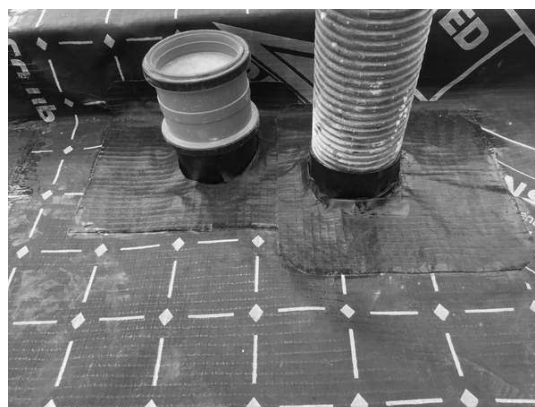
Typical double pipe penetration seal using SAGM to plot 44.

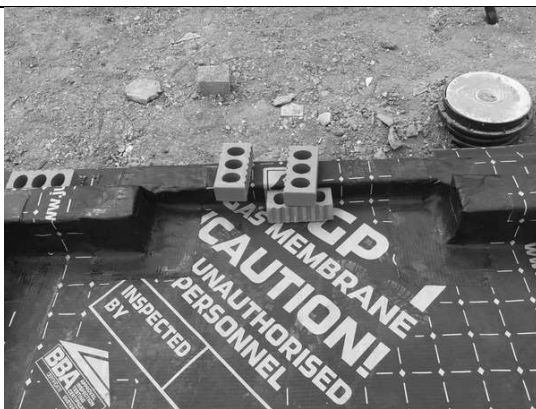
Typical door threshold seal using SAGM to plot 44.

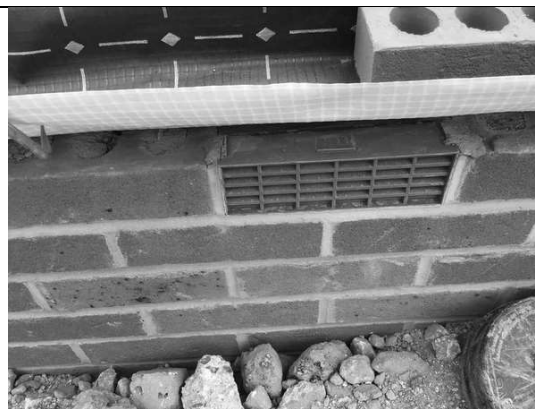
Air brick in place under the membrane to all plots.

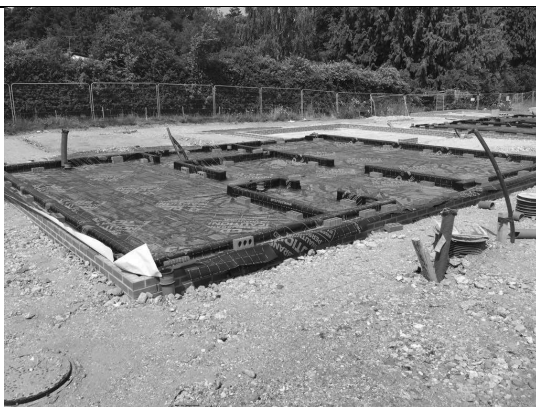
Overview of plot 25.

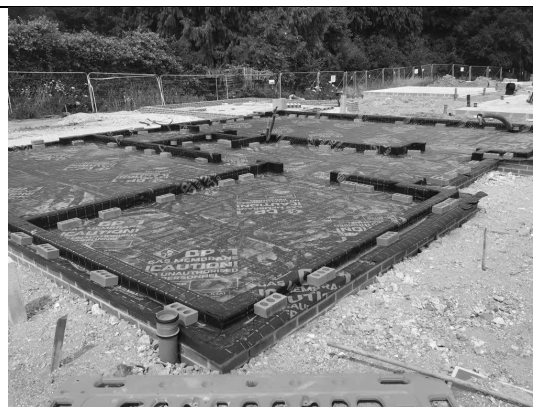
Overview of plot 26.

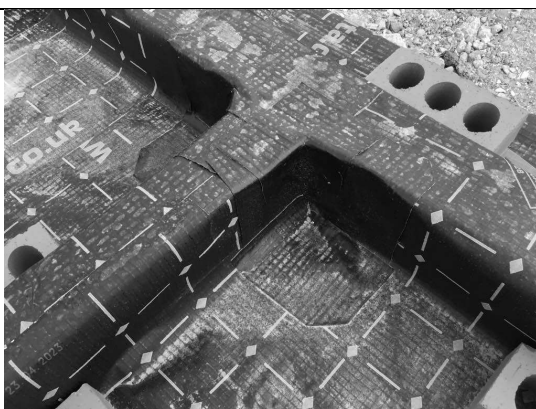
Typical corner seal using SAGM to plot 25.

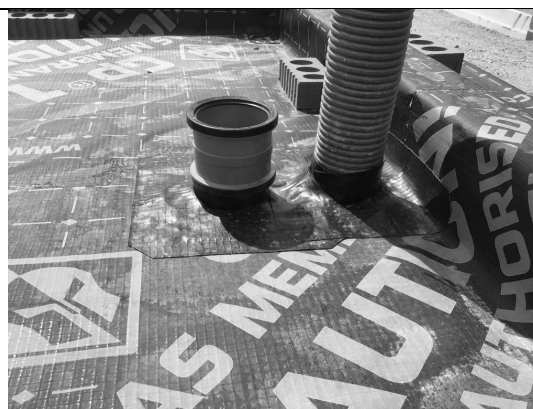
Typical double pipe penetration seal using SAGM to plot 25.

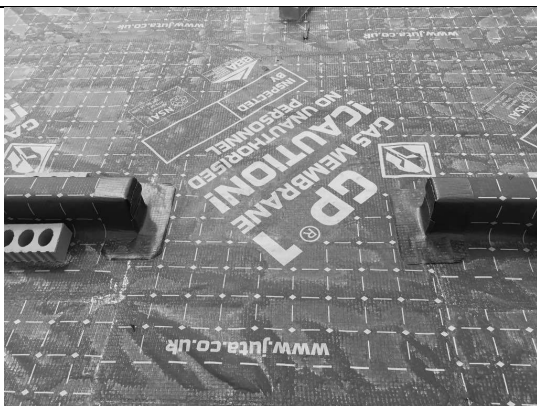
Typical internal door threshold seal using SAGM to plot 25.

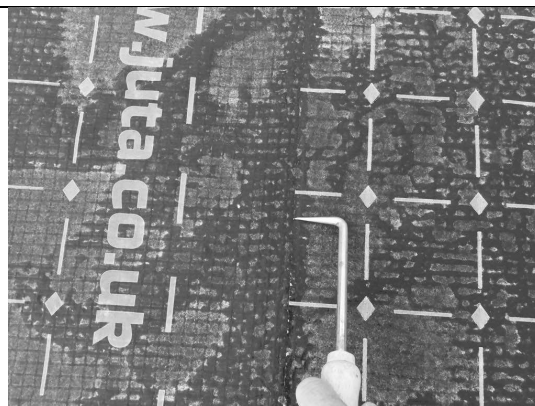
Pick testing all hand welded membrane laps in plot 25.

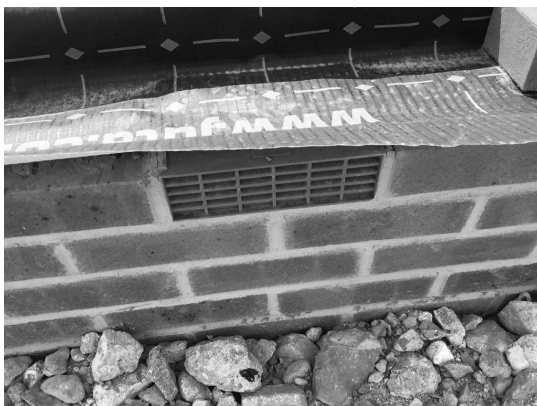
Air brick in place under the membrane during our inspection to plot 26.

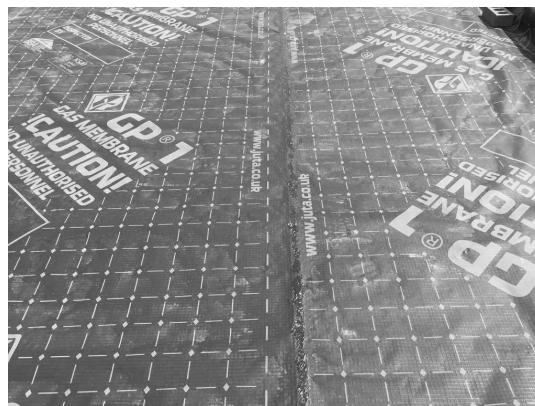
Hand welded membrane lap in plot 26.

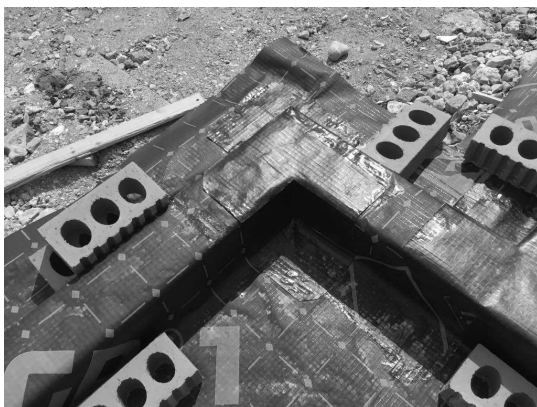
Typical corner seal using SAGM to plot 26.

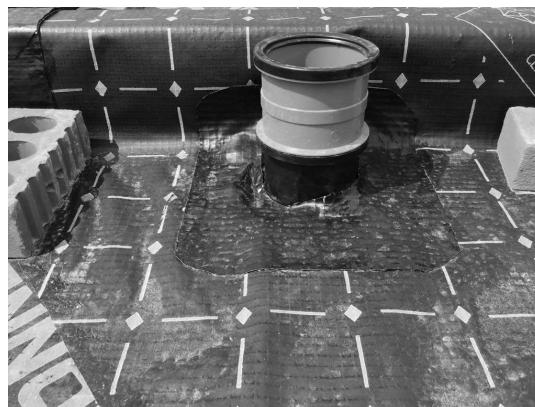
Typical pipe penetration seal using SAGM in plot 26.
