Title and description: Report on structural damage caused by trees to 30 VALLEY ROAD,  
CHANDLERS FORD SO53 1GP

Client: Dr Ezad

Issue No. 1 Issue date: 04/06/2024

For and on behalf of Romsey Structural Engineering Ltd

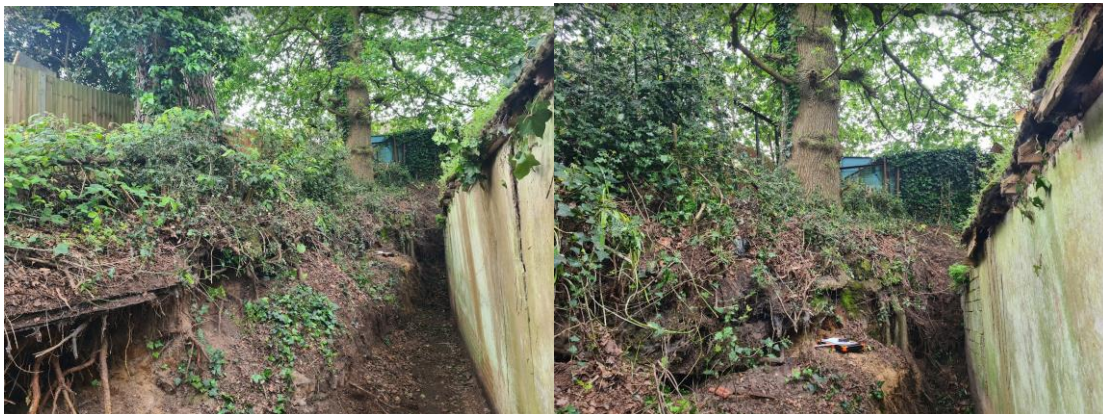
The problematic trees are detailed on Page Sk01 overleaf and in Figure 1 below. The ground slopes sharply up to the boundary, and the trees of concern include one Oak tree and two Scots Pines. Tree roots are visibly penetrating the bank and extending under the garage foundations.

Figure 1: Photographs of the side wall of the garage and the trees adjacent

6.1 The garage wall facing the trees shows significant degradation. This is likely due to several factors, including the age of the walls and the close proximity of mature trees.

6.2 A quick assessment indicates that the centreline of the freestanding wall at the top is outside the base wall width, presenting a high risk of failure.

6.3 The degradation of the garage wall is likely to continue due to the ongoing impact of the three trees. The garage is structurally unsound and poses a collapse risk.

6.6 Root damage has already compromised the garage and will continue to do so unless the trees are removed.

6.4 It is recommended that the garage be rebuilt, as the extent of degradation renders repair uneconomical.

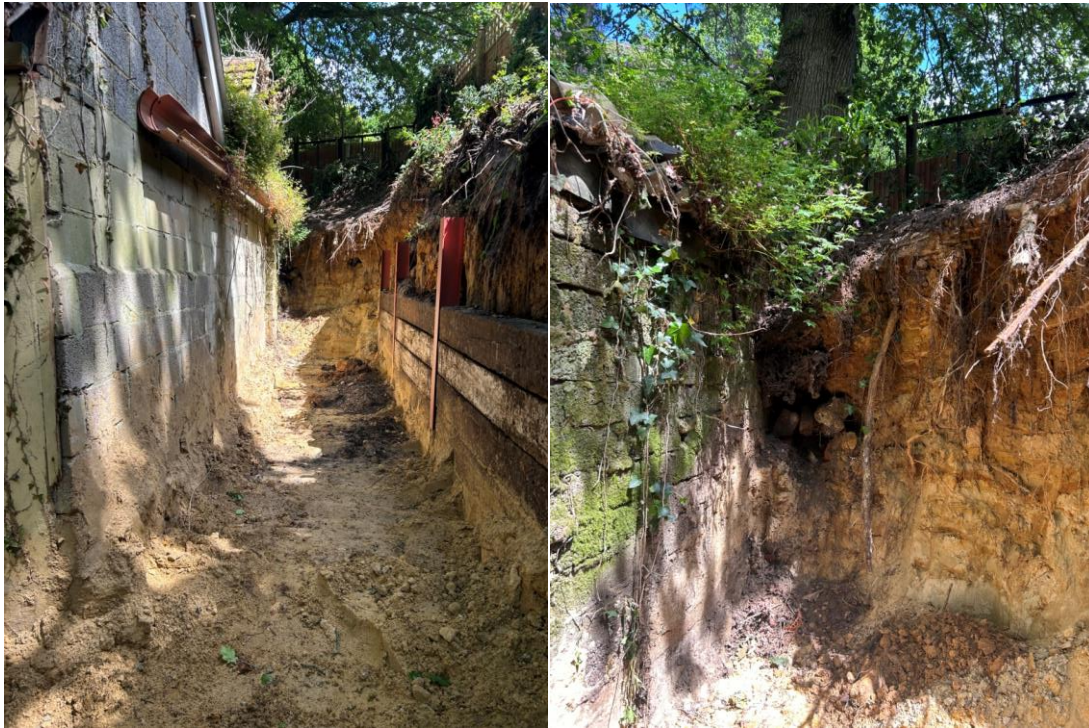
5.1 I am told that the existing retaining wall structure had failed and the bank had collapsed against the rear wall of the garages. This caused concerns for collapse of the garage wall as it is not structurally designed to act as a retaining wall. There were further issues with water impregnation with the bank leaning against the garage walls.

5.2 Works had been started to reinstate the retaining wall however have been stopped as the roots of these trees as identified above are now causing an obstruction. The retaining walls cannot be completed without destroying or damaging the tree roots extensively.

Figure 2: Photographs showing retaining wall to rear of garage and bank/roots collapsed against rear left corner.

6.7 The retaining walls must be completed to the back and side of the garages to allow for the rebuilding of the garages and to protect the rebuilt garage from the risk of the bank collapsing and to prevent any water ingress into the rebuilt walls

6.8 The roots from the Oak and Scots Pines must be removed and the soil around them removed to allow for the completion of the above retaining walls, this will likely affect the stability of the trees and it is recommended the trees be removed.

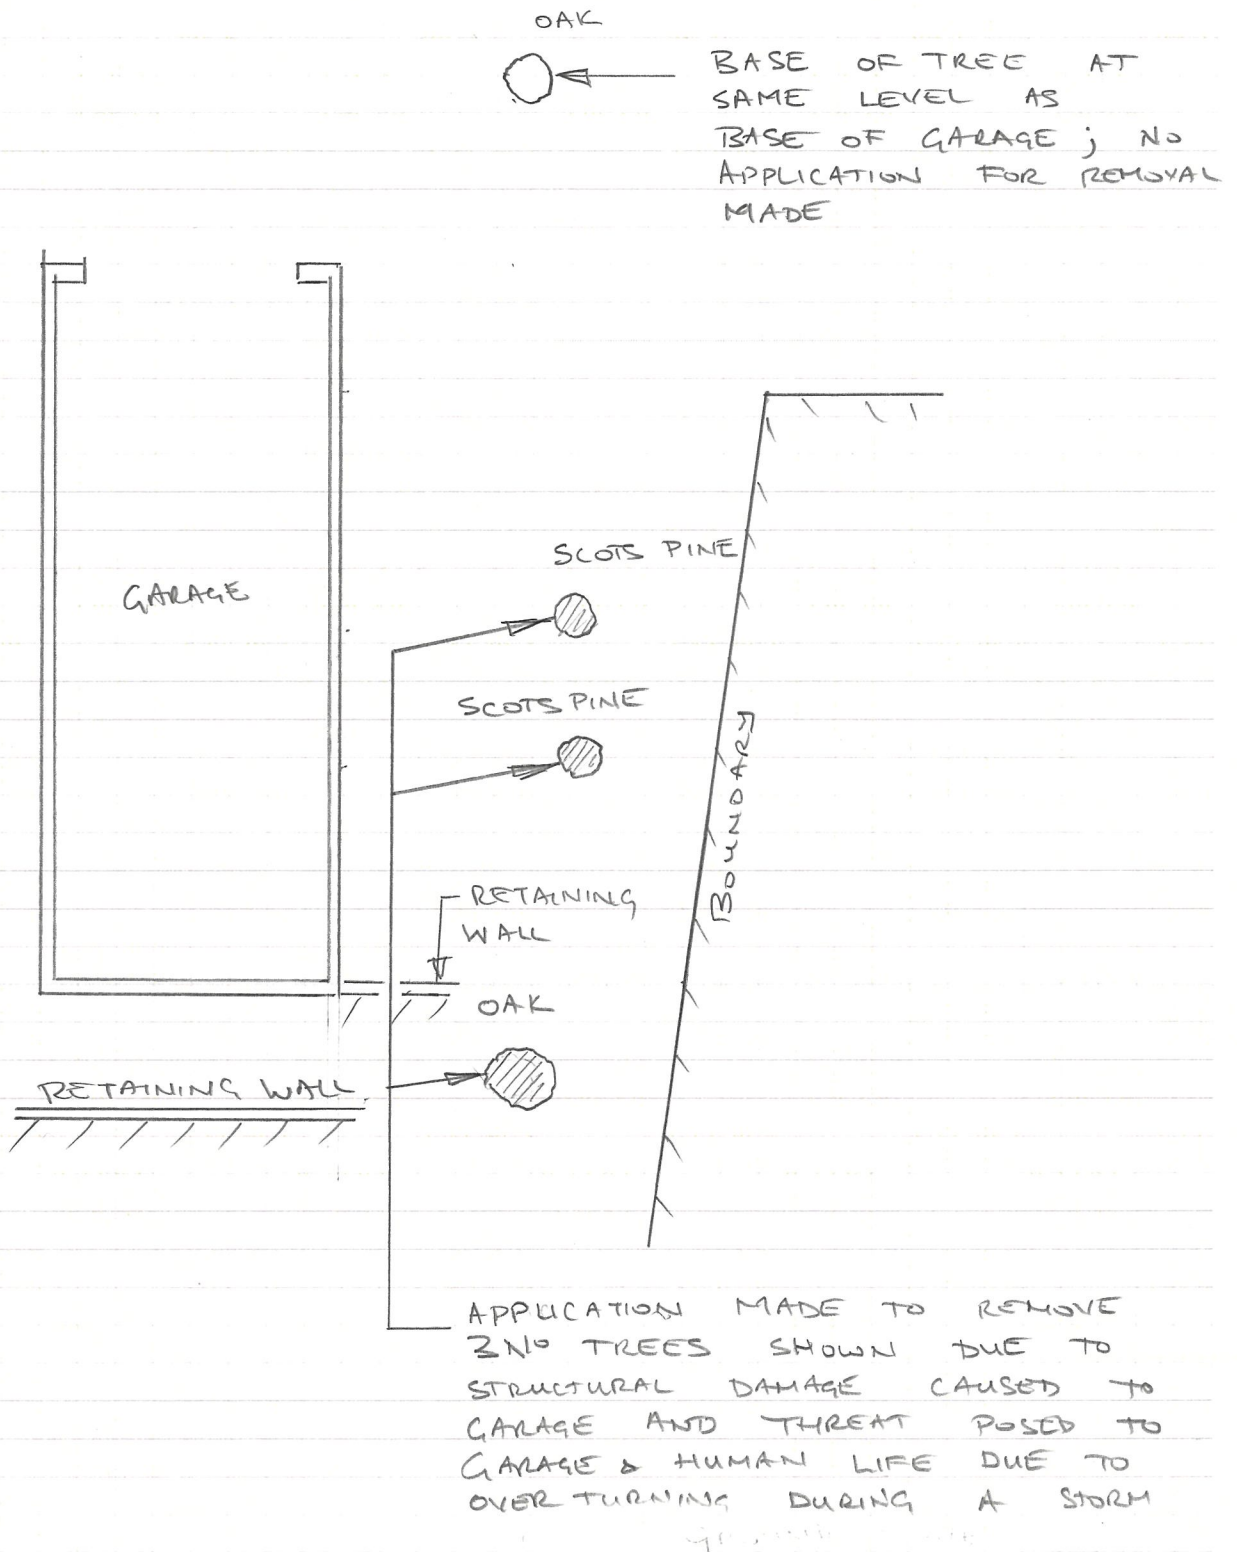
PLAN VIEW SHOWING PROXIMITY OF TREES TO GARAGE

6.5 The three trees shaded on Sk01 (one Oak and two Scots Pines) pose a significant threat to the structural integrity of the garage. Given their roots are going directly under the foundation slab at where the walls are moving and given the steep slope of the ground they are growing on, these trees also present a potential hazard, particularly from overturning during storm-force winds.
