# Tree Condition Survey

13 Kenilworth Drive, Boyatt  
Wood, Eastleigh,  
SO50 4PT

Reference: C042402

Date Issued: **21<sup>st</sup> May 2024**

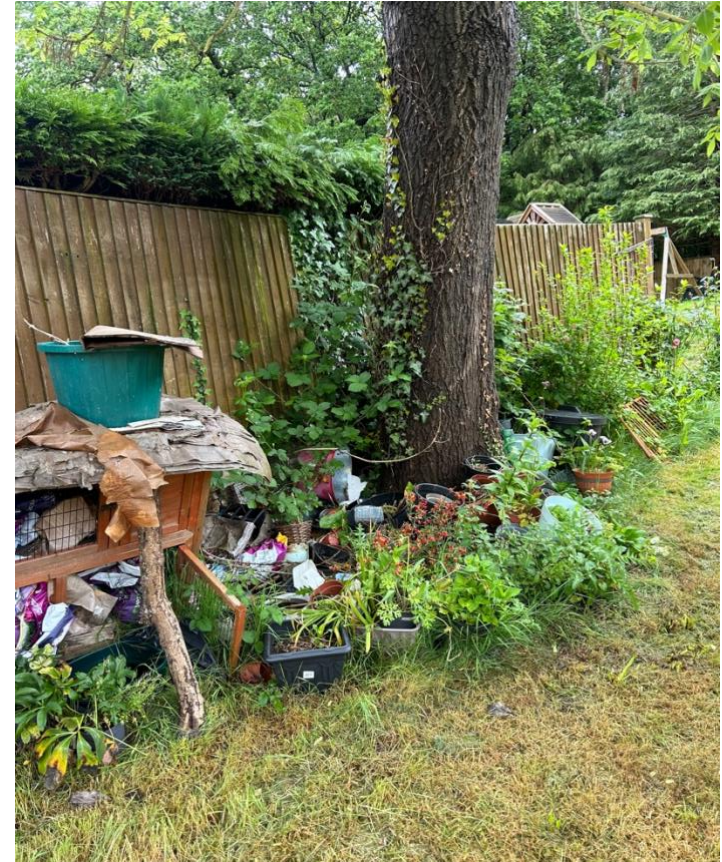
- 4.4. There is a buildup of garden materials stacked around the base of the tree, these will be compacting the soil leading which will lead to long term root asphyxiation. There is also a children's trampoline, and slide located under the crown.

Image of garden materials being stored in the root zone.

- 4.9. I would recommend that the large lateral limb at approximately 7m northwest (over the neighbouring property), is reduce by 2.5m to suitable secondary growth points, as well as the remaining crown spread to be reduced by 2m to suitable secondary growth points. To reduce the end-weight loading in order to reduce the potential any limb loss of the larger laterals. Raise the crown to 3m by selectively reducing or removing secondary limbs to suitable growth points, and remove all major deadwood (diameter greater than 25mm in diameter)
- 4.10. It would also be prudent to remove the build-up of materials from around the base of the tree as these will contribute to long term root asphyxiation by soil compaction.

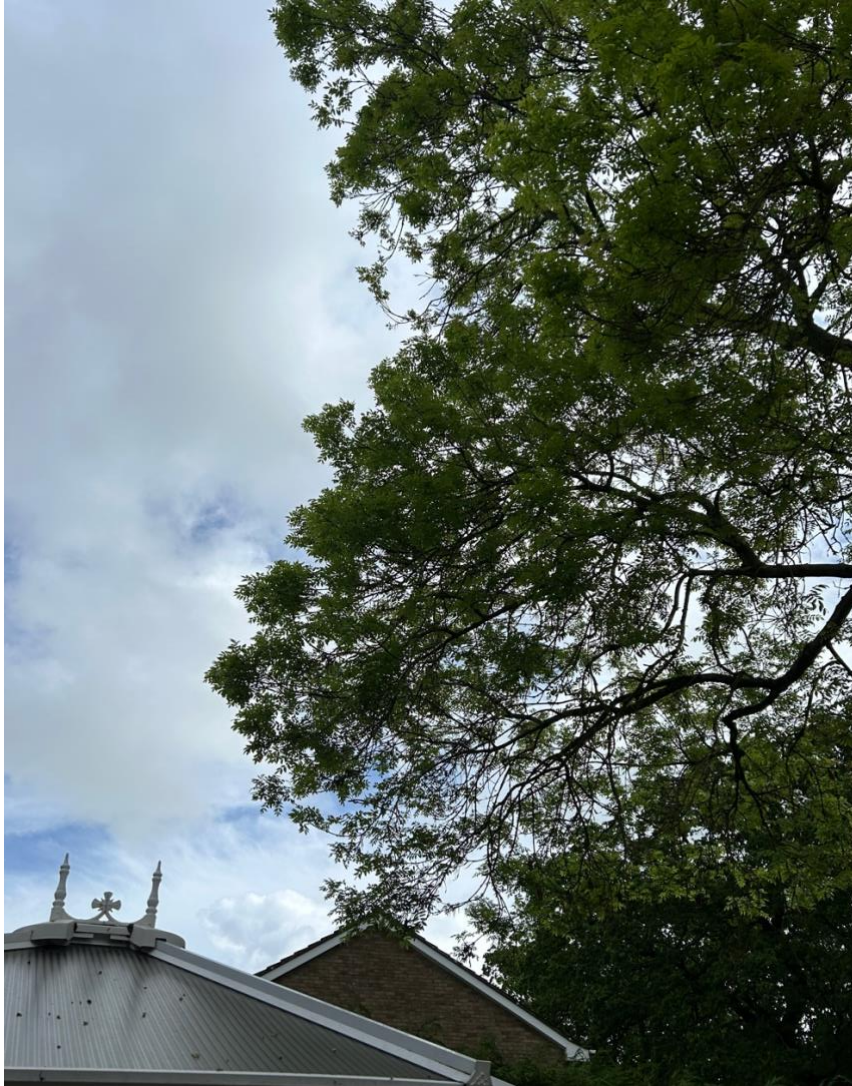
- 4.2. The crown spread to the North is 10m, to the East 8m, to the South 10m and to the West 10m.
- 4.3. The crown spread to the west is in close proximity of the rear of both buildings and the conservatory of No. 13.

View of the crown to the west near the conservatory and rear of the two dwellings

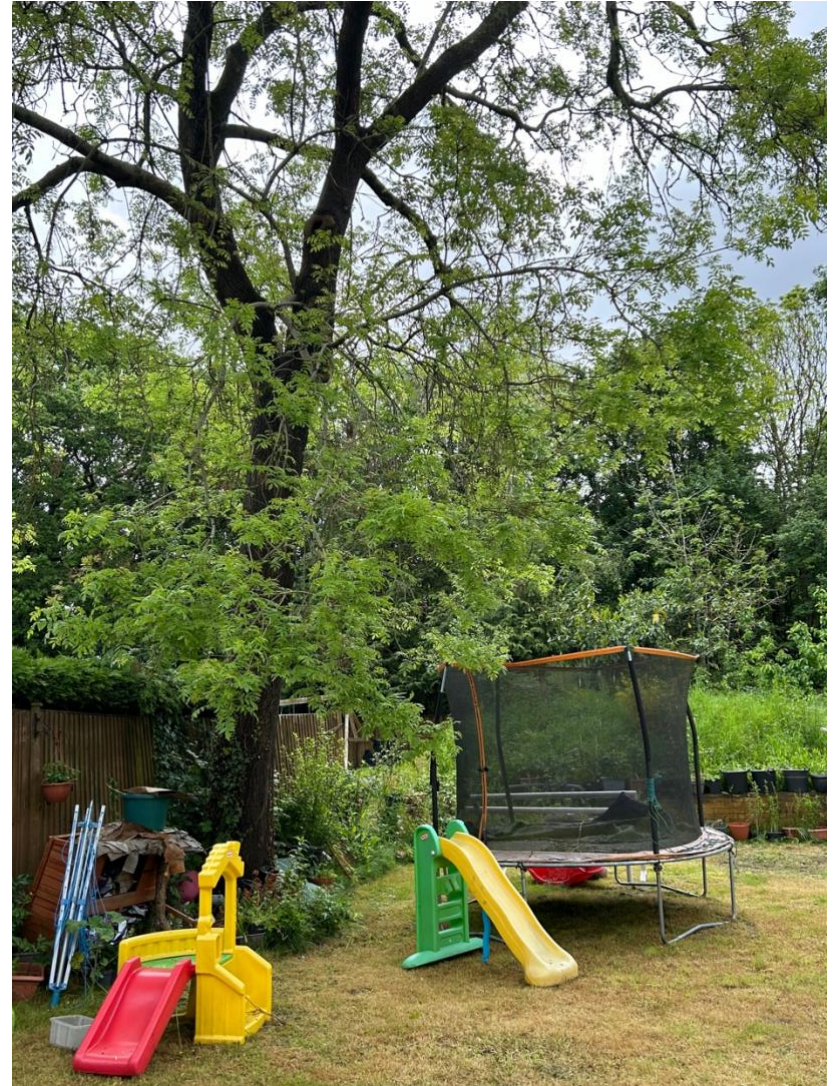
- 4.8. All the large lateral limbs are extended with dense foliage cover towards the extremities, the crown cover is not as extensive to the east and there is a substantial amount of deadwood, some of which has failed and is still suspended within the crown. The lower part of the crown is only 1.5m above ground level in places. However, the overall physiological condition of the tree is good, and the structural condition is fair/good.

Low crown over children's play area and lawn

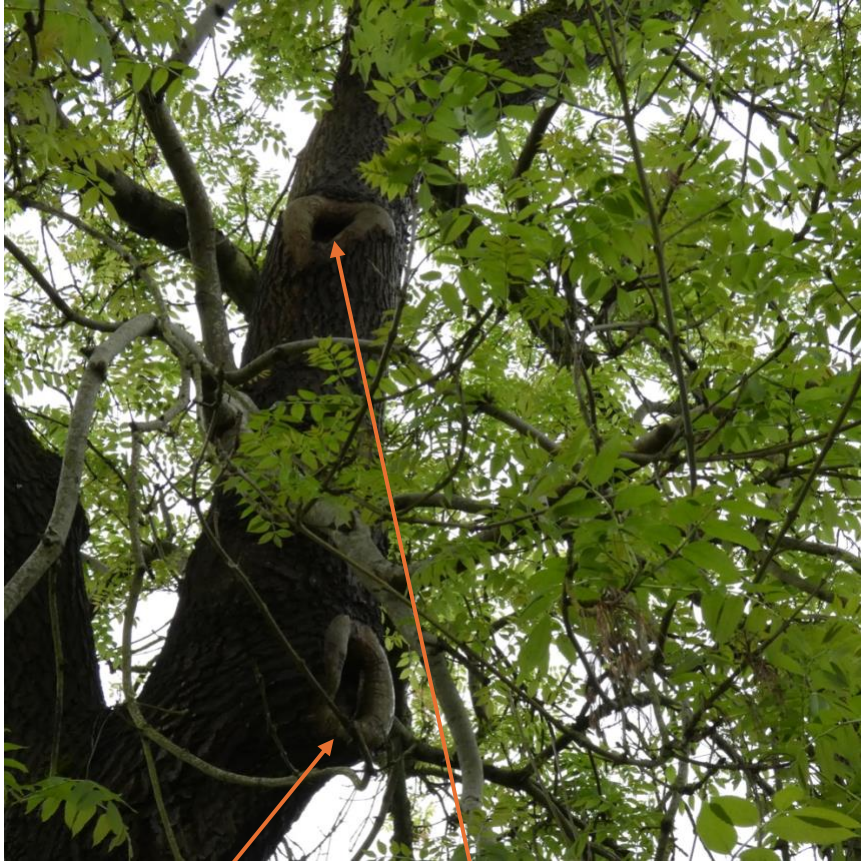
- 4.5. There are historical pruning wounds on the stem at 2.5m east that have occluded.
- 4.6. The stem bifurcates at approximately 5m and just above the bifurcation on the southern stem to the southwest there is a large historical pruning wound (Fig 1. – Appendix III), with a decay cavity exposing the heart wood, the wound is occluding with good reaction wood forming around it. There is an additional historical pruning wound on the southern stem (Fig 2. – Appendix III) at approximately 7m on the west side of the stem with a decay pocket exposing heart wood, the wound is occluding with good reaction wood forming around it. To the south side of the crown (over the lawn area of the garden) there is a large historical wound that is occluding, with some exposed heart wood.

Image of first decay cavity at point of bifurcation and additional cavity further up the southern stem

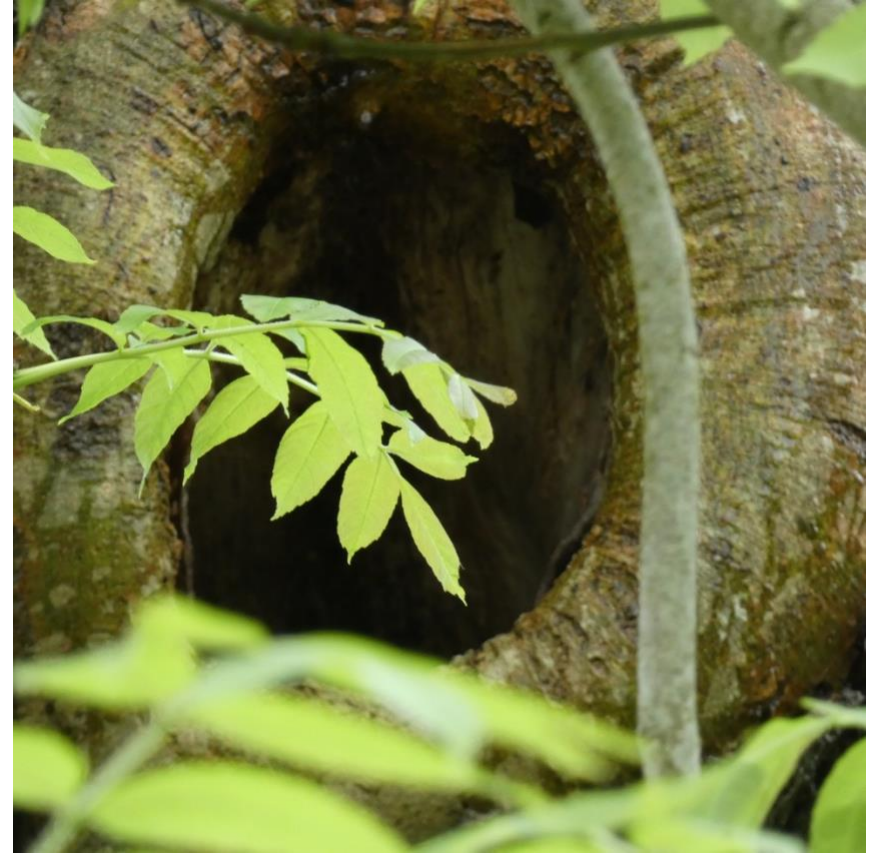
A closer image of the first decay cavity on the southern stem, showing the decay pocket.

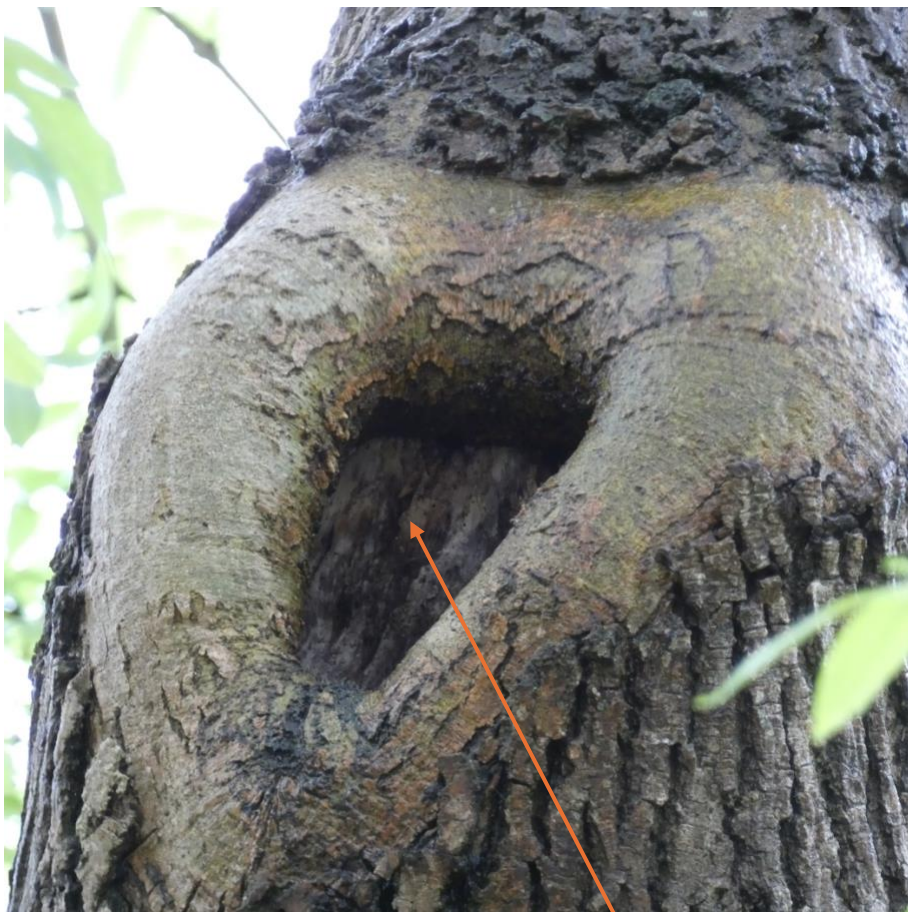
Closer image of second cavity on the southern stem, showing the exposed heartwood and the including wood forming around it

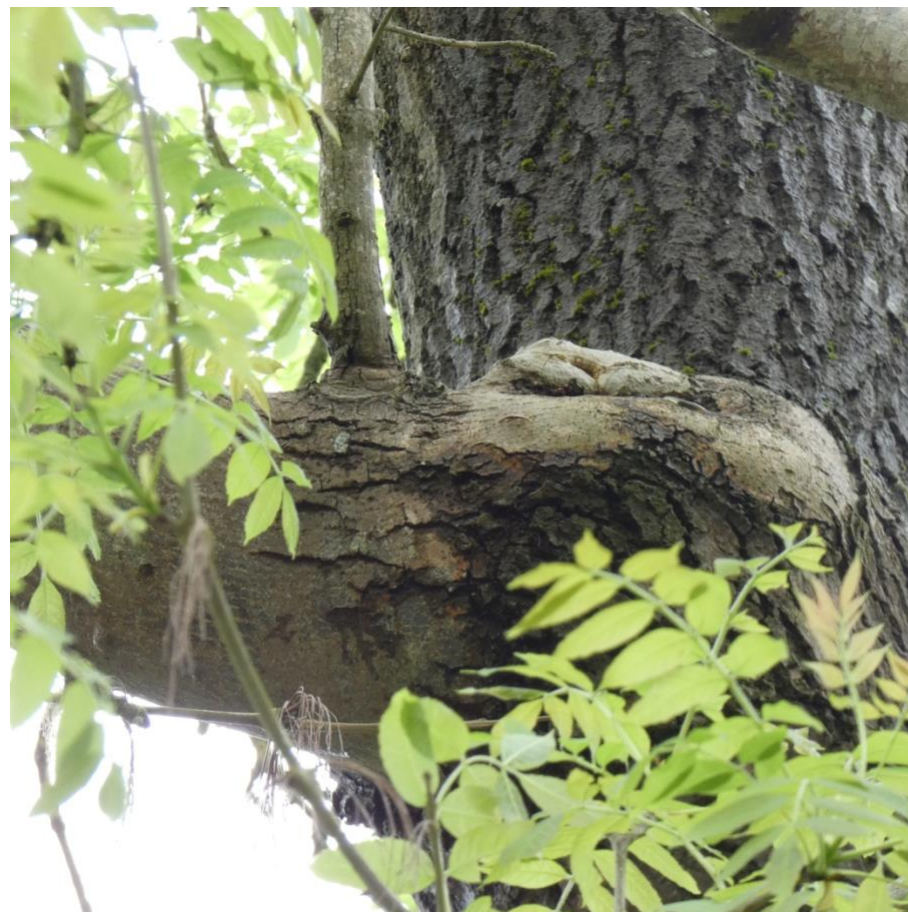
- 4.7. On the northern stem at approximately 7m at the union of a large lateral to the northwest (over the neighbouring property), there is a large wound which is occluding with some exposed heart wood.

Historic wound on the top of large lateral limb to the northwest
