Our ref: GE18008/GR02/190911

**RE: Boorley Green, Parcel B6**

Further to our recent discussions, we write to present an update to the soil contamination assessment for this development parcel.

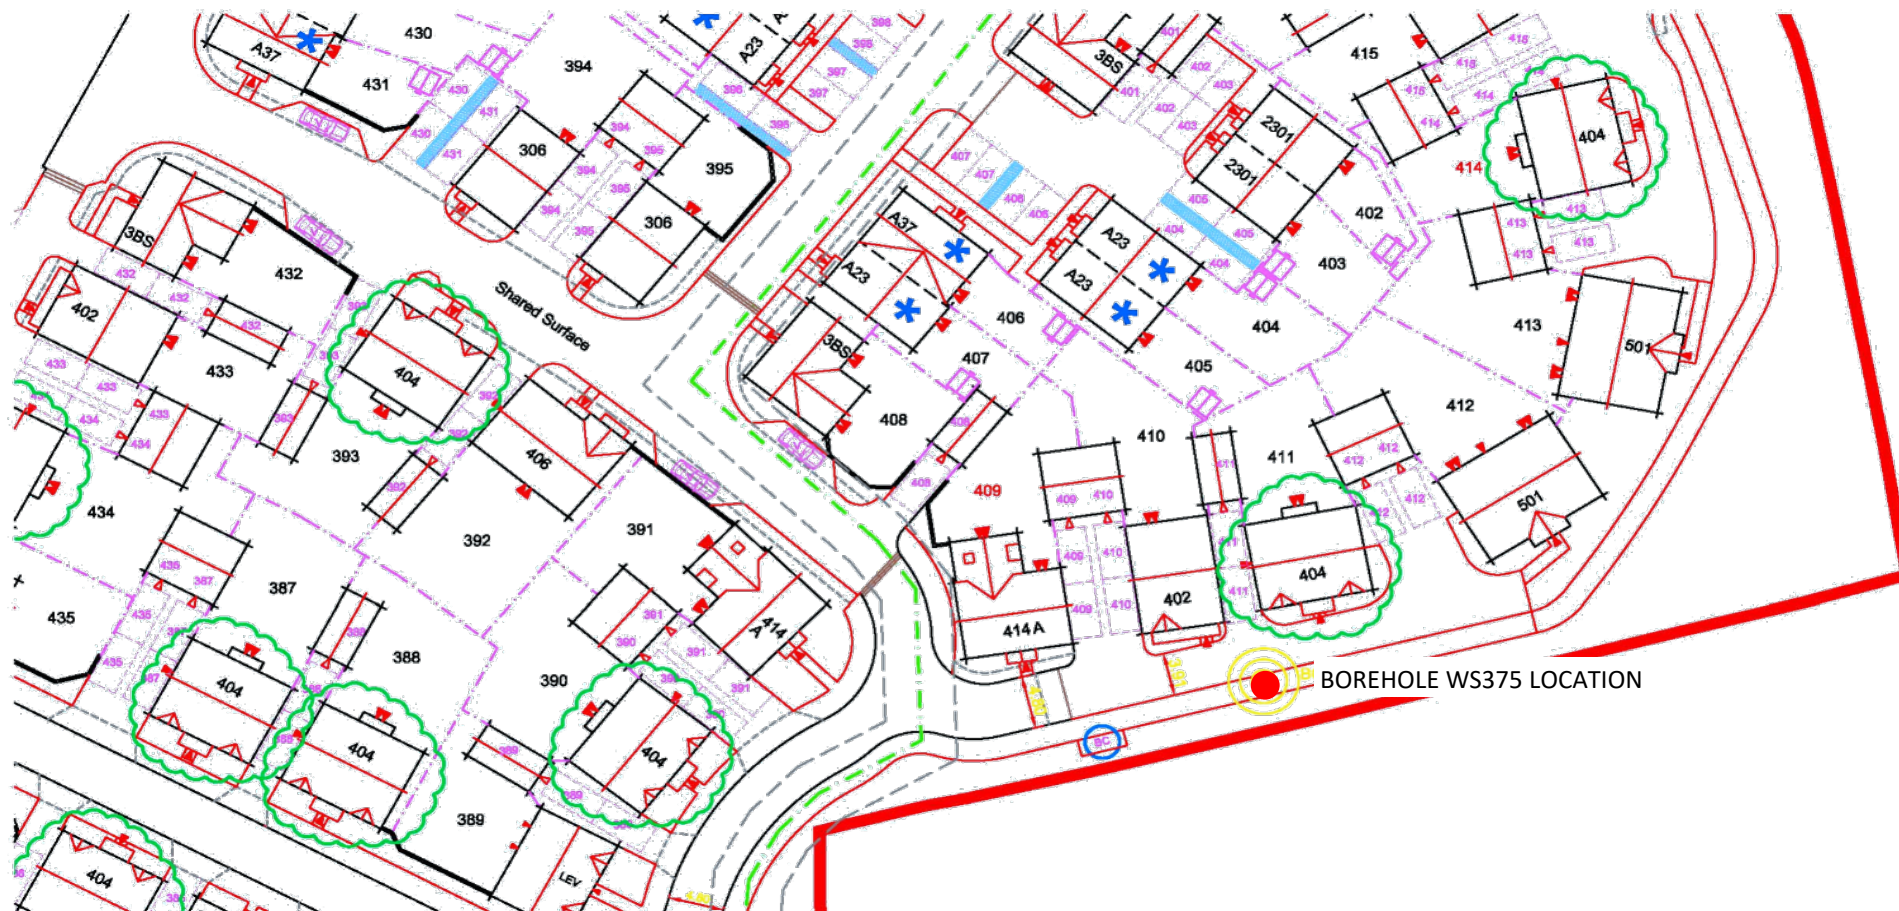
Enc      Figure 1 Development Layout Plan

With reference to the development layout, the borehole location of concern where soil contamination was identified (WS375) is located beneath the proposed shared access road or adjacent footpath to the front of plots 409-412, as shown on the enclosed Figure 1 which is an extract of the development layout CAD plan with the co-ordinated position of WS375 superimposed over the layout.

The form of construction in the area of WS375 is assumed to comprise permanent hard cover which prevents end users coming in to contact with these soils and thus no specific remedial action is required other than segregation of any soils excavated from this area and the soils being removed from the site. These soils would not be suitable for placement at all gardens or in the upper 0.5m of open space landscaping.

Further sampling and testing was undertaken around WS375 and did not identify any other locations where soil contamination was present (letter report ref. GE15030-GR03-16-02-08), i.e. just a possible requirement for remedial intervention within c. 10m around WS375 depending on layout, e.g. if gardens were in this zone.

No gardens are proposed in the immediate vicinity of WS375 and the hard cover would serve to protect end users for remnant soil contamination beneath the placed fill/subsoil and hard cover construction.

The assessment set out in GE15030-GR03-16-02-08 included modelling for a simple soil cover system in open space soft landscaping using the BRE cover system method which determined a soil cover thickness of 465mm for soft landscaping (outside of gardens). However, with reference to the development layout, WS375 is located on the outside of the access road, i.e. side further away from the plots, and beneath a proposed pavement.

Therefore, on the basis of the review of development layout and levels in the vicinity of WS375 coupled with the proposed permanent hard cover end use of the area around WS375, it is considered that no further assessment, risk mitigation/remedial action or verification is required to support the proposed development.
