## **Resistograph Tree Report**

**Vivid Housing Limited**

**Prepared by  
Richard Daubeney Our Ref 0624-RD  
26th June 2024**

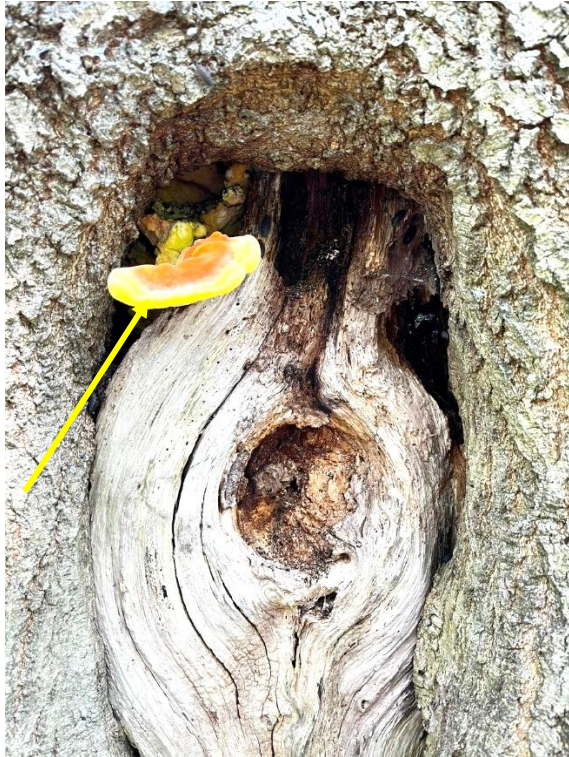
| Tree No.<br>Tree Tag. | Tree Species | Hgt (m) | Past Management | Age Class | Risk Target | Defects | Works | Work Priority |
|---|---|---|---|---|---|---|---|---|
| T1 Tree tag: N/A | English oak | 20-25m | No significant recent management noted. | Mature | High/<br>reinspect in 2027 | Gross Defect Noted<br>Large cavity on stem at 1.2m to the West. With fruiting body of <i>Laetiporus sulphureus</i> (Chicken of the woods) located within the cavity, fresh in appearance. The cavity when tapped with sounding hammer is hollow sounding. Co dominant stems at 9m above ground level. Deadwood throughout canopy. Crown weighted towards Southeast due to tree group pressure from North and West. | Reduce to 8-10m above ground level.<br><br>Tree works to BS3998 (2010) | Urgent Within 3 months |

**T1 English oak tree looking East towards cavity and  
*Laetiporus sulphureus* fungus bracket.**

- 6.1 Following the results of T1 English oak tree mentioned within this report, we now provide our conclusions.
- 6.2 The English oak tree T1 showed that although there is evidence of some residual sound wood present within the stem around the section of the cavity and below the cavity at ground level, however the readings do also show that there are significant areas of dysfunctional wood present within the stem which would not only link to the cavity but also the likely the presence of the fruiting body attachment. This then turns to the tree overall and its setting, with consideration of the tree location with multiple targets such as building, garden and general public all within striking distance of the tree, the tree at its current height and spread is likely placing considerable pressure to the lower section of the stem mainly around the cavity and rooting area of the tree. In our opinion the English oak has a significant risk of stem failure. We therefore recommend that the T1 English oak tree is reduced in height to 8-10m above ground level. Reducing this tree will ensure that the tree can be retained with a more compact size and limiting the risks to the targets surrounding the tree.

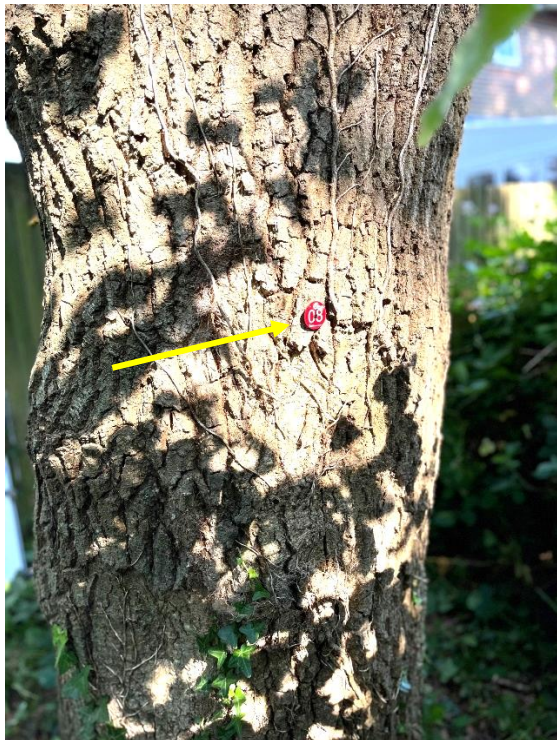
- 5.3 Following the testing of the T1 English oak tree it showed areas of significant decay within the stem. This is highlighted within readings 5 and 8, which were positioned either side of the cavity area, this was carried out to demonstrate the sound live wood available centered around the cavity area. Both readings 5 and 8 showed little in terms of sound residual holding wood and the significant areas of decayed wood present within the stem. Reading No.6 also demonstrated areas of moderate decayed wood within the stem, but however there is also sound holding wood within this reading. The remaining readings showed significant area of decayed wood present within the stem. The cavity on the stem currently has a fruiting body *Laetiporus sulphureus* (Chicken of the woods) bracket, which is fresh in appearance. (See below for further information on this fungus) The large cavity with internal decay at 1.2m to the West side of stem shows moderate reaction wood surrounding the cavity. The tree has large standing deadwood present throughout the canopy.

**T1 English oak looking to North towards Drill  
location No.8**

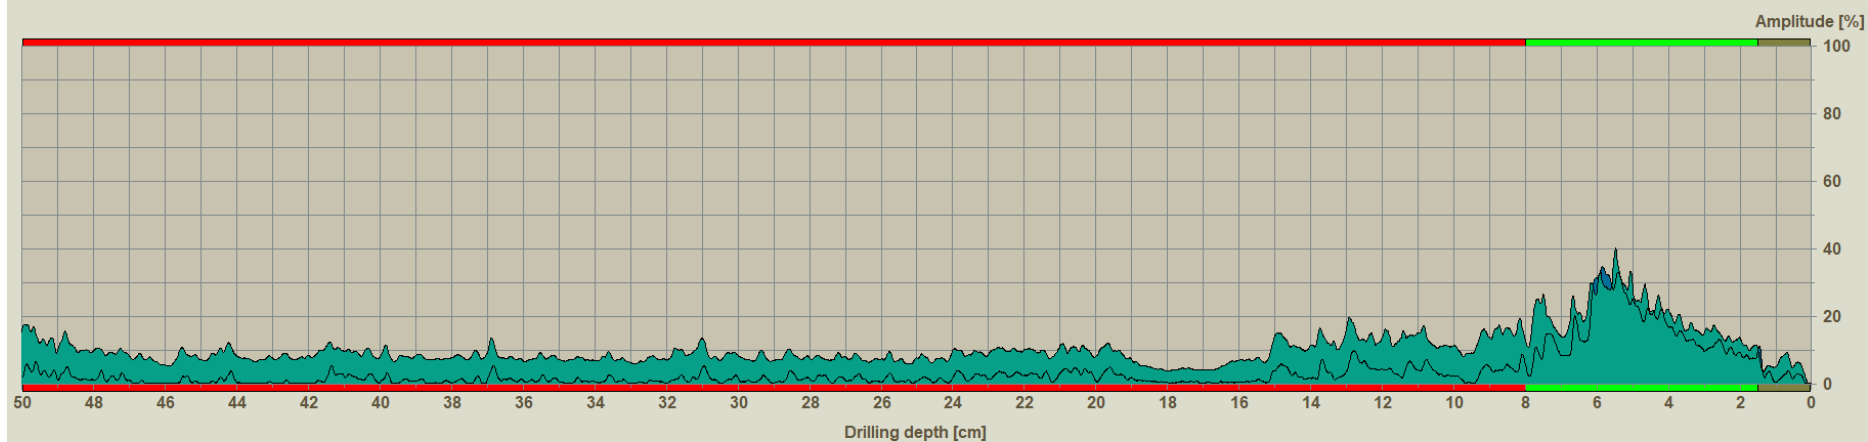
## T1 English oak Measurement 2

| From 0,00 cm to 1,50 cm : | Bark |
| From 1,50 cm to 8,00 cm : | Sound wood |
| From 8,00 cm to 50,00 cm : | Decay |

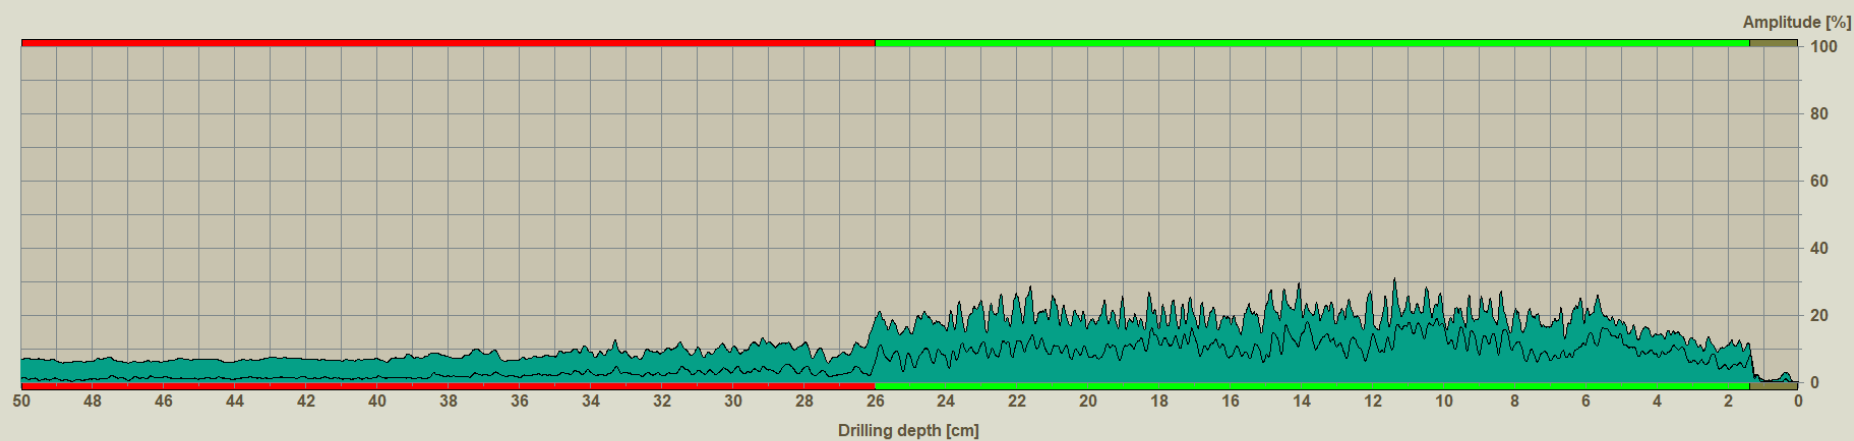
## T1 English oak Measurement 3

| From | 0,00 cm | to | 1,40 cm | : | Bark |
| From | 1,40 cm | to | 26,00 cm | : | Sound wood |
| From | 26,00 cm | to | 50,00 cm | : | Decay |

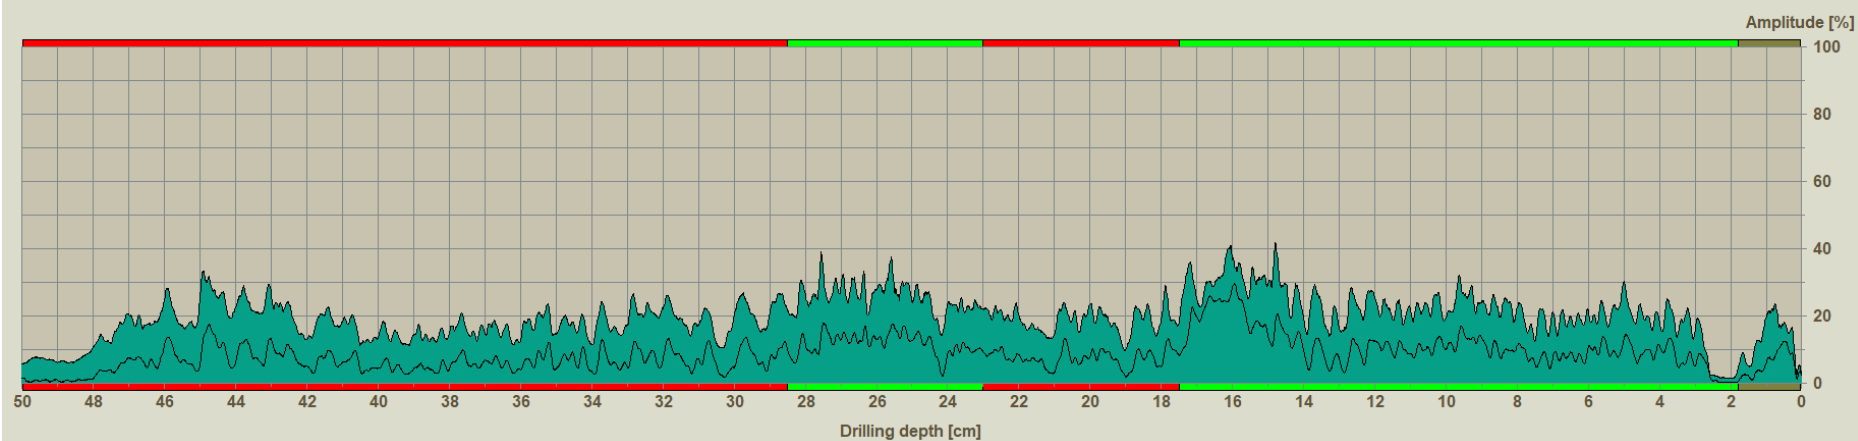
## T1 English oak Measurement 4

| From | 0,00 cm | to | 1,80 cm | : | Bark |
| From | 1,80 cm | to | 17,50 cm | : | Sound wood |
| From | 17,50 cm | to | 23,00 cm | : | Decay |
| From | 23,00 cm | to | 28,50 cm | : | Sound wood |
| From | 28,50 cm | to | 50,00 cm | : | Decay |
