## SITE VISIT REPORT

**Project:** Kestrel Park, Bursledon

**Client:** Taylor Wimpey UK Ltd (Southern Counties)

**Contract No.:** C-08162-C

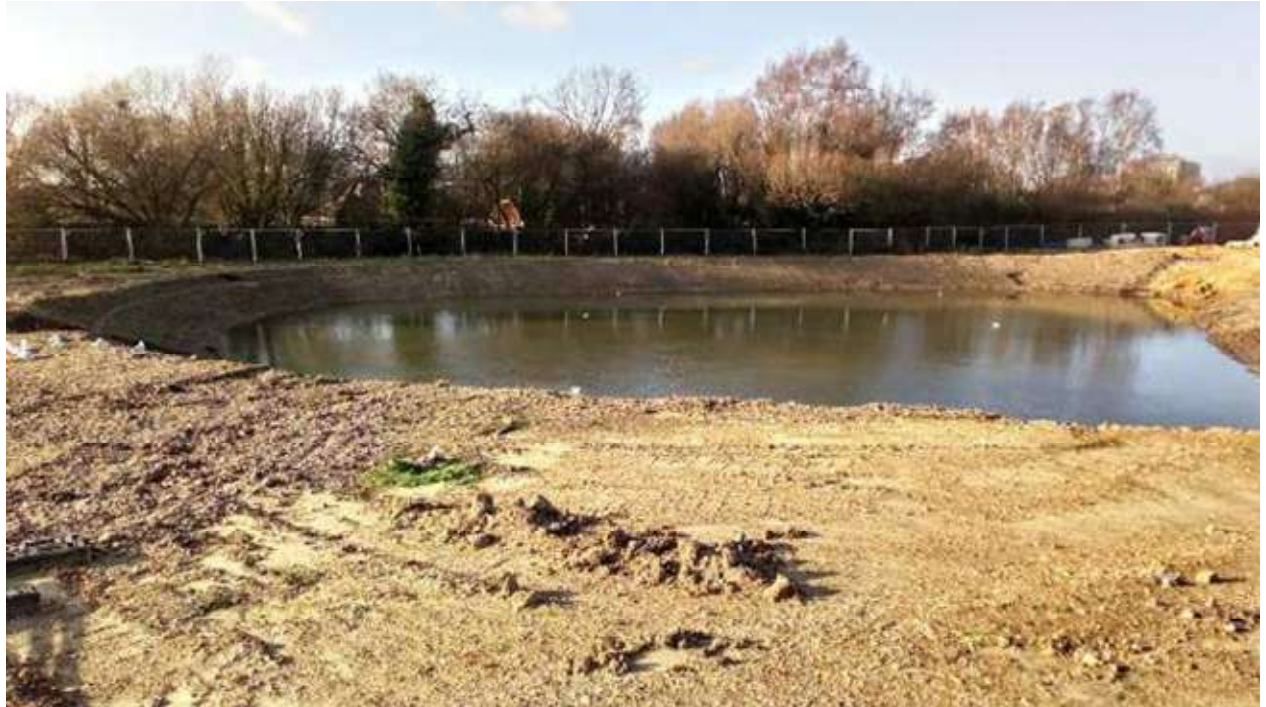
**Photograph 1: Northern balancing lagoon**

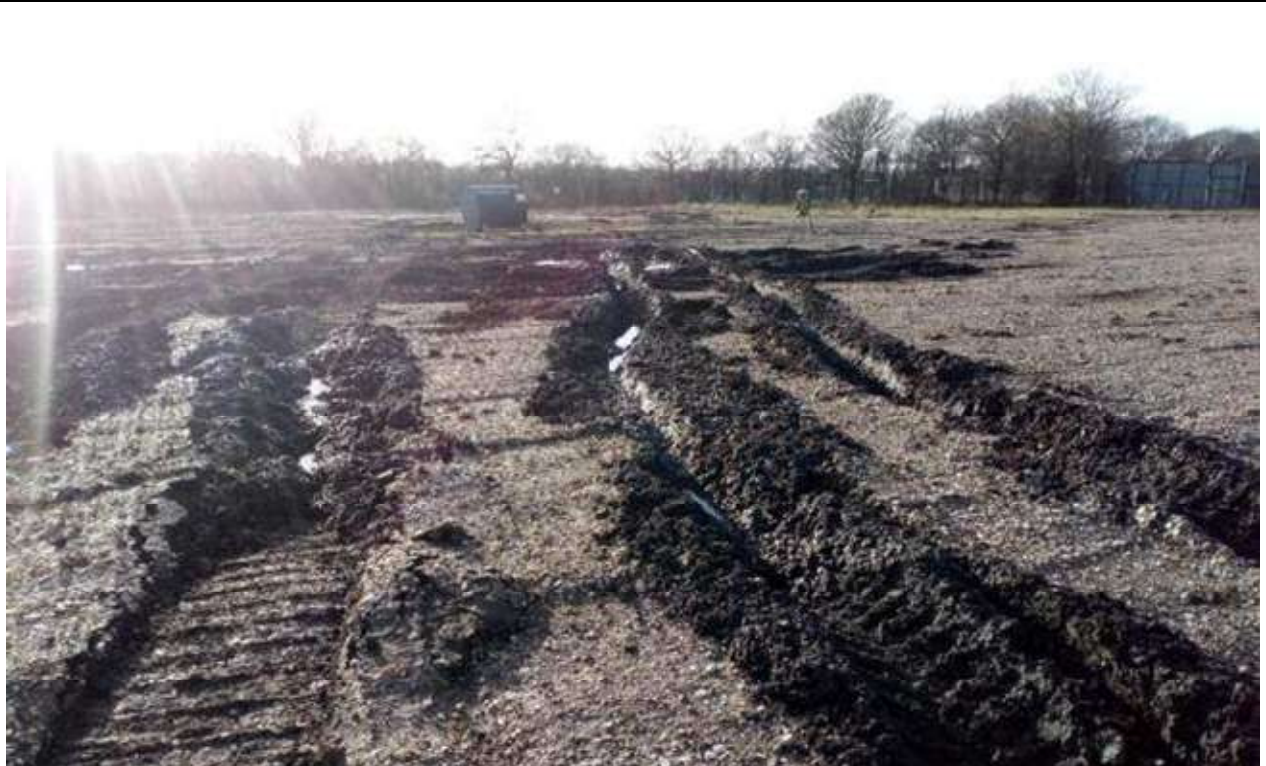
**Photograph 2: Fuel bowser and rutting in knotweed burial pit area**

- Relocate fuel bowser.
- Keep materials and tools off placed gas membranes to remove risk of damage.
- Notify TW/Hydrock of any significant contamination identified during groundworks.
- Survey stockpiles regularly to track volume of soils recovered. Volumetrics are required to progress MMP
- Continued silt management

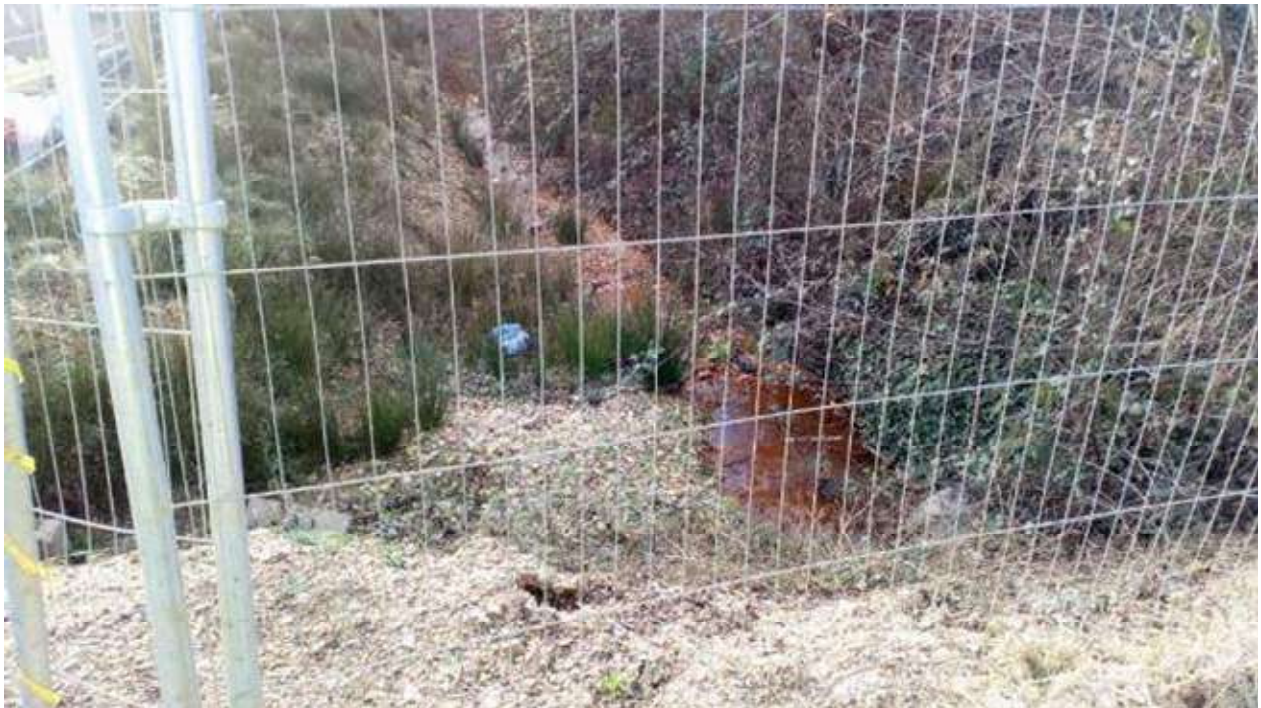
**Photograph 4: View into stream, waters are clear and not silted.**

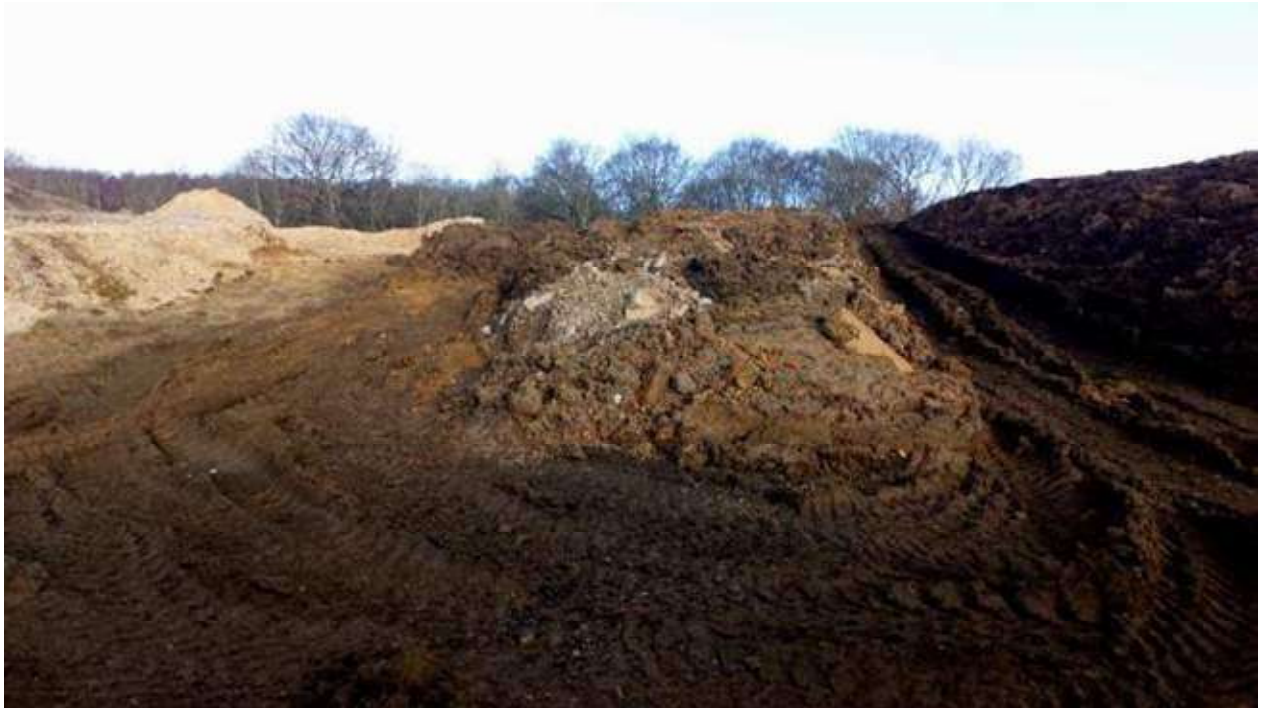
**Photograph 5: Ongoing stockpiling of soils with anthropogenic contents**

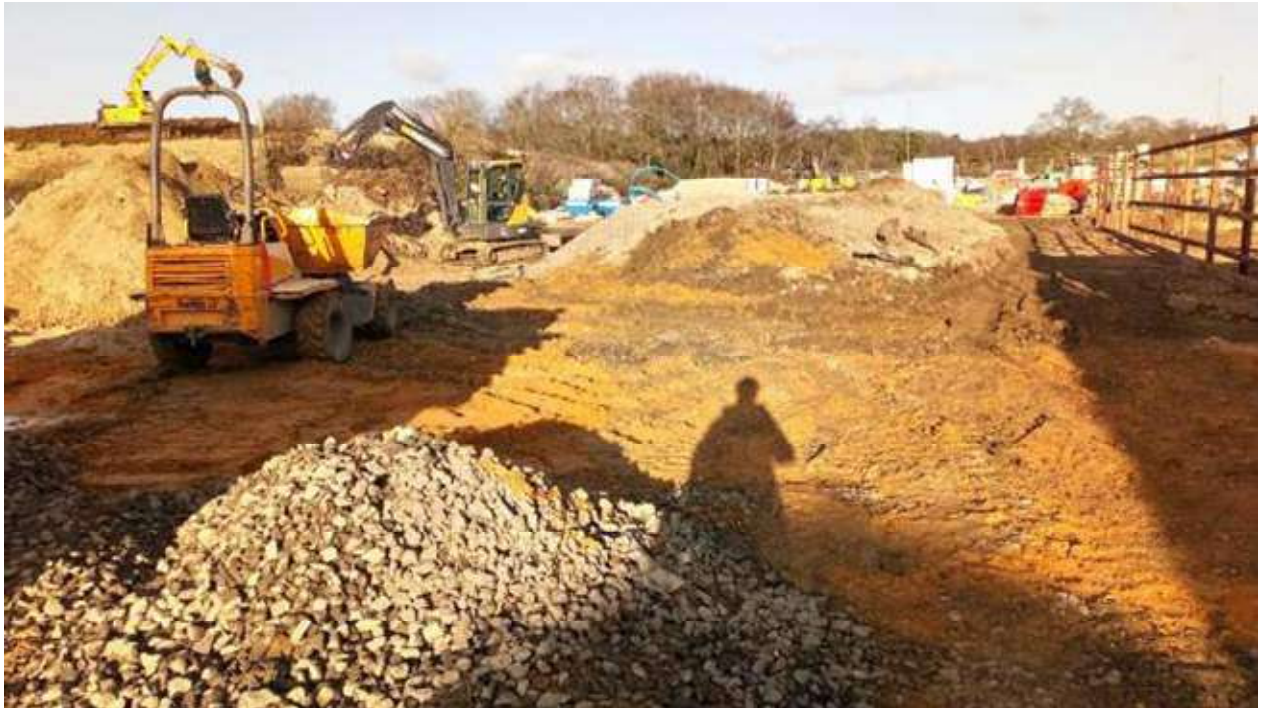
**Photograph 7: Stockpiling materials and completion of Taylor Wimpey compound area**

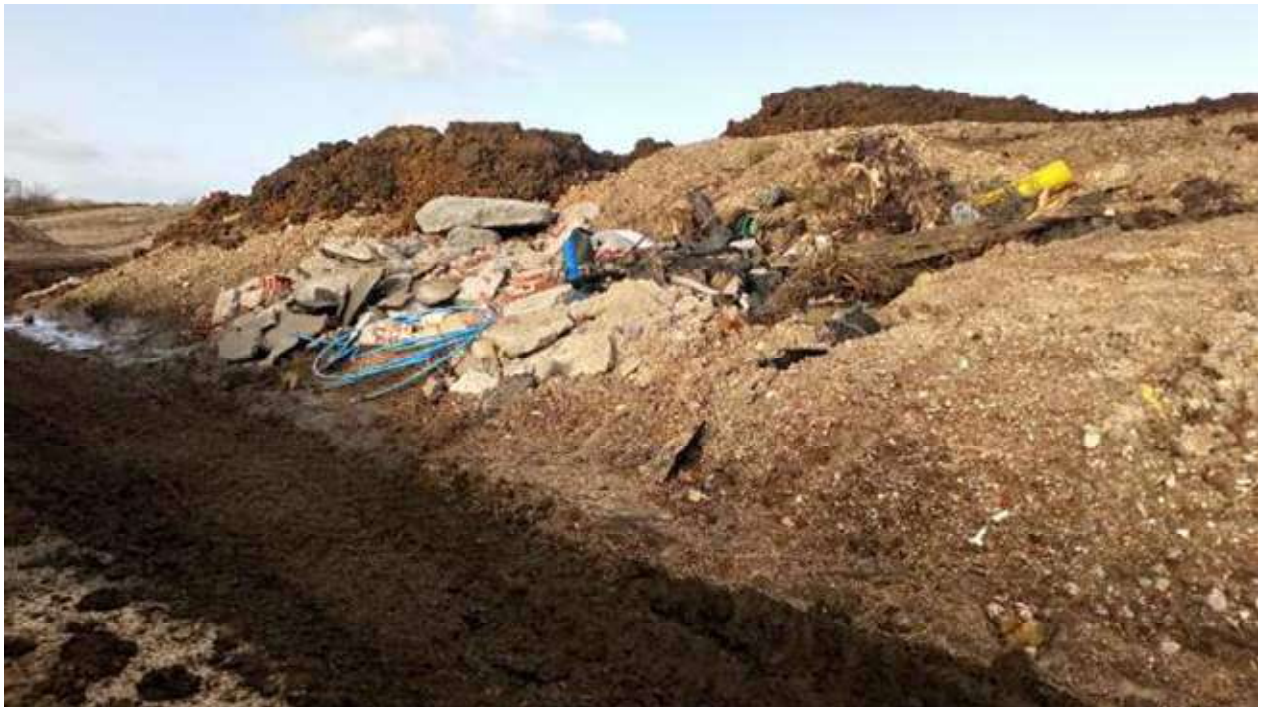
**Photograph 8: Various materials within large stockpile area**

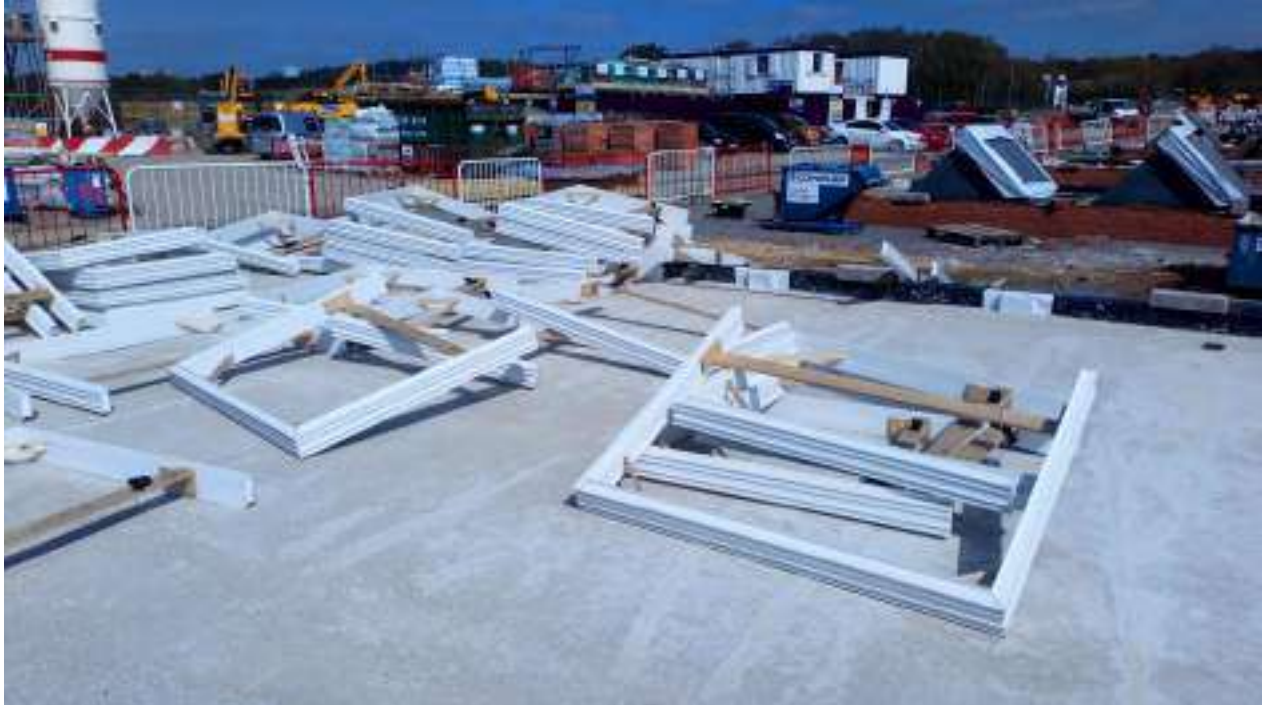
**Photograph 3: Materials stored on plots where screed has been placed near site compound.**

- Materials are being stored on plots near the compound where screed has been placed. Whilst no detrimental effect to gas membranes is evident from the placement of these materials care should be taken in placing retrieving these items to ensure that exposed membrane is not damaged/compromised.

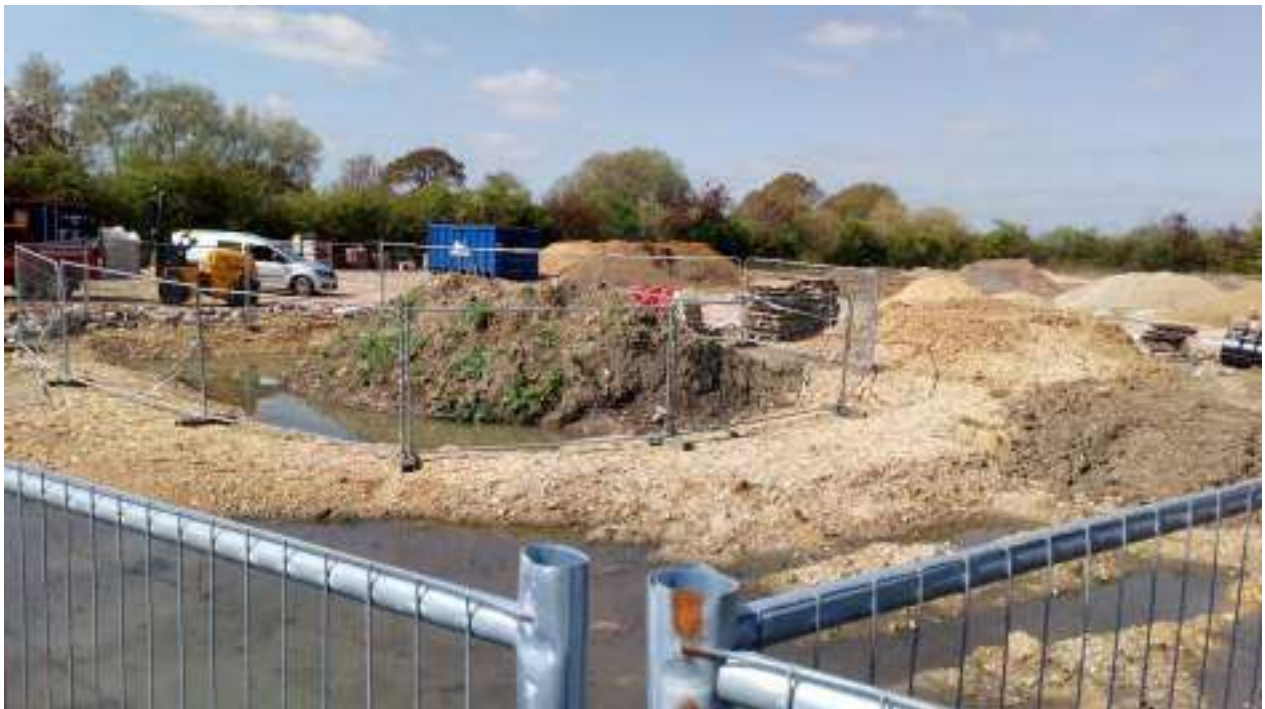
**Photograph 4: Asbestos impacted materials fenced off and various aggregate stockpiles**

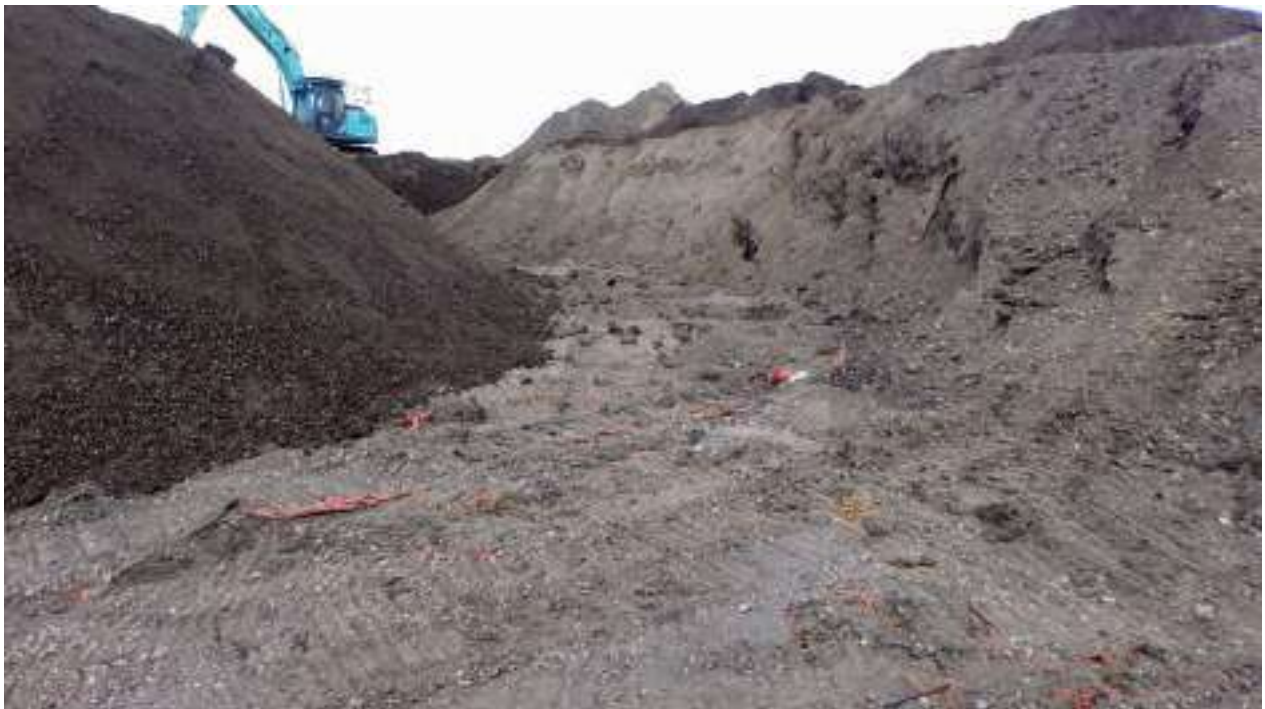
**Photograph 2: Membrane evident beneath stockpile and screened Topsoil**

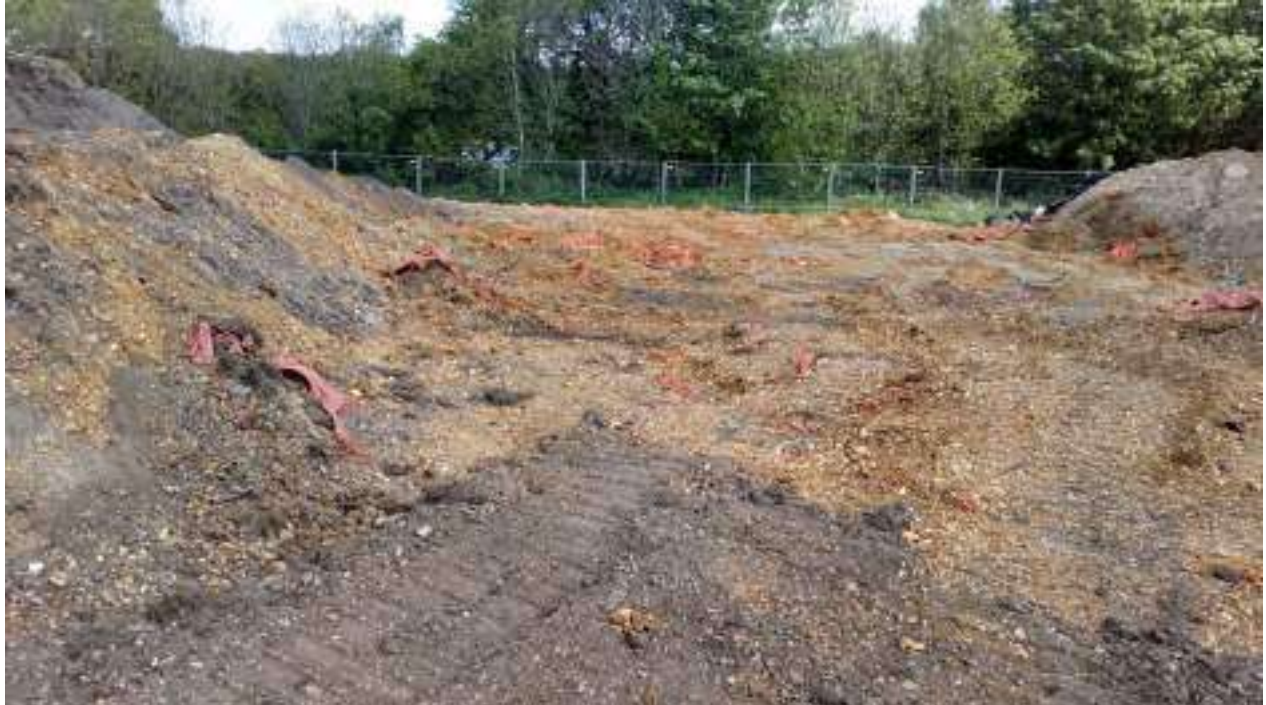
**Photograph 3: Membrane evident where natural soil arising stockpiles have been utilised**

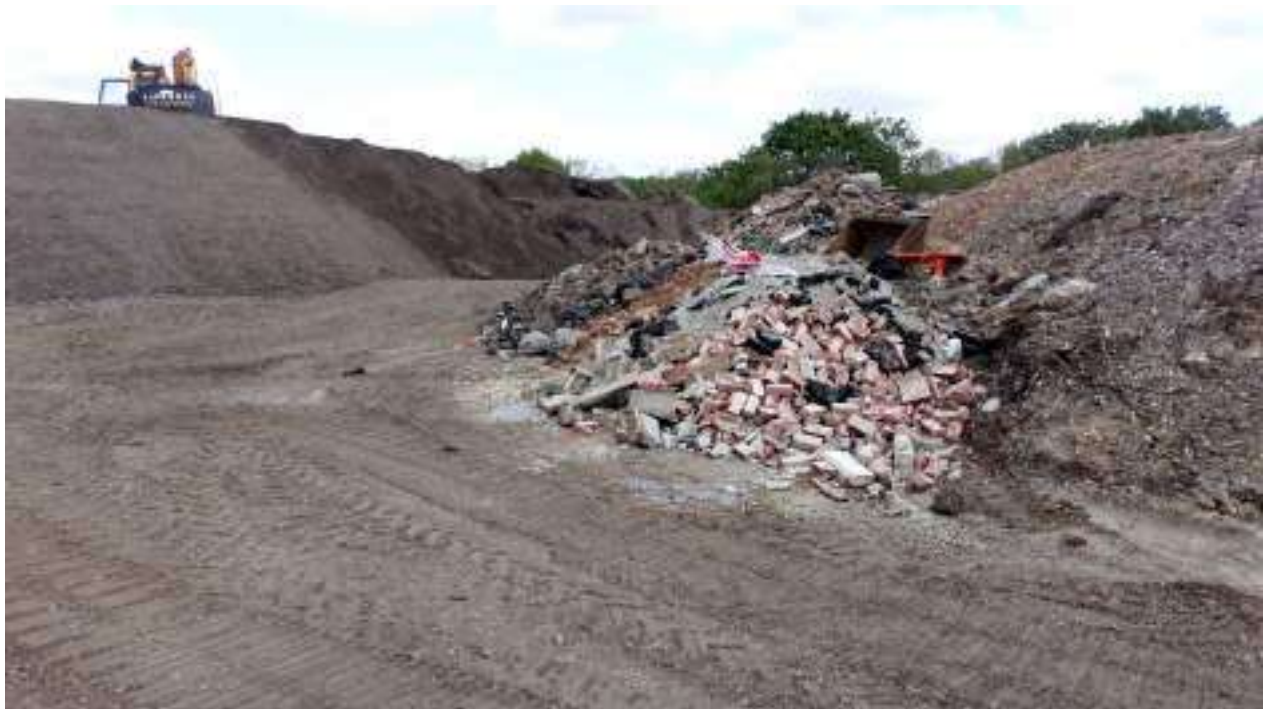
**Photograph 4: Construction waste materials placed to the south of the topsoil stockpile**

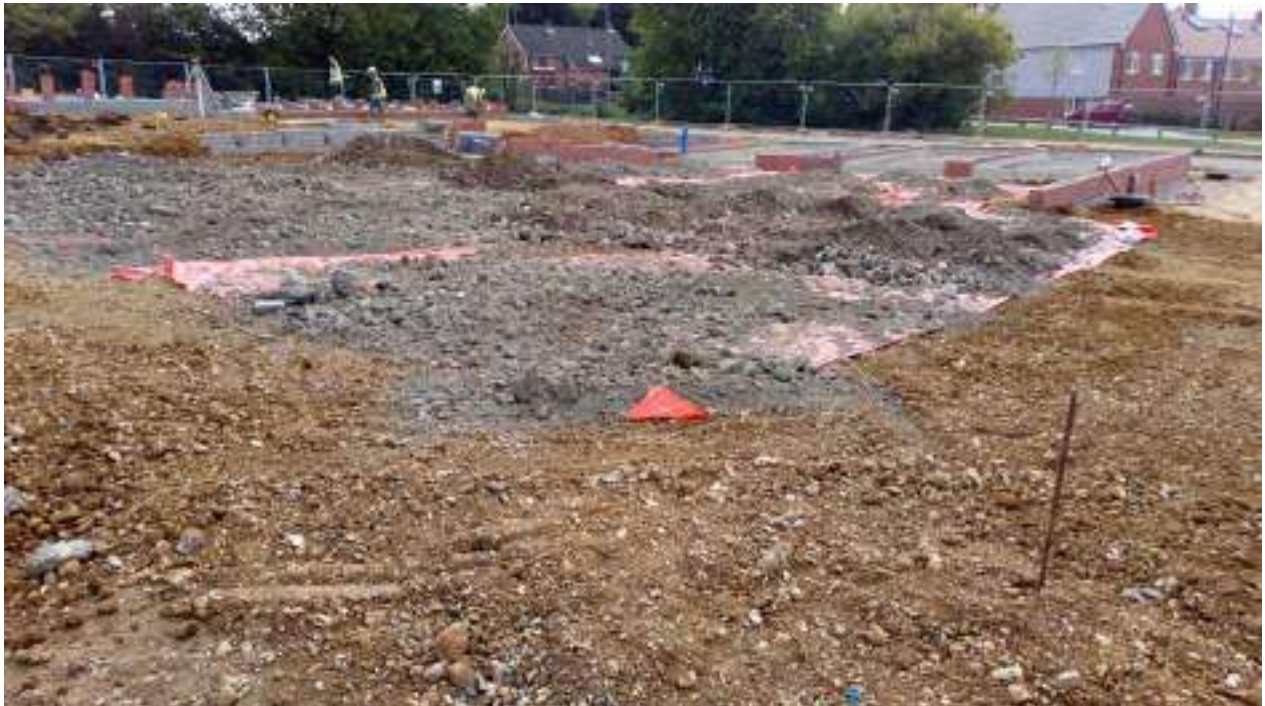
**Photograph 8: Placement of crush material on top of membrane in the south east of the site**

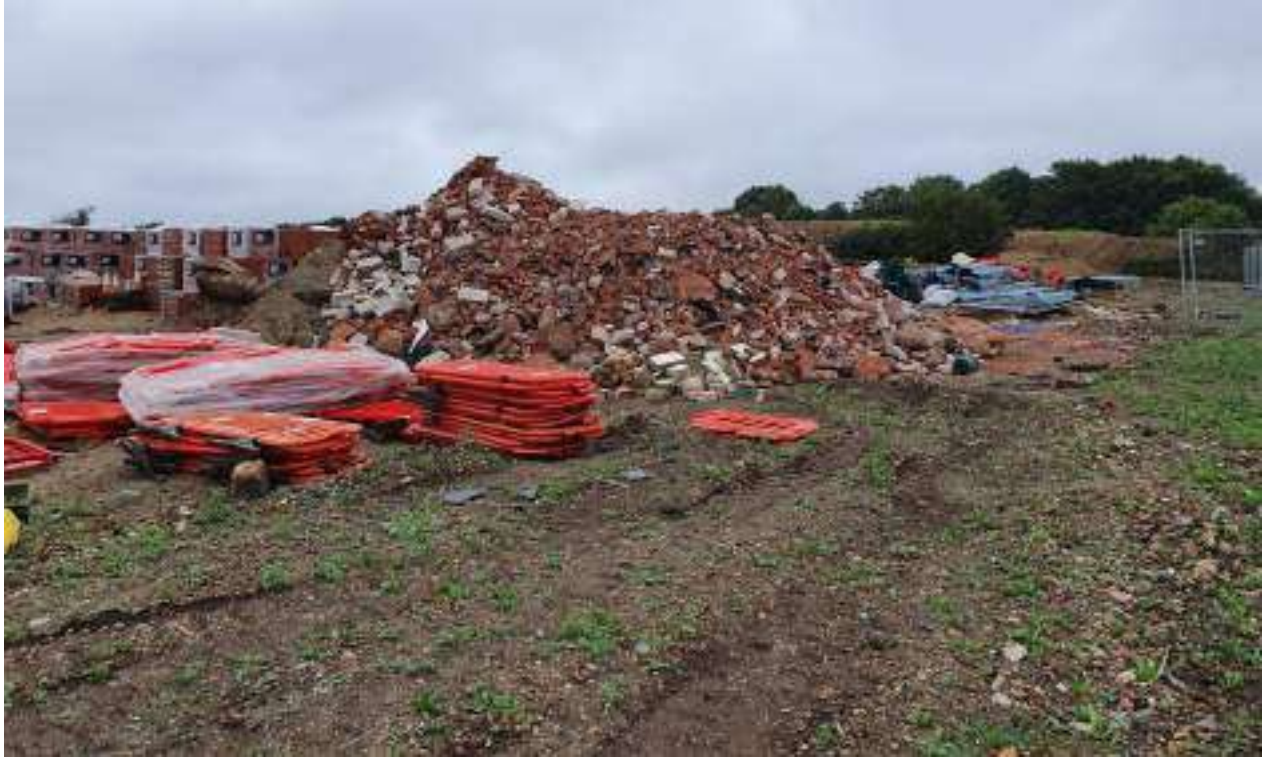
**Photograph 1: Brick and block waste stockpile to west of TW compound**

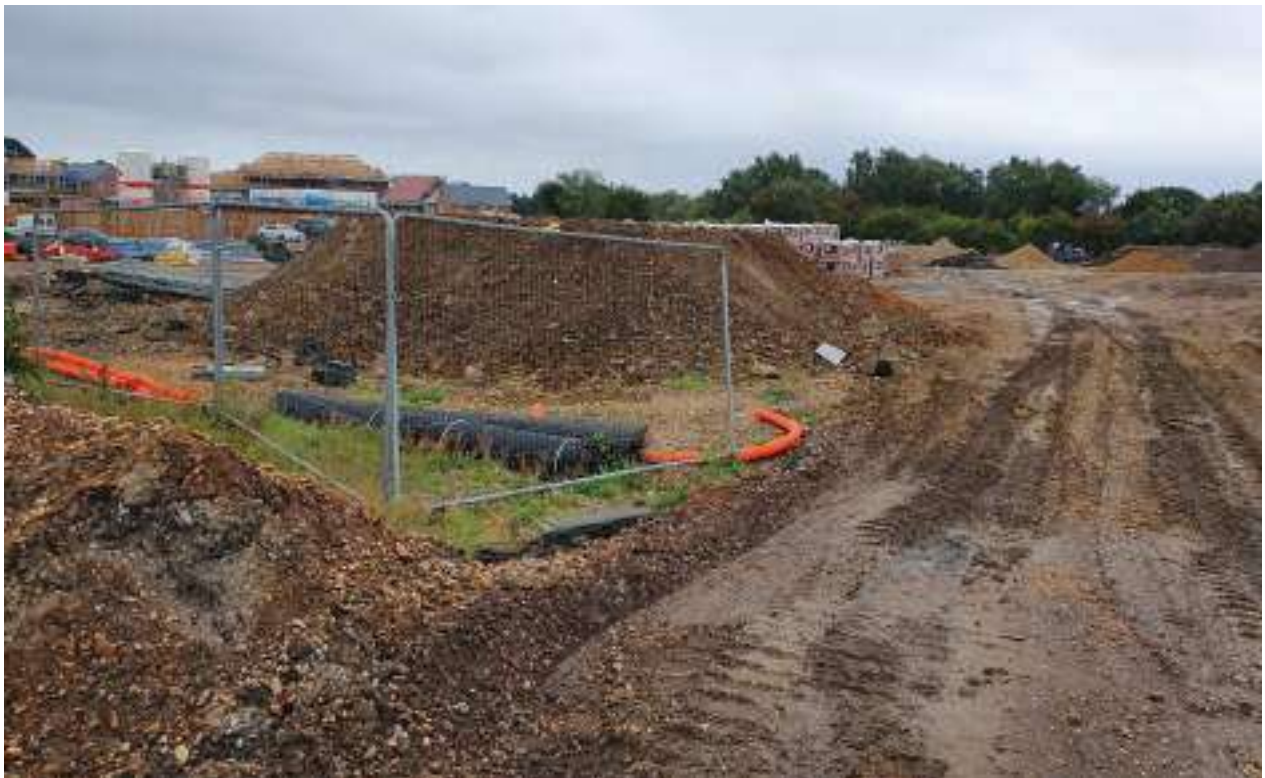
**Photograph 2: Soil and brick waste stockpile to west of TW compound**

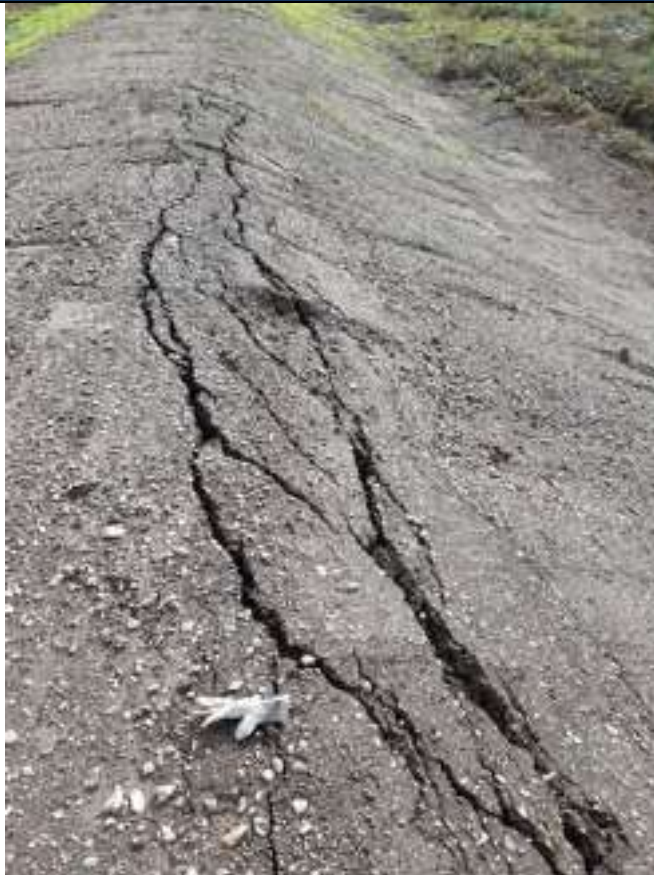
- The steep sides of the bund have numerous surface cracks present due to instability of materials.
  - The bund seems to be well compacted however it is extremely water logged in places and water ingress was noted during hand excavation of an inspection pit.

**Photograph 3: Surface cracks within topsoil of the bund.**

- Records of materials imported to the site should be maintained and efforts should be made to ensure that materials placed in the vicinity of stockpiles will not have a negative effect of stockpiled materials (i.e. cross contamination).
- Monitoring of the bund to ensure that cracks do not increase which could potentially cause bund failure.

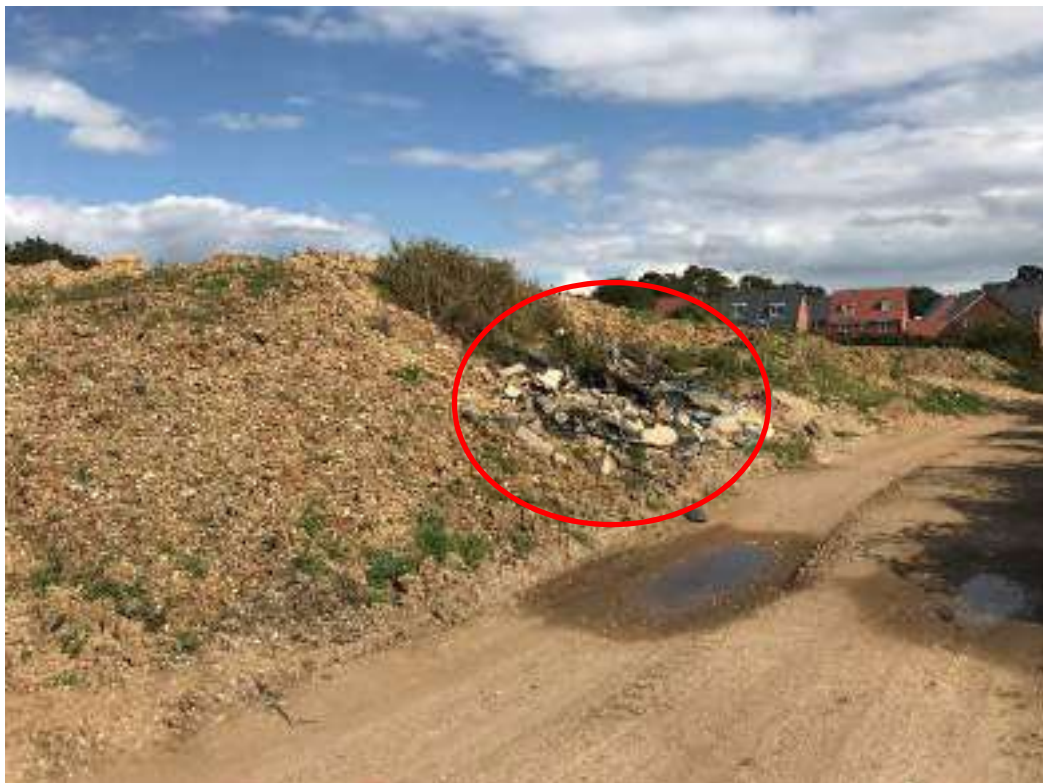
**Photograph 4: Mixed soils stockpile – unsuitable materials circled**

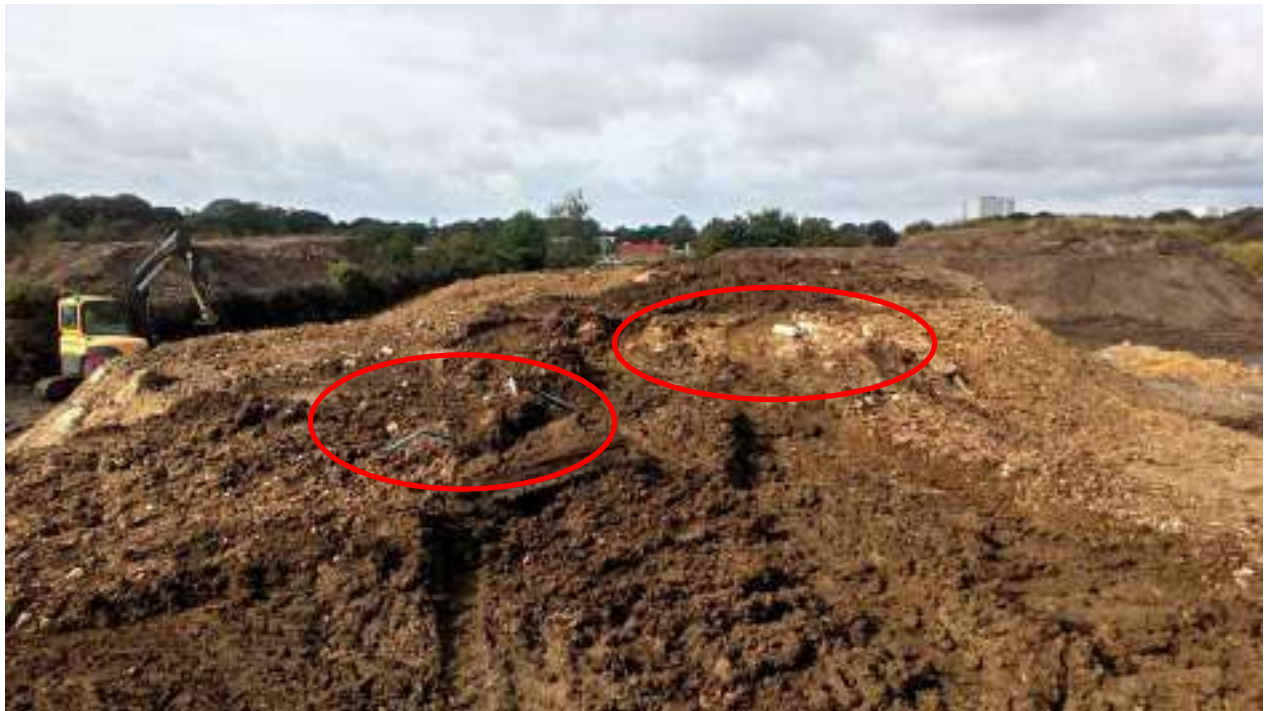
**Photograph 5: Mixed soils stockpile – unsuitable materials circled**

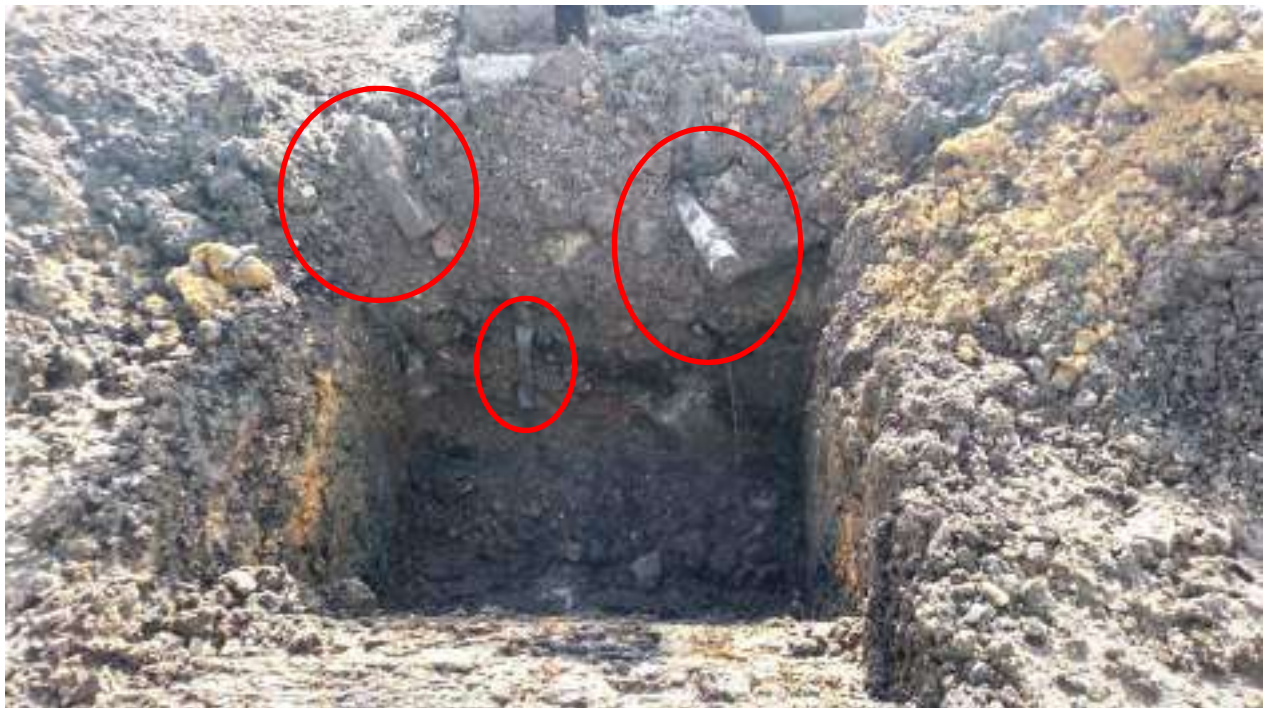
**Photograph 6: Excavation in mixed soils stockpile – unsuitable materials circled**

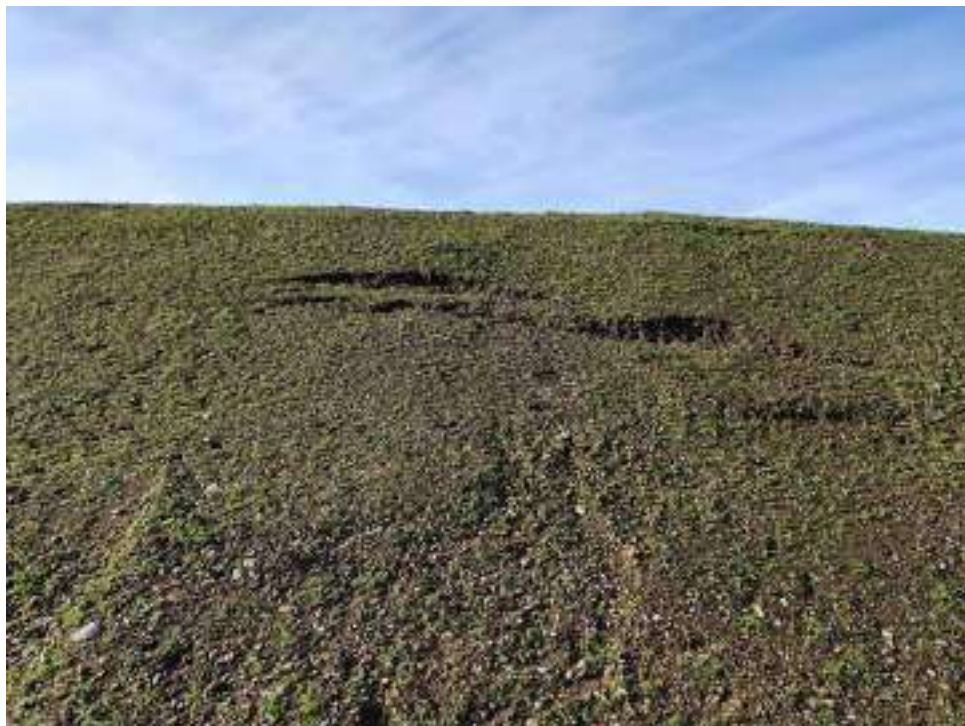
- Several of the surface cracks present within the bund appear to have grown larger since the last visit to site (09/10/2019) with occasional small failures present.

**Photograph 4: Surface cracks in bund. Facing southwest.**

- Stockpiles should be appropriately managed to ensure retention of good quality materials for reuse and no cross-contamination.
- Materials management tracking info on soil import from Burr ridge Green must be provided e.g. consignment notes.
- Monitoring of the bund to ensure that cracks do not increase which could potentially cause bund failure.

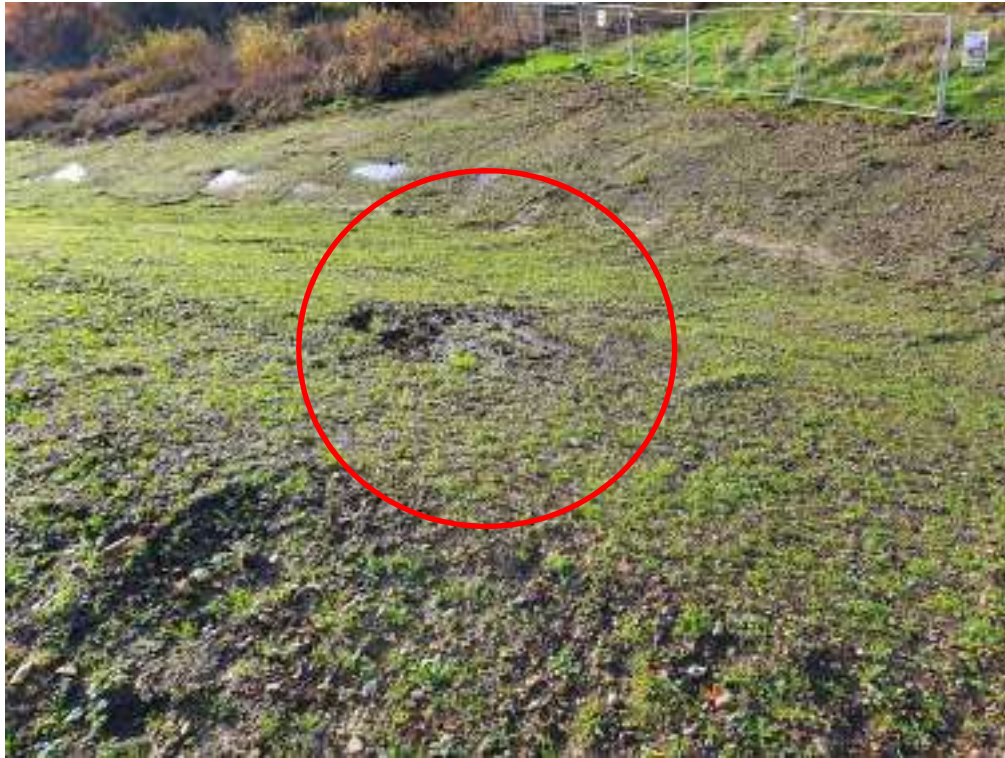
**Photograph 5: Small bund failure on west facing slope of bund (approx. 2m length)**

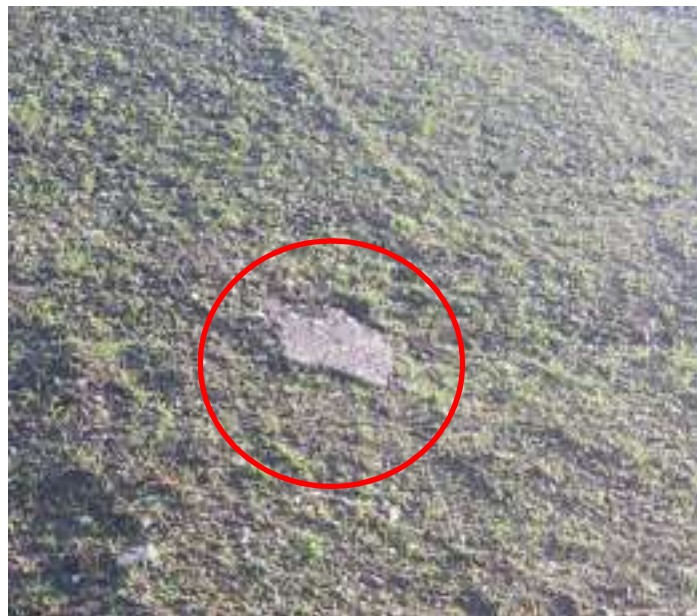
- It is noted that several large pieces of asphalt remain in the soil bund created to the south of the site access road. Previous recommendations were made that large objects were to be removed from the stockpile using a riddle bucket for example.

**Photograph 6: Asphalt remains within west face of bund (approx. 50cm)**

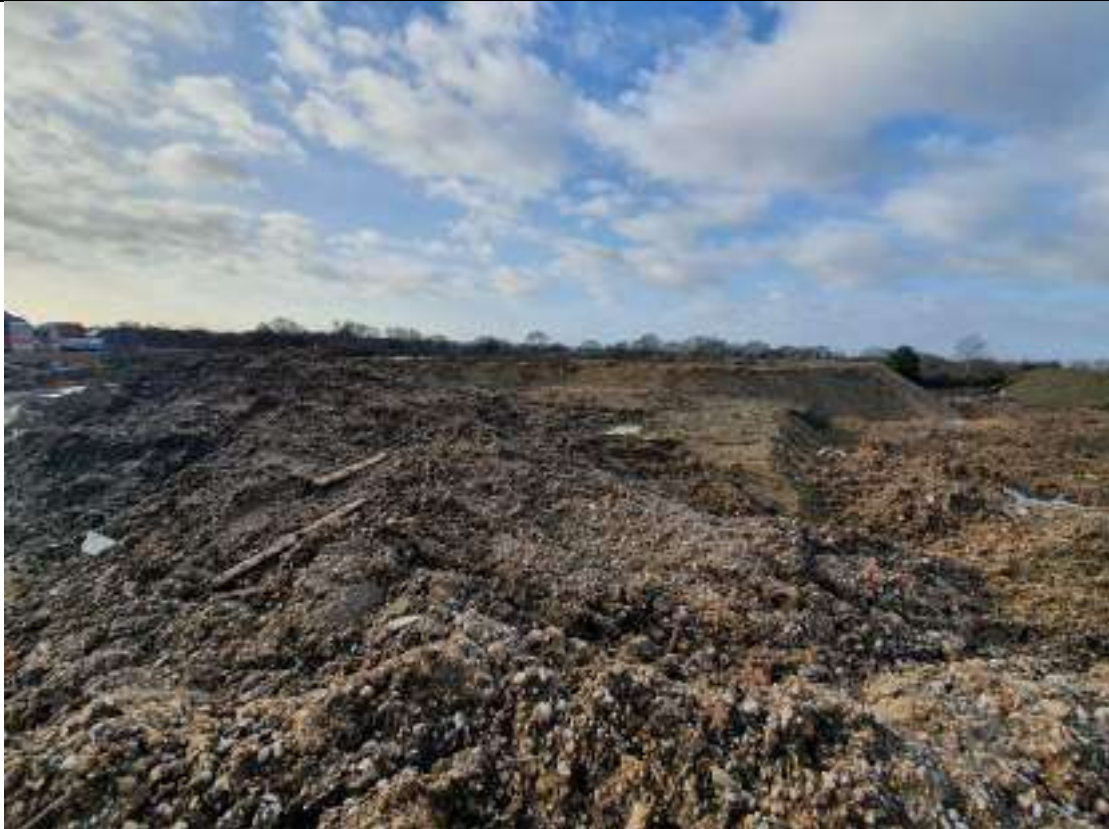
- Gracelands have been advised not to utilise or move the mixed subsoil stockpile following identification of the presence of asbestos fibres within the soils based on the subsoil verification works undertaken on 09/10/2019. This material must be fenced off until further notice.
- Stockpiles should be appropriately managed to ensure retention of good quality materials for reuse and no cross-contamination.
- Materials management tracking info on soil import from Burr ridge Green must be provided e.g. consignment notes.
- Monitoring of the bund to ensure that cracks do not increase which could potentially cause bund failure.
- Tracking info to be provided for movement of topsoil from Heron Walk.

**Photograph 4: Remaining mixed subsoil stockpile.**

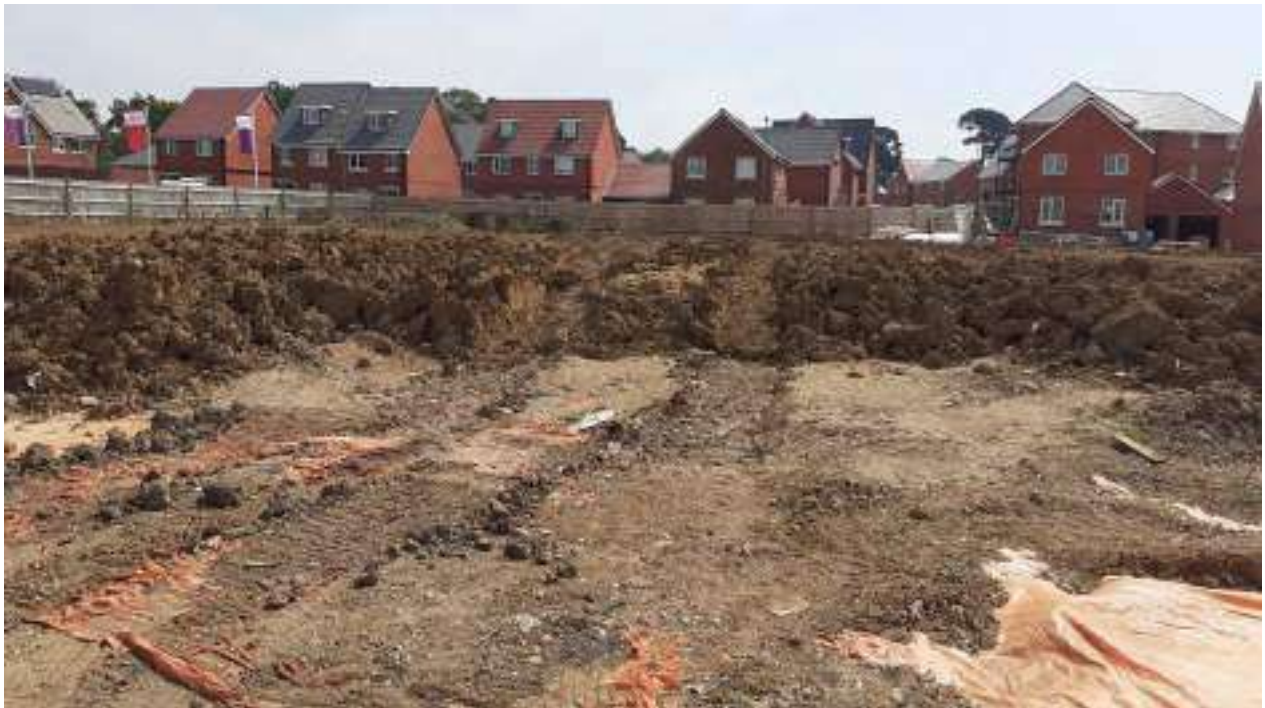
- Stockpiling of materials imported from the BurrIDGE Green has been ongoing. Stockpiles and soil bunds are vegetated where not recently placed.
- Soils are noted to have been placed to the north of the site compound.

**Photograph 2: Recently placed soils to the north of site compound**

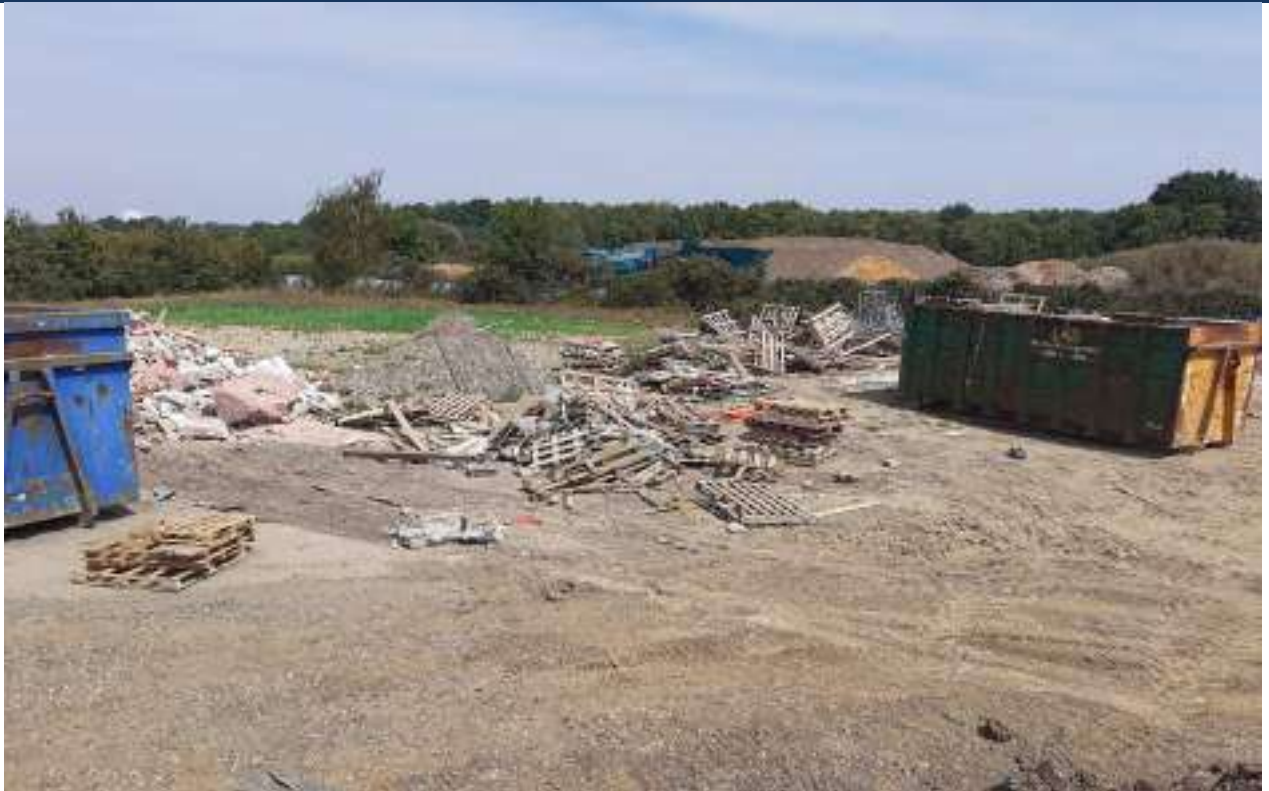
**Photograph 7: Looking north across area of Japanese Knotweed burial pit, stockpiled waste materials**

- Stockpiles should be appropriately managed to ensure retention of good quality materials for reuse and no cross-contamination.
- Waste soils and materials noted in the vicinity of the Japanese Knotweed burial pit should be disposed of appropriately.
- Materials management tracking info on soil import from Burr ridge Green must be provided e.g. consignment notes. Some records have been provided to date. Details of where soils are being placed should be provided to Hydrock.
- Monitoring of the bund to ensure that cracks do not increase which could potentially cause bund failure.
- Tracking info to be provided for movement of topsoil from Heron Walk.
- Membrane to be placed beneath capping layer prior to placing clean soils in the former landfill area – Hydrock to be informed in advance of capping layer construction to allow for inspections and testing.

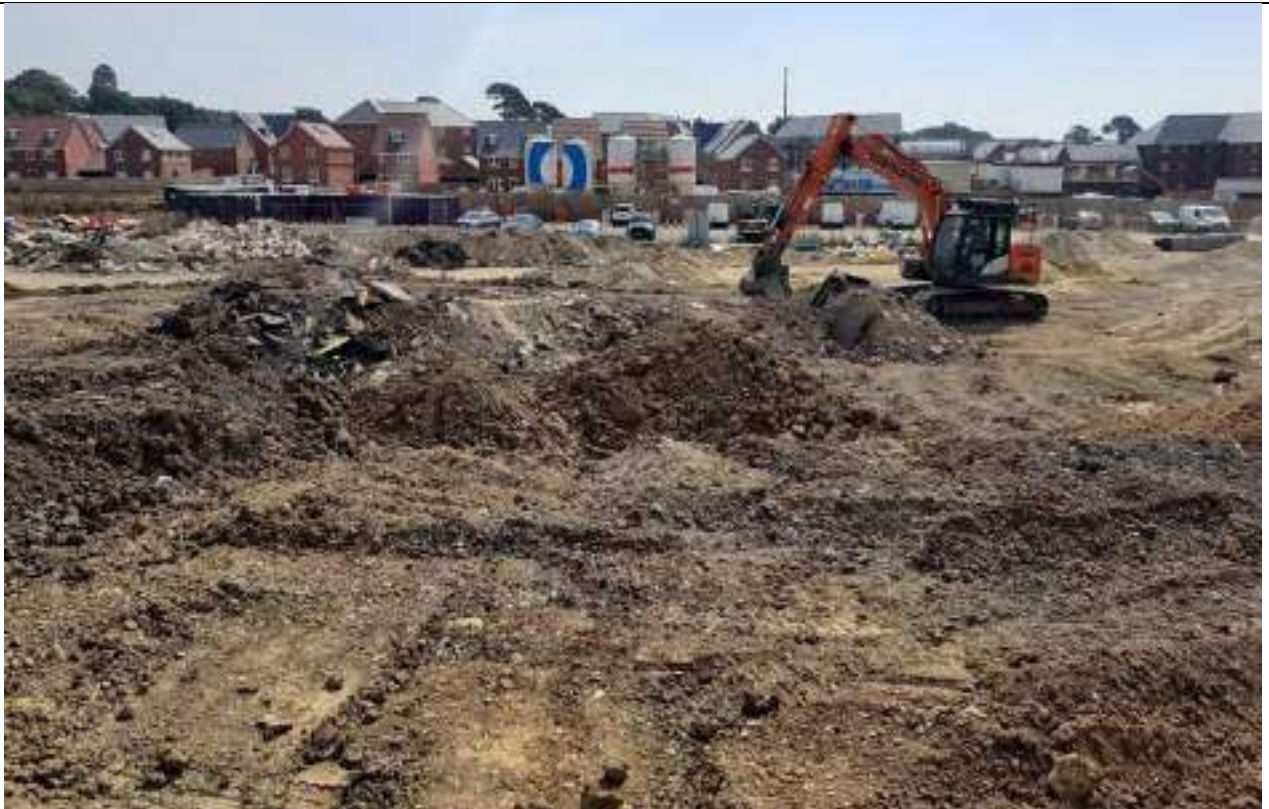
**Photograph 8: Various mixed soils and construction waste materials to the west of the site compound.**
